ARBORICULTURAL IMPACT ASSESSMENT

PROPOSED CHILD CARE DEVELOPMENT APPLICATION

187-189 ADELAIDE STREET ST MARYS, NSW

14th November 2021 – Version 1

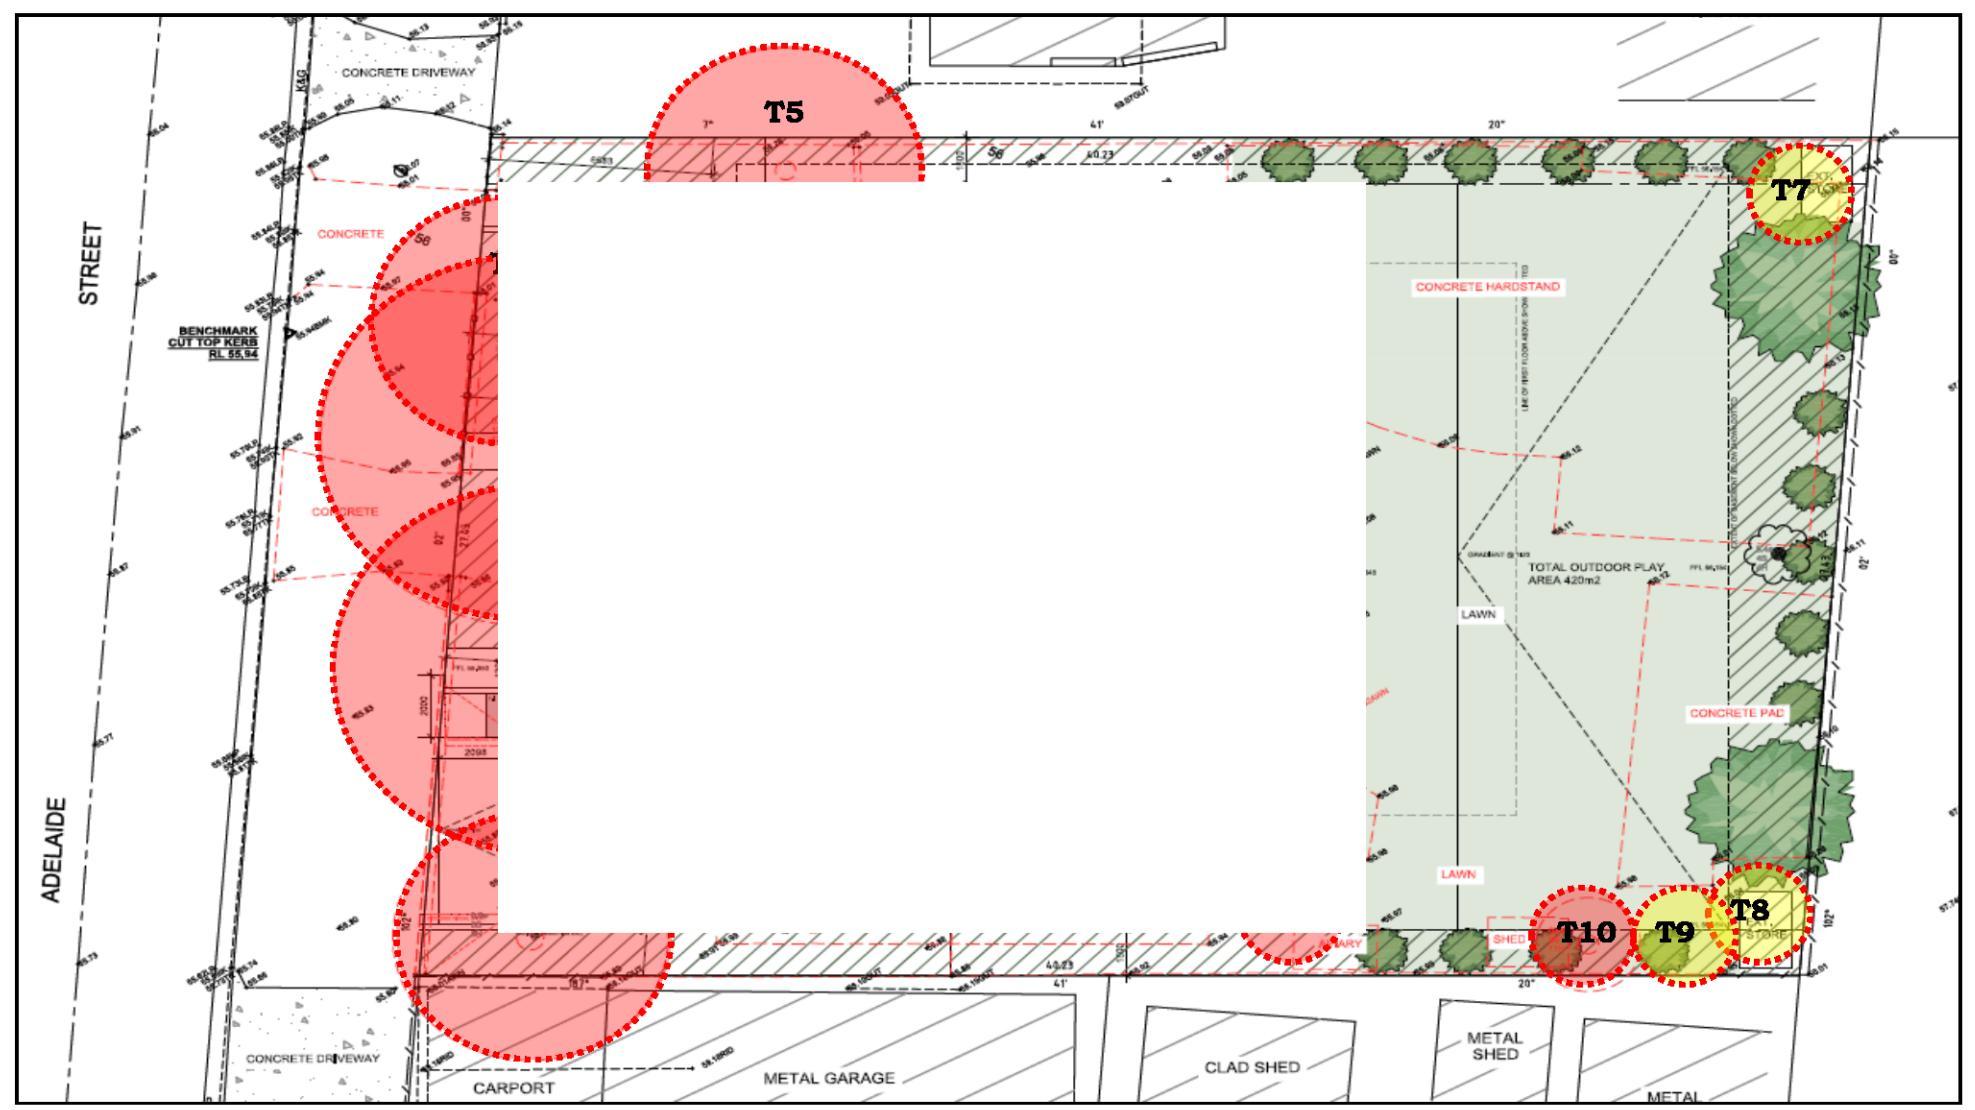
Figure 6 Shows the trees in RED to be removed or TPO Exempt in YELLOW based on the plans provided.

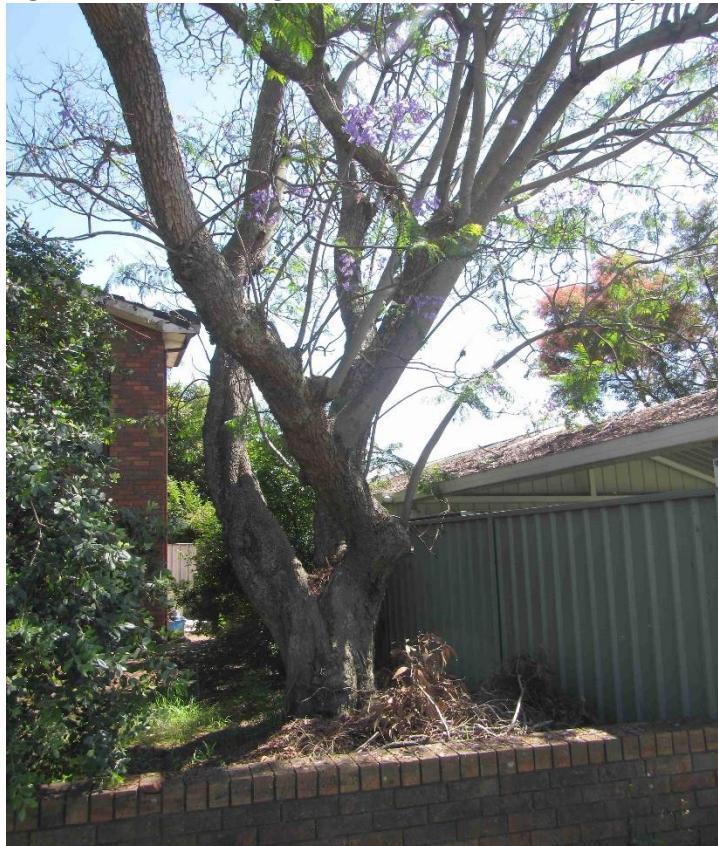
Figure 7 Shows Tree 1 to be removed as it is located within the proposed driveway envelope.

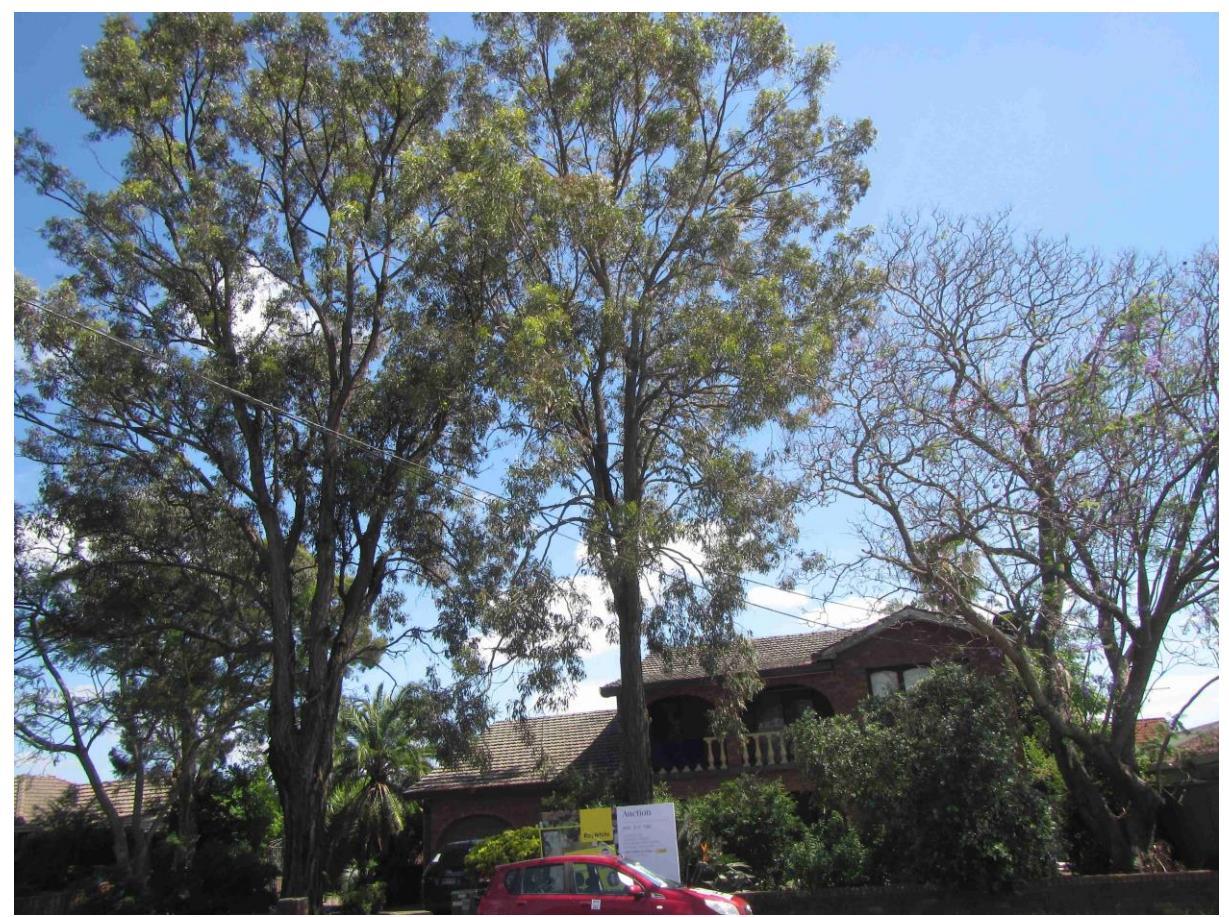
Figure 8 Shows Trees 1, 2 and 3 from a distance to be removed and replaced.

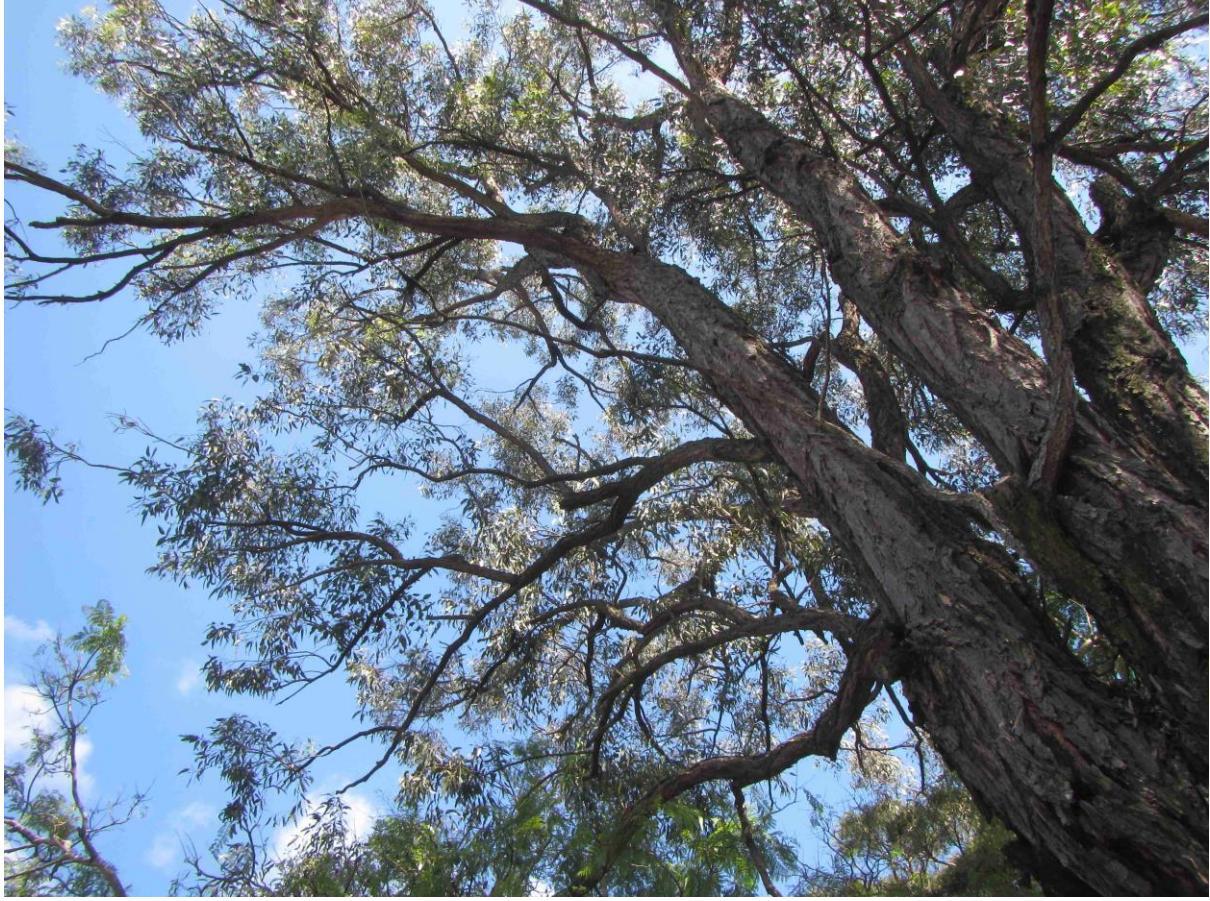
Figure 9 Shows Tree 4 with deadwood, and declining canopy required to be removed.

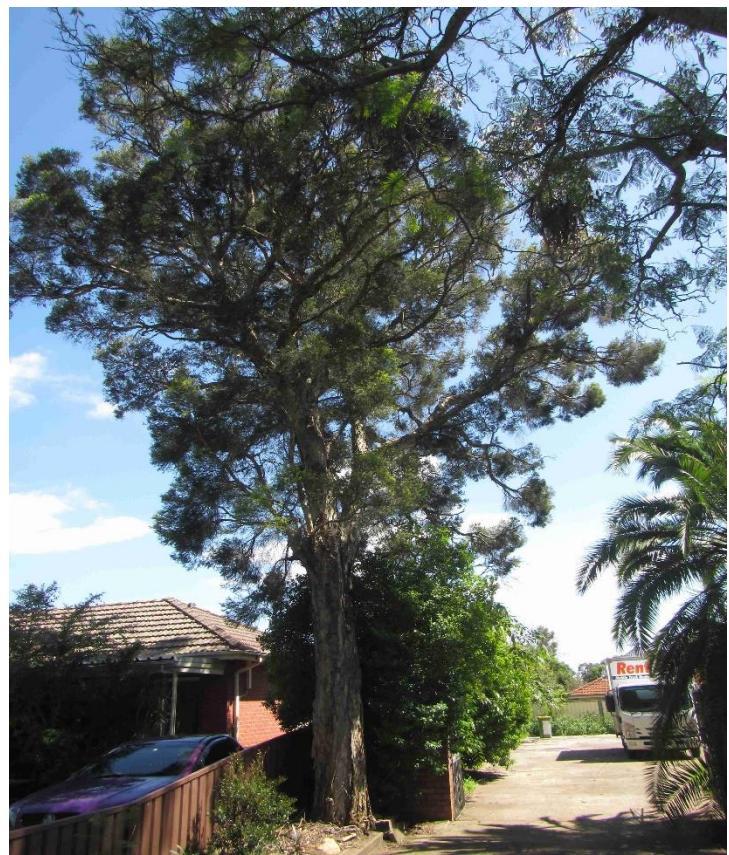
Figure 10 Shows Tree 5 from a distance that is required to be removed due to site modifications and proposed building envelope and scope of works.

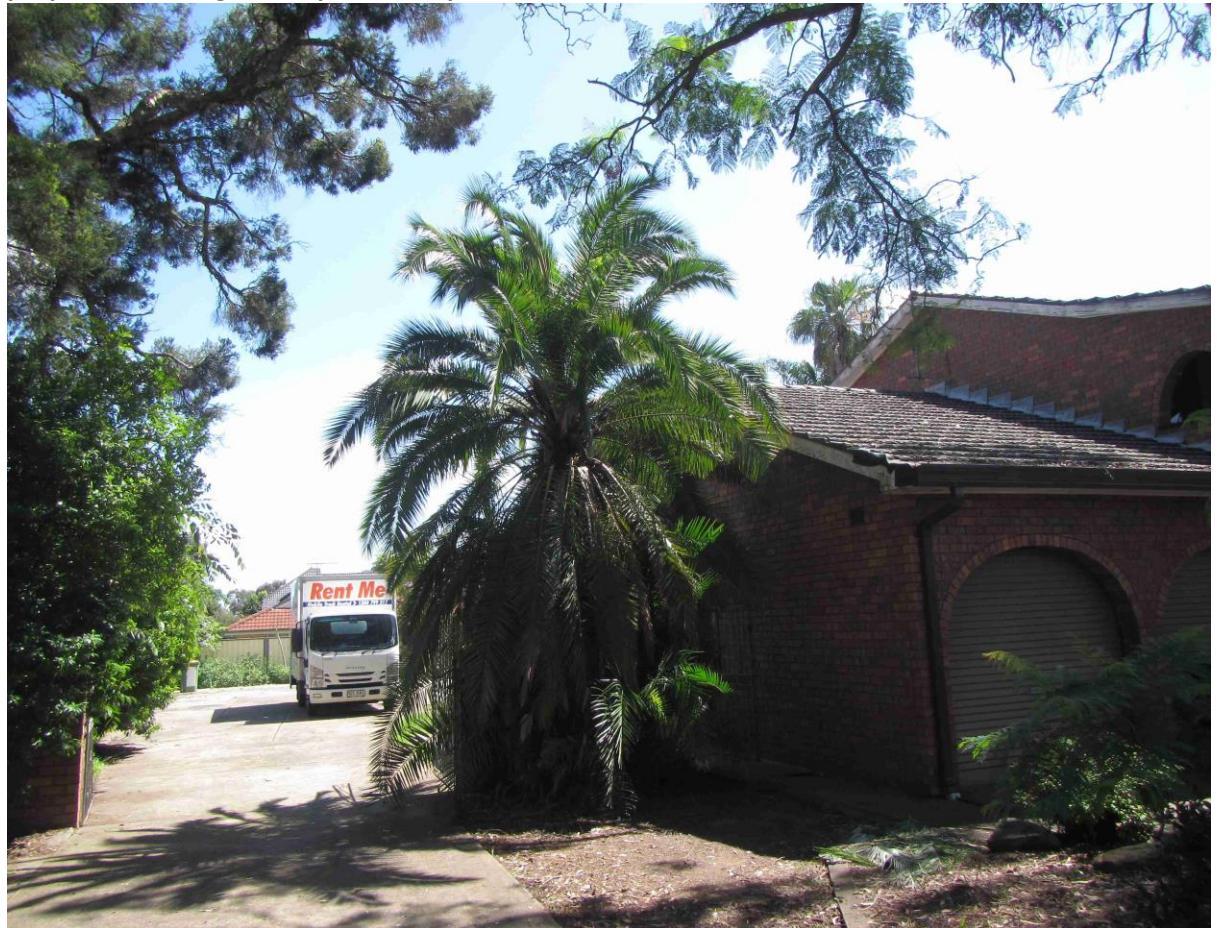
Figure 11 Shows minor palm Tree 6 that is required to be removed.

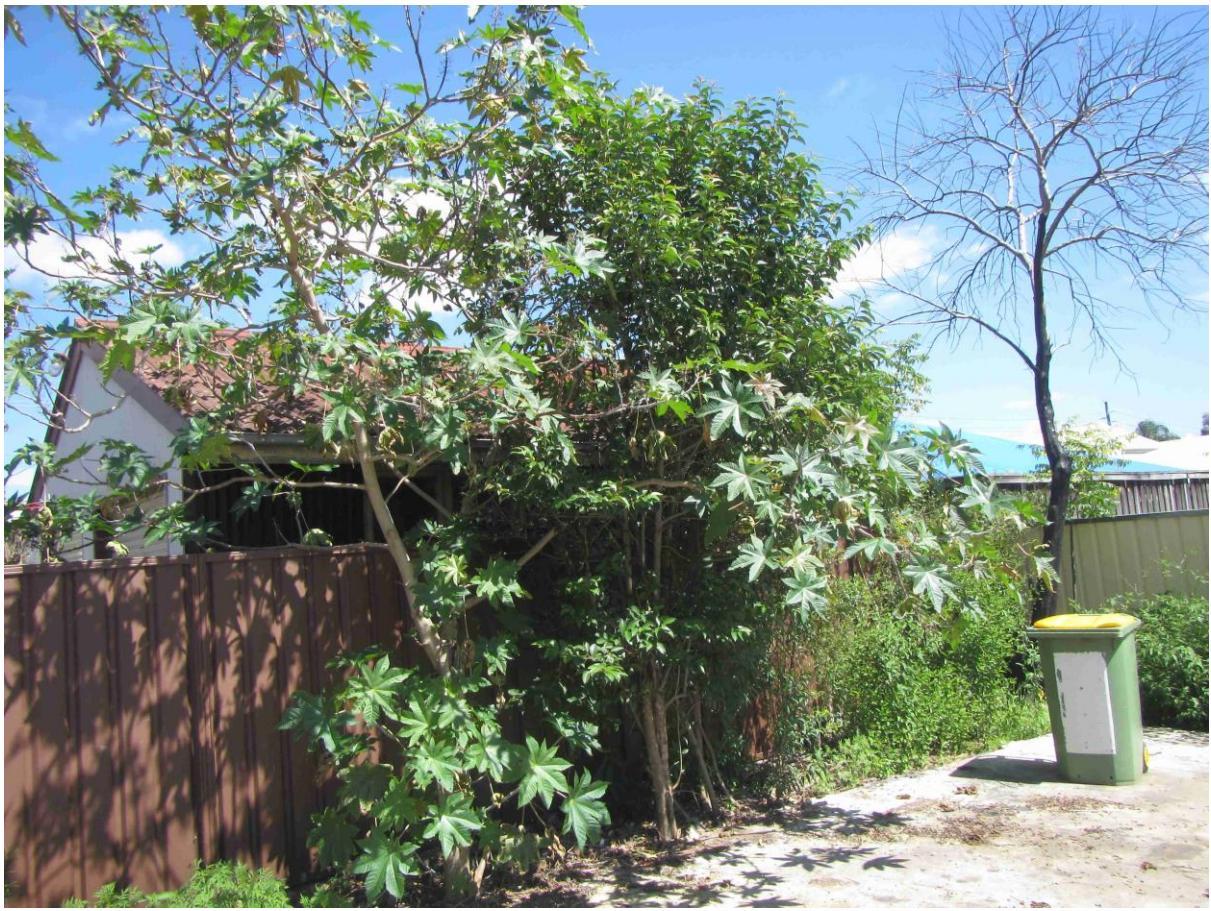
Figure 12 Shows Castor oil, privet, and dead Tree 4 to be removed.

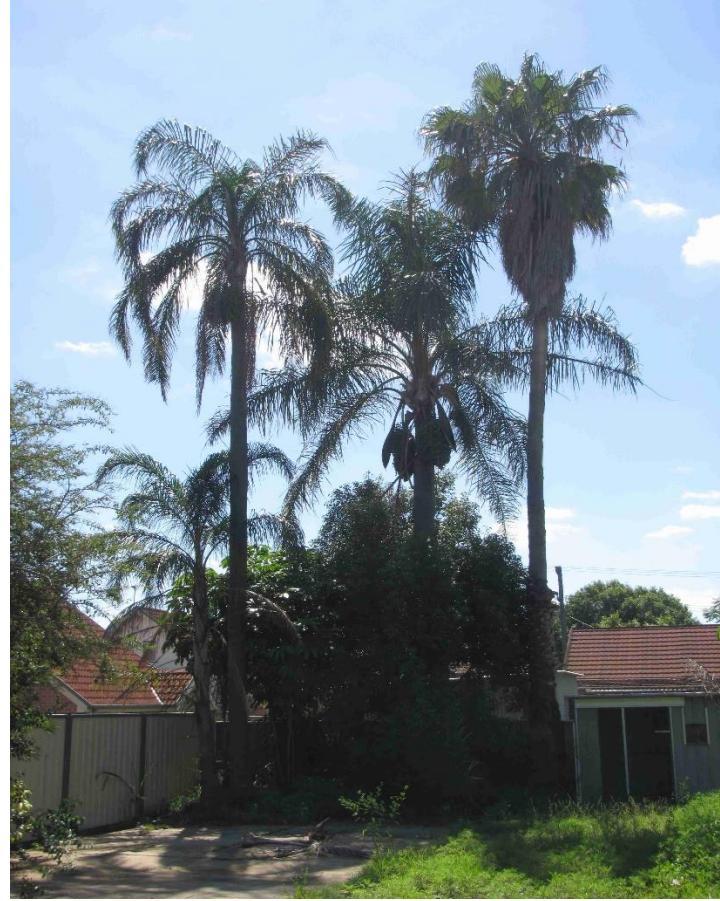
Figure 13 Shows palm Trees 8, 9 and 10 from a distance required to be removed.
