Report on
Land Capability Assessment

Fernhill Estate
Eastern Precinct
Mulgoa Road, Mulgoa

Prepared for
Cubelic Holdings Pty Ltd

Project 71706.01
June 2013

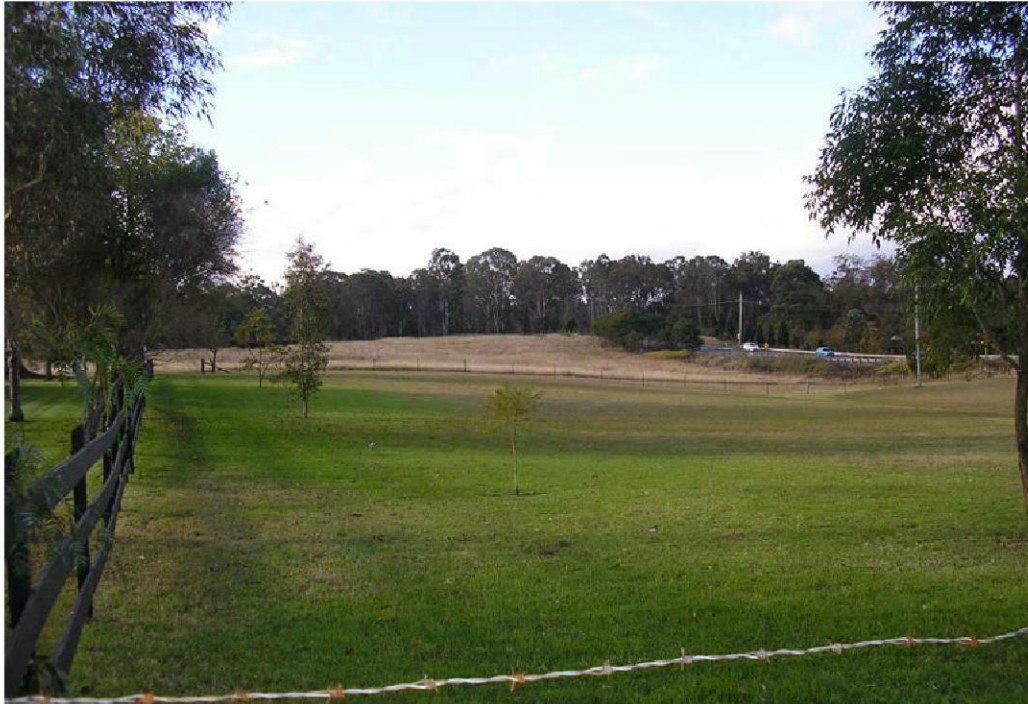
Photo 1 – View looking north across eastern part of Lot 1 between existing dwelling and Mulgoa Road

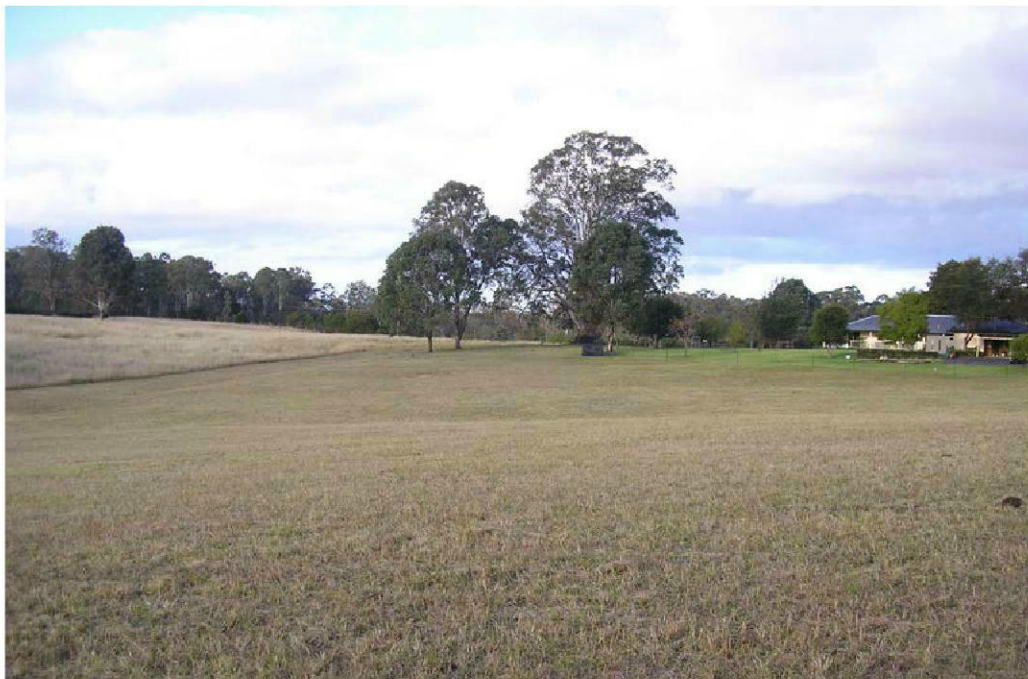
Photo 2 – View looking east across central eastern part of Lot 1 between Dam 1 and existing dwelling

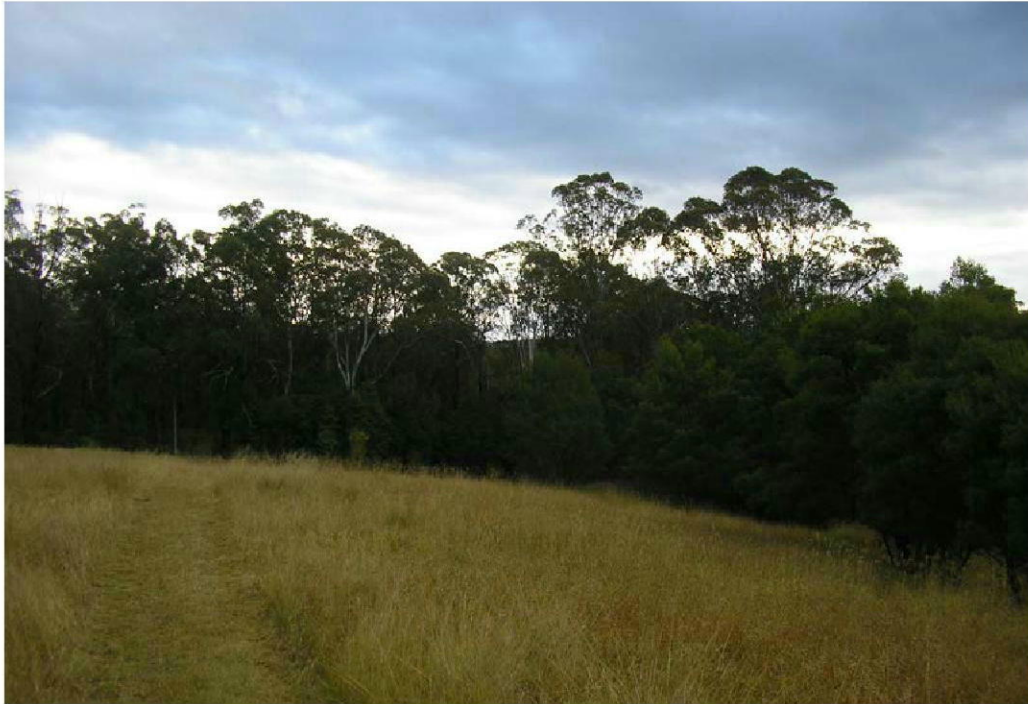
Photo 3 – View looking west across western part of Lot 1 west of Dam 1 towards tree line along western site boundary

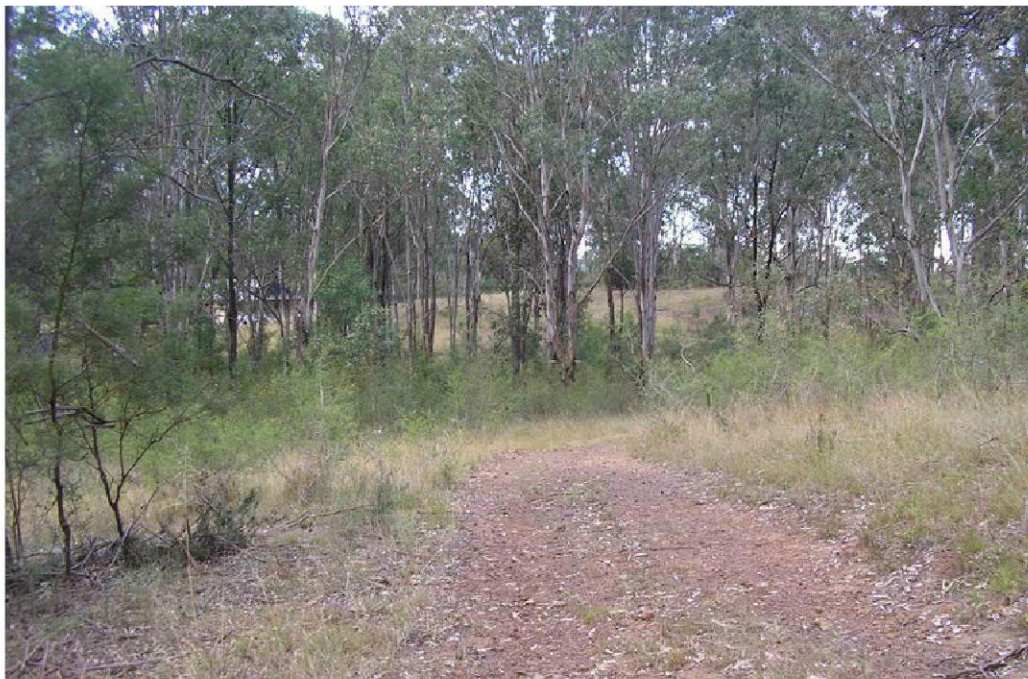
Photo 4 – View looking along existing unsealed track traversing partly cleared bushland near northern site boundary

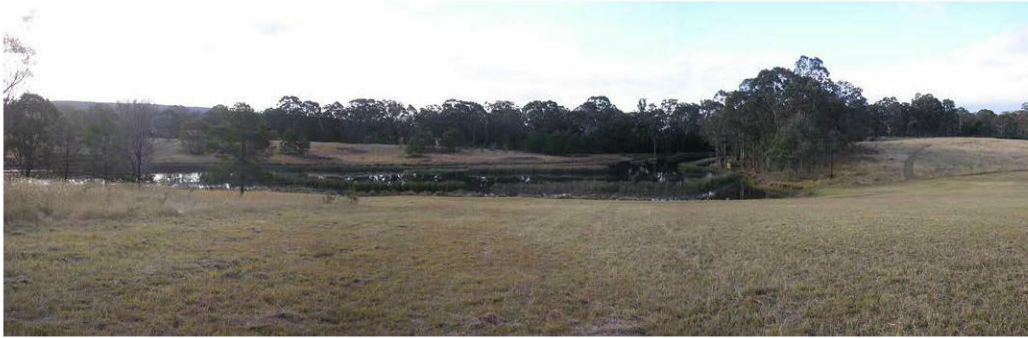
Photo 5 – Panoramic view looking north across Dam 1 through central part of Lot 1

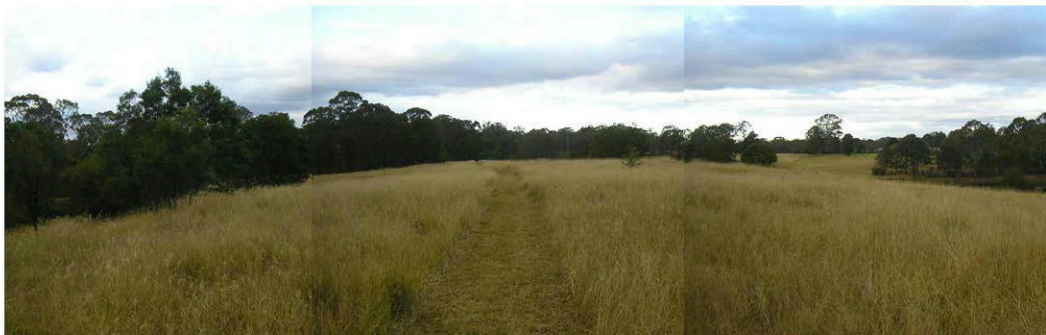
Photo 6 – Panoramic view looking north-east across western part of Lot 1

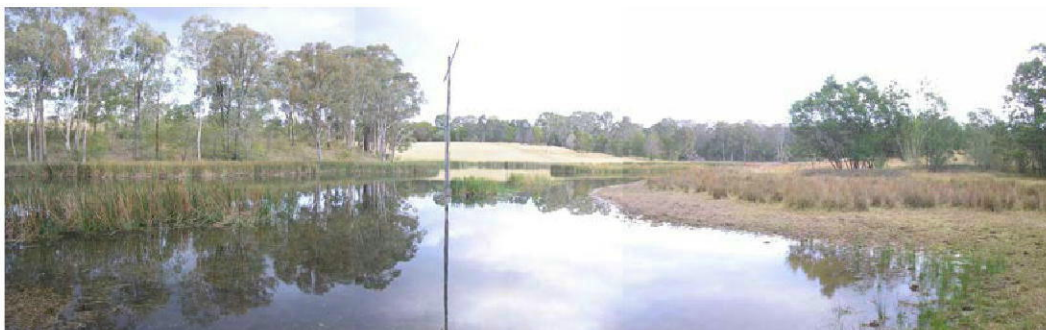
Photo 7 – Panoramic view looking south across Dam 1 through central part of Lot 1
