Preliminary  
Phase 2 Environmental Assessment  
University of Western Sydney  
South Werrington Sub-Precinct  
University of Western Sydney

February 2009

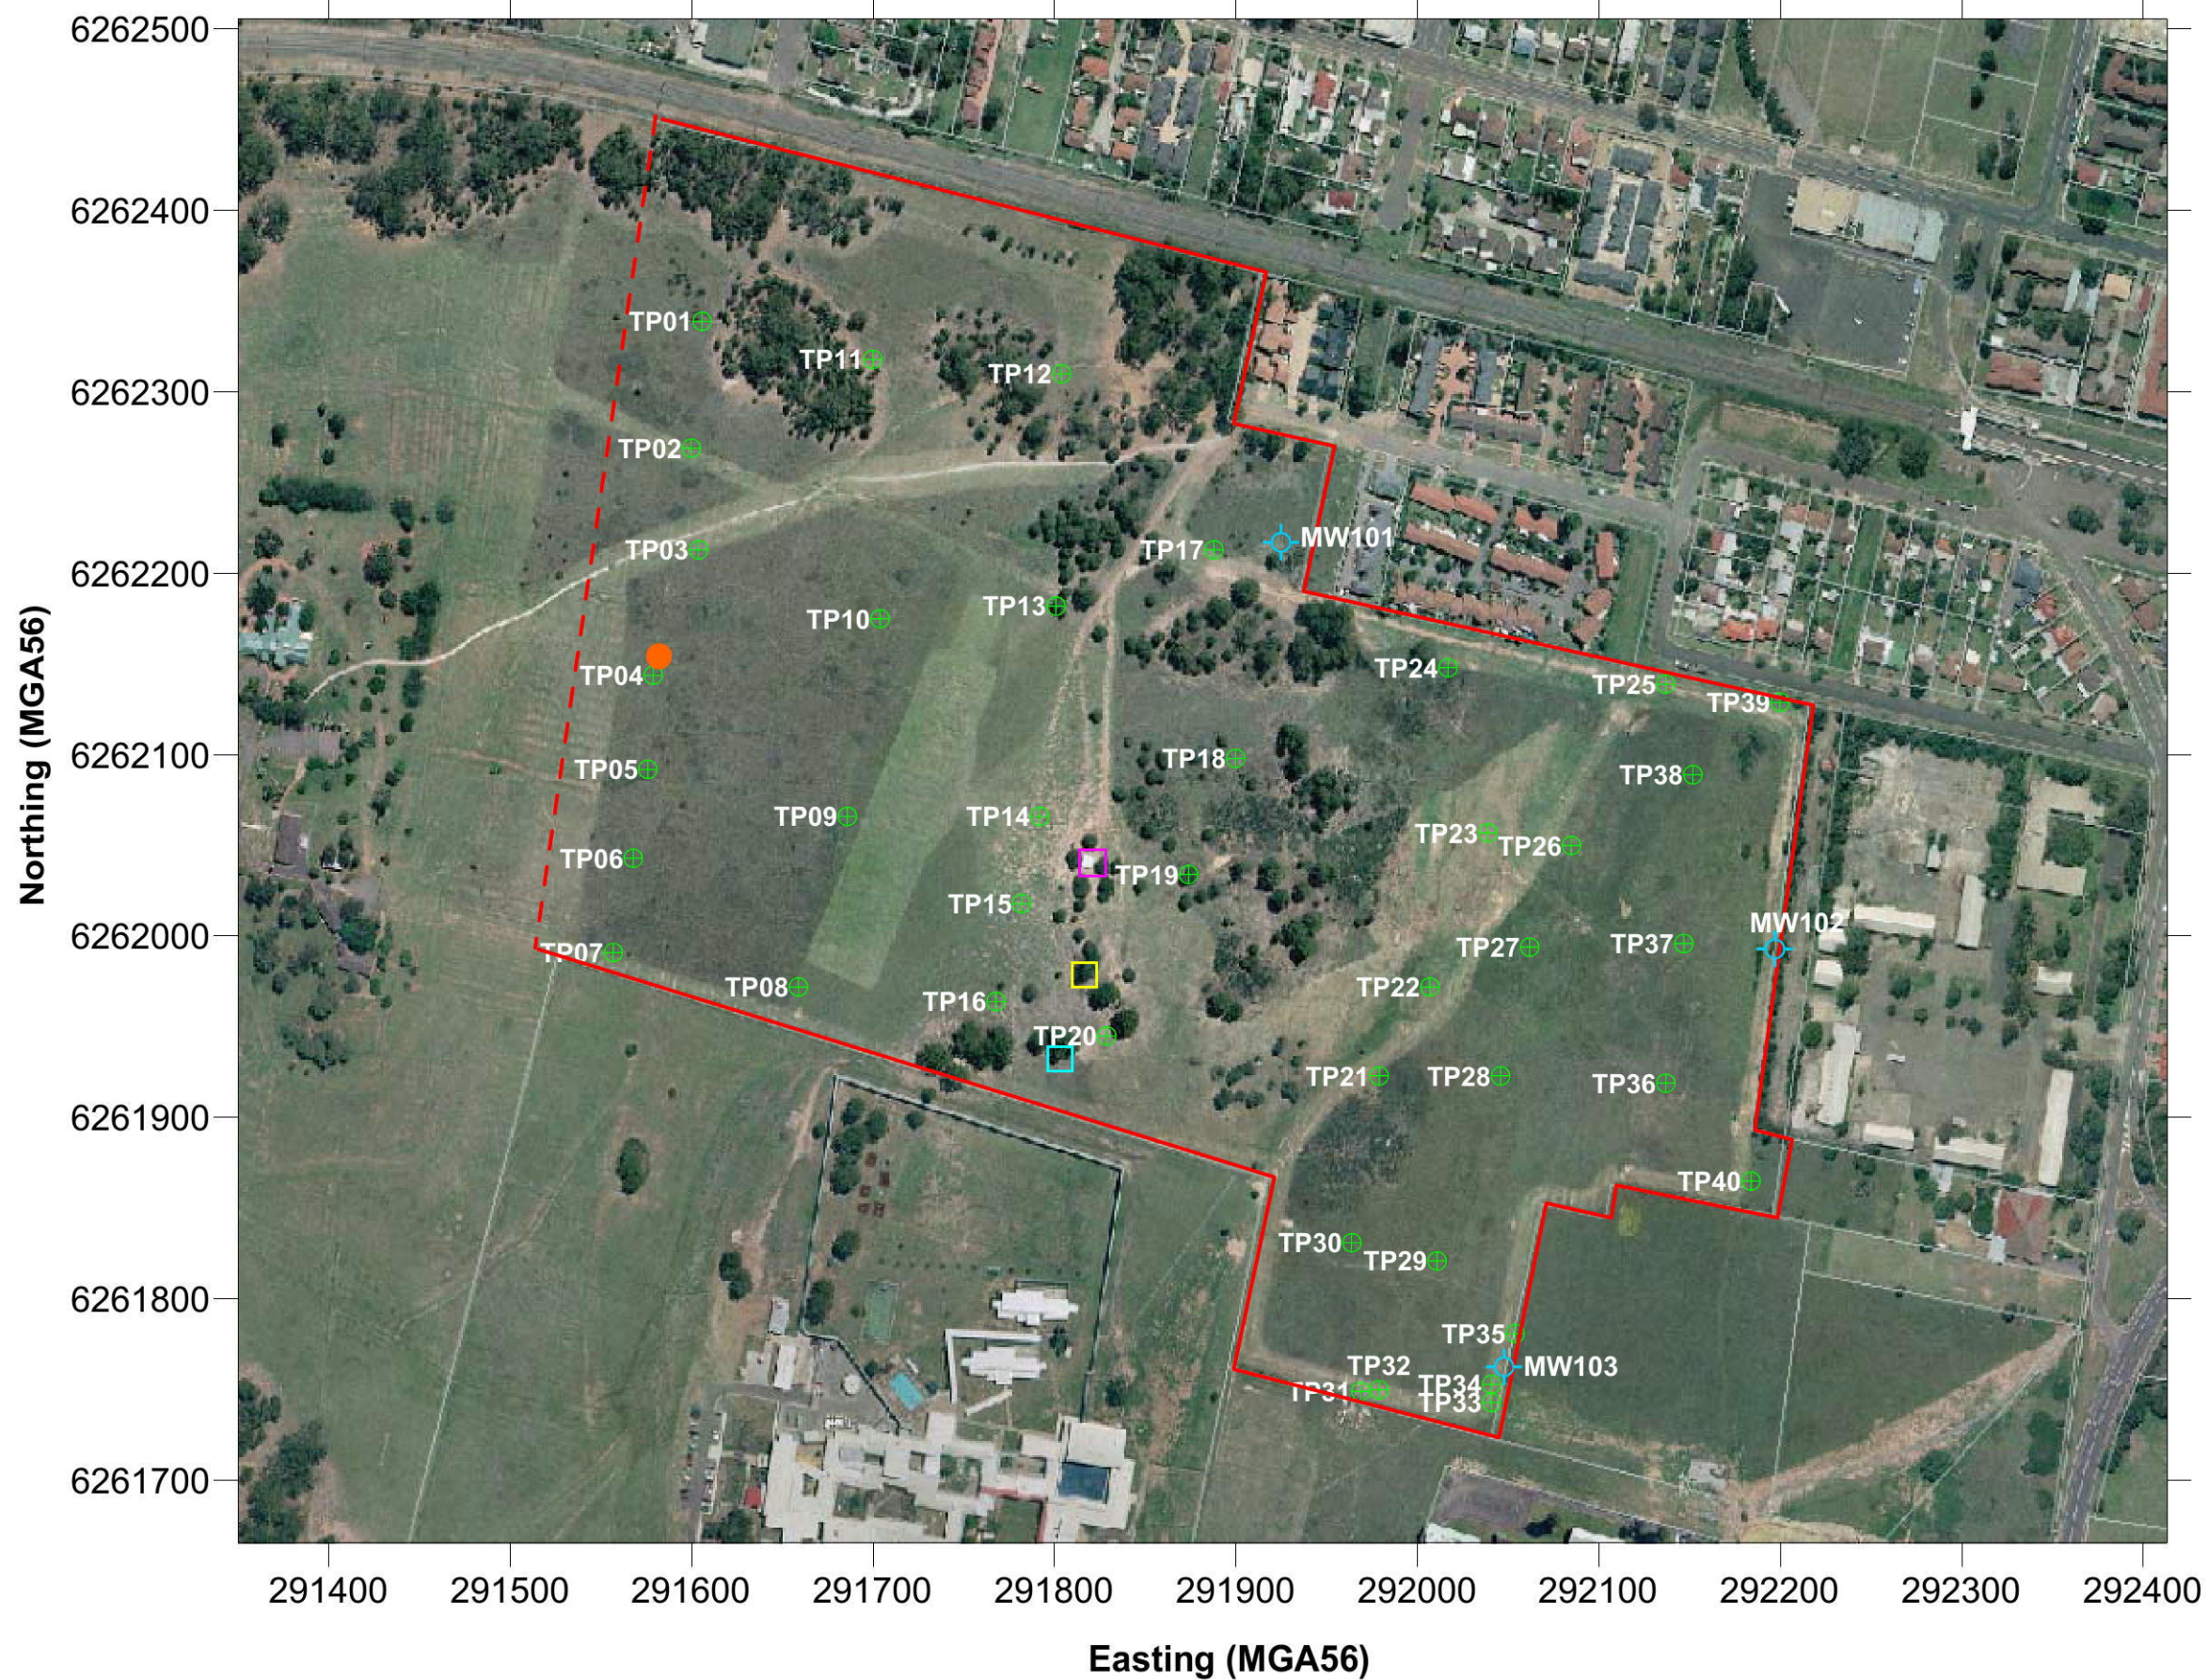
**Figure 3**

- Site Boundary
- - - Estimated Site Boundary
- ⊕ Testpit
- Pipe (containing asbestos)
- Toilet
- Shelter Shed
- Work Bench and Empty Drums

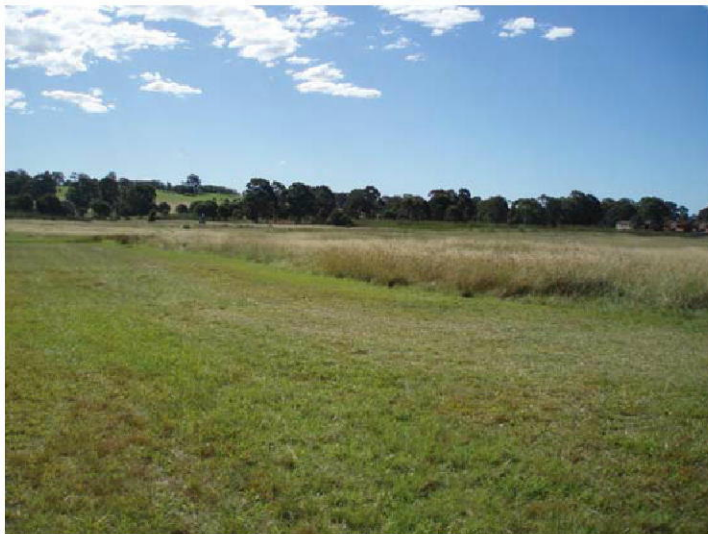
Plate 1 Looking west from south-east corner of site. Note tall grass, area inundated.

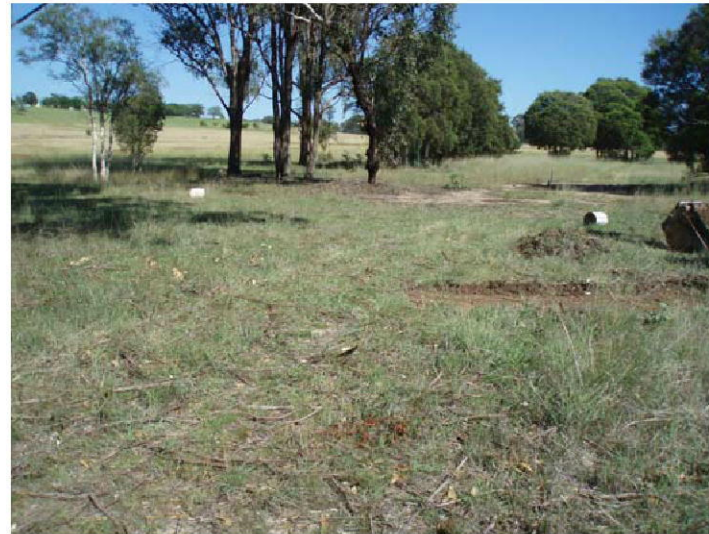
**Plate 6 Location of test pit 20 (right) adjacent to drums and workbench.**

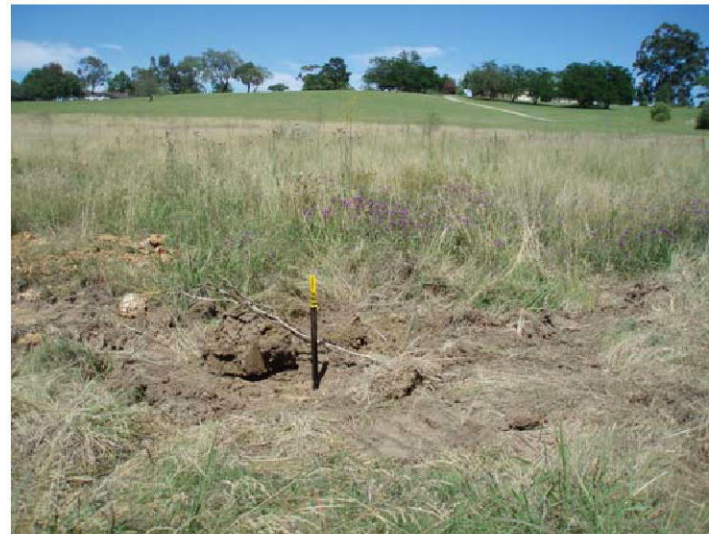
No fibre cement fragments were observed on the surface or in soils at the site during WSP site works, however a fibre cement pipe was encountered near TP04. Soils were moist to damp, with no evidence of groundwater flow observed in the soil profile.

**Plate 8 Location of asbestos pipe encountered at ~ 0.2. m bgl.**

In order to facilitate proposed future development, WSP recommends that UWS delineate the extent of the asbestos containing pipe identified near TP04 and remove the pipe in accordance with current best practice.
