Wastewater Management Plan: Proposed Alterations and Additions – 26 Kingswood Road, Orchard Hills, NSW

P1404110JR01V06
October 2016

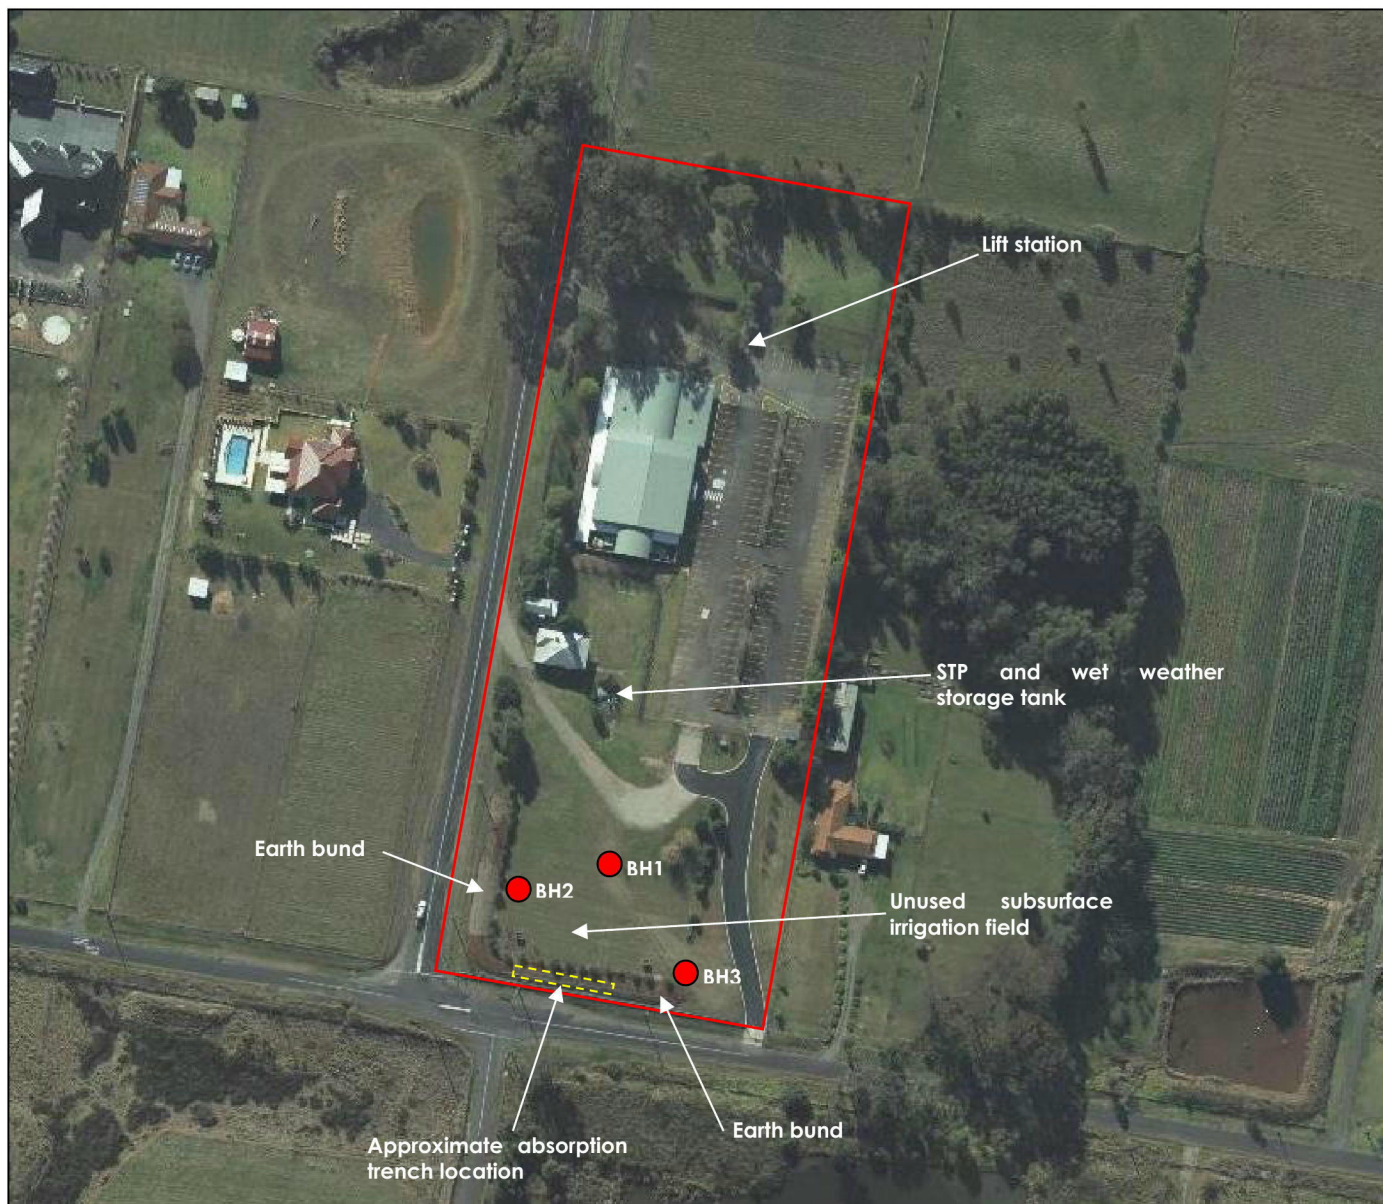
Attachment A – Site Plan

Martens & Associates Pty Ltd ABN 85 070 240 890		Environment Water Wastewater Geotechnical Civil Management	
Drawn:	MLK	Site Plan and Existing Wastewater System Layout	Drawing No:
Approved:	GT		ATTACHMENT A
Date:	15/04/2014		
Scale:	NA		Job No: P1404110

An existing site plan is provided in Attachment A with survey details provided in Attachment D.

Wastewater generated onsite is from toilet flushing only as no kitchen or canteen facilities are provided. It is pumped to an onsite sewage treatment plant (STP) via a lift well with 2 macerator pumps located to the north east of the main building in the existing carpark (Attachment A).

The STP is located south of the main building (Attachment A). According to the manufacturer (J Pridham, February 13, 2014) the system is a Gebe! Aquasafe extended aeration unit with a capacity of 15 KL/day plus an additional 60KL wet weather storage tank (Attachment F). The treatment system includes tertiary filtration, UV sterilisation and chlorine dosing.

Treated effluent was applied to a grassed irrigation field in the site's south (Attachment A) from 4 pop-up sprinklers. An alternative disposal system has since been installed as follows:

We understand that no Council approval for the absorption system has been obtained and the system has not been sized and designed in accordance with AS/NZS 1547 (2012). General location of the absorption trench is provided in Attachment A.

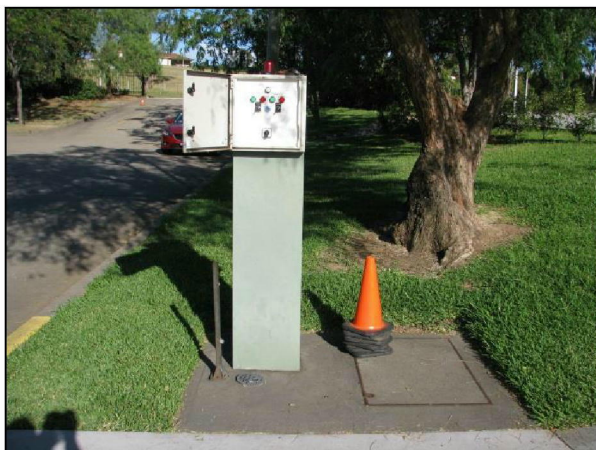
Plate 1: Lift station

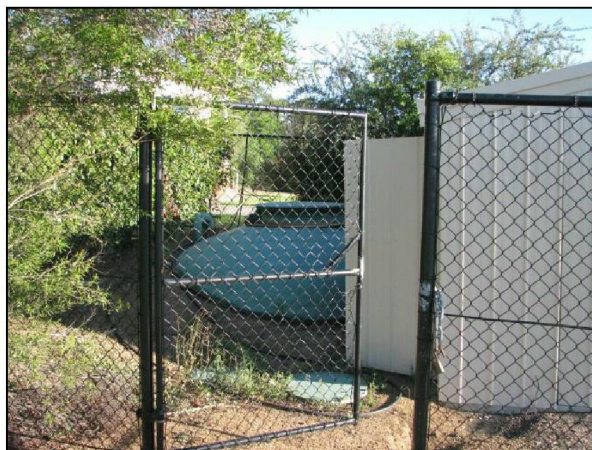
Plate 2: STP tank and control shed

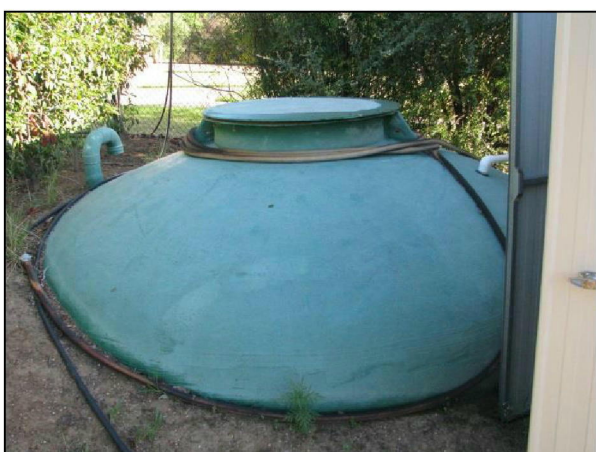
Plate 3: STP

Site inspection of the STP showed it to be in good working order and well maintained. No leaks or odours were noted. Servicing records (April 2012 – October 2013) supplied by the client indicate the system is maintained quarterly by the manufacturer. No issues or incidents are noted on supplied servicing records.

The existing STP is, based on inspection by Martens, in good working order and well maintained. No leaks or odours were noted. Maintenance records from the last 18 months indicate no significant or ongoing issues with the system.

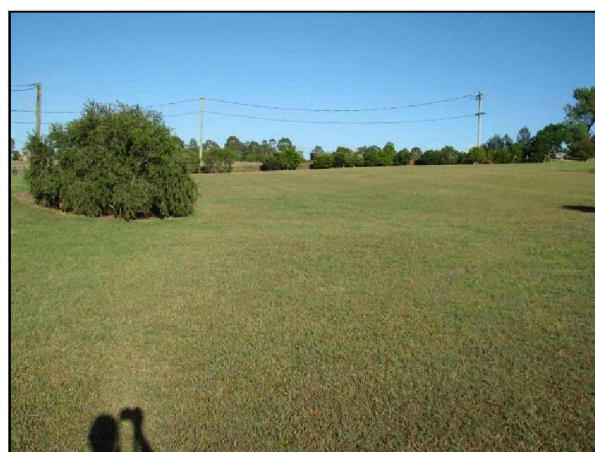
Plate 4: Proposed irrigation field location. View facing north west.

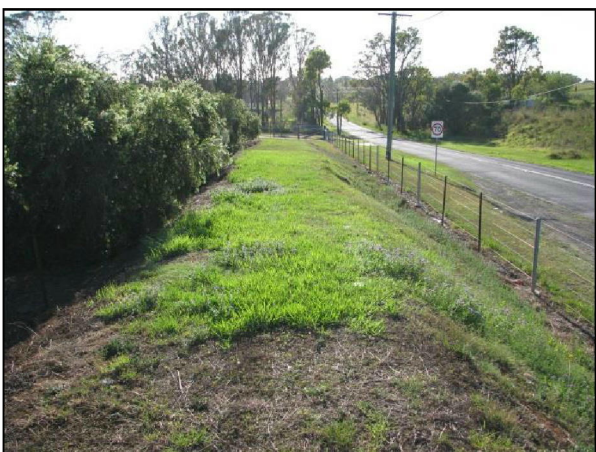
Plate 5: Existing earth bund along southern boundary and absorption trench location. View facing east.

- Absorption trench is approximately 6.0 m long and 0.5 m wide, constructed into medium clay beneath an earth bund (2.0 – 2.5 m wide and 1.0 – 1.5 m high) along the southern boundary.

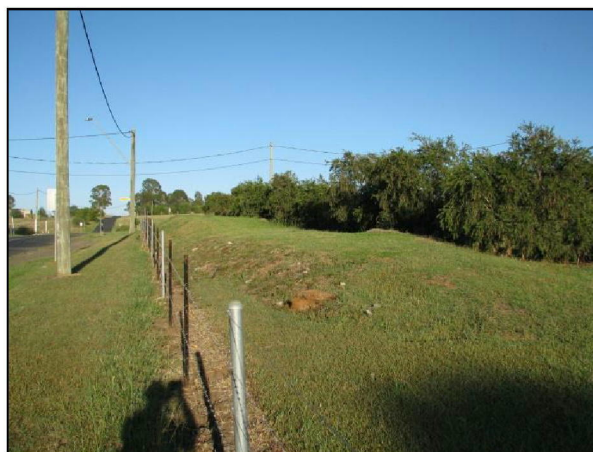
Plate 6: Existing earth bund along southern boundary. View facing west.
