Detailed Site Investigation:
South Werrington Urban Village
Precinct, Lot 102 DP1140594,
16 Chapman Street, Werrington NSW

P1504996JR01V01
October 2015

This report prepared by Martens and Associates (MA), for Universal Property Group Pty Ltd documents a Detailed Site Investigation (DSI) completed for 16 Chapman Street, Werrington, NSW (the site).

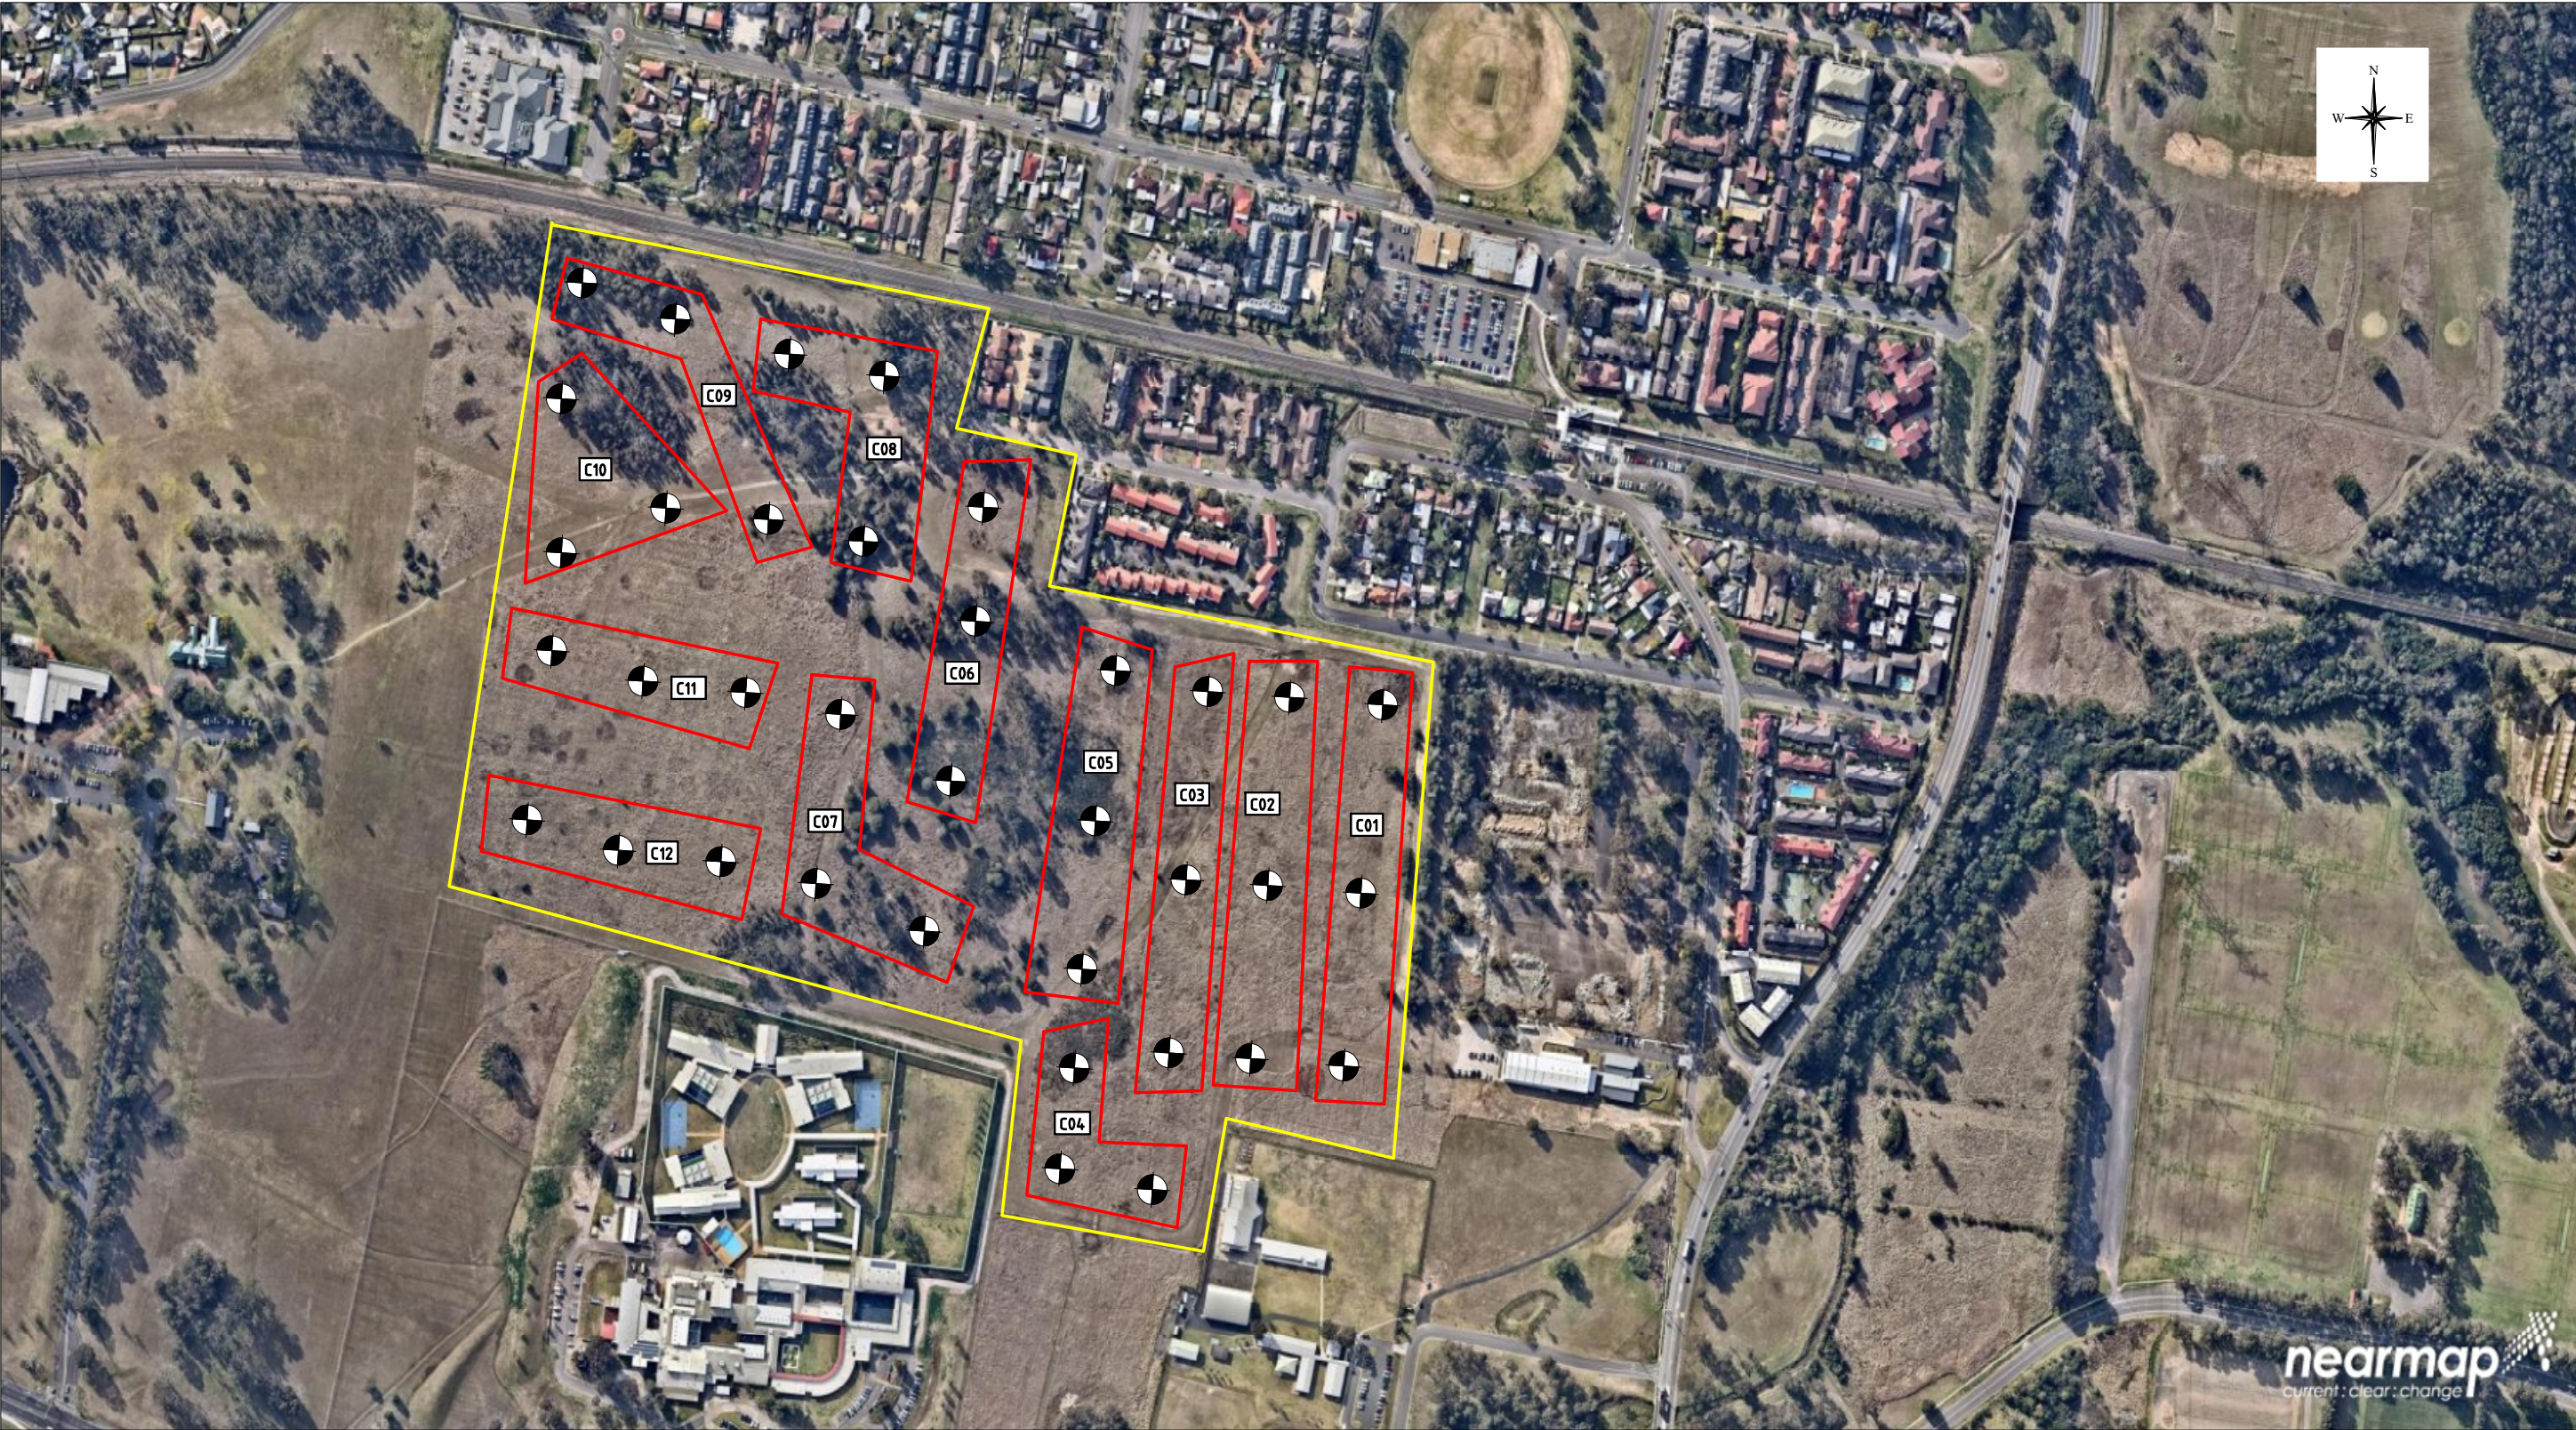
| Step 4 Study Boundary Definitions | Study boundaries are as follows: <ul style="list-style-type: none"> o Lateral – Lateral boundary of the assessment is defined by the site boundary as indicated in Figure 1 (Attachment A). o Vertical – Vertical boundary will be governed by the maximum depth reached during subsurface investigations. <p>It is noted that assessment of site groundwater and soil vapours is outside of the scope of this assessment.</p> |

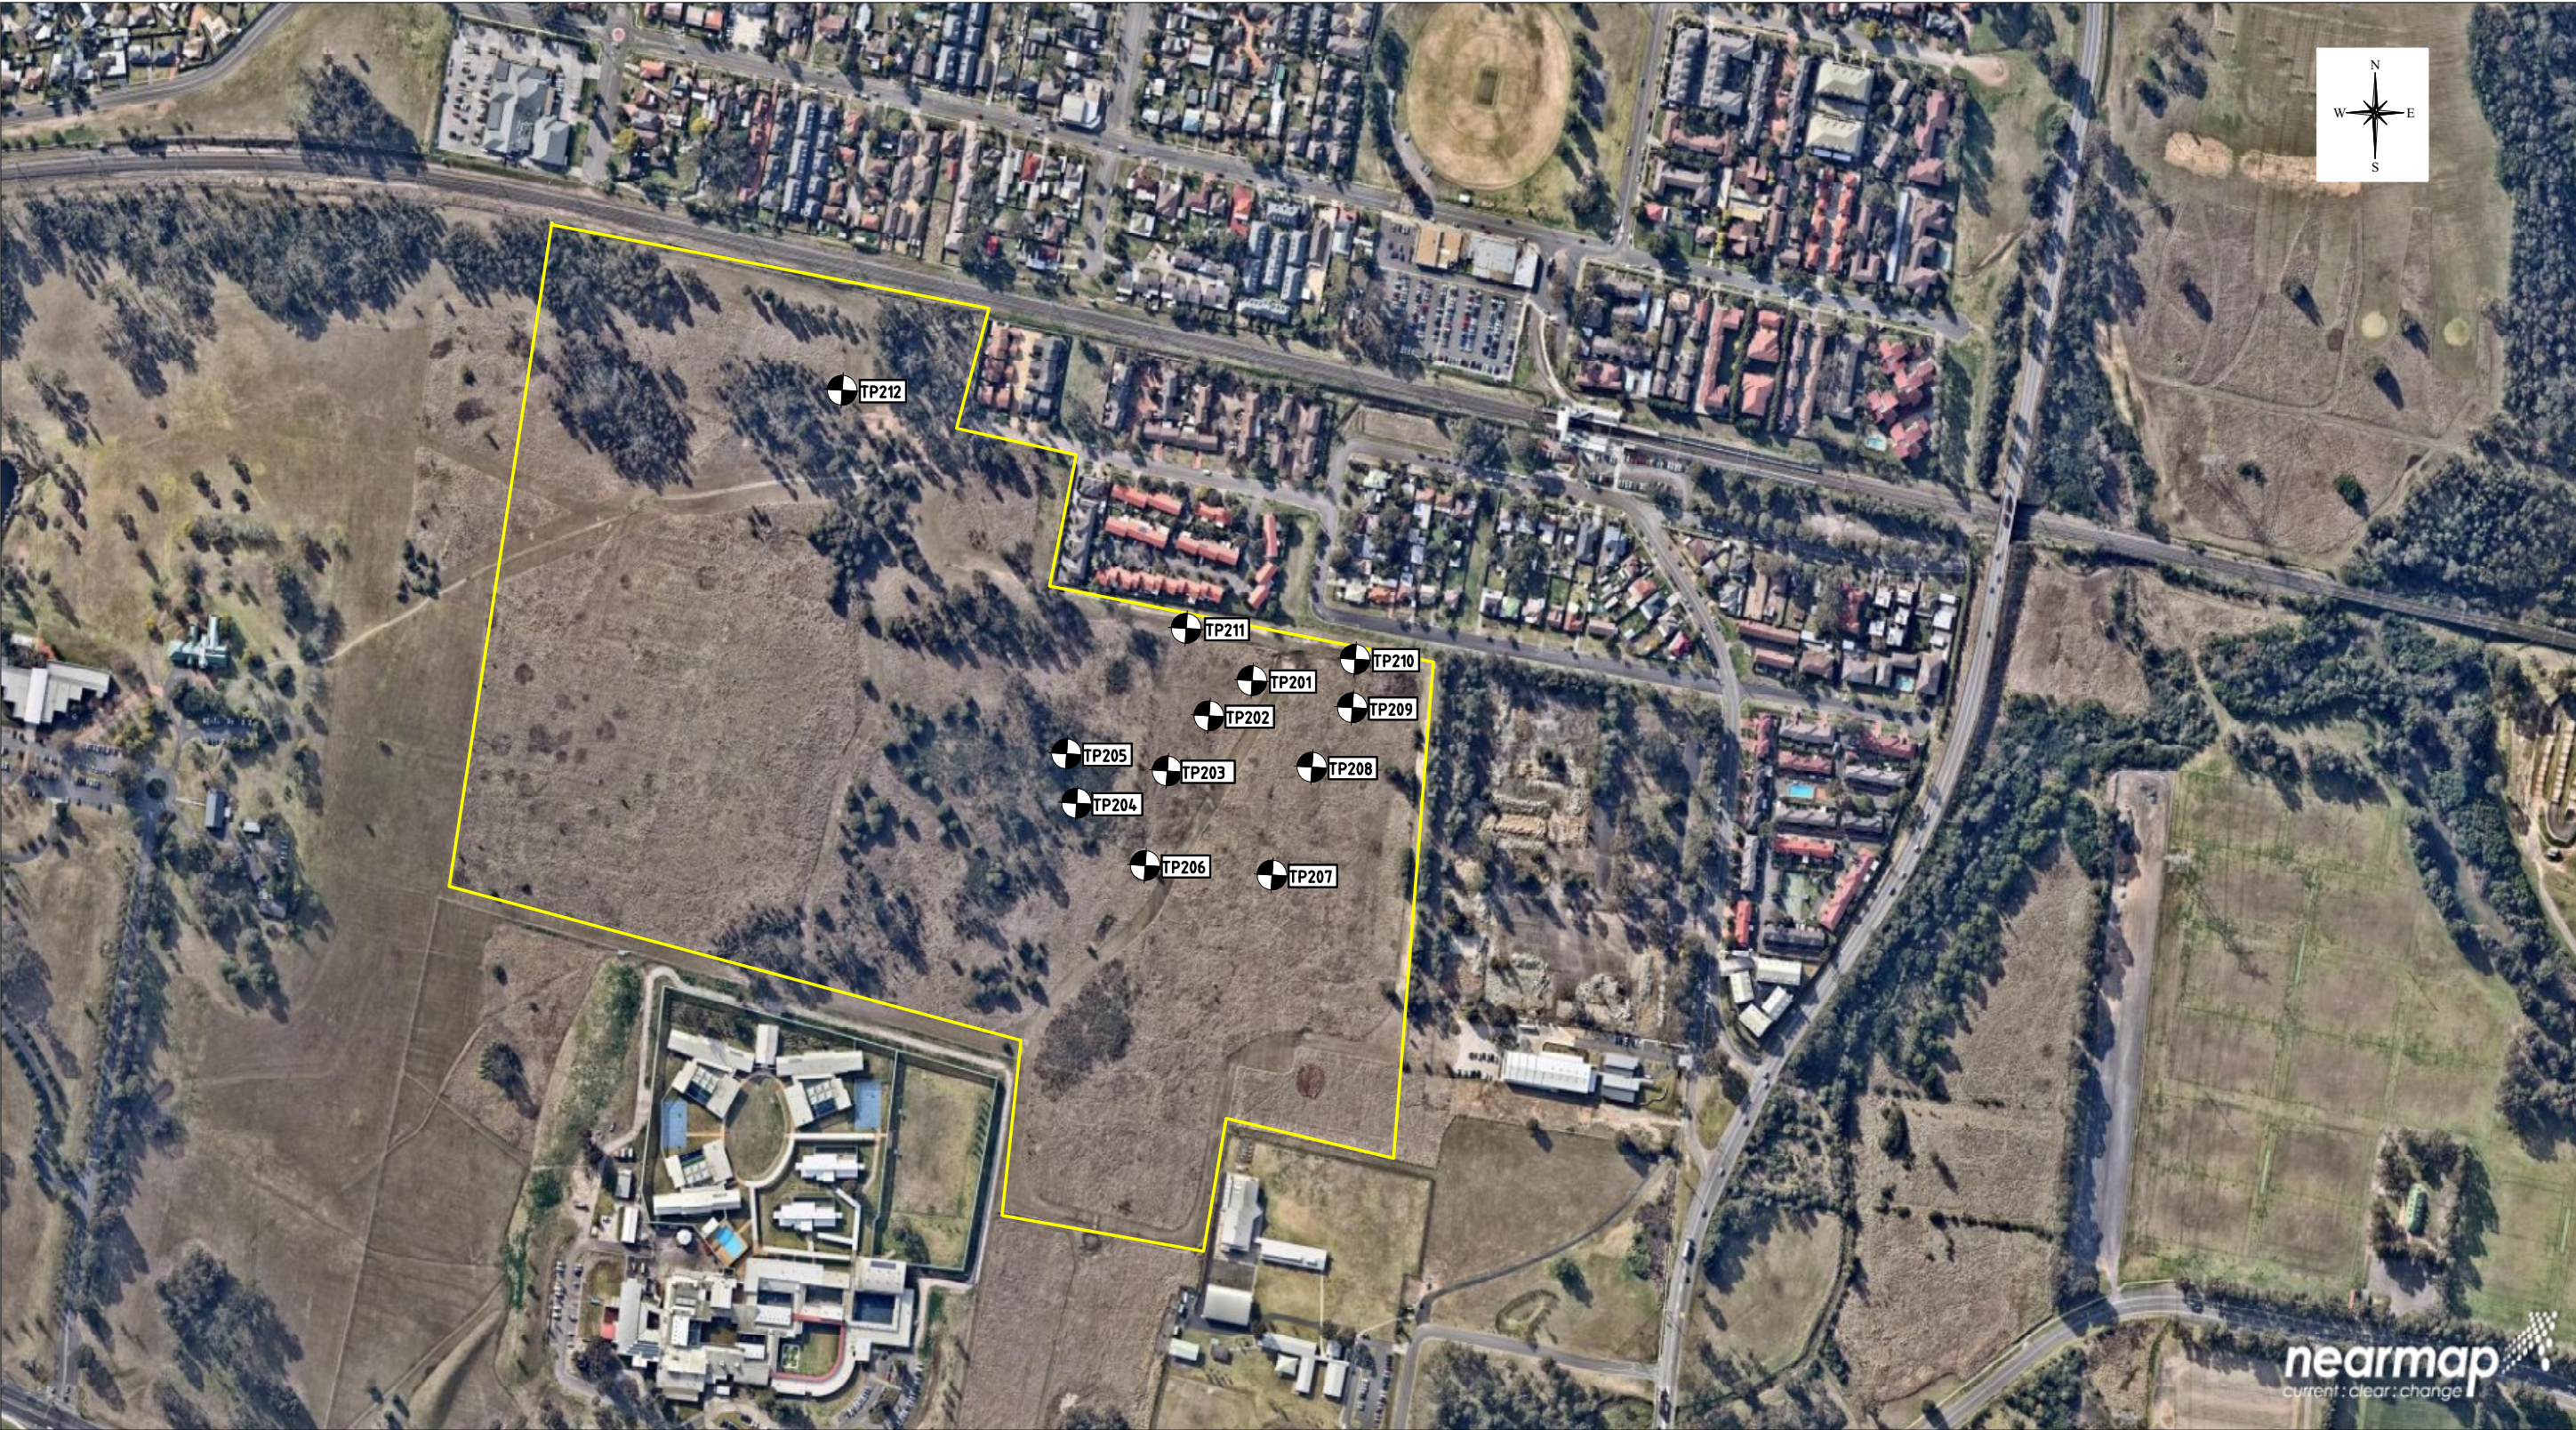
A subsurface investigation has been completed by MA targeting areas of site filling identified in the PESA (DP, 2014a). Additional surface samples were collected from across the site to address potential historic agricultural land use. Results of soil sampling found no contaminant level above SAC.
