Preliminary  
Phase 2 Environmental Assessment  
University of Western Sydney  
South Werrington Sub-Precinct  
University of Western Sydney

February 2009

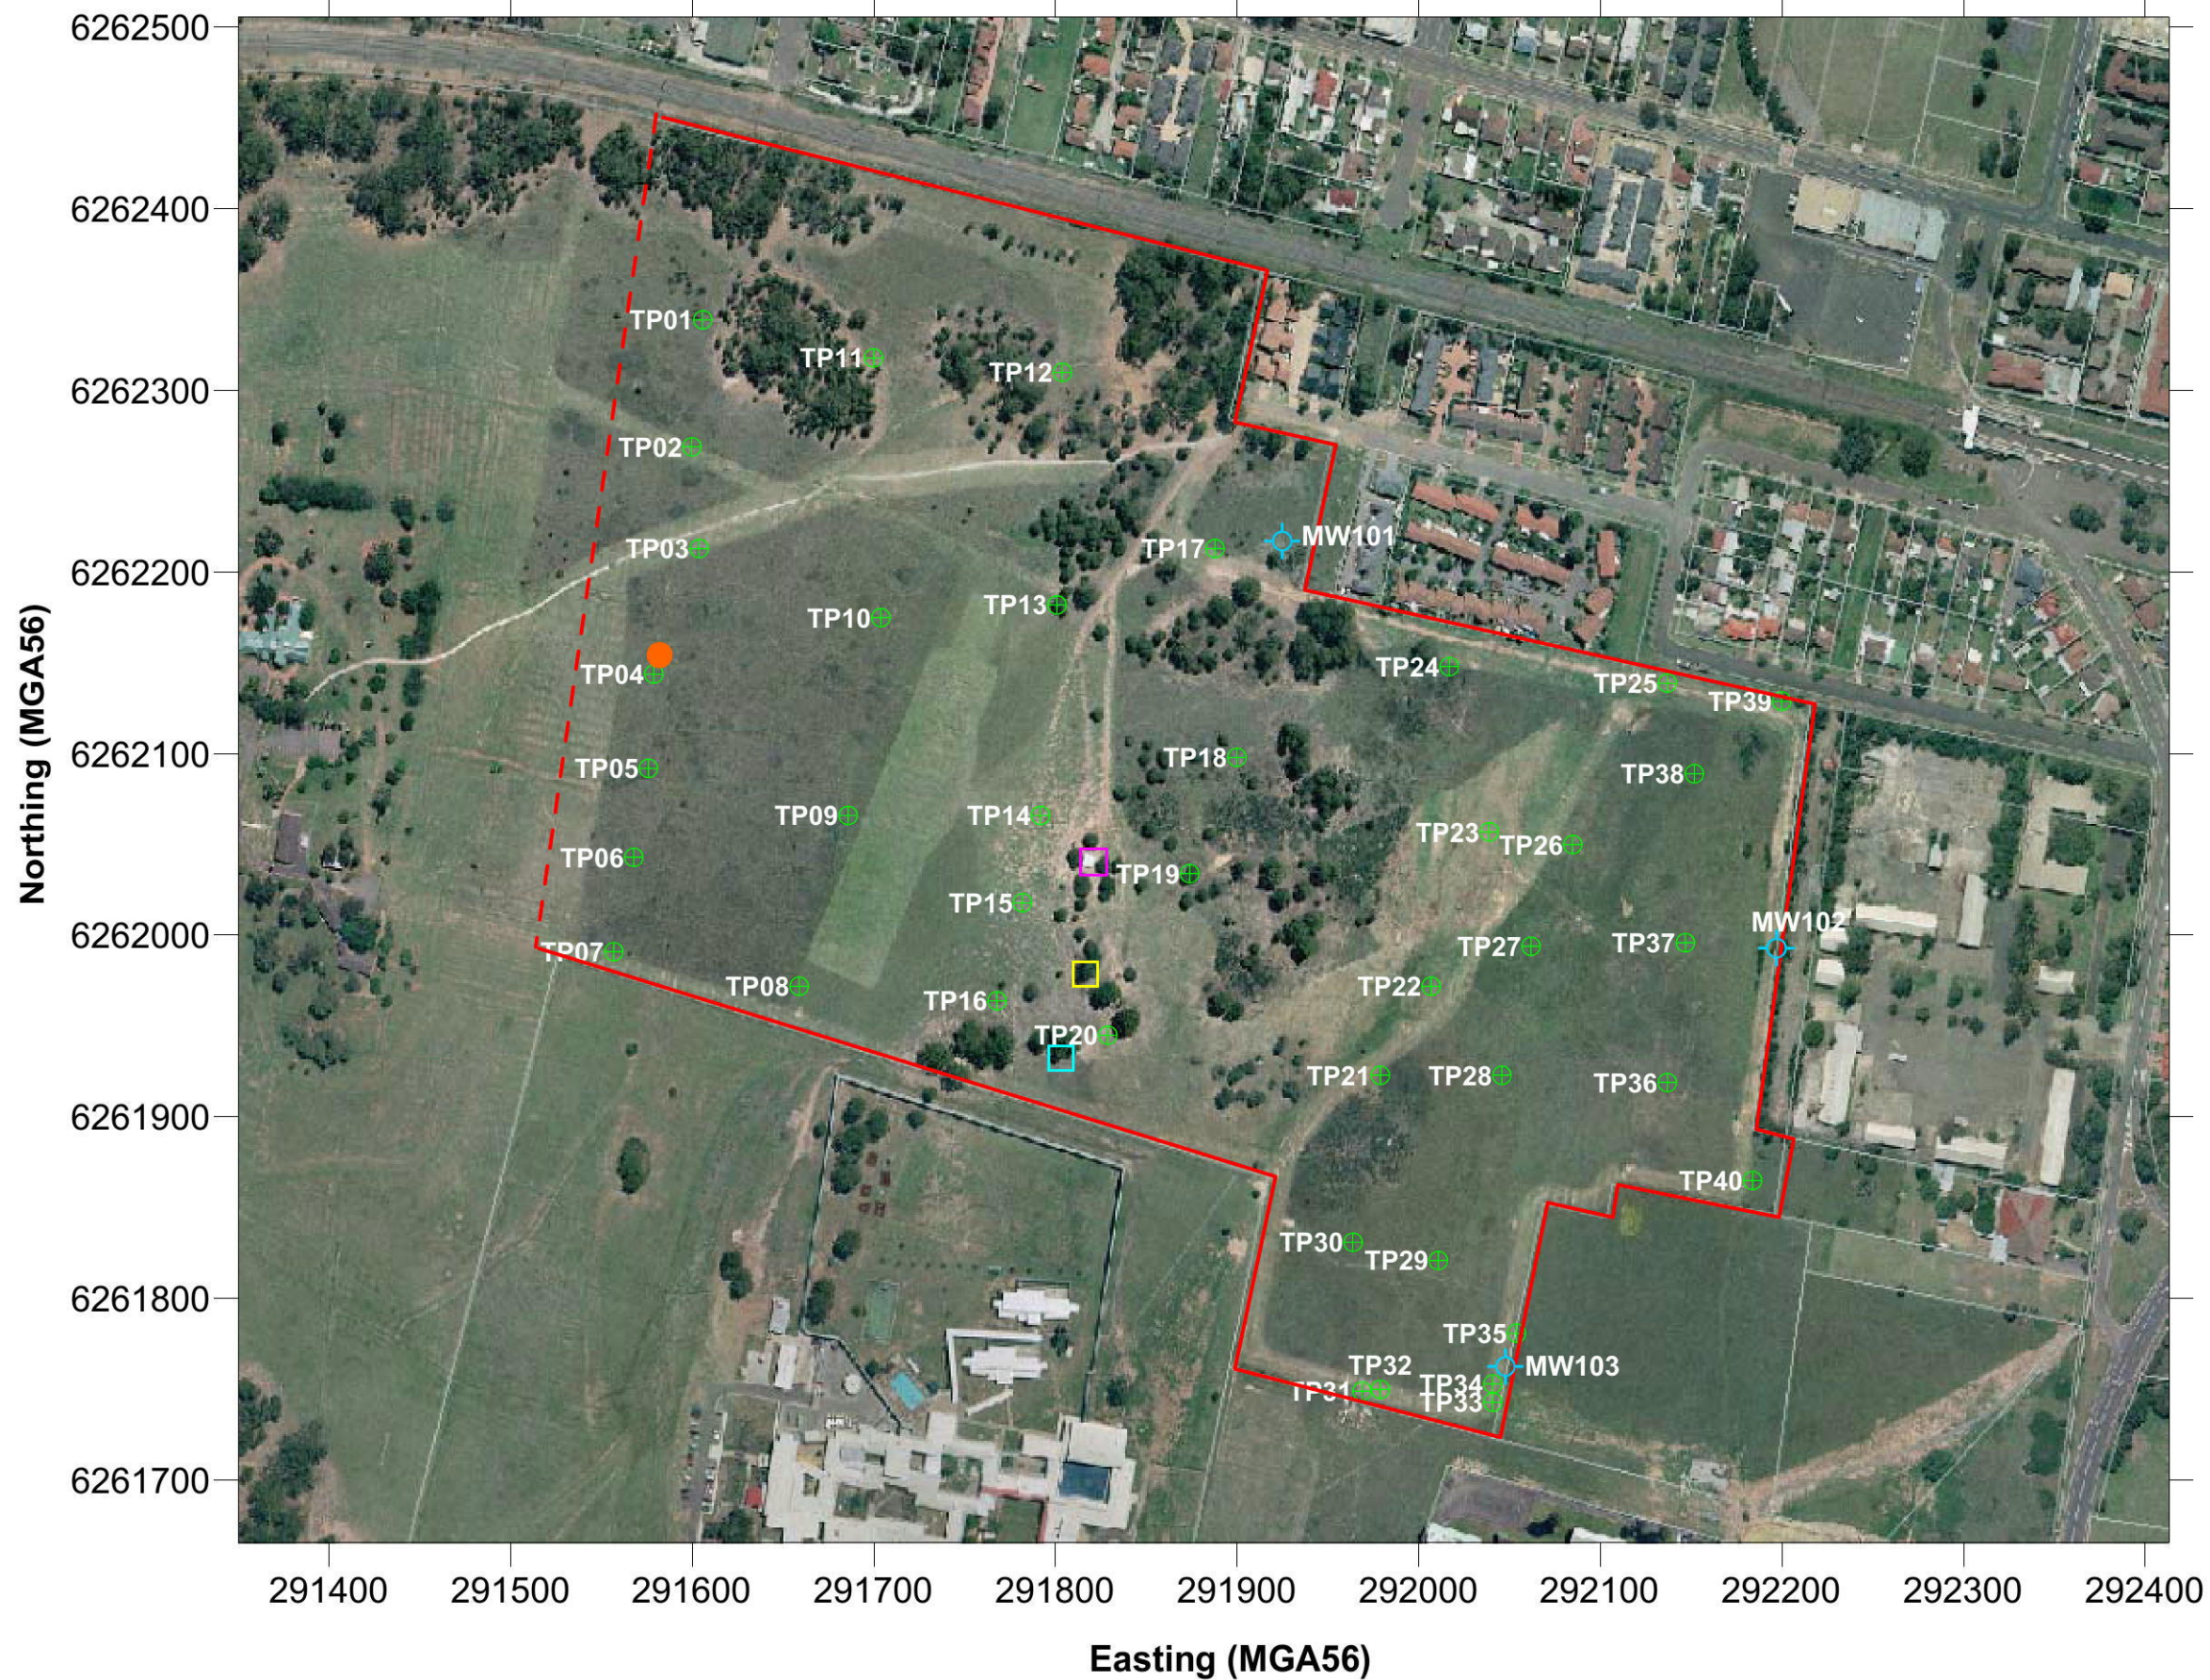
**Figure 3**

- Site Boundary
- - - Estimated Site Boundary
- ⊕ Testpit
- Pipe (containing asbestos)
- Toilet
- Shelter Shed
- Work Bench and Empty Drums

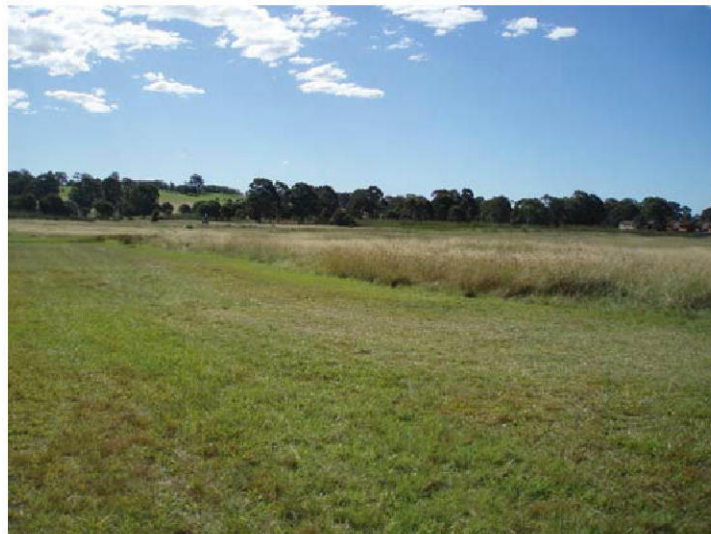
Plate 1 Looking west from south-east corner of site. Note tall grass, area inundated.

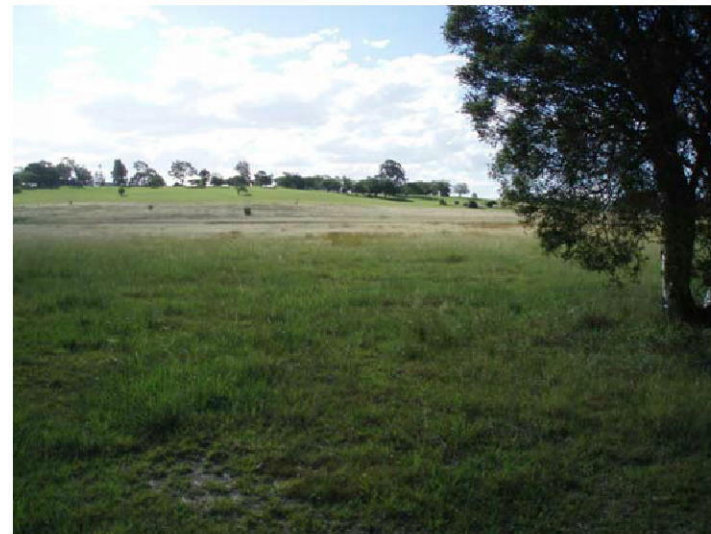
Plate 2 Looking west from centre of site (near sheds). Note the foot-slopes form western portion of site. Light coloured grass is ~1 m in height.

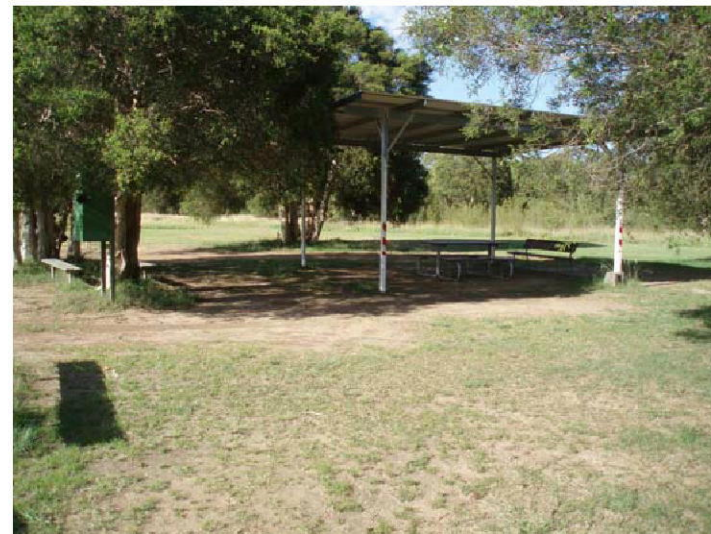
Plate 4 Shelter shed in centre of site.

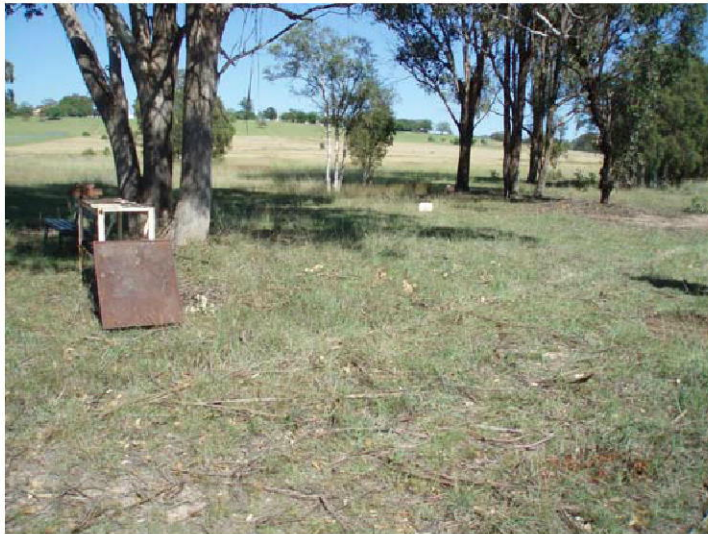
- Small structures in the south-western area of the site included a shelter shed, toilet, shed and a workbench and 3 empty drums (unlabelled). There was no observed staining of surfaces or leaks from the empty drums, and these locations were targeted with test pits at TP15, TP19 and TP20.

**Plate 5 Workbench and drums in centre of site.**

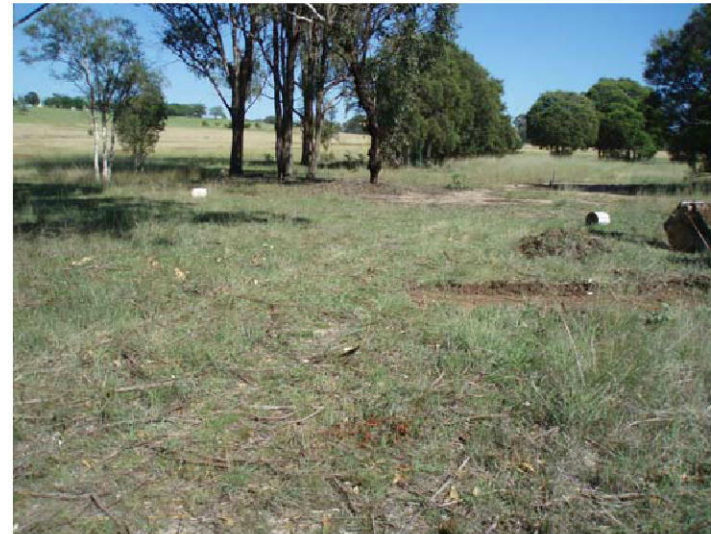
**Plate 6 Location of test pit 20 (right) adjacent to drums and workbench.**

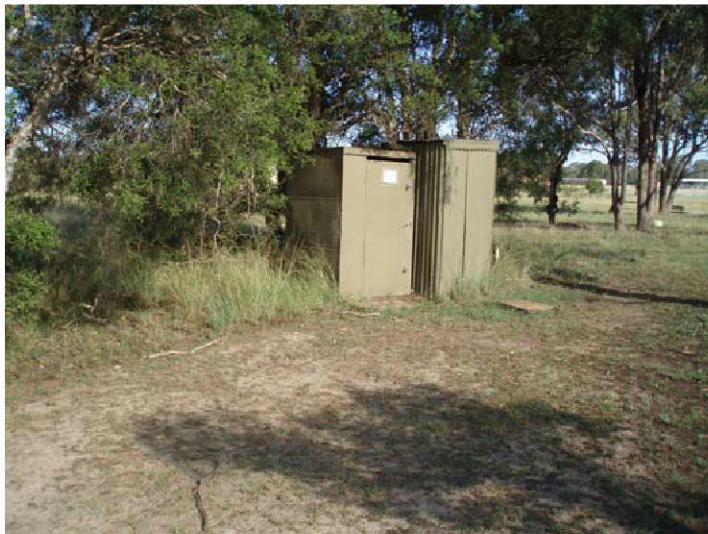
**Plate 7 Shed and "toilet" located in centre of site.**

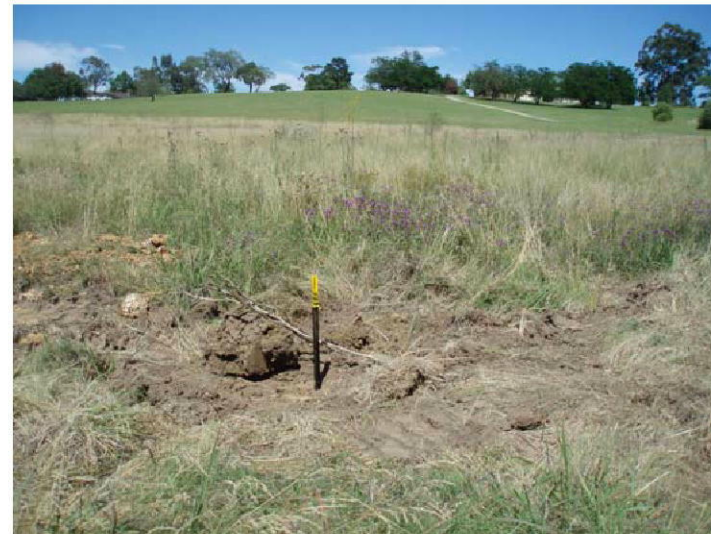
No fibre cement fragments were observed on the surface or in soils at the site during WSP site works, however a fibre cement pipe was encountered near TP04. Soils were moist to damp, with no evidence of groundwater flow observed in the soil profile.

**Plate 8 Location of asbestos pipe encountered at ~ 0.2. m bgl.**

In order to facilitate proposed future development, WSP recommends that UWS delineate the extent of the asbestos containing pipe identified near TP04 and remove the pipe in accordance with current best practice.

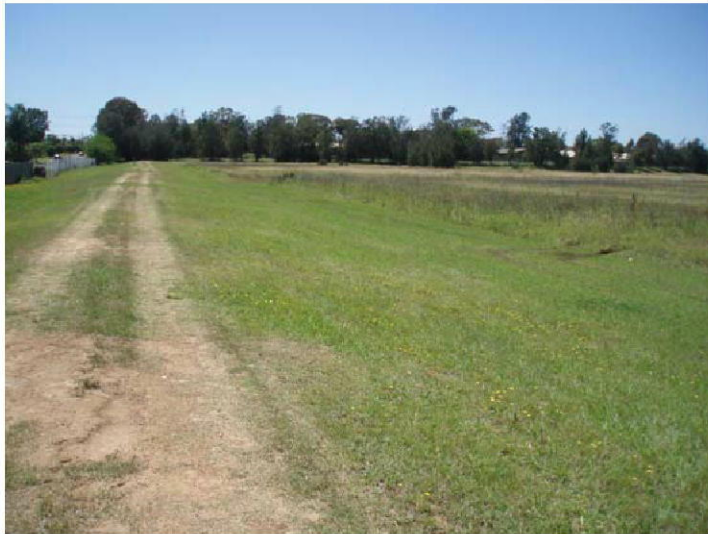
- No staining, malodours or discolouration of soils was observed and a maximum of 0.0 ppm was recorded with a PID for soil samples. Plastic fragments were observed at a depth of 0.8m bgl in reworked natural material forming the retention wall (AEC 8).

**Plate 9** Looking east along northern boundary at AEC 8. Note drop in elevation to right of image.

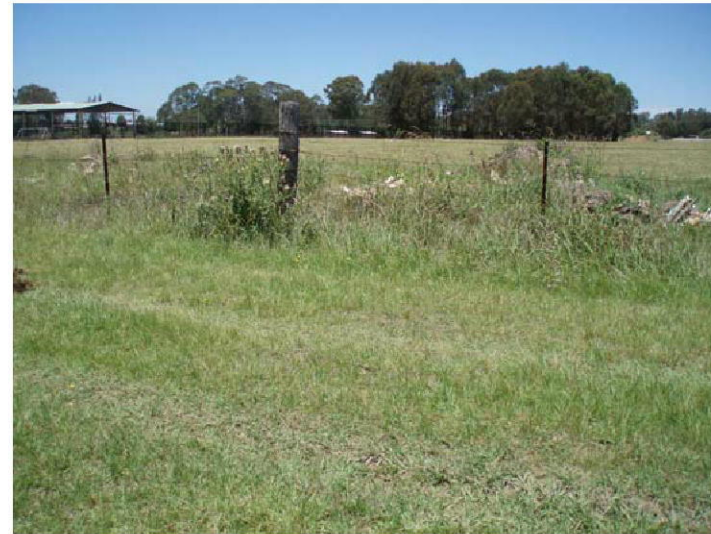
**Plate 10** Abandoned waste stockpiles (AEC5) located offsite, along southern boundary of site.
