**REPORT  
on  
PHASE 1 CONTAMINATION ASSESSMENT**

**SOUTH WERRINGTON SUB PRECINCT**

**Prepared for  
UNIVERSITY OF WESTERN SYDNEY AND  
SOUTH WERRINGTON PLANNING COORDINATION  
GROUP**

**Project 43739A Rev1  
April 2007**

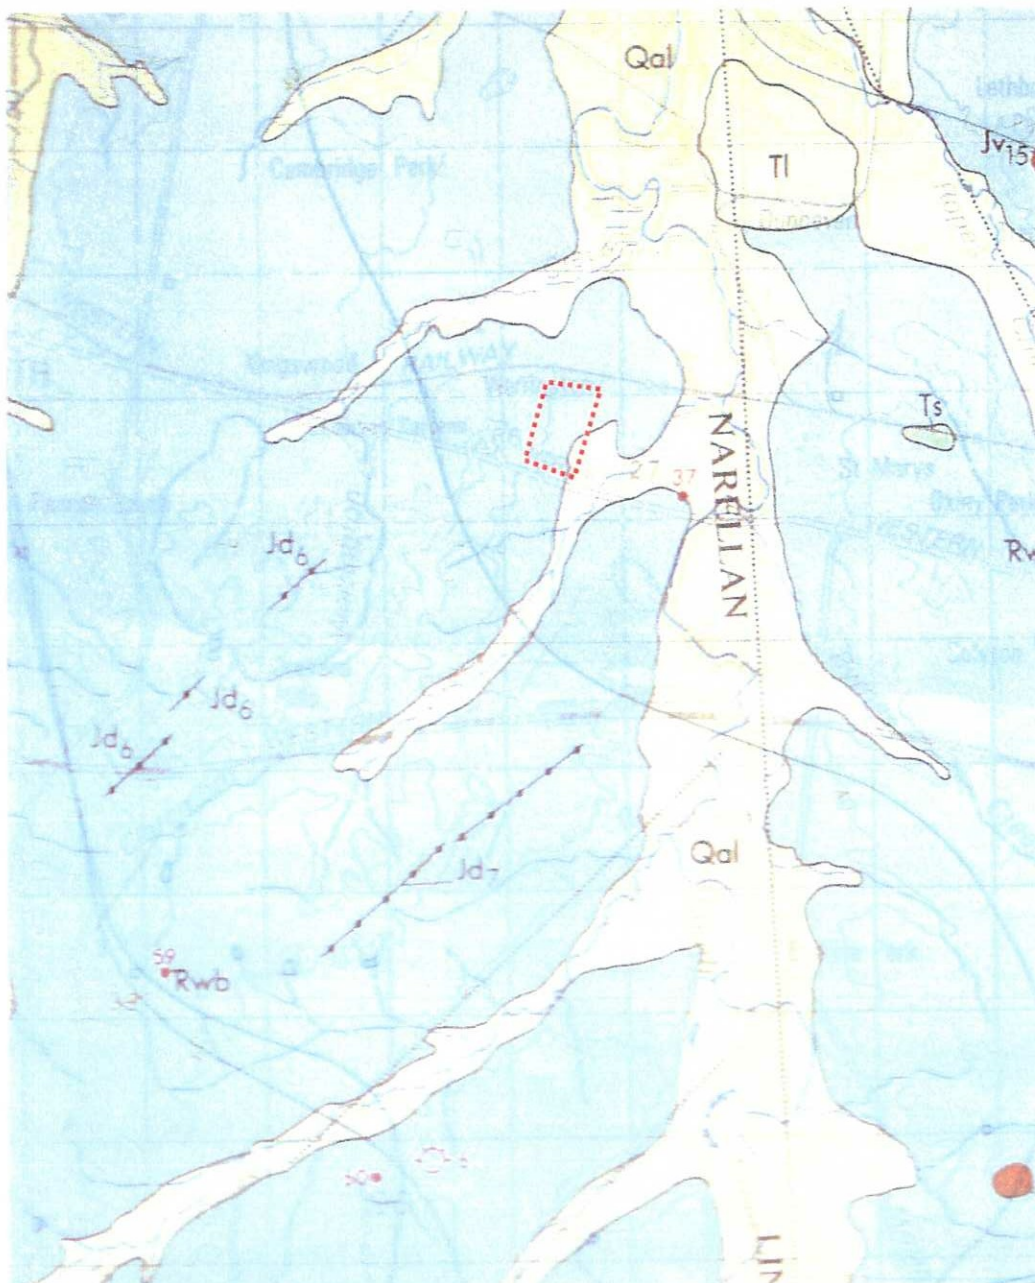
Reference to the *Geology of the Penrith 1:100,000 Sheet* (Ref. 1) indicates that the site is underlain by the Bringelly Shale, the uppermost formation of the Wiannnamatta Group of Triassic age. The Bringelly Shale typically comprises interbedded claystone, siltstone and laminate with minor fine to medium grained sandstone lenses or bands and rare coaly bands. Drawing 3 shows an excerpt of the Geology Map in the vicinity of the site.

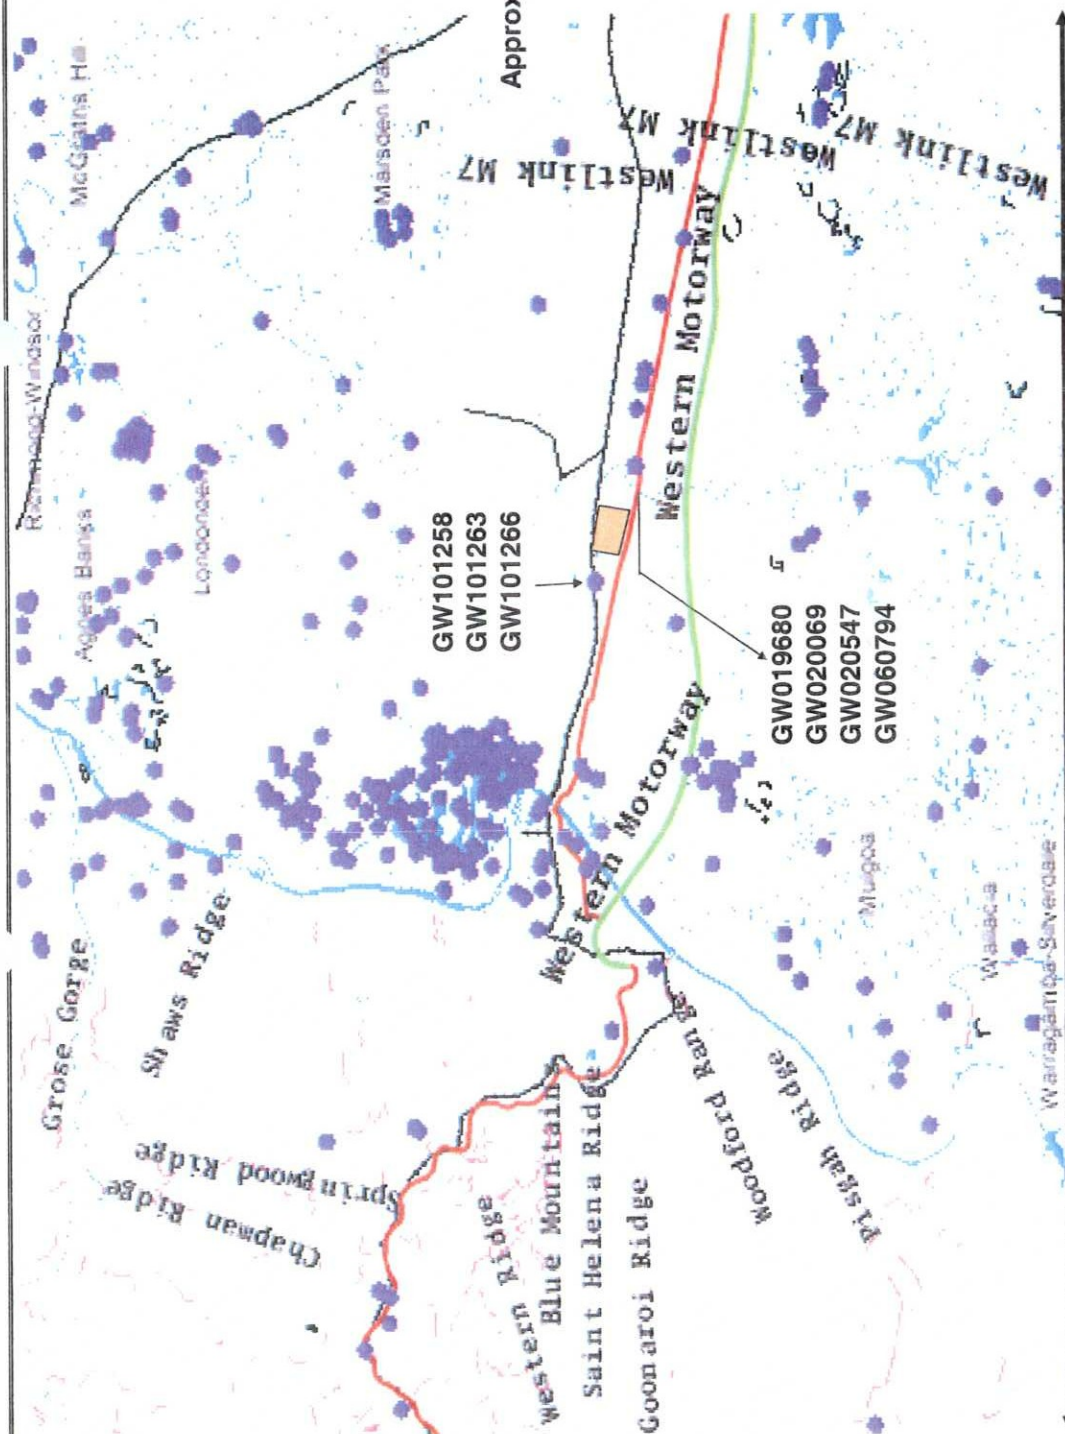
A search of groundwater bores in the area registered to the Department of Infrastructure, Planning and Natural Resources (DIPNR) was undertaken for the site. The location of registered bores in relation to the site is provided in Drawing 4. The work summaries for each of the bores is provided in Appendix B. The following points are noted regarding bores within a 2 km radius of the site:

- there are no registered bores within the boundaries of the site;

- a cluster of four bores are located to the south-east of the site. The bores were all drilled to depths of more than 70 m. The bores encountered natural clay soils to a depth of around 10 m, after which shale bedrock with interdispersed clay zones was encountered to the termination depth. Isolated narrow water bearing zones were encountered with the shale bedrock at depth with low yields only. No information on groundwater quality was provided in any of the bore logs;
- a cluster of three bores are located to the north-west of the site. The bores were all drilled to depths of 6-8 m. The bores encountered silty clay soils until the termination depth and no details are provided in relation to water bearing zones or the standing water level in the bores constructed. No information on groundwater quality was provided in any of the bore logs.
