**GEOTECHNICAL REPORT FOR
36-38 RODLEY AVENUE, PENRITH NSW**

INGLOW INVESTMENT TWO PTY LTD

Reference: P1720_ 01 rev1

13 August 2019

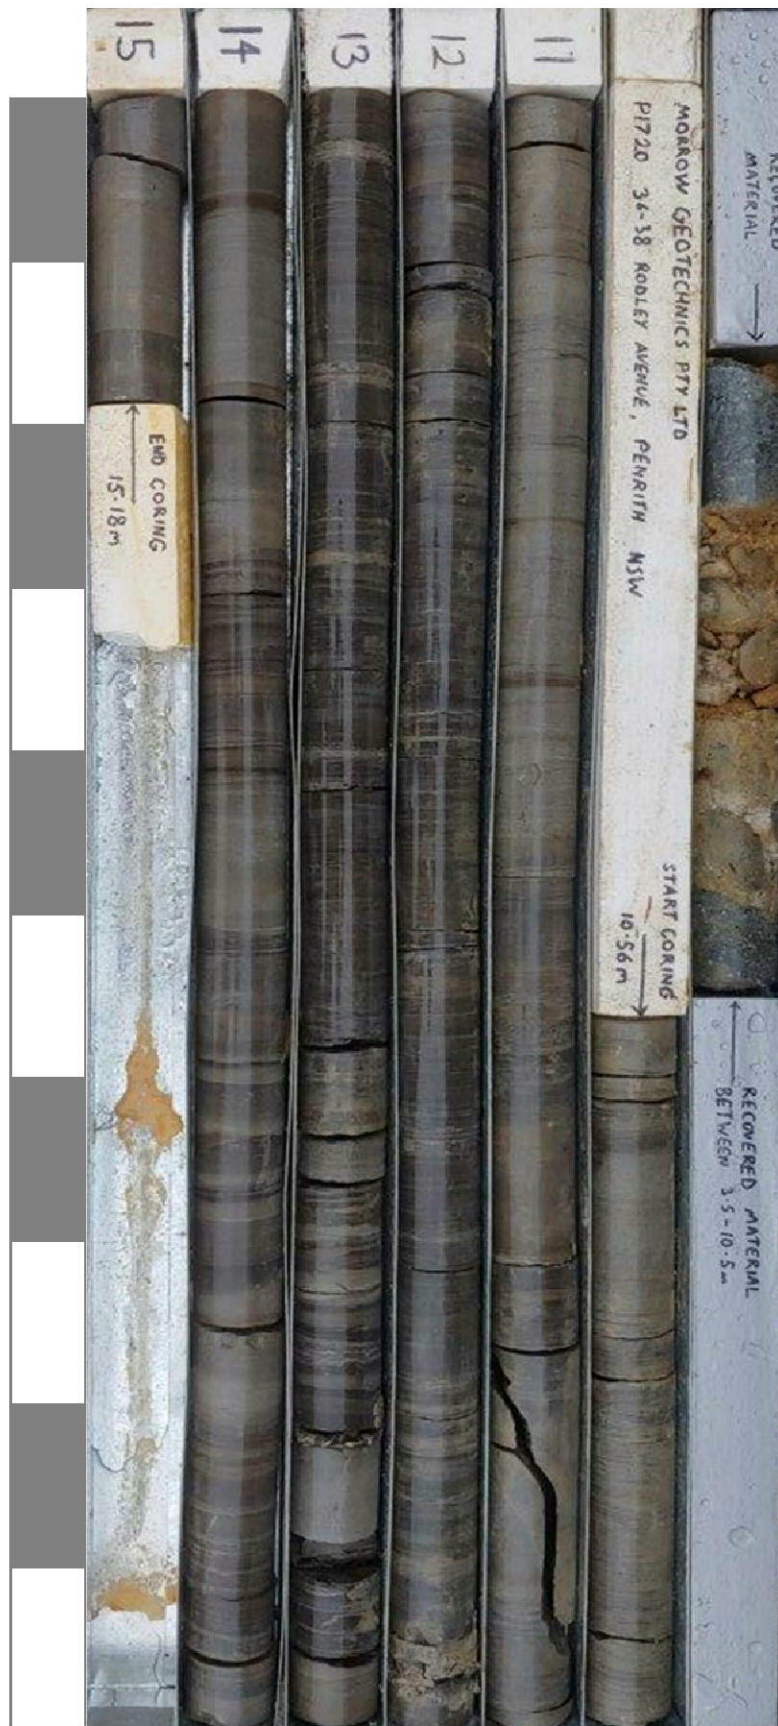
BH1

Drilling Method	Resistance	Water	Sampling	USCS	Depth	Stratigraphy	Consistency	Density	Moisture	Additional Observations
SFA	L	GWNE	SPT1-1 0.5-0.95 m 2, 2, 2 N = 4	Cl - CH	0.0	FILL - Silty SAND, fine to medium grained, black / dark grey, with fine to medium sub-angular gravel (roadbase)	F		D - M	FILL
			SPT1-2 1.5-1.95 m 3, 3, 4 N = 7		0.5	Silty CLAY, medium to high plasticity, brown mottled grey				ALLUVIAL SOIL
RR / NMLC	H	GWNO	SPT1-3 3.0-3.45 m 8, 7, 9 N = 16		1.0		St

Drilling Method	Resistance	Water	Sampling	USCS	Depth	Stratigraphy	Consistency/Density	Moisture	Additional Observations
RR / NMLC	H	GWNO			8.5	AS ABOVE, COBBLE, up to 200mm (basalt and granite), dark grey/dark red/brown, with silt, with fine to coarse grained sand, boulders present			ALLUVIAL SOIL
					9.0				
					9.5				
					10.0				
					10.5				
					11.0	Start Coring at 10.56m			
				11.5					
				12.0					
				12.5					
				13.0					
				13.5					
				14.0					
				14.5					
				15.0					
				15.5					
				16.0

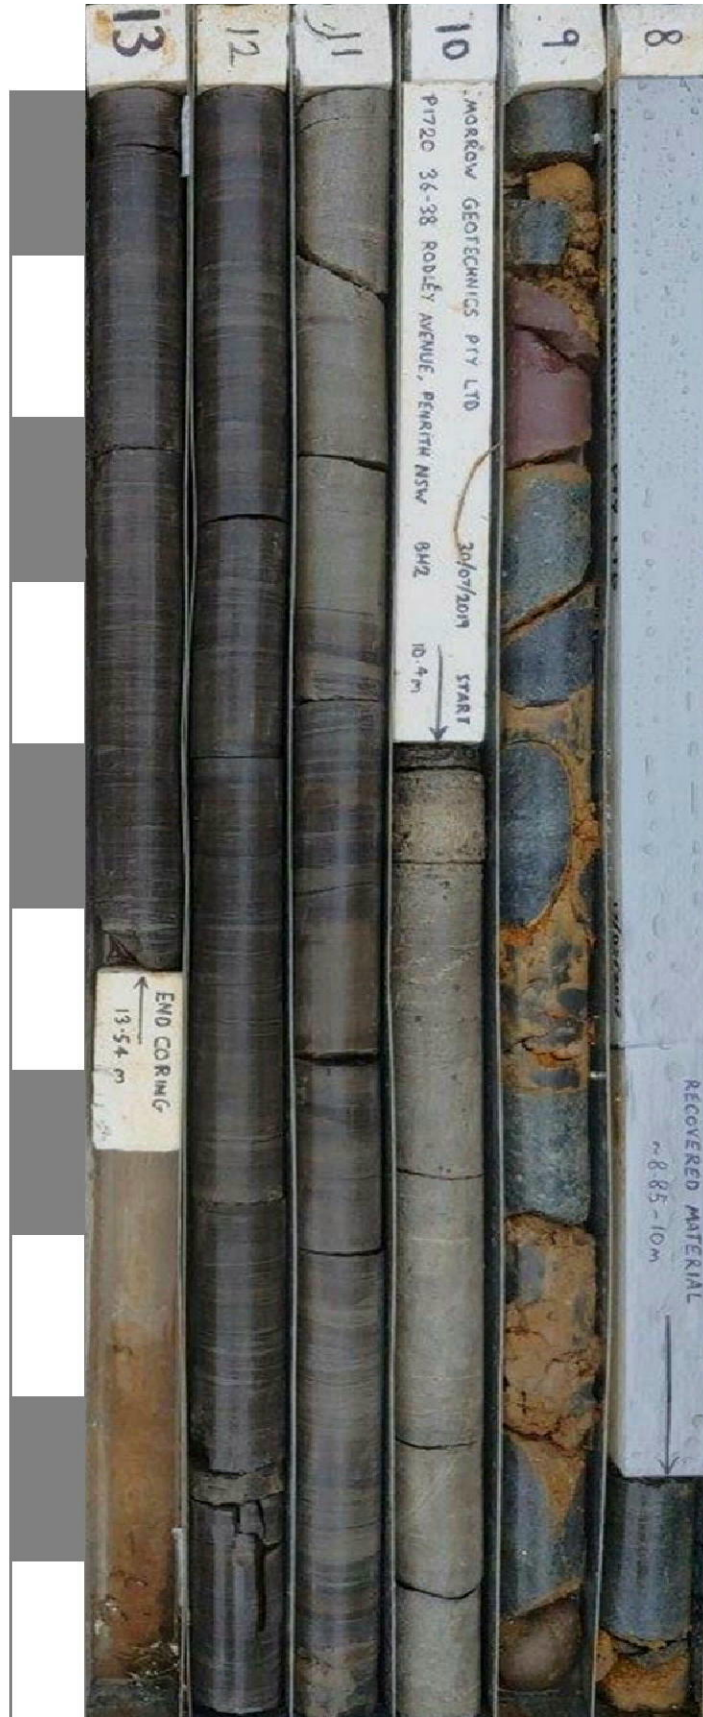
BH2

Drilling Method	Resistance	Water	Sampling	USCS	Depth	Stratigraphy	Consistency/Density	Moisture	Additional Observations
HA	L			SM	0.0	TOPSOIL - Silty SAND, find to medium grained, brown, root fibres present, poorly graded	-	D	TOPSOIL

Drilling Method	Resistance	Water	Sampling	USCS	Depth	Stratigraphy	Consistency/Density	Moisture	Additional Observations
RR / NMLC	H	GWNO			8.5	AS ABOVE, COBBLE up to 200mm (basalt and granite), with silt, with fine to coarse grained sand, trace of medium to coarse rounded gravel (basalt and granite), boulders present			ALLUVIAL SOIL
					9.0				
					9.5				
					10.0				
					10.5				
					11.0				
					11.5				
					12.0				
					12.5				
					13.0				
					13.5				
					14.0				
					14.5				
					15.0				
					15.5				
					16.0

Drilling Method	Water	TCR	RQD (SCR)	Rock Strength						Weathering	Depth	Stratigraphy	Defect Spacing	Defect Description
				EL	LV	L	M	H	V					
NMLC	GWNO	100	97 (94)	0	0.03	0.1	0.3	1	3	10				
											8.5			
											9.0			
											9.5			
											10.0			
											10.5			
											11.0			
											11.5			
											12.0			
											12.5			
											13.0			
											13.5			
											14.0			
											14.5			
											15.0			
											15.5			
											16.0
