PROPOSED RESIDENTIAL SUBDIVISION
NORTH PENRITH DEFENCE LANDS – STAGE 1.2
COREEN AVENUE, PENRITH

SITE CLASSIFICATION

REPORT 7824/4-ABR 3 SEPTEMBER 2012

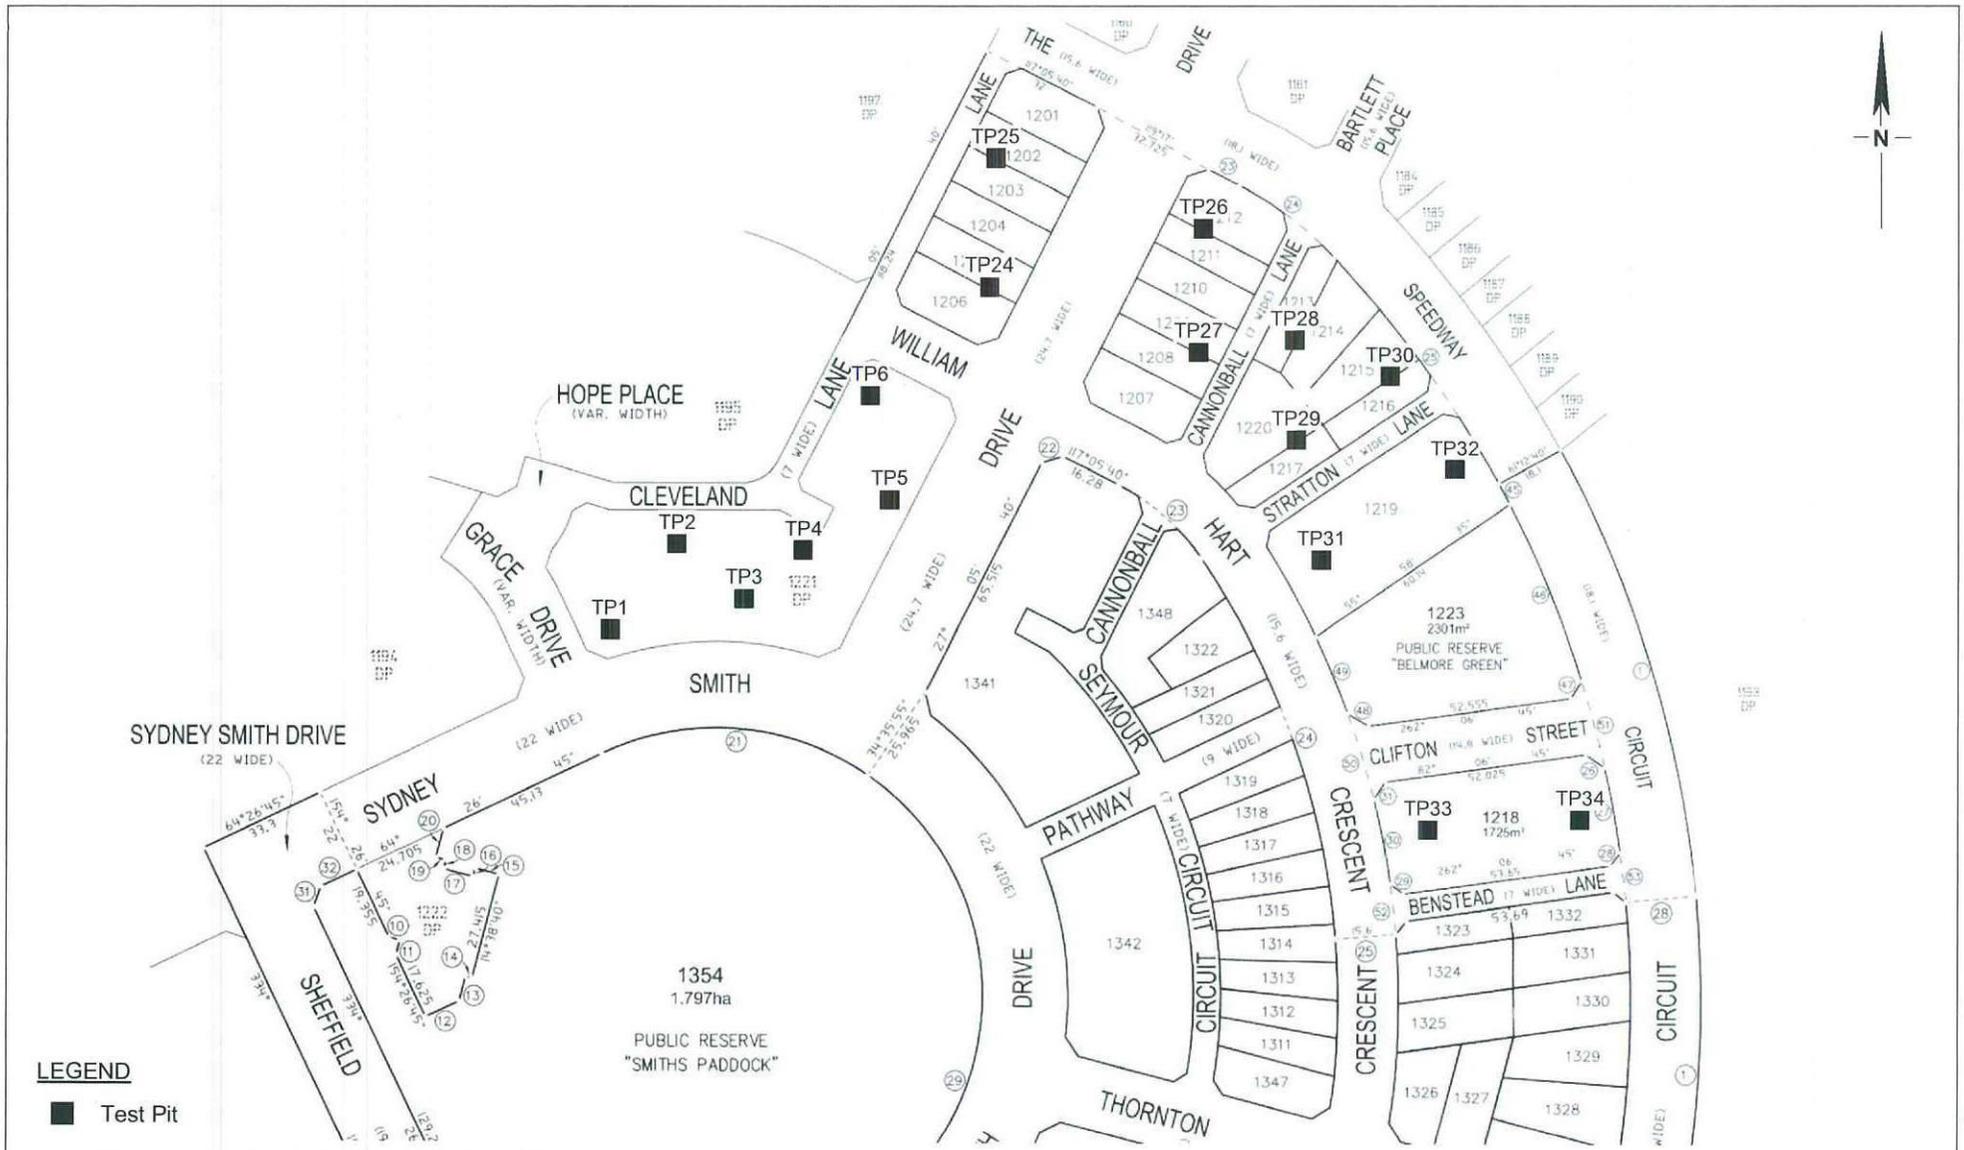
Test Pit Locations

Field work for the investigation was carried out on 8 May and 25 August 2012 and consisted of excavation of seventeen test pits (TP1 to TP6 and TP24 to TP34) to a depth of 1.5m, using a rubber-tyred backhoe. The test pit logs are summarised and presented in Appendix A.

The test pit locations are indicated on Drawing No 7824/4-AB1 in Appendix A.
