SITE AUDIT REPORT AND SITE AUDIT STATEMENTS

Caddens Release Area, Kingswood, NSW, 2747

Report Number: 097623019 007 R Rev0

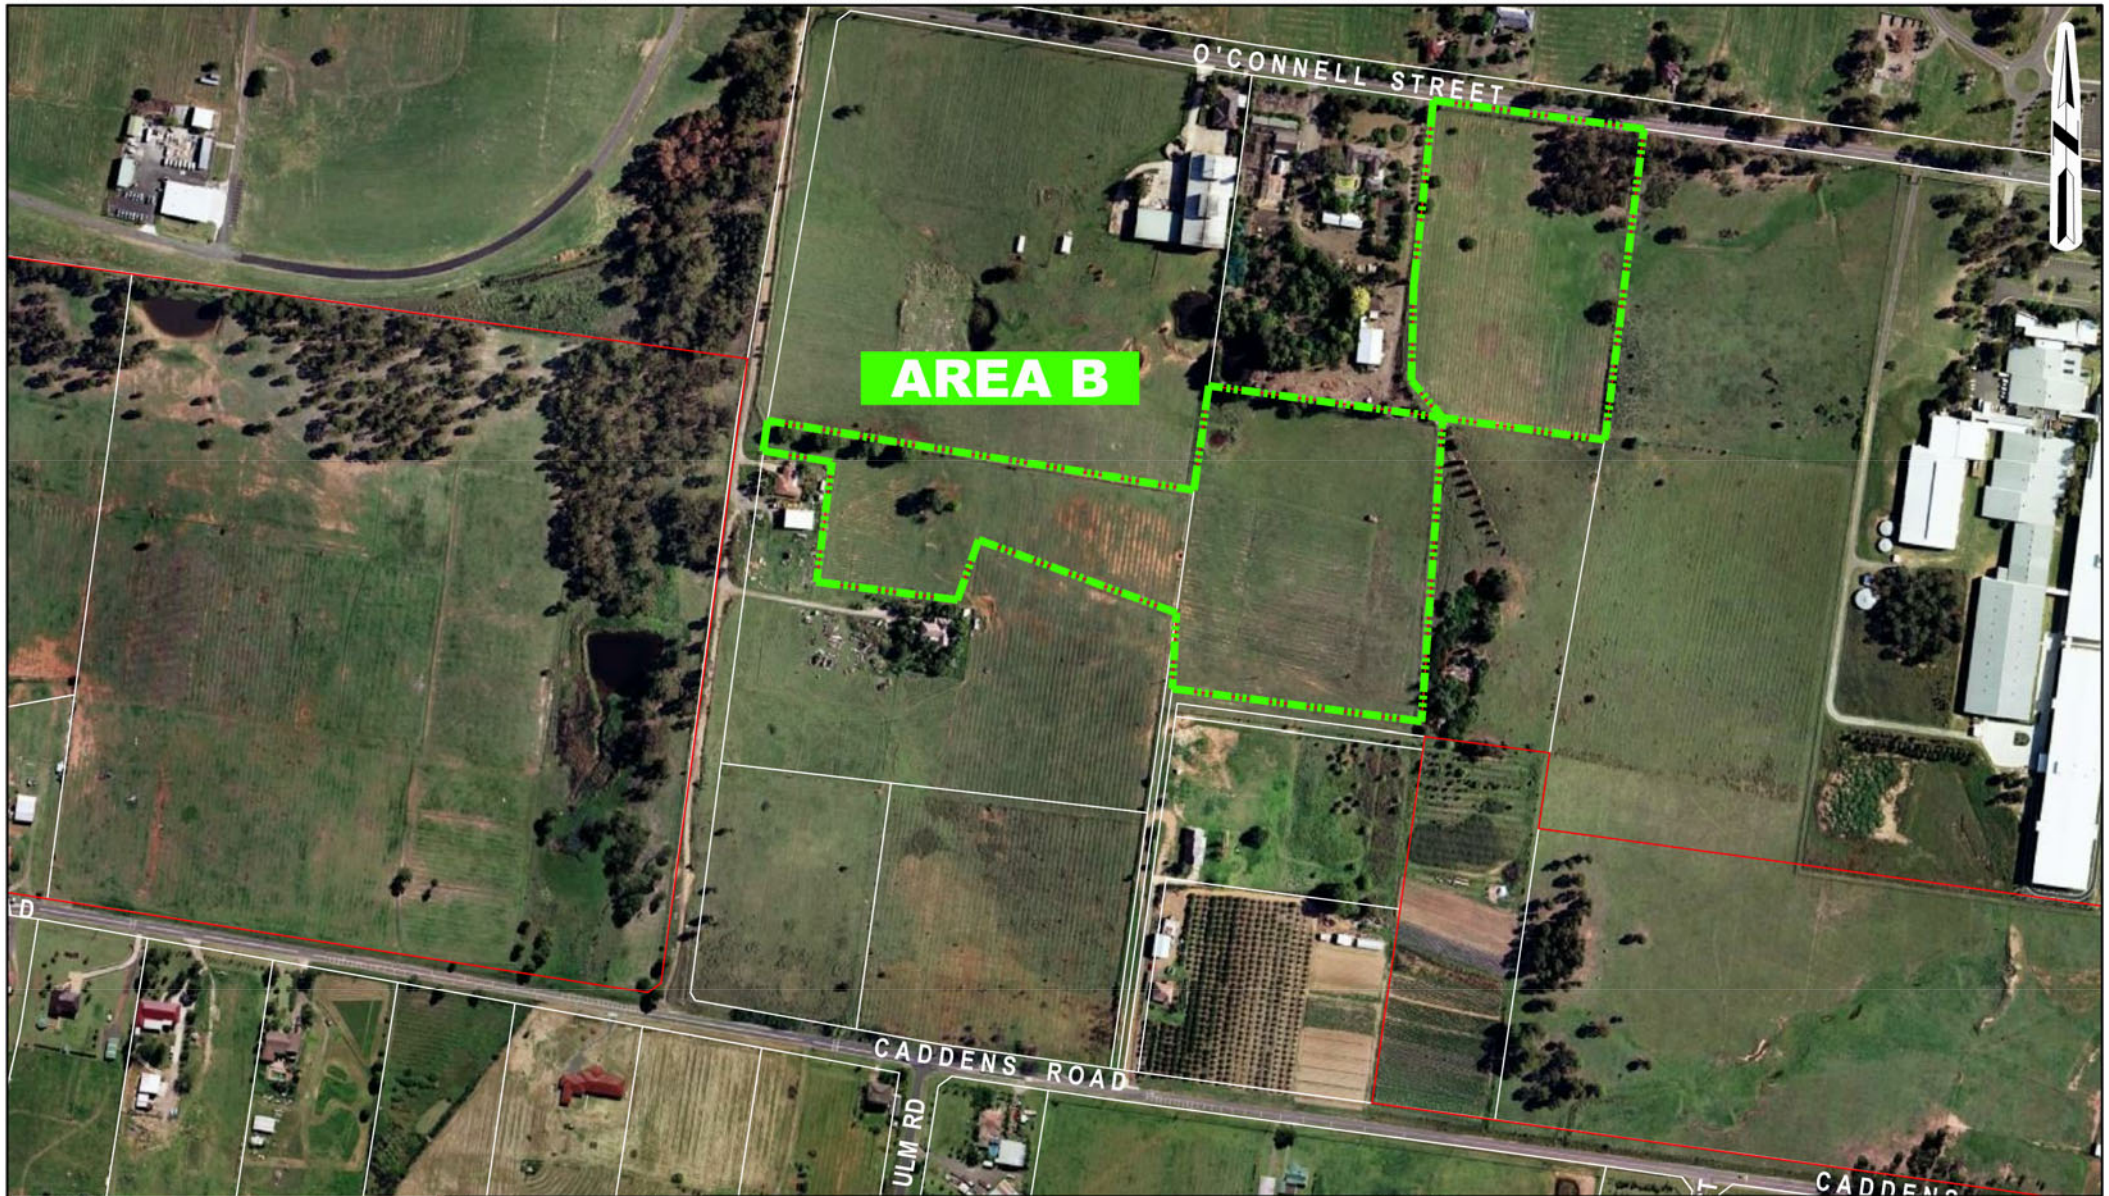
CLIENT LANDCOM		PROJECT SITE AUDIT REPORT : CADDENS RELEASE AREA, KINGSWOOD, NSW	
DRAWN HC	DATE 14.08.2009	TITLE AREA B (SITE AUDIT STATEMENT RJP023)	
CHECKED MU	DATE 14.08.2009	PROJECT No 097623019	DOC No 007
SCALE 1:5000	A4	DOC TYPE R	FIGURE No F0002
		REV No 0	FIGURE 2b

LEGEND
- - - - - BOUNDARY OF AREA B
