STATEMENT OF HERITAGE IMPACT

74 Henry Street, Penrith
Prepared for Rizon Building
December 2019

Prepared by:
Steven Guadagnin
SG Architectural and Heritage
steven@sgah.net.au

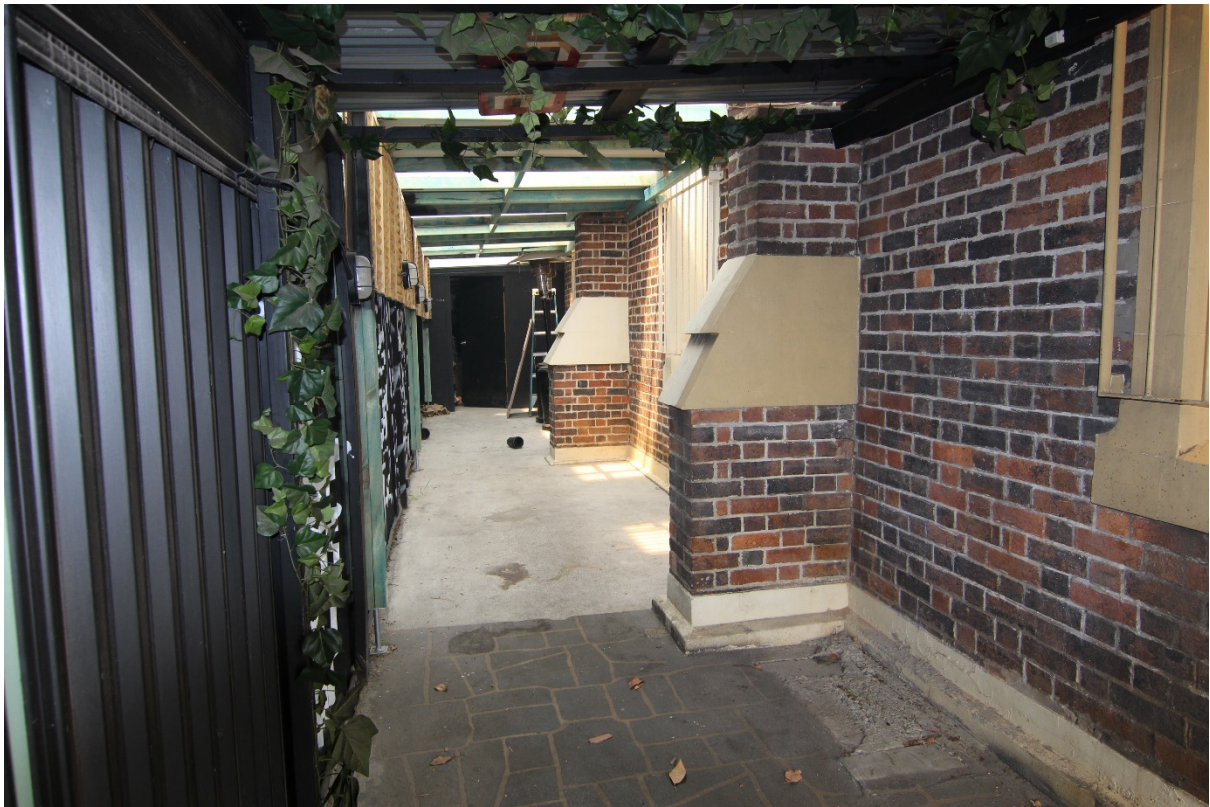
Fig. 7: View inside enclosed timber structure attached to side elevation.
(Source: Steven Guadagnin, November 2019.)

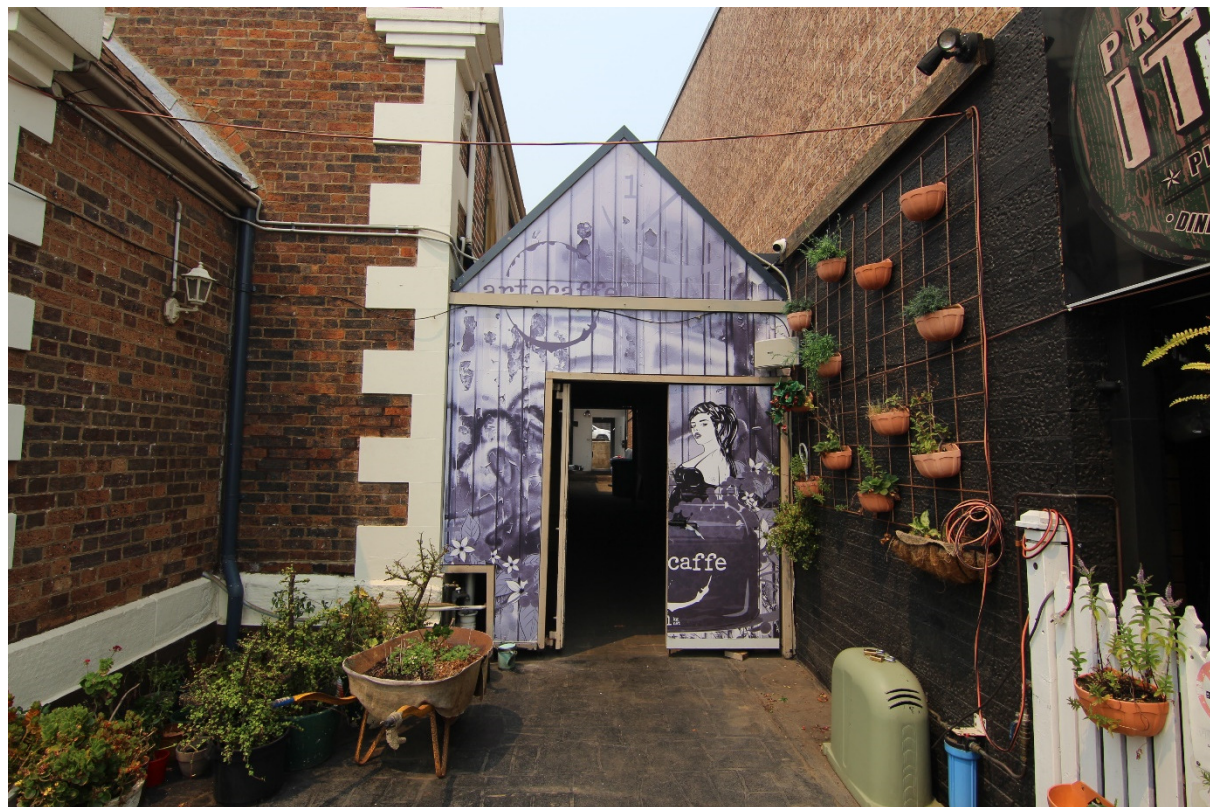
Fig. 8: View of enclosed timber structure attached to side elevation.
(Source: Steven Guadagnin, November 2019.)

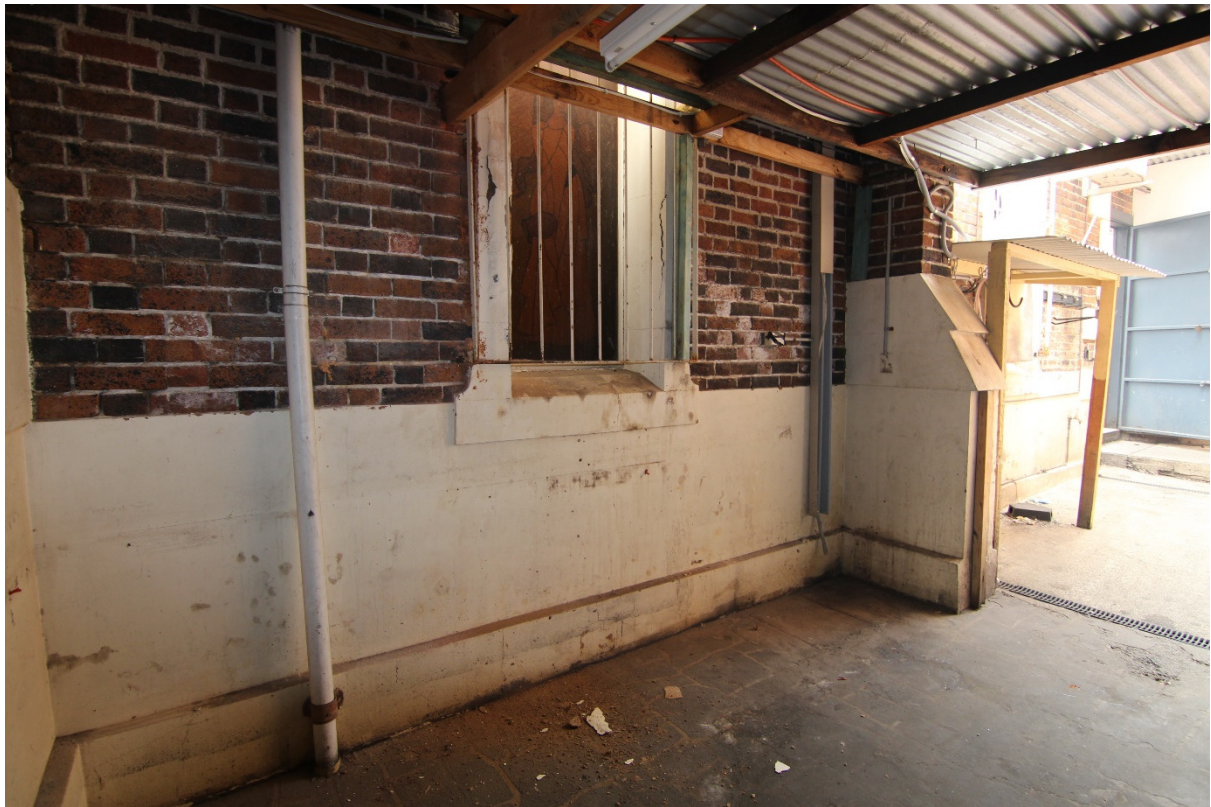
Fig. 9: View of rising damp affecting brickwork and render along west elevation.
(Source: Steven Guadagnin, November 2019.)

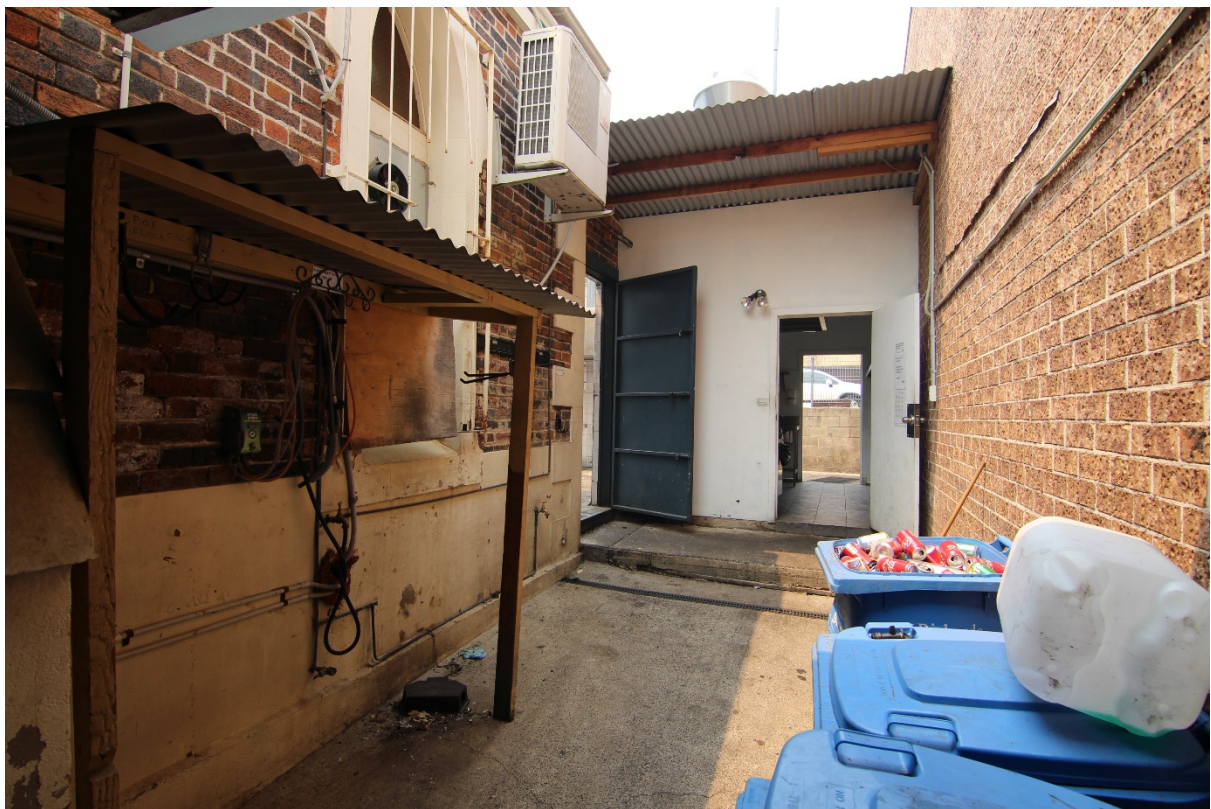
Fig. 10: View of external kitchenette.
(Source: Steven Guadagnin, November 2019.)

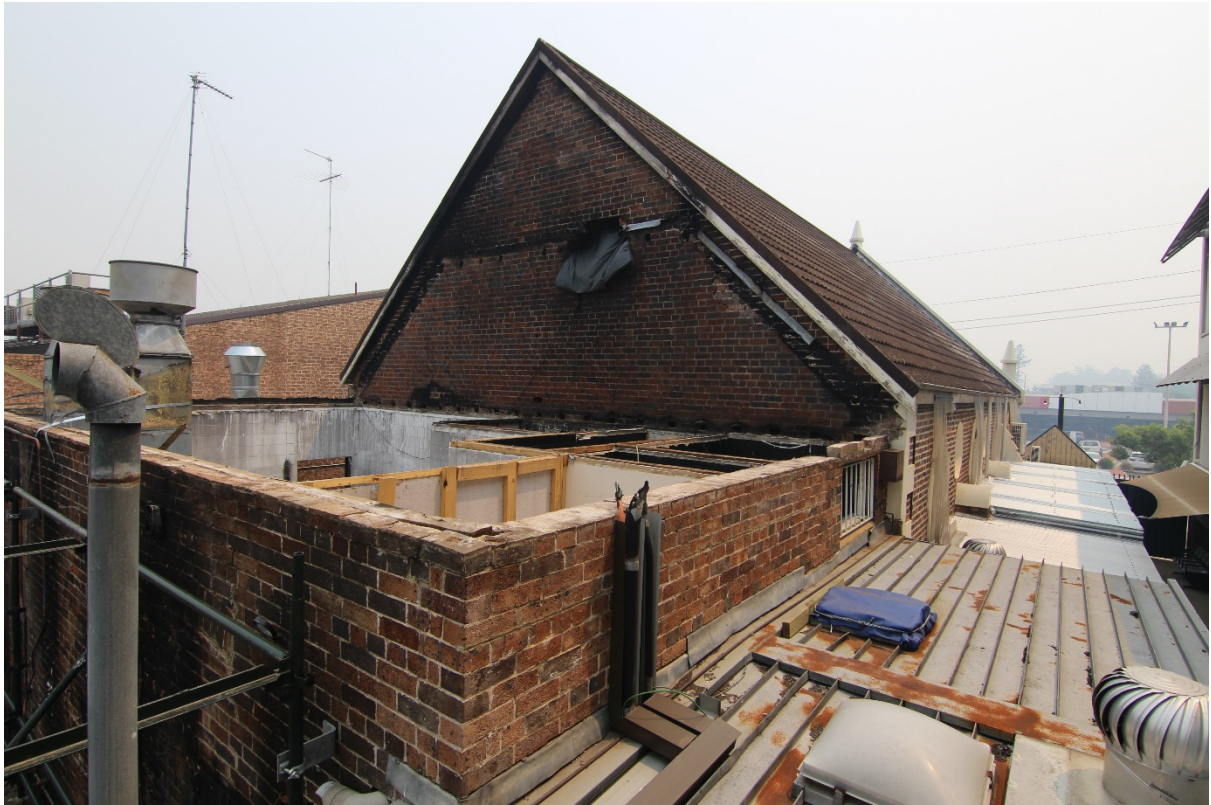
Fig. 11: Rear of building – origin of fire.
(Source: Steven Guadagnin, November 2019.)

- Demolition and reconstruction of the rear southern external brick wall.
- Demolition and reconstruction of the internal timber framed walls surrounding the store room.
- Reconstruction of the roof structure over the kitchen area to the rear of the building.
- Replacement of the hot water unit.

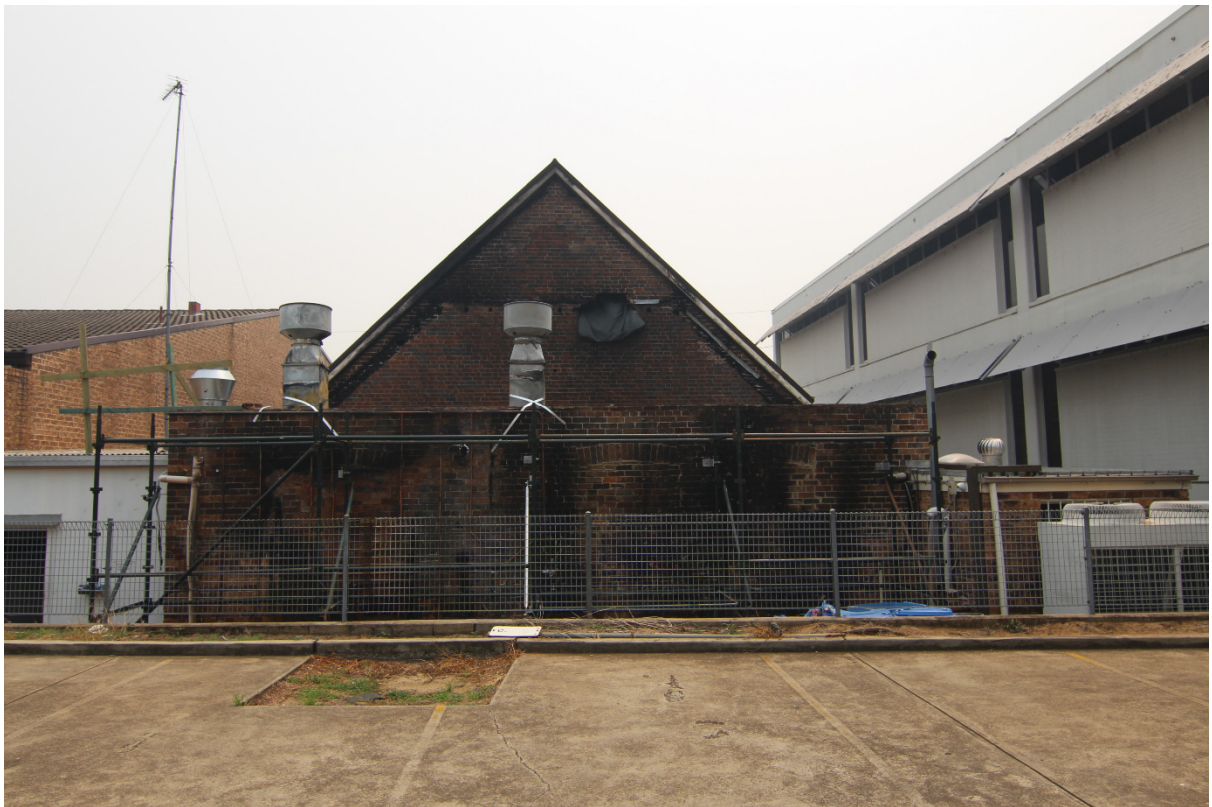
Fig. 12: Rear of building – origin of fire.
(Source: Steven Guadagnin, November 2019.)

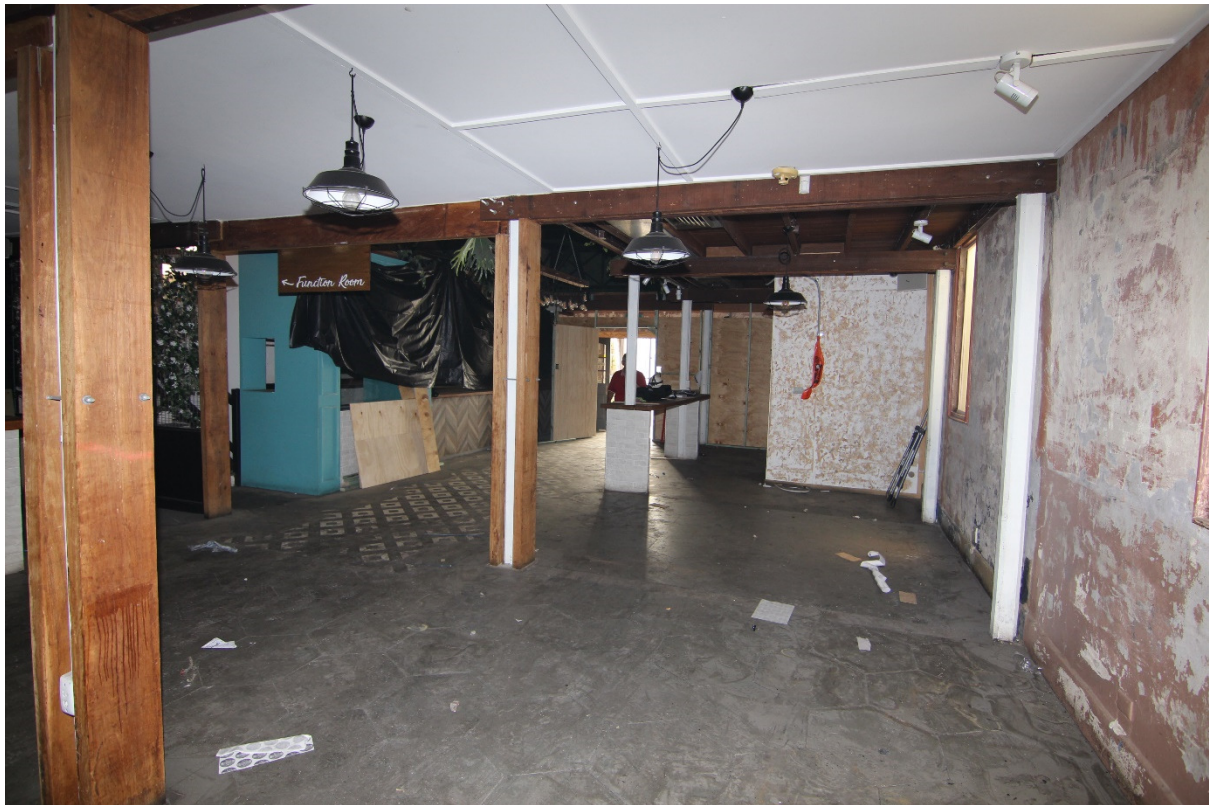
Fig. 13: View of ground floor restaurant area – note the columns supporting first floor loft area.
(Source: Steven Guadagnin, November 2019.)

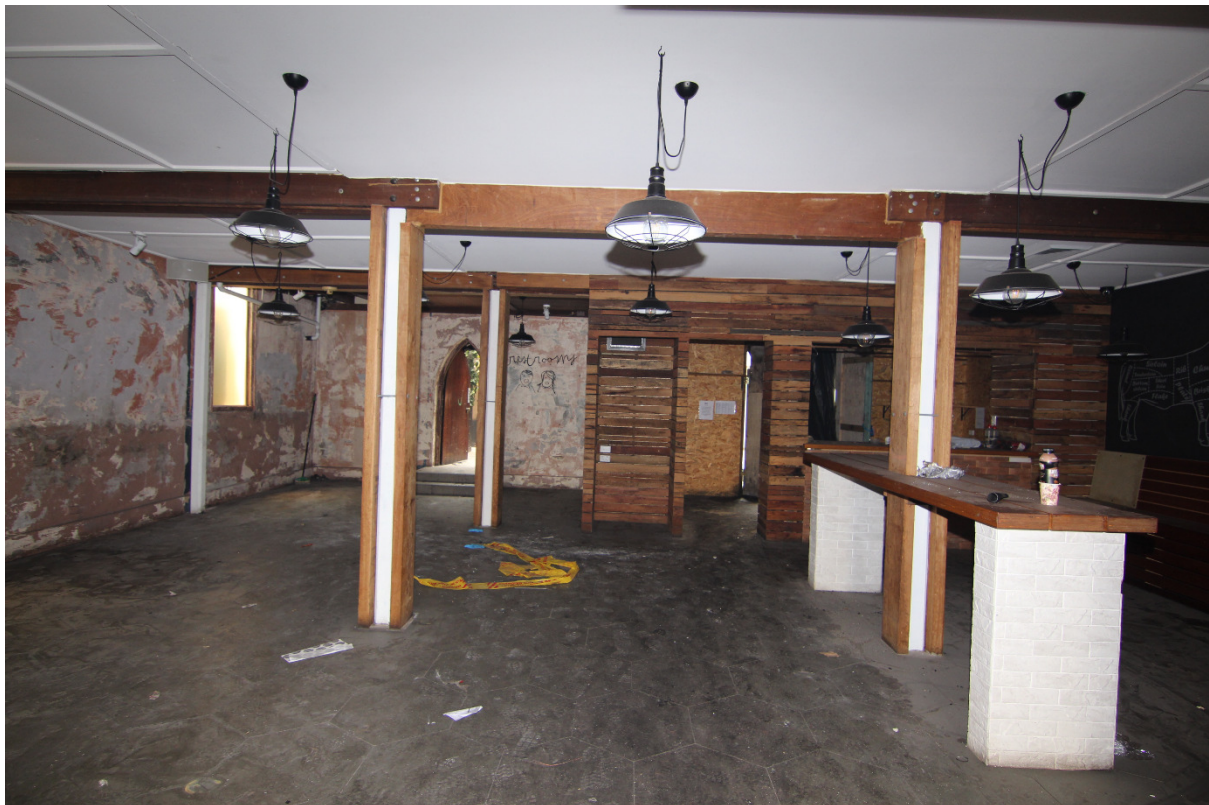
Fig. 14: View of ground floor restaurant area – note the columns supporting first floor loft area.
(Source: Steven Guadagnin, November 2019.)

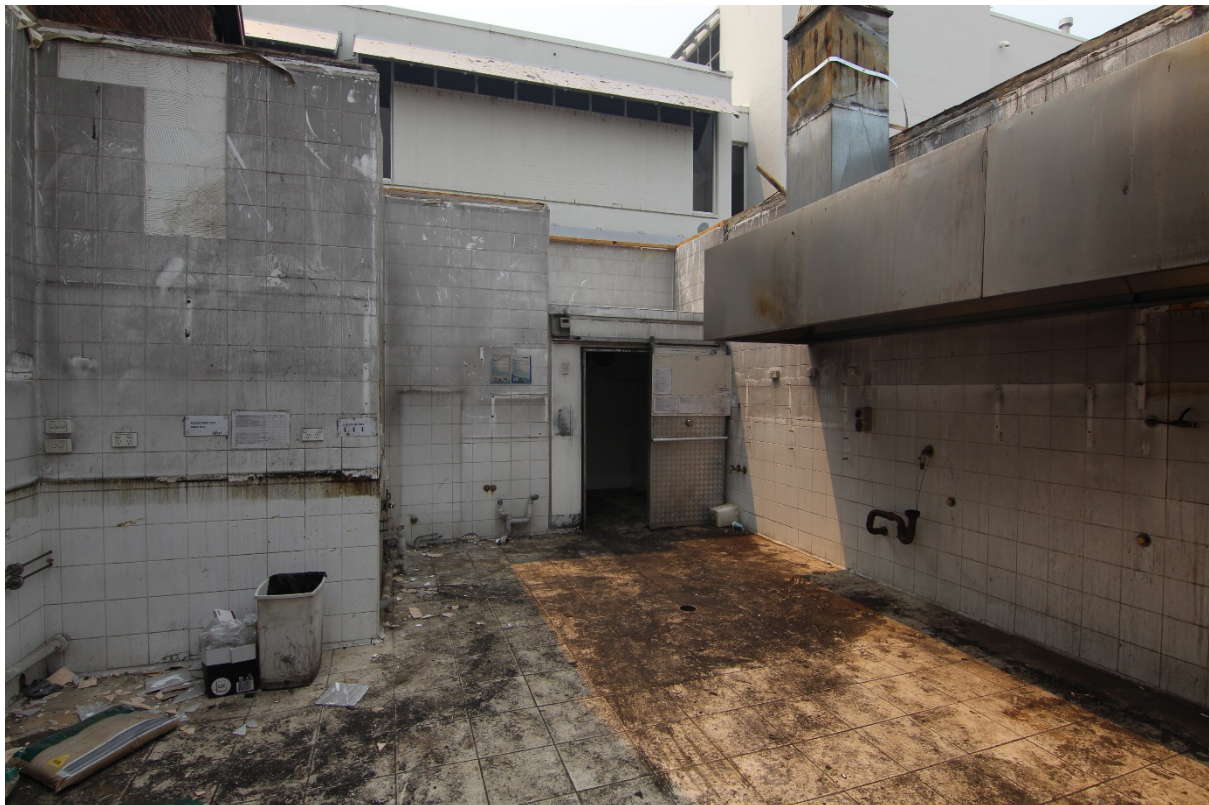
Fig. 16: View of kitchen area – note the roof above kitchen area demolished as part of make safe works.
(Source: Steven Guadagnin, November 2019.)

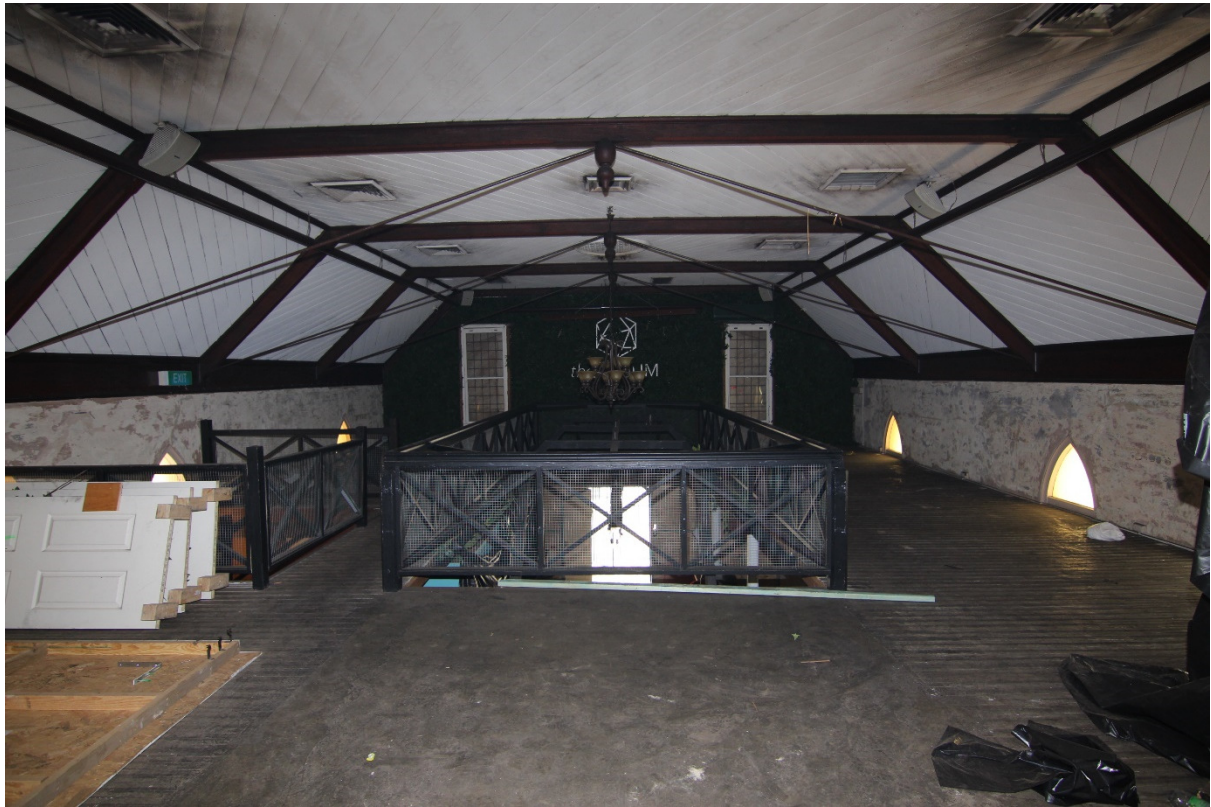
Fig. 17: View of first floor loft dining area – note the void space and exposed roof trusses.
(Source: Steven Guadagnin, November 2019.)

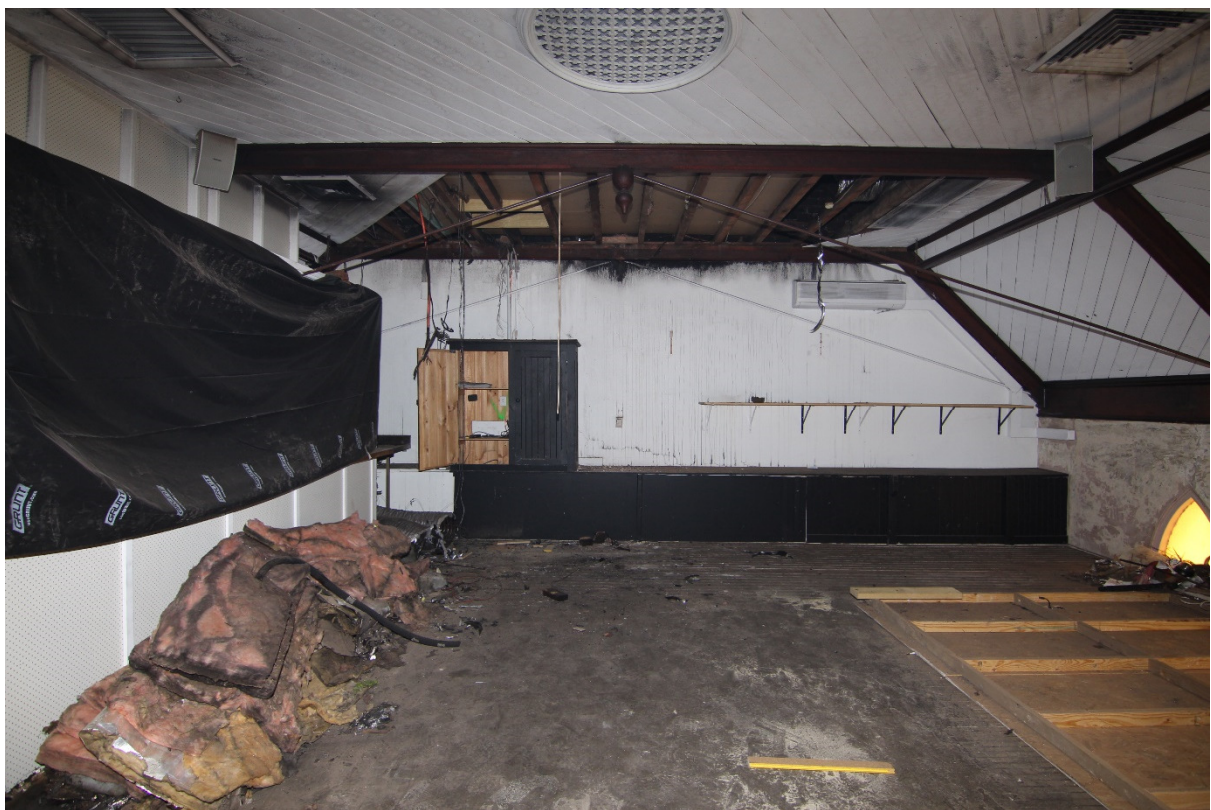
Fig. 18: View of first floor loft dining area – note the area of fire damaged roof.
(Source: Steven Guadagnin, November 2019.)

- Demolition and reconstruction of the rear southern external brick wall.
- Replacement of two exposed timber trusses including rafters and ceiling joists to the rear of the main roof.
- Removal of the existing roof cladding to the entire main roof and replacement with corrugated sheet metal.

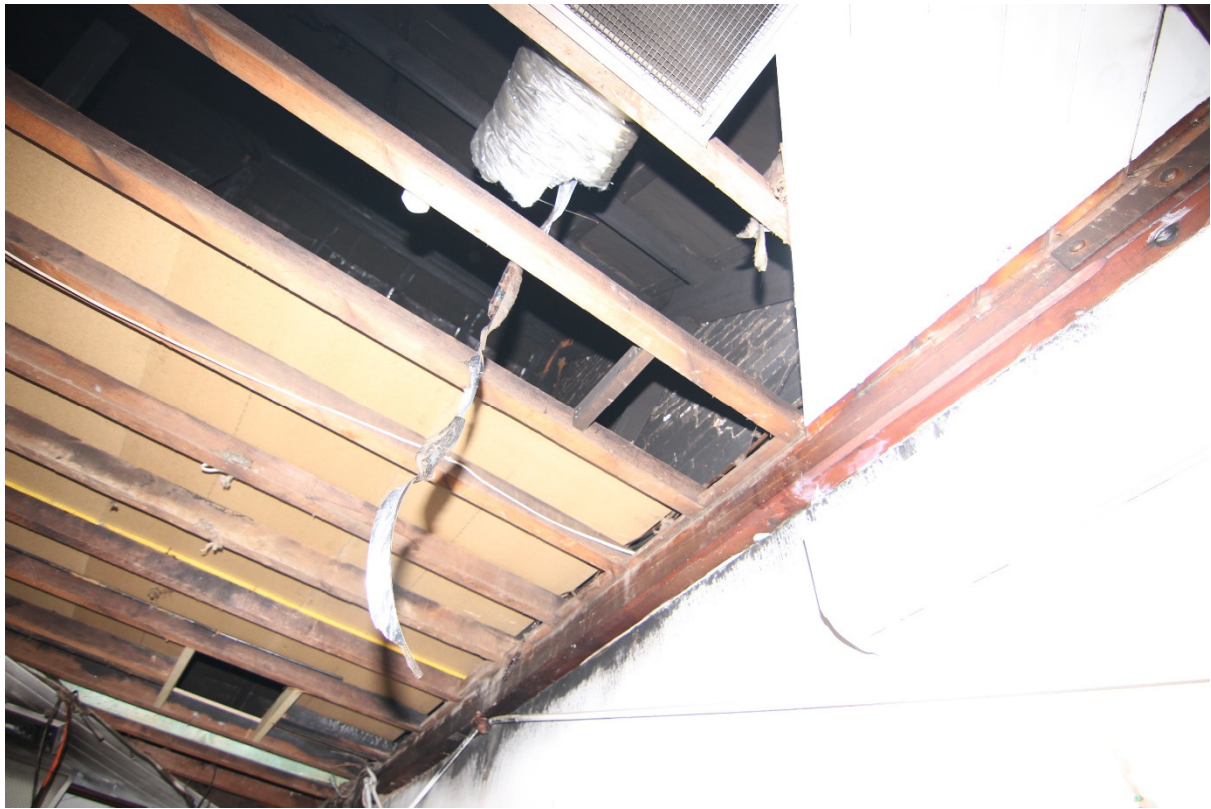
Fig. 19: View of fire damaged first floor roof framing.
(Source: Steven Guadagnin, November 2019.)
