## Hydrogeological Assessment

Erskine Park Landfill, Quarry Road, Erskine Park, NSW

Prepared for:  
Cleanaway Solid Waste Pty Ltd  
85-87 Quarry Road, Erskine Park, NSW, 2759  
PO Box 804, St Marys, NSW, 1790

2 April 2020

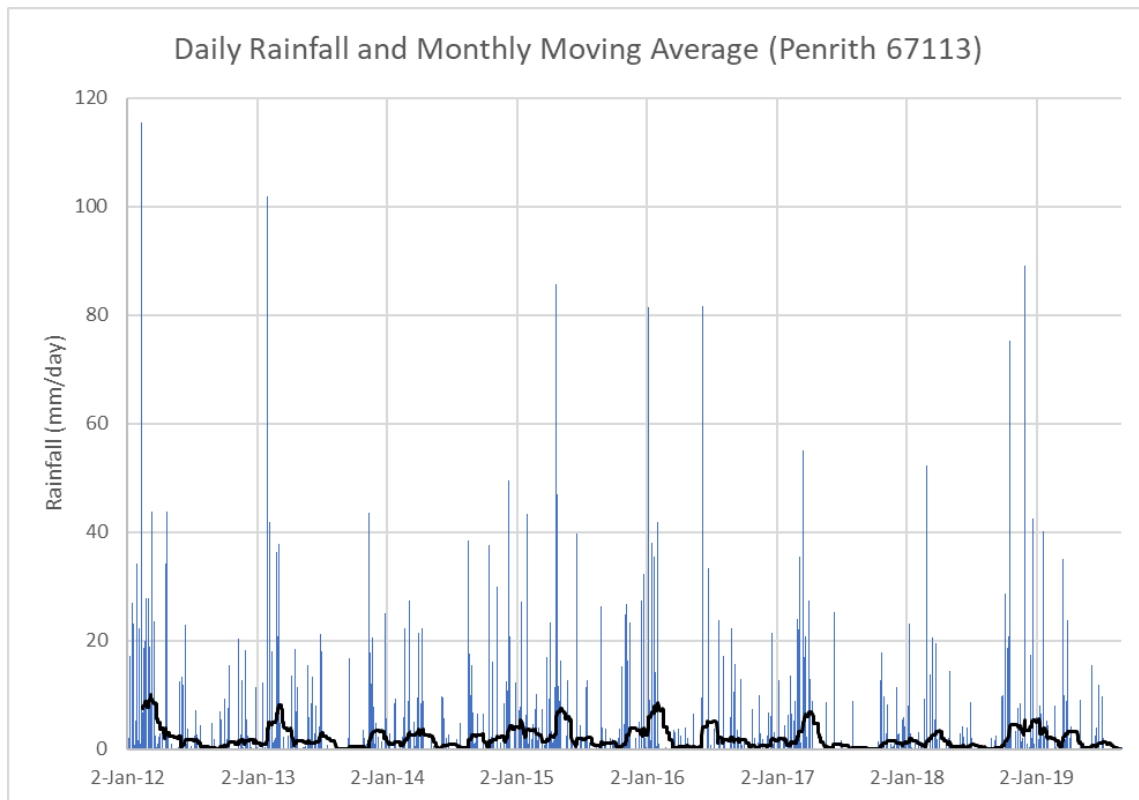
**Figure 2: Daily Rainfall Trends (Penrith 67113))**

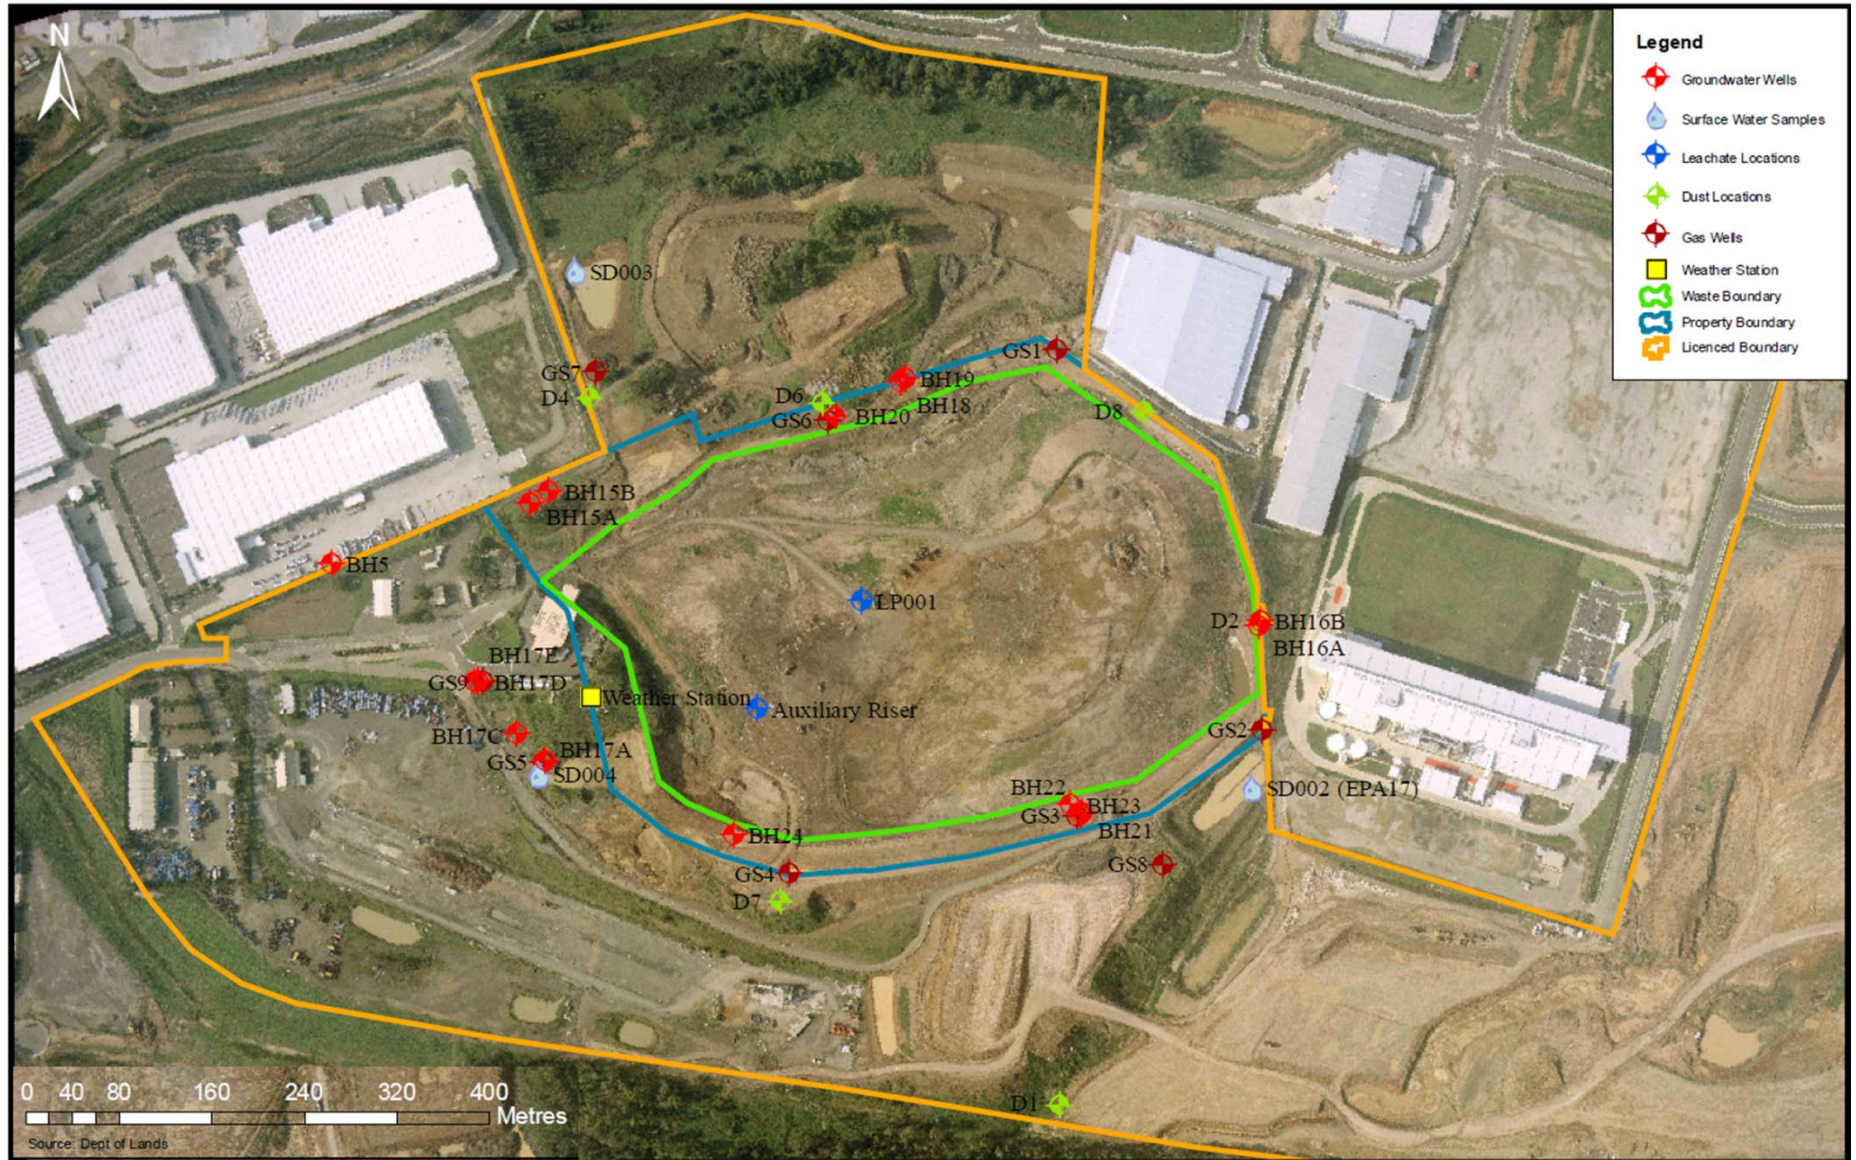
Figure 4: Current Groundwater Monitoring Well Network (after CES, 2009)

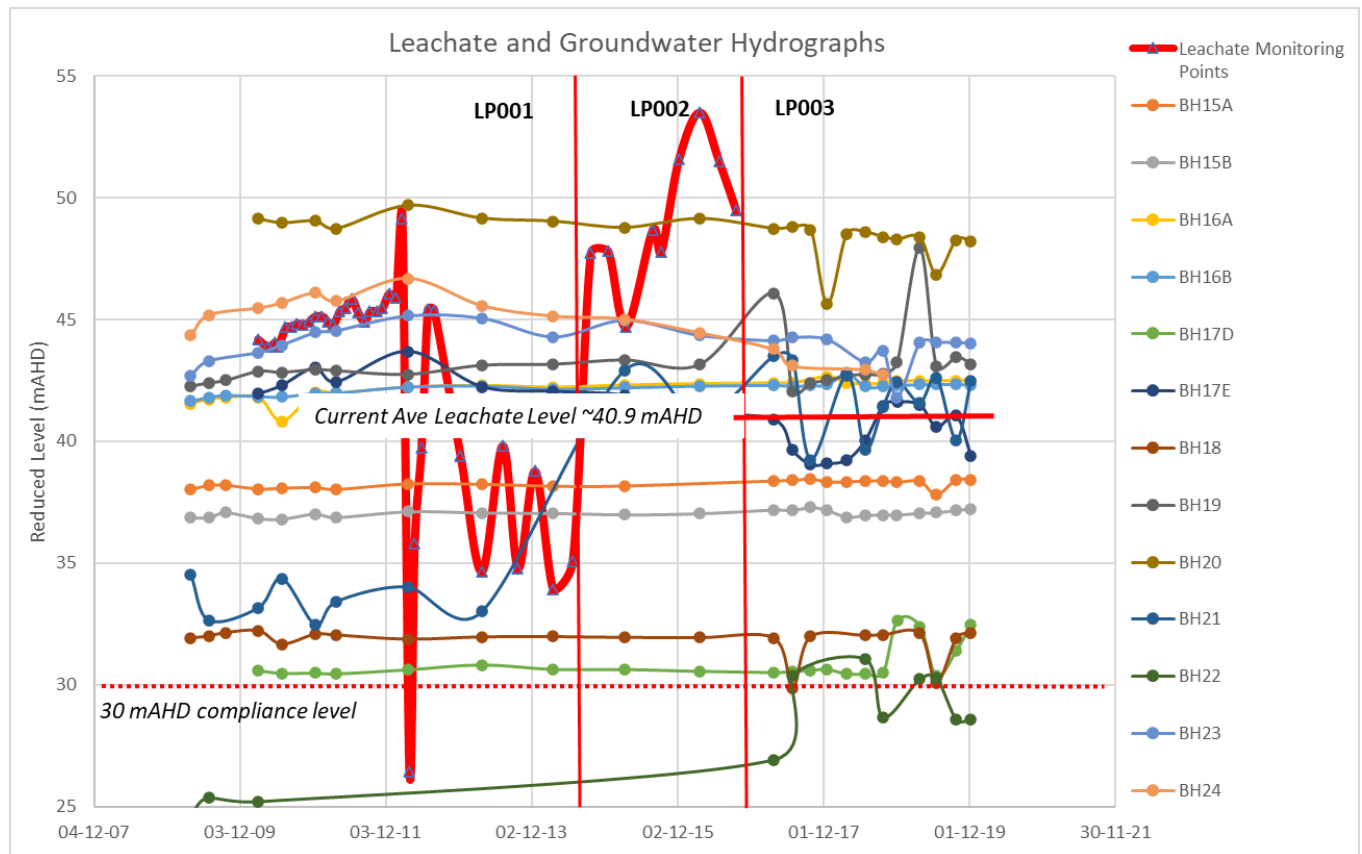
**Figure 5** below summarises the available leachate and groundwater elevation data, as compiled from available documentation and recent data collected as part of this project. The leachate level was observed to be decreasing towards 30 m AHD during 2011 to 2013, after which a rapid increase occurs to approximately 50 m AHD by late-2015. As of December 2019, the leachate level in LP003 was measured at approximately 40.5 m AHD, as measured using a downhole camera. The average leachate RL was estimated at approximately 40.9 m AHD (refer **Table 4a** in **Section 4.1.1**).

Figure 5: Leachate and Groundwater Hydrographs

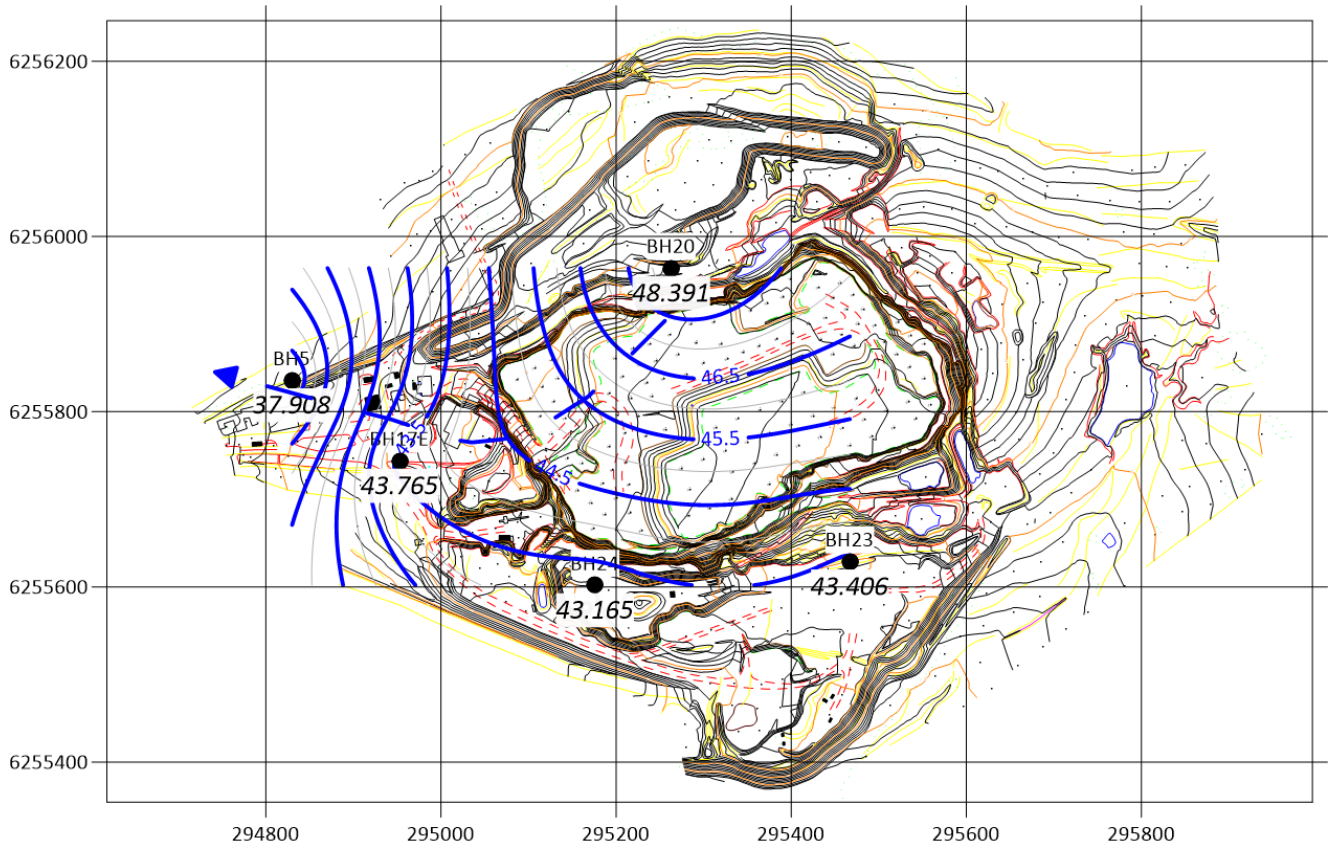
**Figure 6: Shallow Monitoring Well Reduced Water Level Contours (m AHD) (March 2017)**

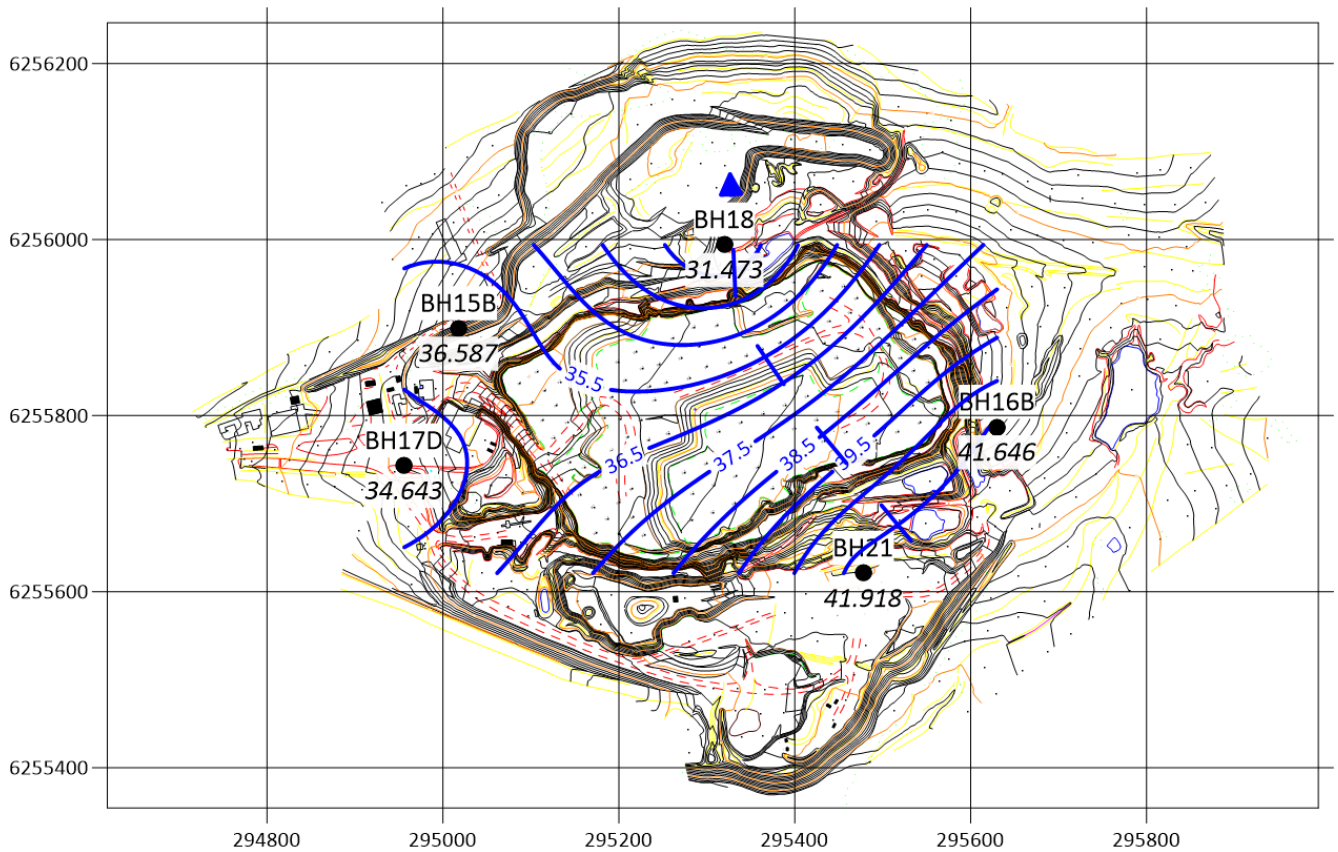
**Figure 8: Deep Monitoring Well Reduced Water Level Contours (m AHD) (July 2019)**

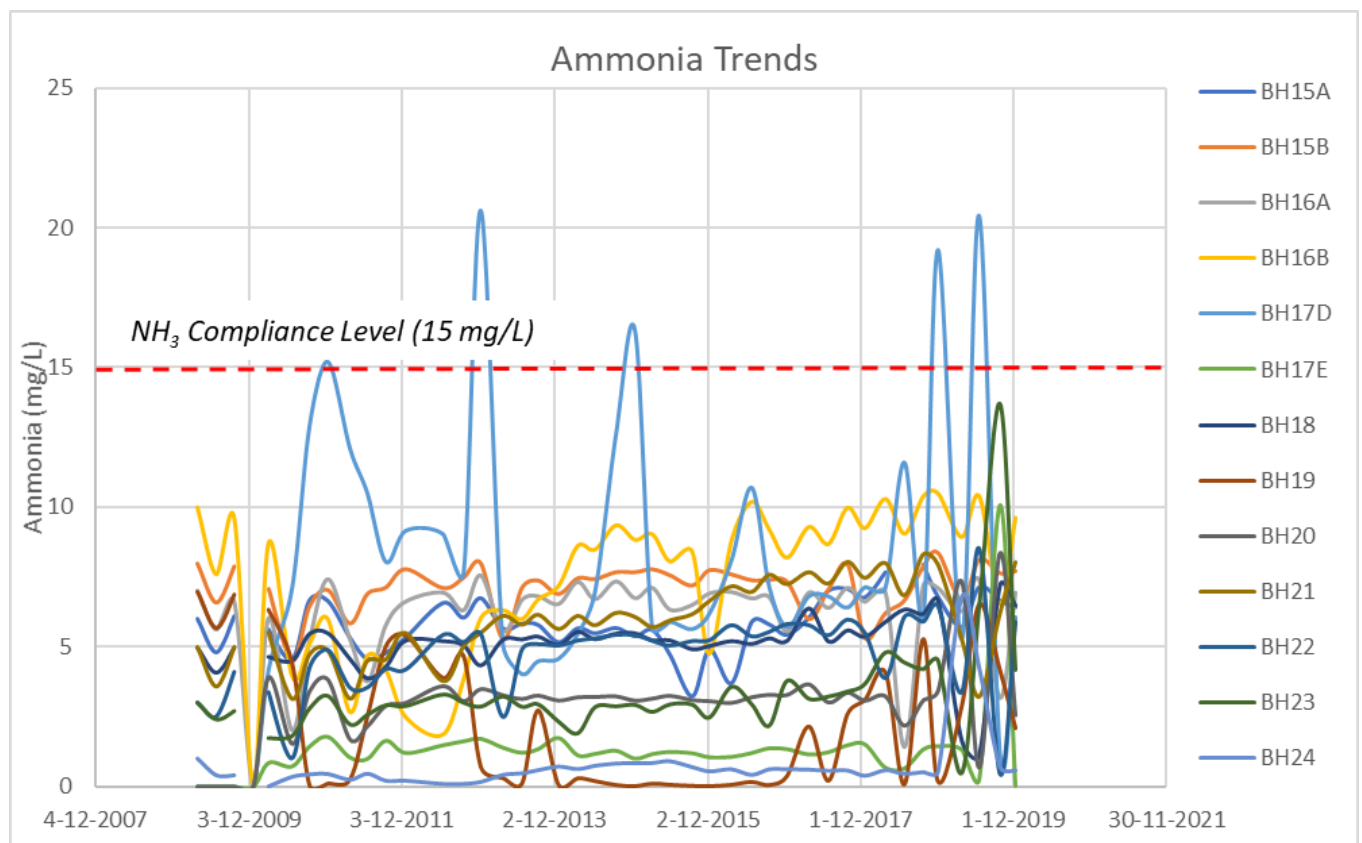
Figure 10 below shows the temporal trends in ammonia concentrations in all groundwater monitoring wells for the period 2016-2019, and the 15 mg/L ammonia criterion (Condition U1.1 in EPL 4865).

**Figure 10: Ammonia (as N) in Groundwater Concentration Trends (2009 to date)**

**Figure 10** indicates that the EPL criterion of 15 mg/L has been exceeded on four occasions since 2009, and only in one well (BH17D). Observed variations in ammonia in BH17D may be due to its proximity to an operating wash bay, combined with its location within a bunded area. **Table 4b** in **Section 4.1.2** indicates the depth of the sampling pump within BH17D sits over 30 m above the screened interval of the groundwater bore, hence, samples of groundwater collected from this deep bore may not be representative of the groundwater in the area, and could be a combination of groundwater and infiltrated surface water collected within the bore's solid casing.

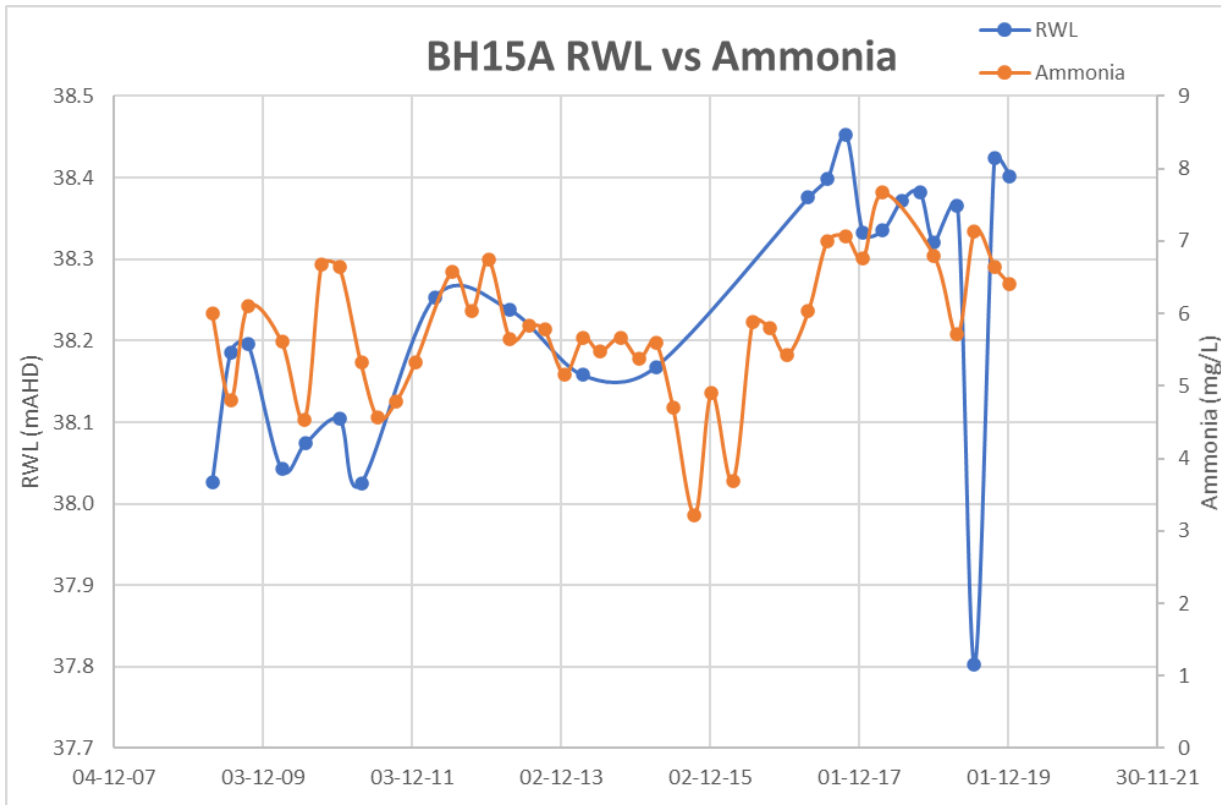
Figure 11: Ammonia vs RWL Trends (BH15A)

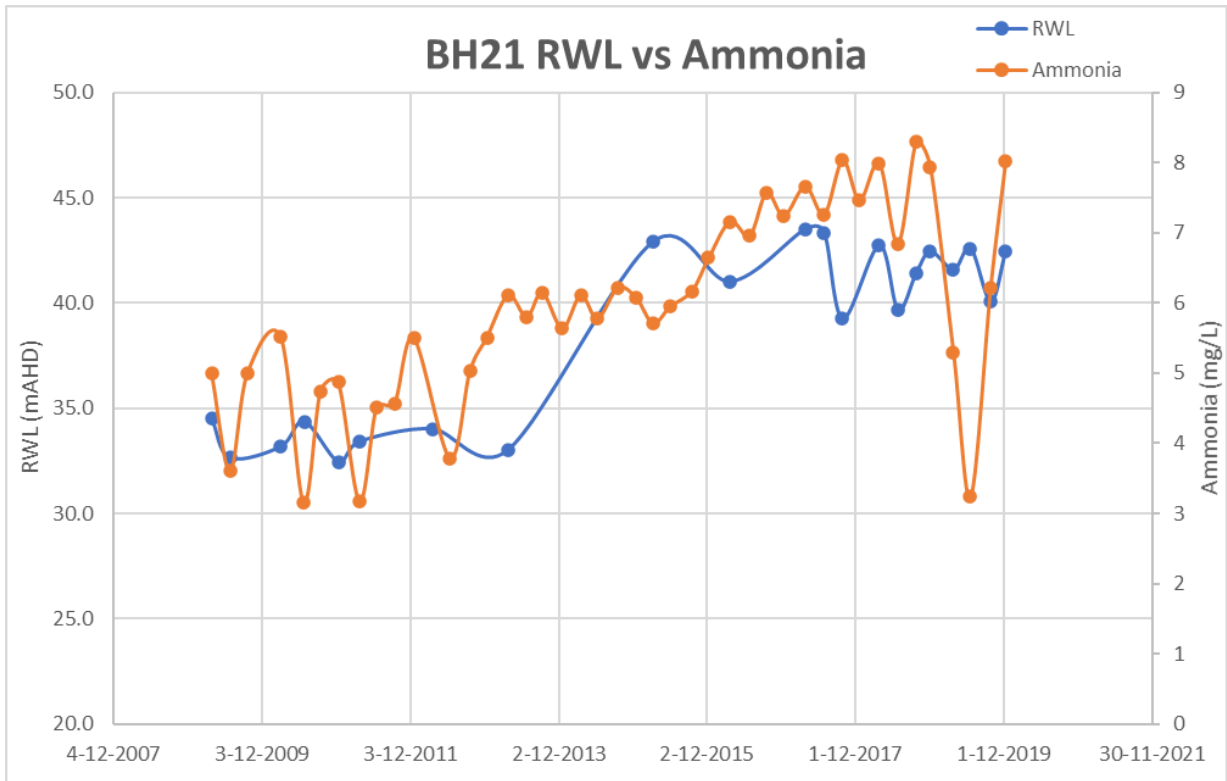
Figure 12: Ammonia vs RWL Trends (BH21)

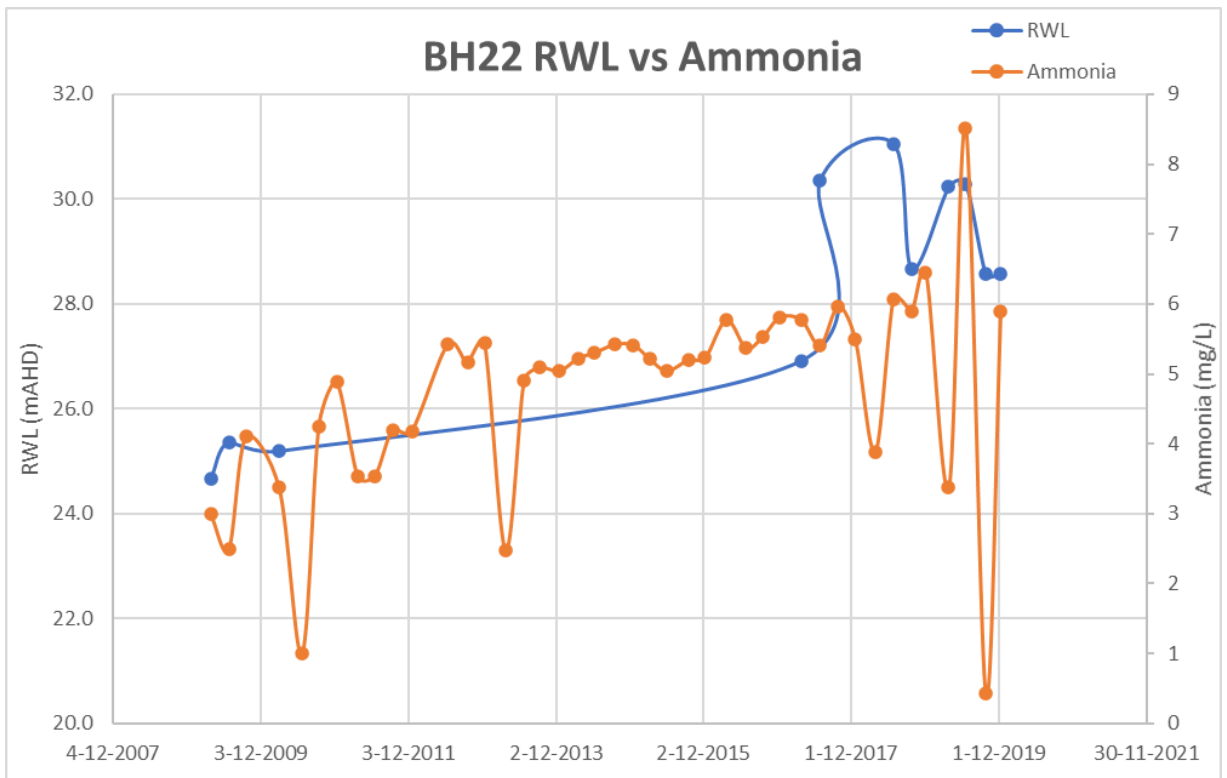
Figure 13: Ammonia vs RWL Trends (BH22)

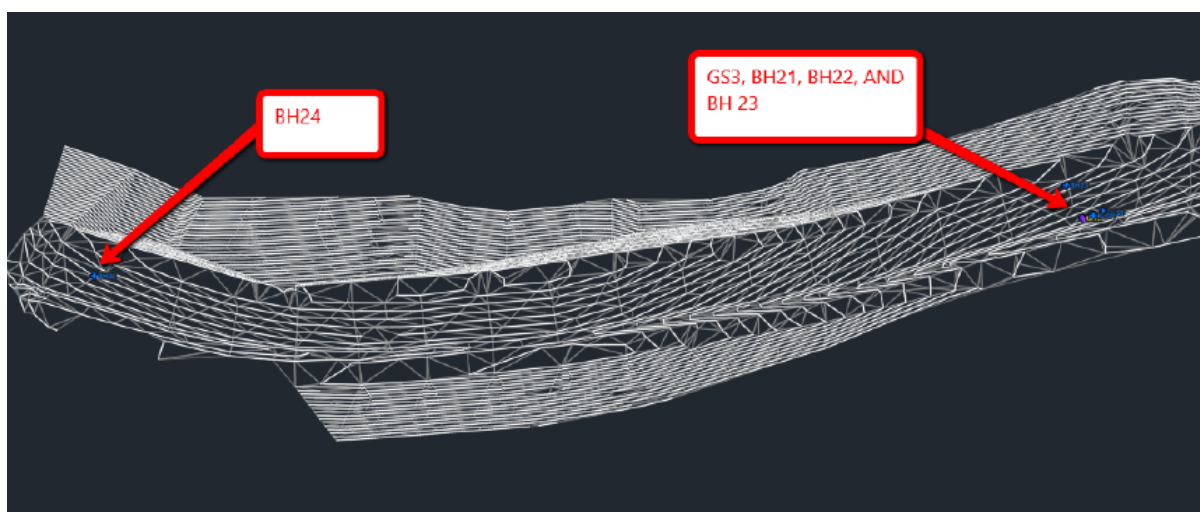
*Groundwater monitoring bores BH21 to BH24 have also been installed through the clay liner wall (as inferred in Figures 14 to 17: cross-sections N to Q). The screenshot below shows the extent of the southern clay wall versus the bore locations.*

Construction bore records indicate groundwater monitoring bores BH21 to BH23 drilled through approximately 6 m of fill before encountering natural material, while the bore record for BH24 indicates approximately 14 m of fill and overburden overlying natural material . While none of the bores screened through the fill material, they could potentially be influenced by runoff infiltration around the landfill perimeter, as the perimeter swale is located in very close proximity at the base of the clay wall.

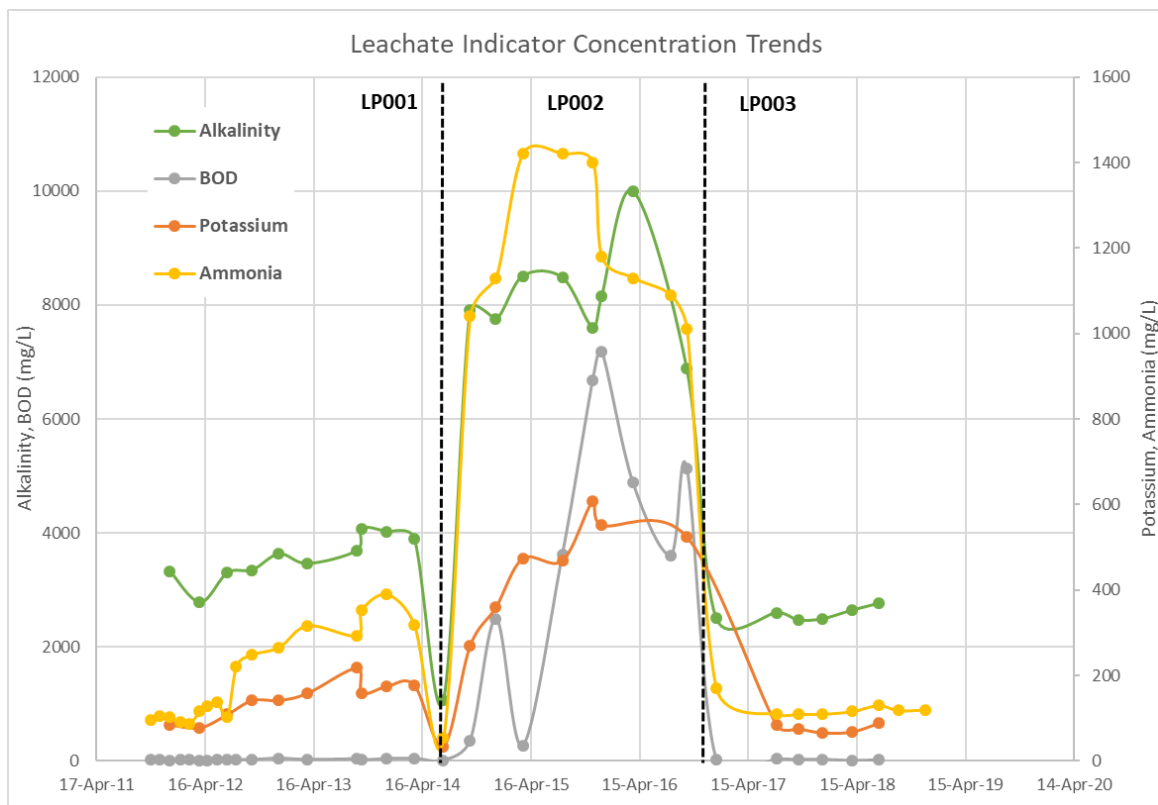
**Figure 14: Leachate Indicator Concentration Trends**

- Between mid-2014 to late-2016, leachate sampling was switched to LP002, after which a rapid and significant increase in leachate strength was observed (e.g. ammonia increased from approximately 200 mg/L to over 1400 mg/L). Based on previous reports, it had been assumed that LP002 was simply receiving leachate from LP001 until late 2016, at which point LP001 was buried under landfill, and leachate extraction was transferred to LP003 (Auxiliary Riser). Recent sampling of all leachate risers has, however, confirmed similar leachate composition to historical results. This suggests that leachate in LP002 was being extracted and sampled at a greater depth than LP001, and possibly in proximity to layers of organic waste deposited historically at the site.

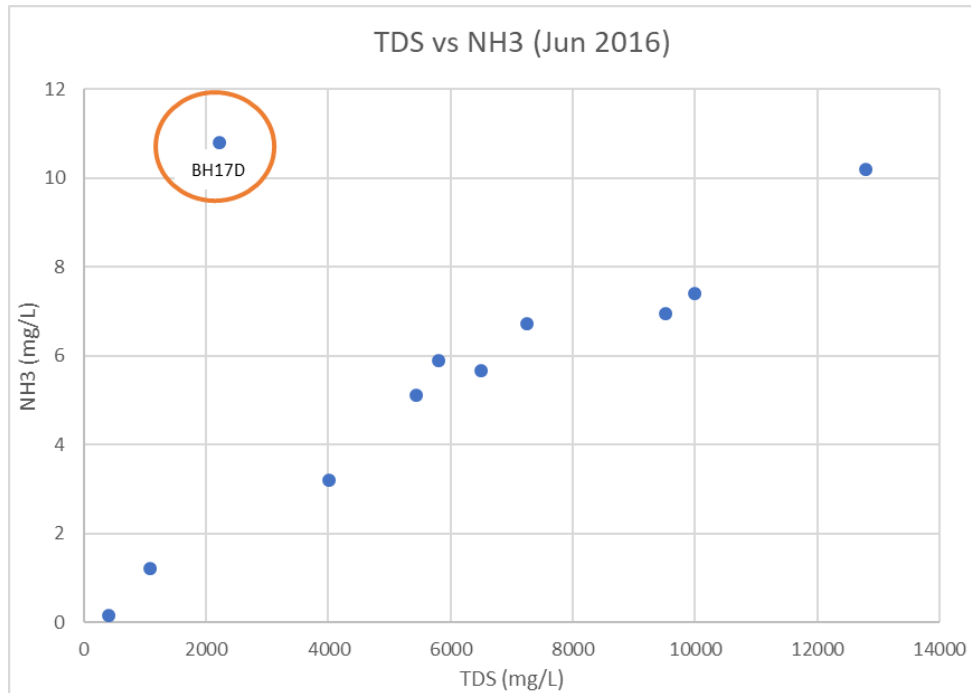
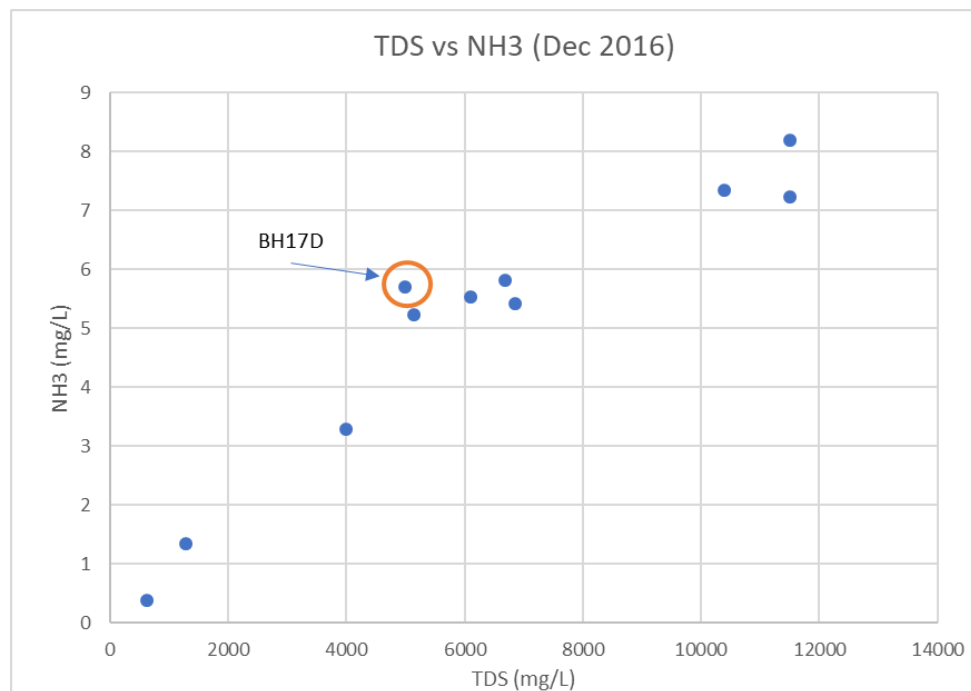
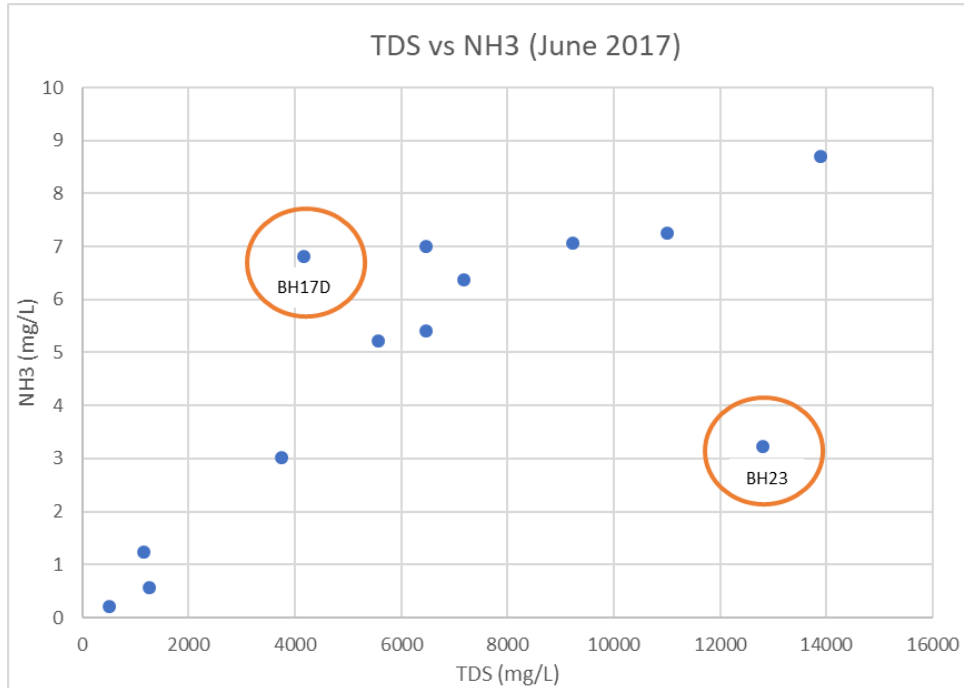
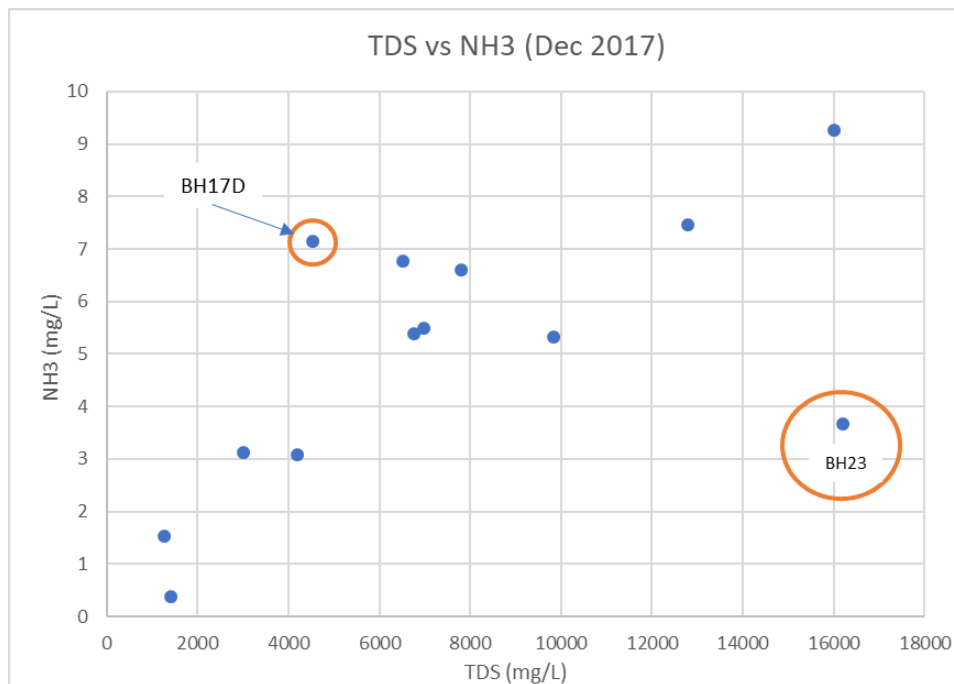
Figure 15: TDS vs Ammonia Concentrations (June 2016)

Figure 16: TDS vs Ammonia Concentrations (December 2016)

Figure 17: TDS vs Ammonia Concentrations (June 2017)

Figure 18: TDS vs Ammonia Concentrations (December 2017)

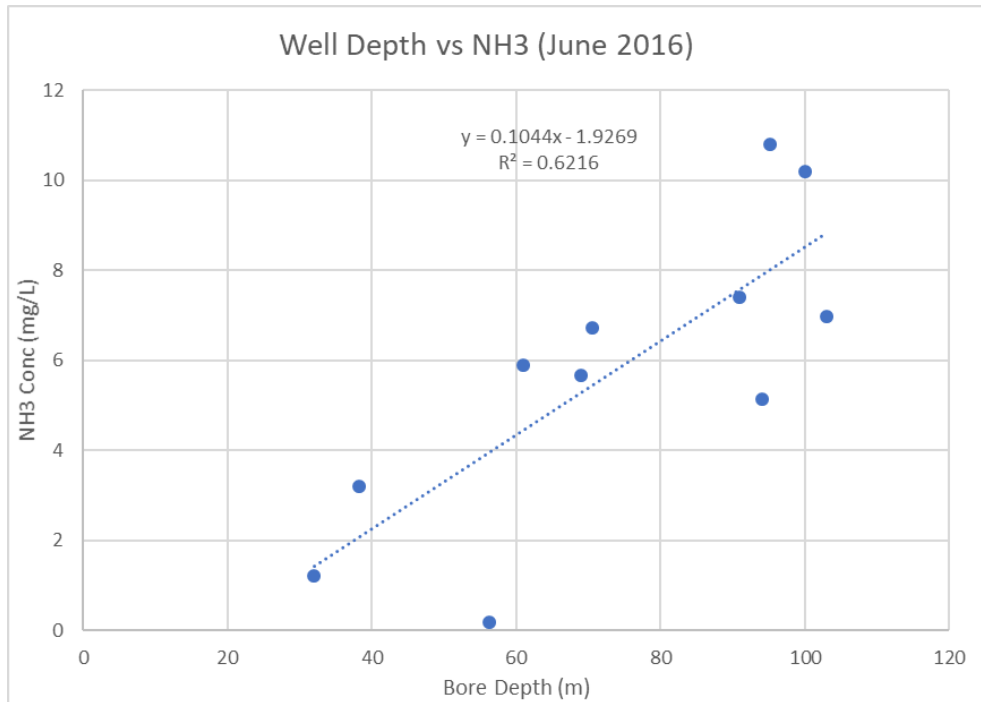
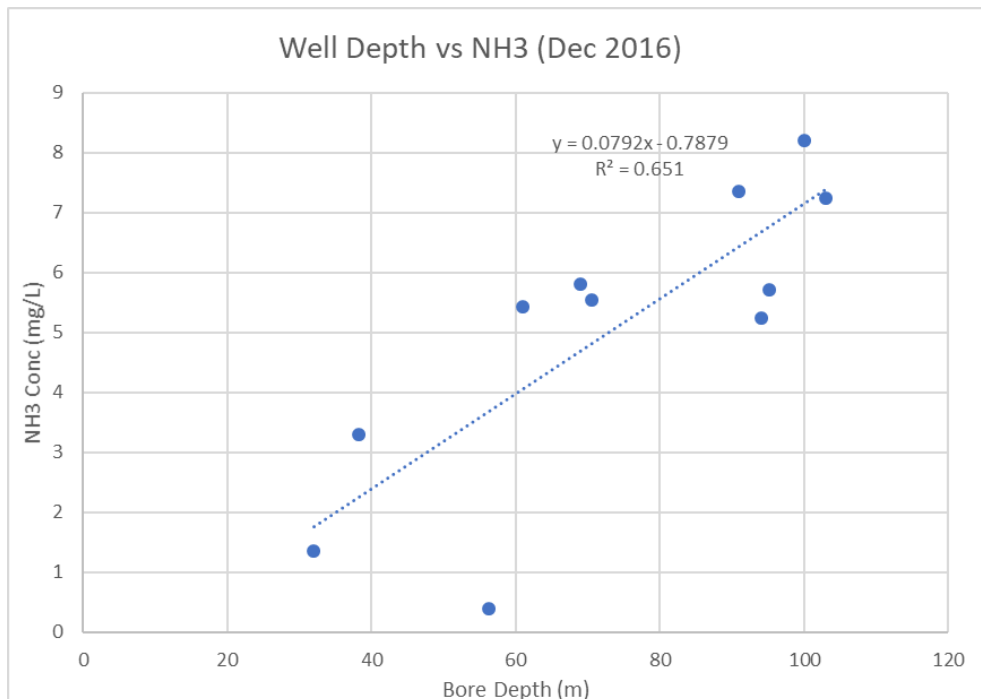
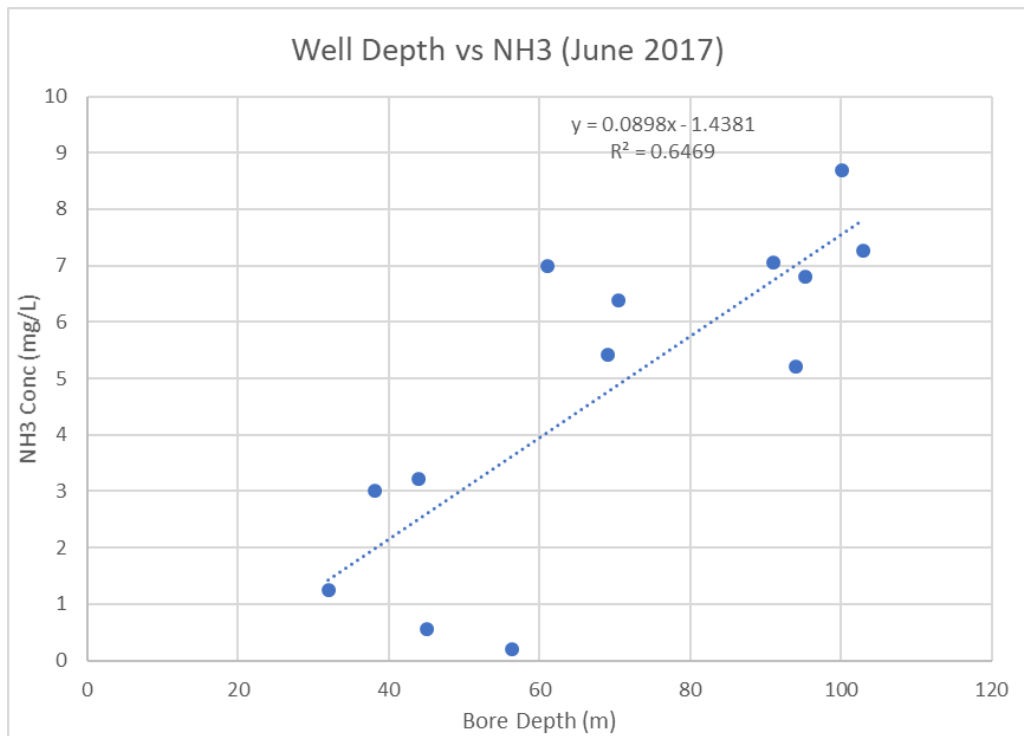
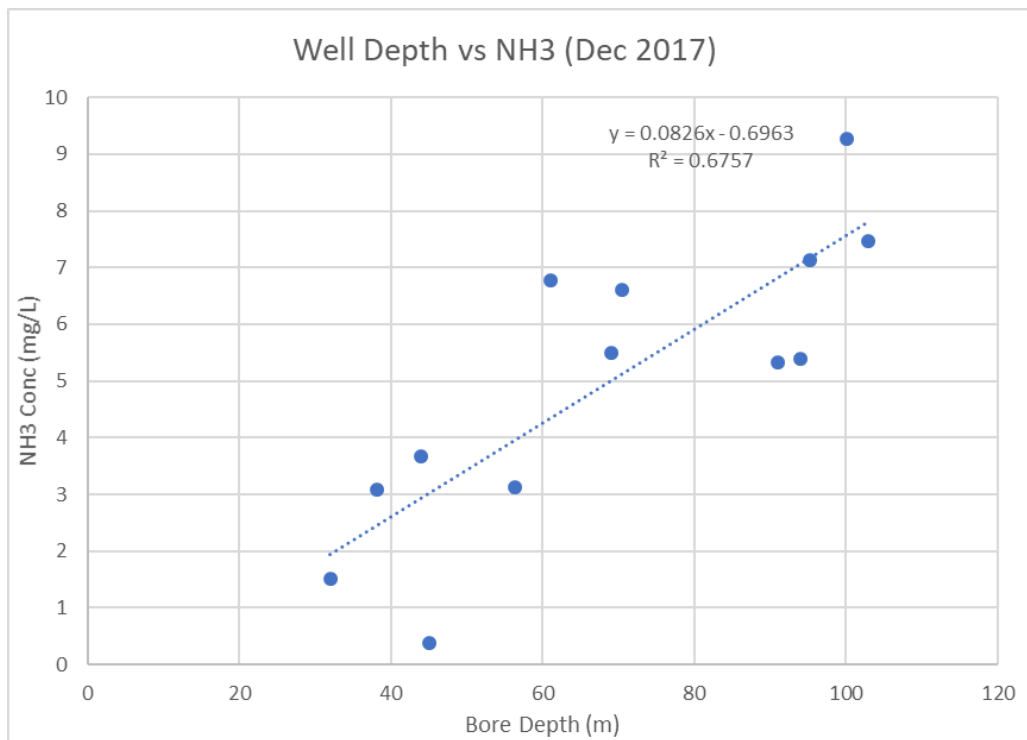
Figures 19 to 22 are plots showing the well depth (in metres) vs ammonia concentrations in groundwater, and show a generally consistent correlation between bore depth and ammonia, which confirms that both salinity and ammonia increase with depth. This may be attributed to the connate (i.e. ancient) nature of groundwater in the Wiannamatta Group aquifers, as described in Lovering (1954). This correlation may also, however, possibly be attributed to density driven flow, or preferential migration from the base of the landfill, and so further lines of evidence were required (i.e. hydrochemistry, environmental isotopes).

Figure 19: Bore Depth vs Ammonia Concentration (June 2016)

Figure 20: Bore Depth vs Ammonia Concentration (December 2016)

**Figure 21: Bore Depth vs Ammonia Concentration (June 2017)**

**Figure 22: Bore Depth vs Ammonia Concentration (December 2017)**

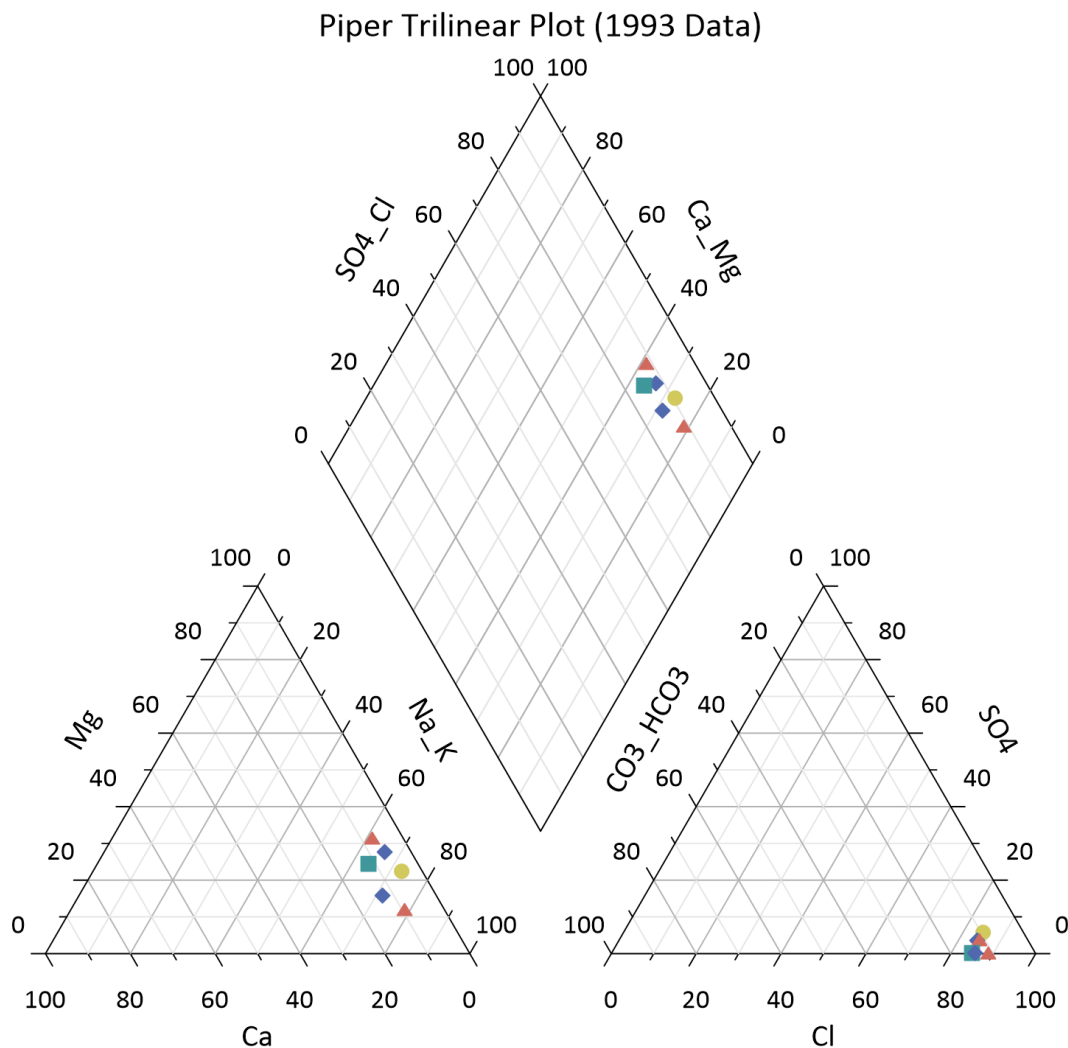
**Figure 23** is a piper trilinear plot of groundwater ionic composition based on the 1993 data – the tight grouping (clustering) of data is readily apparent suggesting a consistent water type and origin.

**Figure 23: Piper Trilinear Plot (1993 data) (after CMPS&F, 1994) (note no leachate data available)**

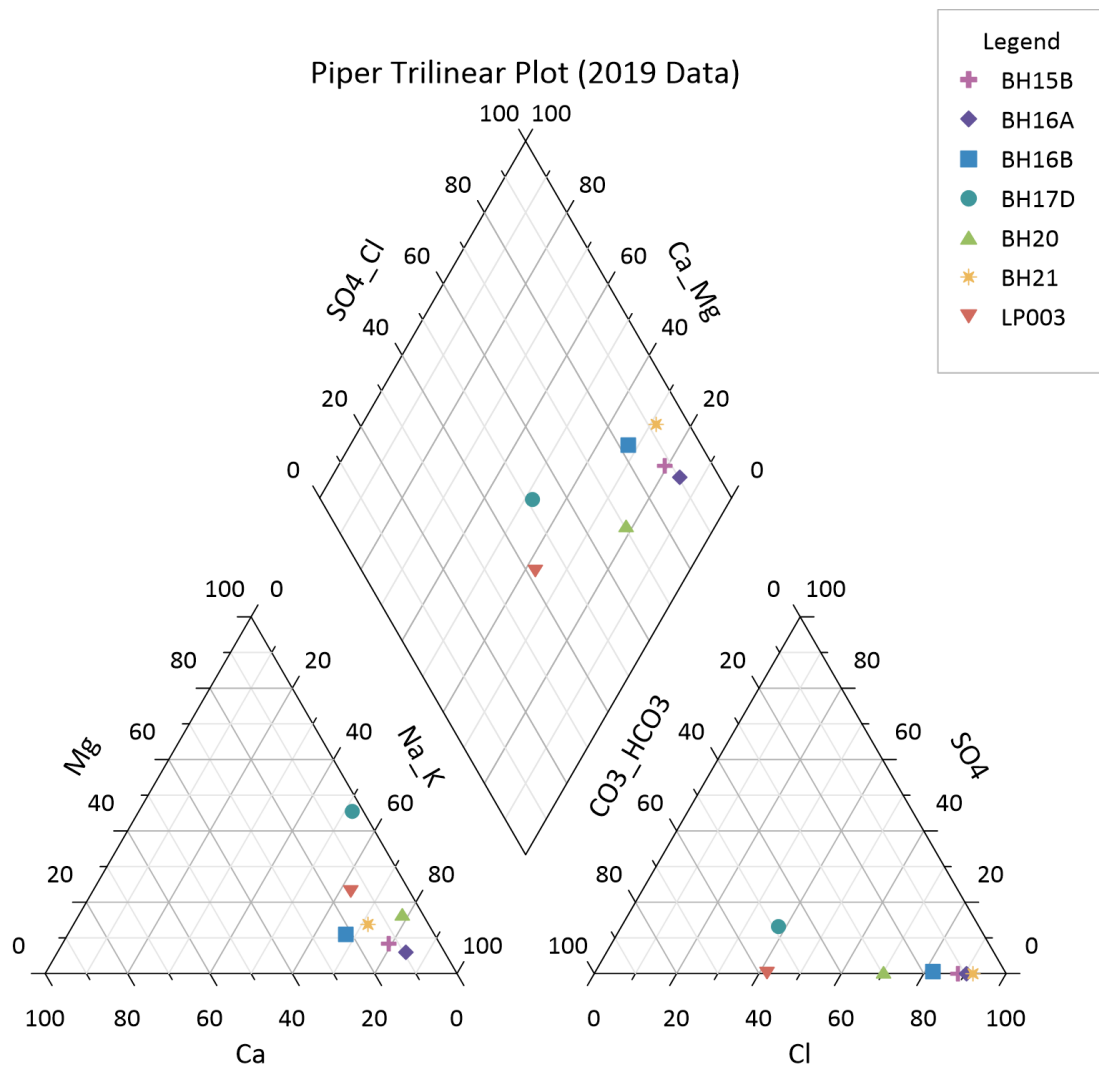
**Figure 24** below is a piper plot based on July 2019 data, and includes both groundwater and leachate ionic data. The majority of wells plot within a hydrochemical grouping similar to that shown in 1993, with the exception that water quality at BH17D (and possibly BH20) appears to have some similarity to leachate at LP003.

**Figure 24: Piper Trilinear Plot (2019 data)**

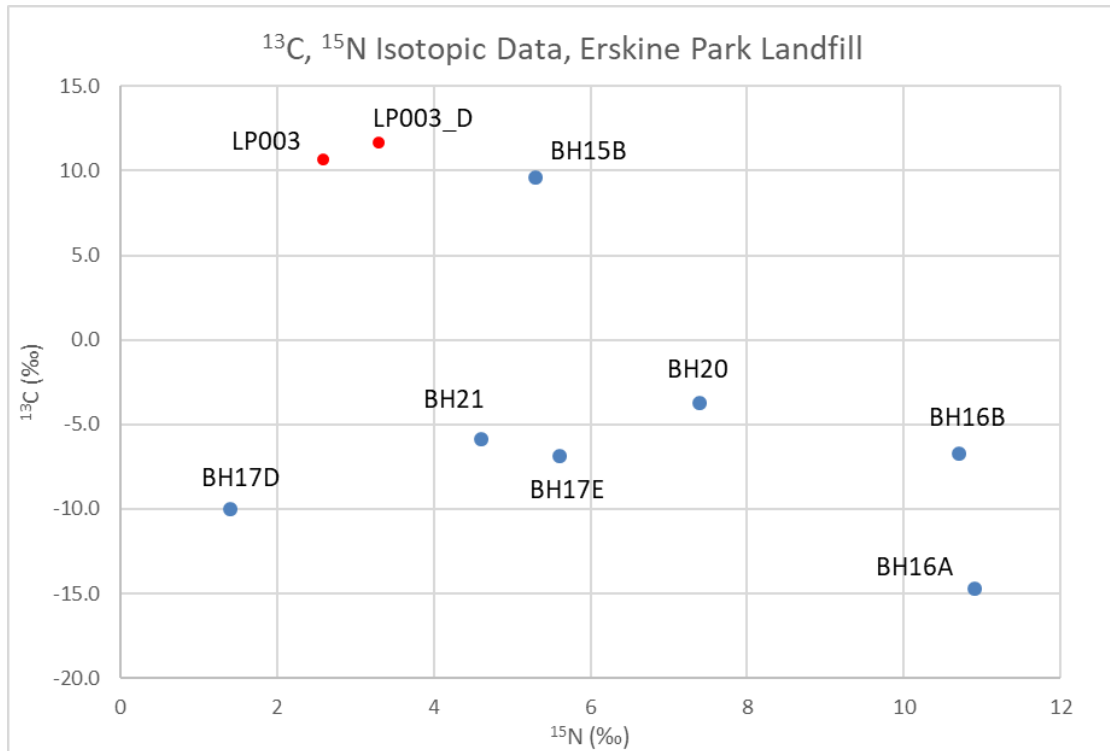
Figure 25: Isotopic Analysis ( $^{13}\text{C}$  vs  $^{15}\text{N-NH}_4$ )
