## Hydrogeological Assessment

Erskine Park Landfill, Quarry Road, Erskine Park, NSW

Prepared for:  
Cleanaway Solid Waste Pty Ltd  
85-87 Quarry Road, Erskine Park, NSW, 2759  
PO Box 804, St Marys, NSW, 1790

2 April 2020

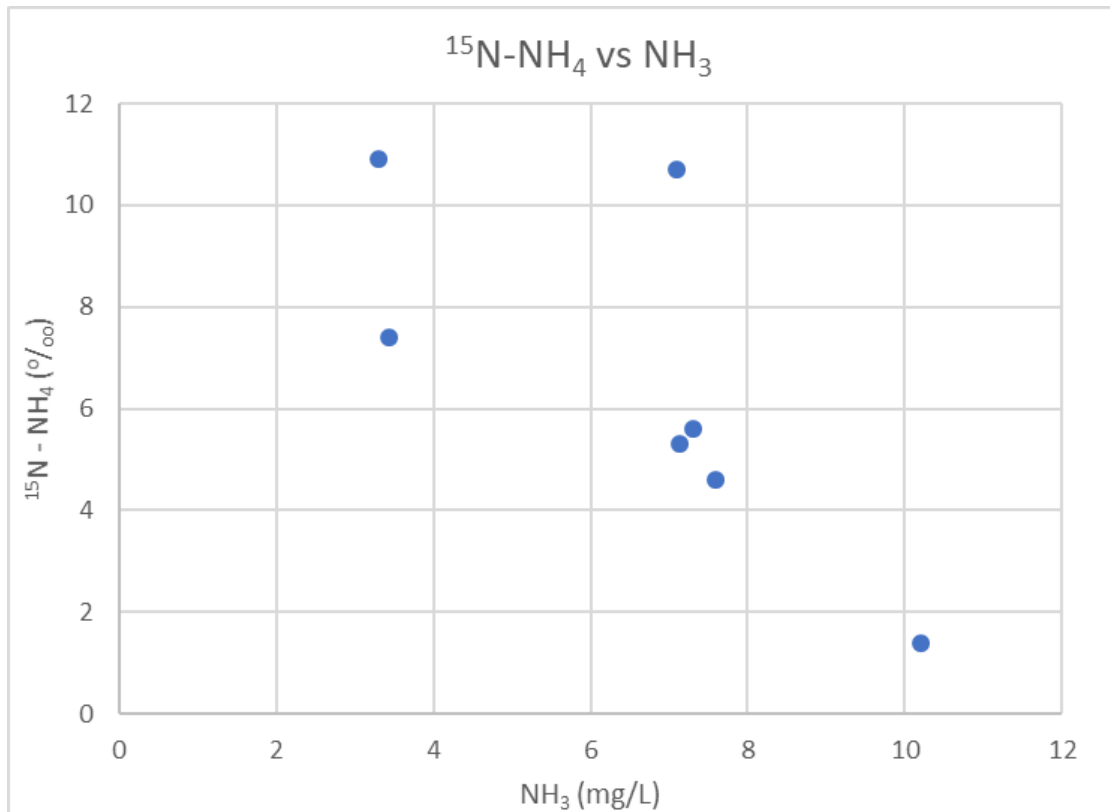
**Figure 26** is a plot of  $^{15}\text{N}$ - $\text{NH}_4$  vs ammonia (as N) in groundwater, and there is a general inverse correlation which, based on previous analysis, means that  $^{15}\text{N}$ - $\text{NH}_4$  decreases with depth. Gormly and Spalding (1979) identified a similar inverse correlation for  $^{15}\text{N}$ - $\text{NO}_3$  and nitrate concentration beneath agricultural fields, and attributed this to increasing denitrification with depth. The degree of  $^{15}\text{N}$ - $\text{NH}_4$  enrichment in groundwater at the site appears to be related to depth and, therefore, is possibly related to natural background (connate) conditions, with  $^{13}\text{C}$ -DIC likely to be a better indicator of leachate impact.

Figure 26:  $^{15}\text{N-NH}_4$  vs  $\text{NH}_3$  in Groundwater

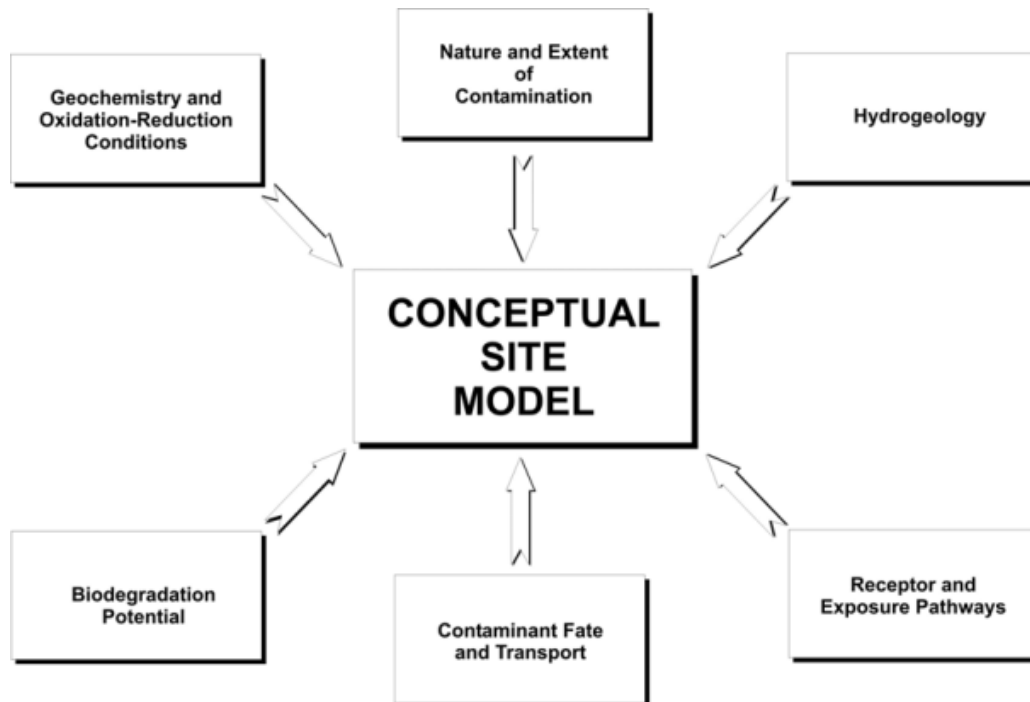
A conceptual site model (CSM) generally consists of the elements shown in **Figure 27**:

**Figure 27: Typical CSM Elements**

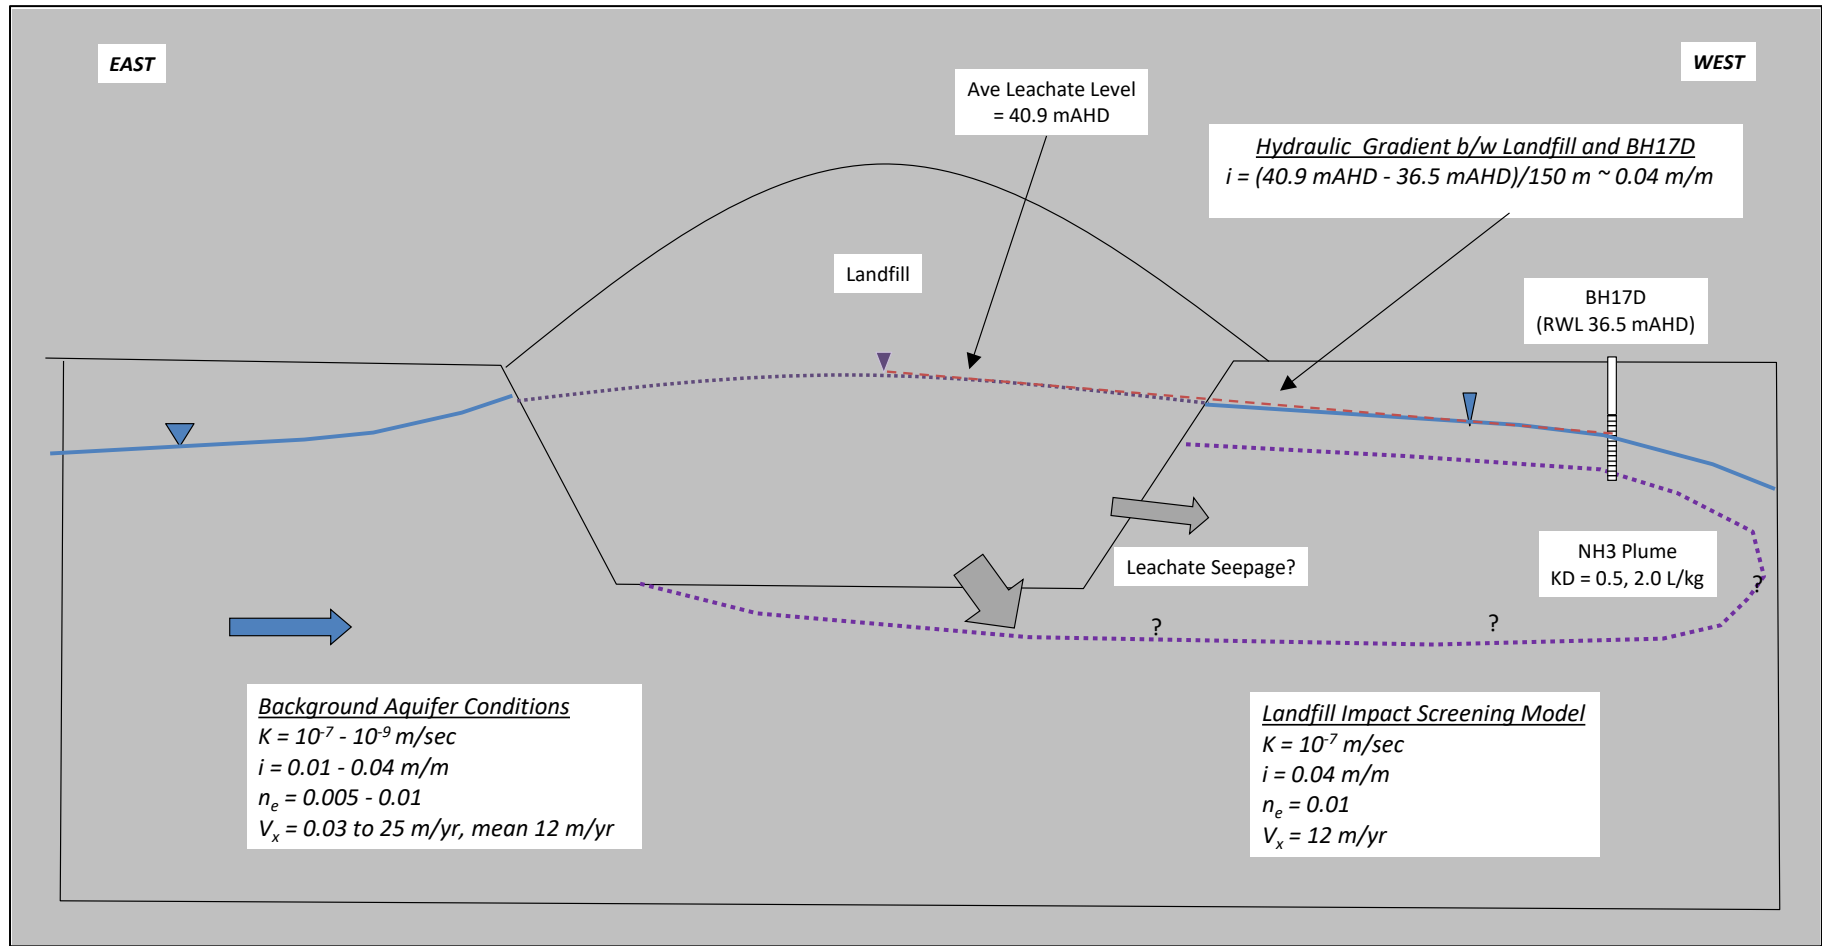
**Figure 28** presents a schematic graphically illustrating the CSM.

Figure 28: Erskine Park Landfill Conceptual Site Model

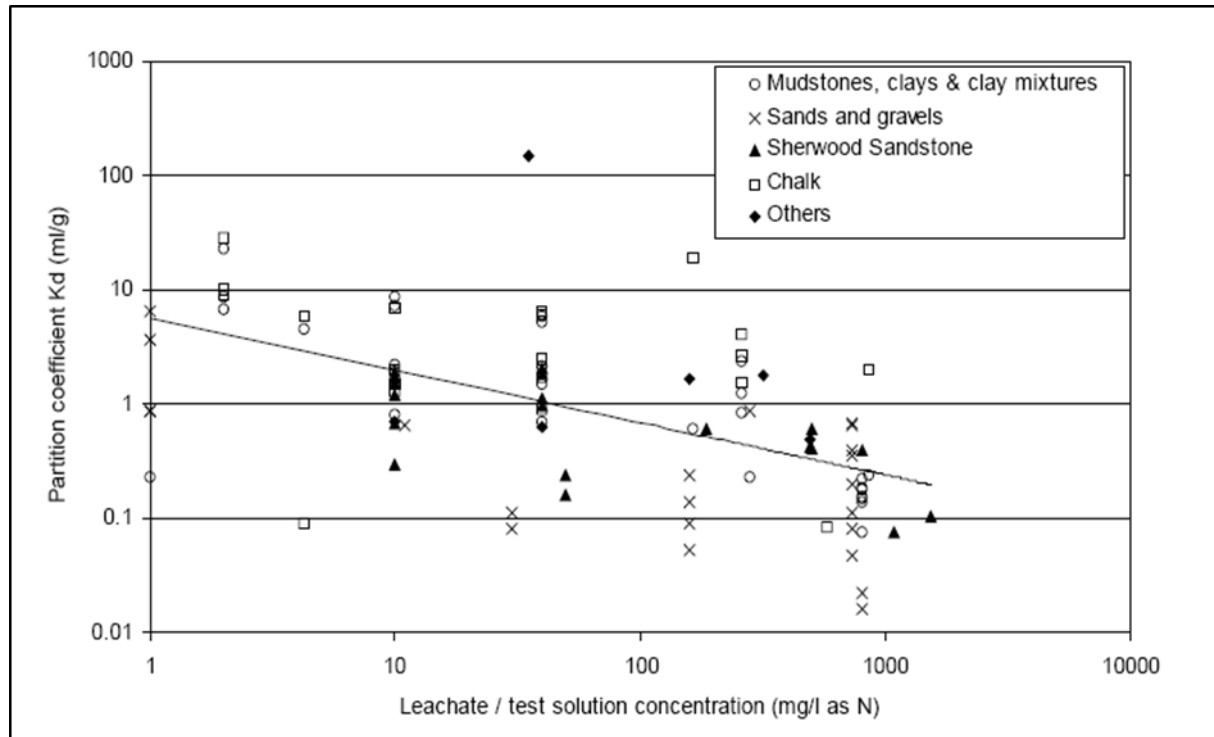
Figure 29 graphically summarises the results of the above tabulated ammonium partition data.

Figure 29: Ammonium Partition Coefficients According to Lithology (after UKEA, 2003)

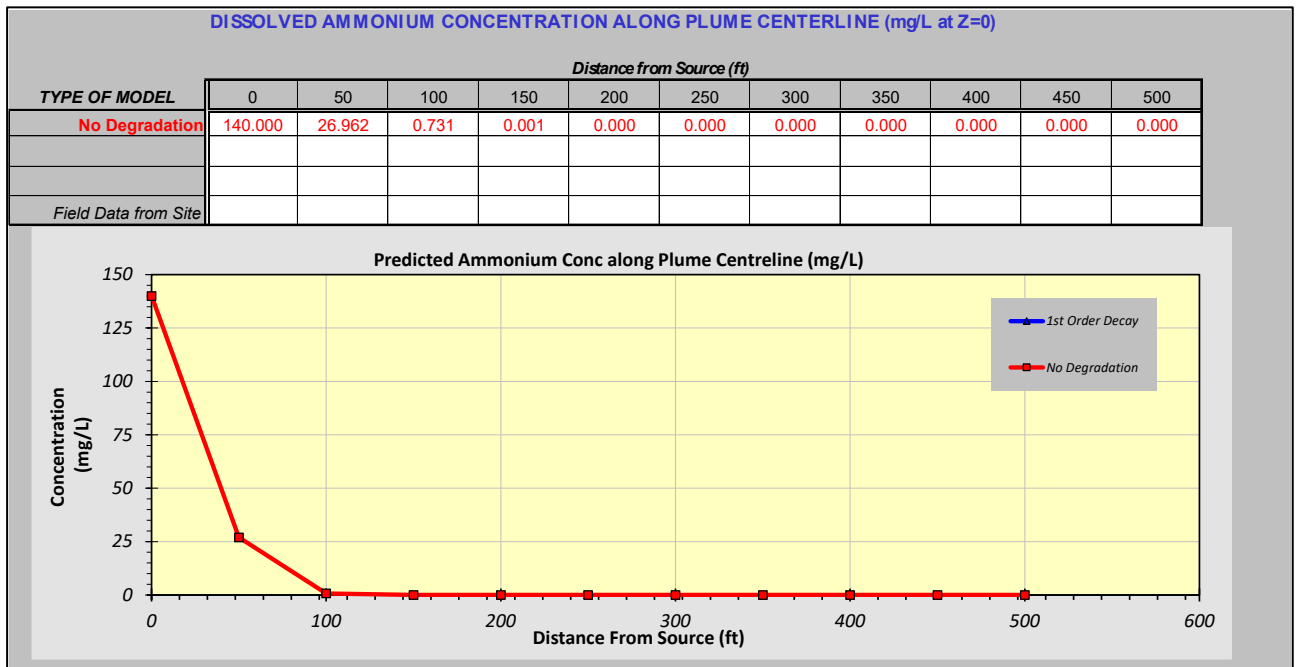
**Figure 31: Predicted Ammonia Plume Migration (mean groundwater seepage rate, mean retardation, 100 years simulation time)**

The modelling results indicate a limited potential extent for ammonium migration, even under the conservative scenario (maximum seepage rate, low retardation), where 140 mg/L NH<sub>3</sub> is predicted to migrate approximately 180 m (~600 feet) in groundwater after 100 years. The reasonable case model results in potential ammonia migration of only 50 m (150 feet) over 100 years.

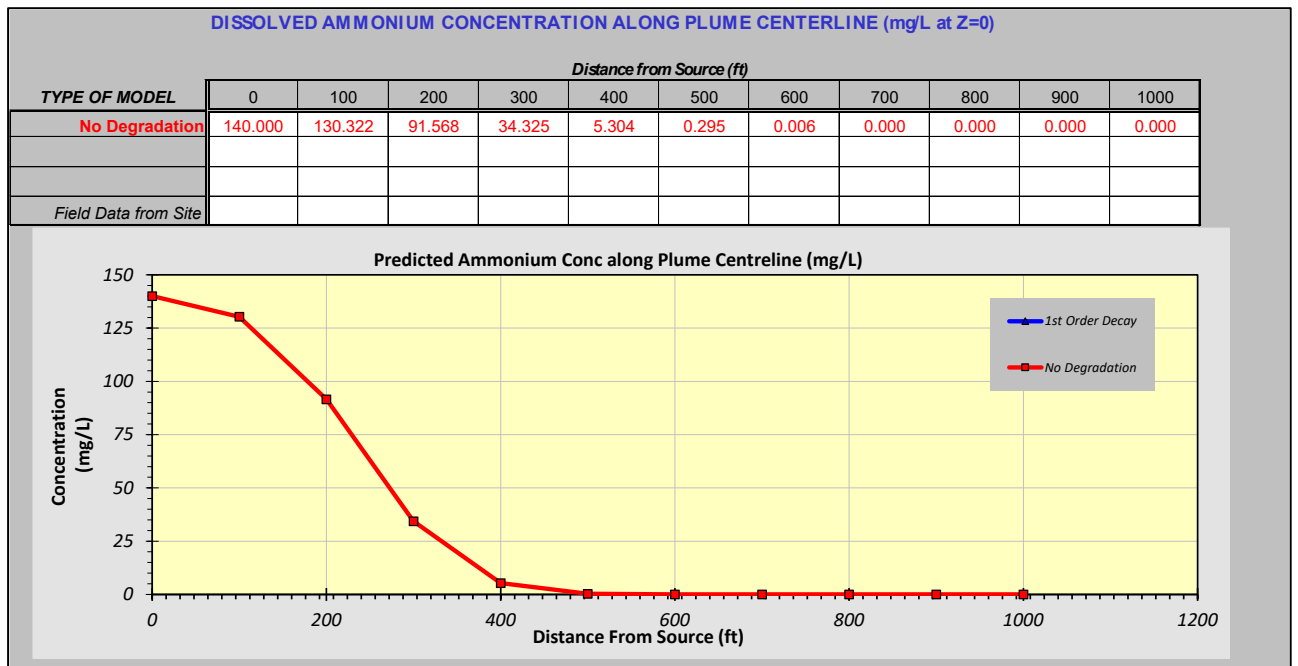
**Figure 32: Predicted Ammonia Plume Migration (maximum groundwater seepage rate, low retardation, 100 years simulation time)**

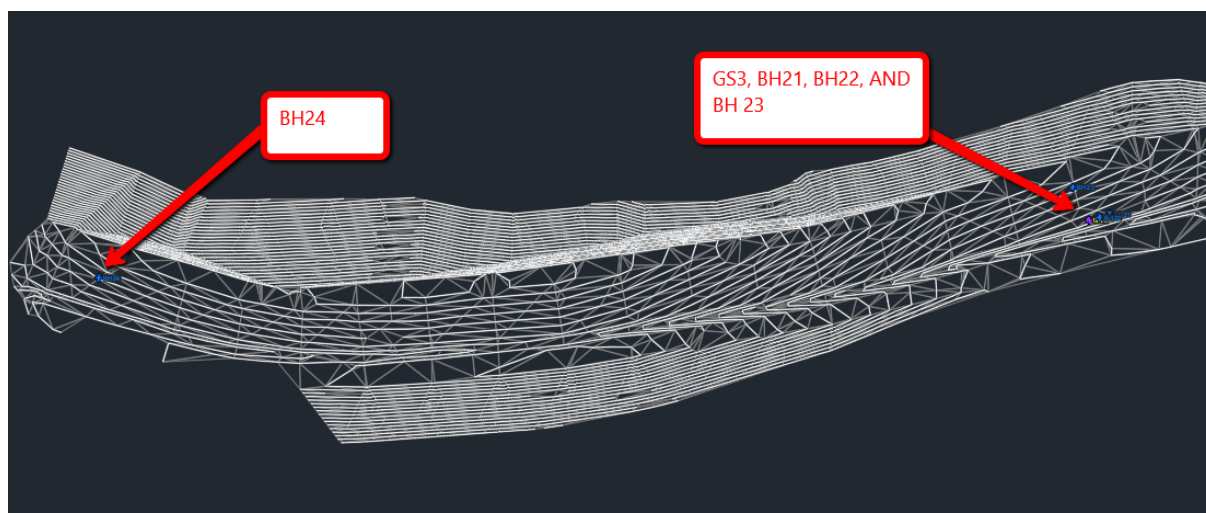
28. Sections of the clay liner wall appear to have been compromised:
  - a. Gas monitoring bore GS3 has been installed through the clay liner wall (inferred in Figure 14: cross-section N). The screenshot below shows the extent of the southern clay wall versus the bore location.
  - b. Groundwater monitoring bores BH21 to BH24 have also been installed through the clay liner wall (as inferred in Figures 14 to 17: cross-sections N to Q). The screenshot below shows the extent of the southern clay wall versus the bore locations.

- c. It appears the installation of the Austral Bricks Gas feeder pipeline has gone through part of the clay wall in cross-section M, and is potentially sitting on the clay liner wall in the vicinity of cross-section R.

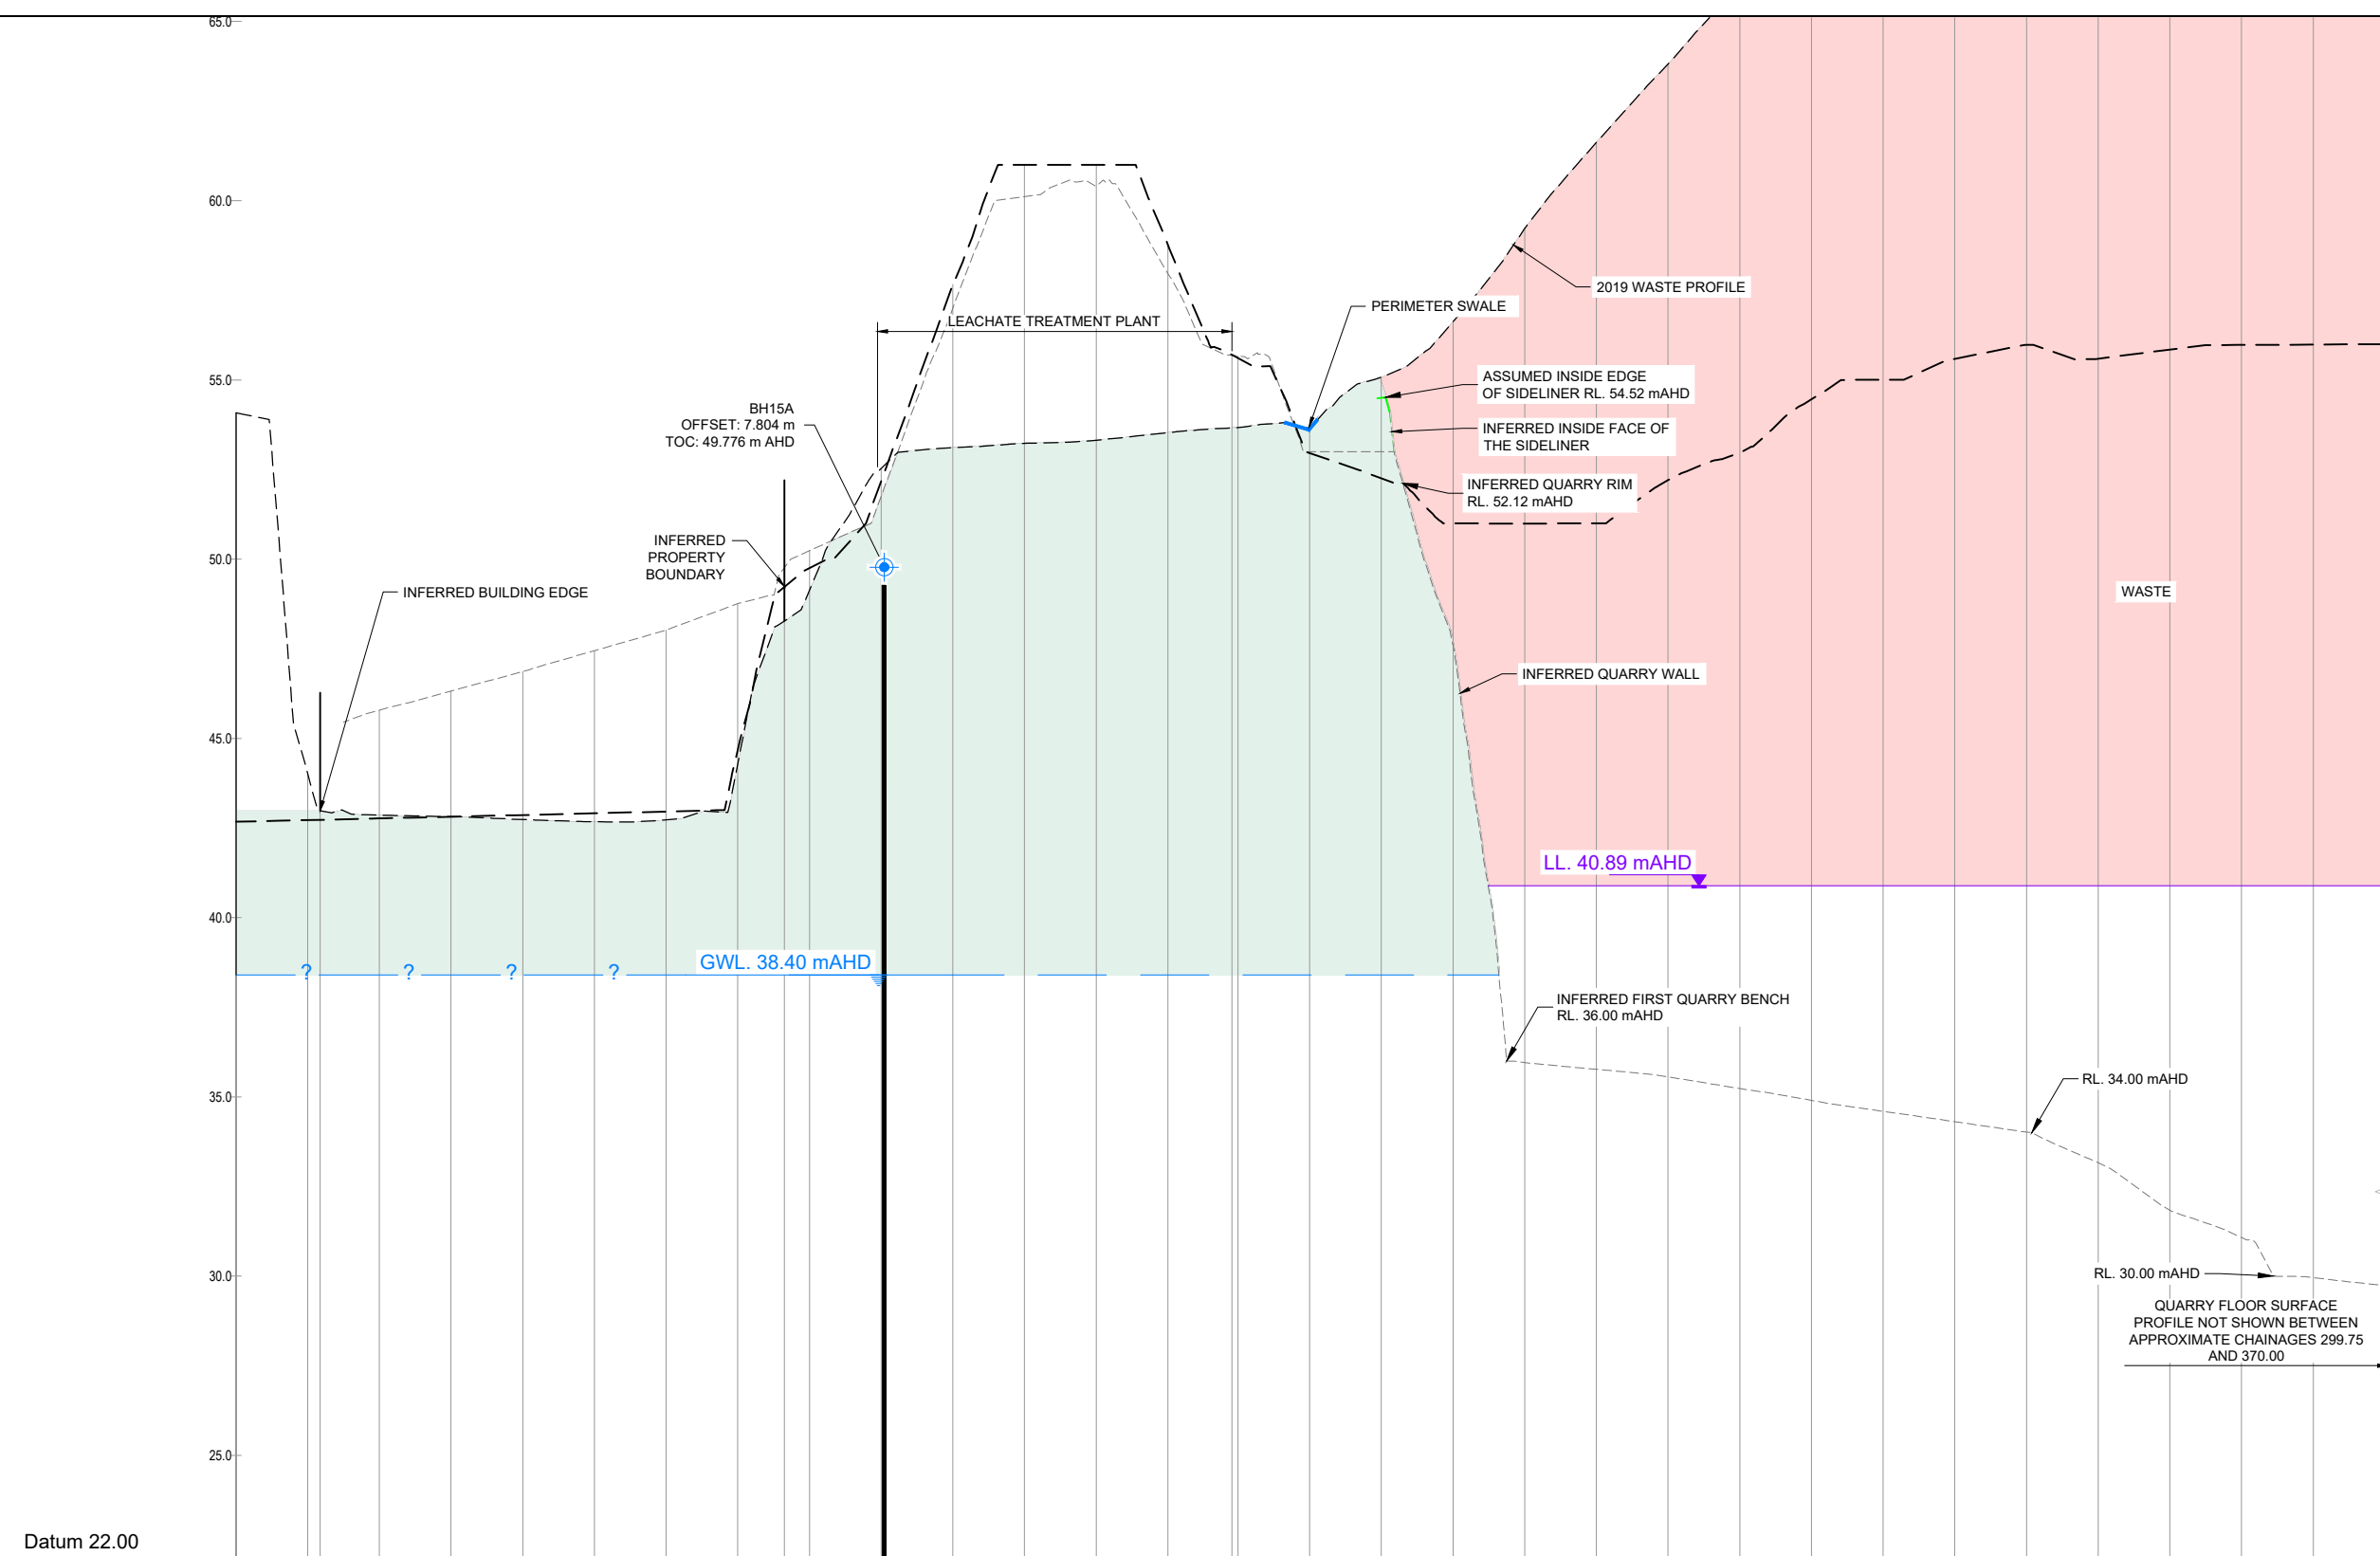
- NOTES:**
- SECTION PLOTTED WITH A VERTICLE EXAGGERATION OF 5:1
  - QUARRY FLOOR PROFILE NOT SHOWN BETWEEN CH 299.75 AND CH 370.00

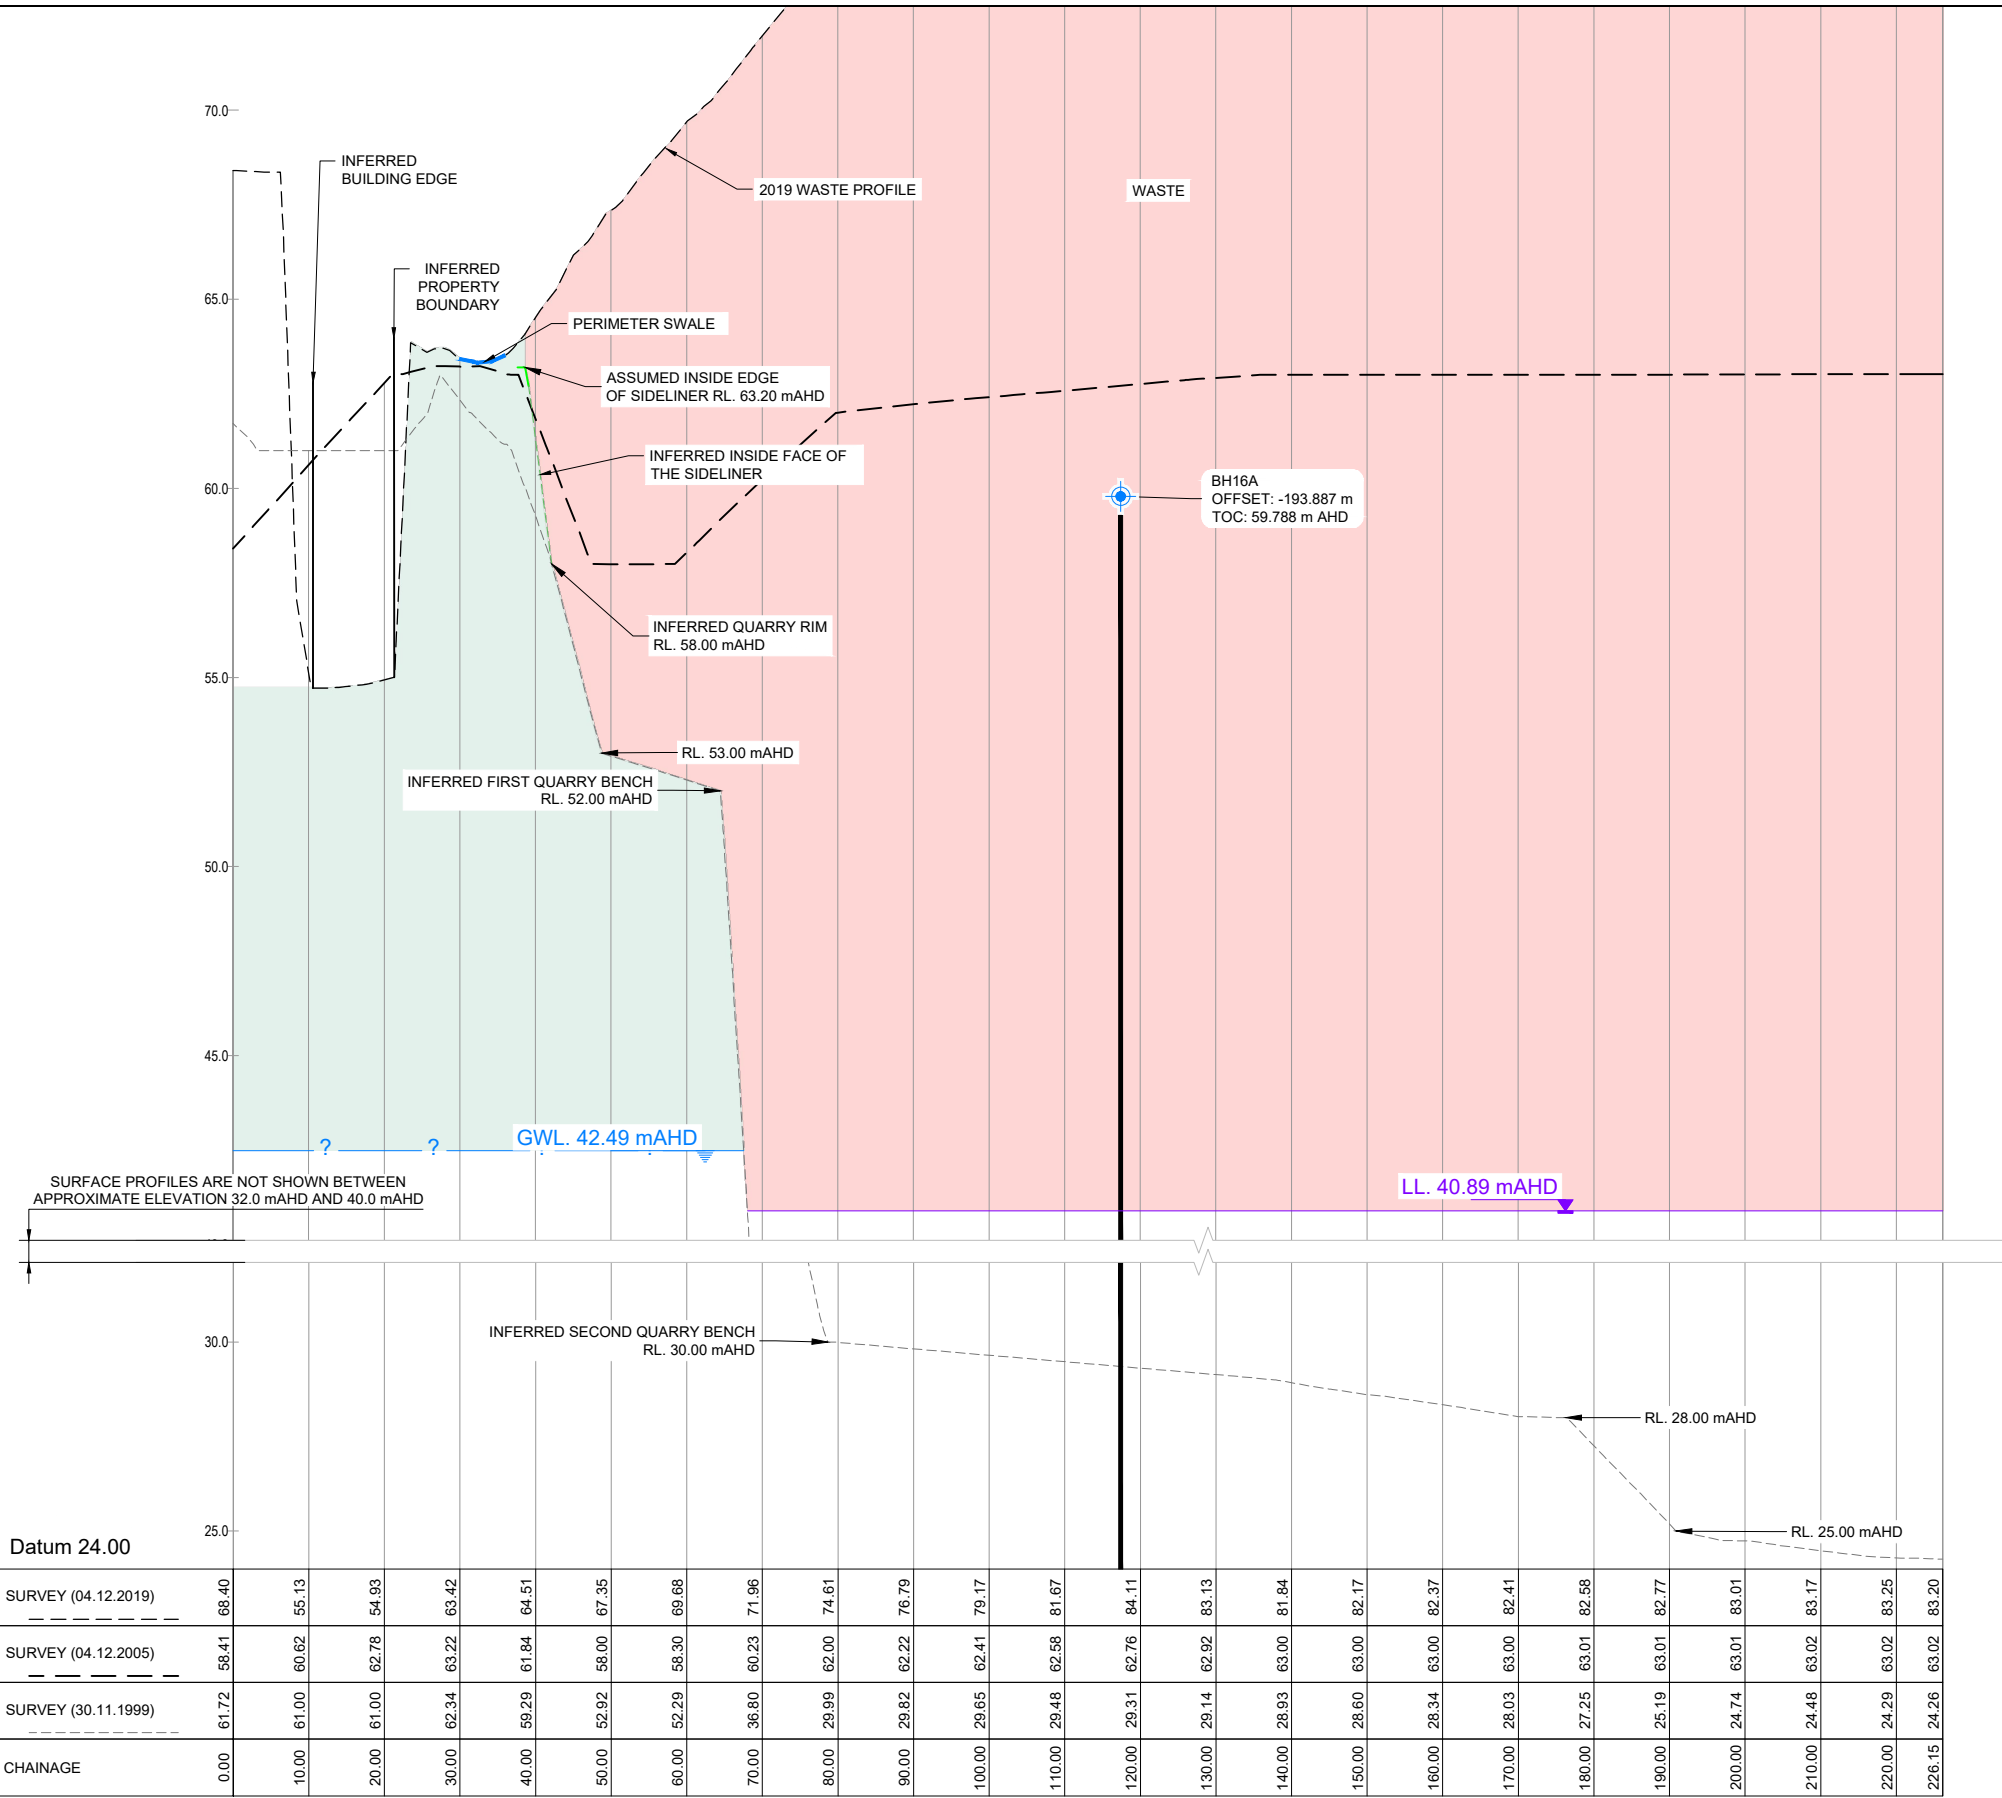
1. SECTION PLOTTED WITH A VERTICLE EXAGGERATION OF 5:1
2. SURFACE PROFILES ARE NOT SHOWN BETWEEN APPROXIMATE ELEVATION 32.0 mAHD AND 40.0 mAHD

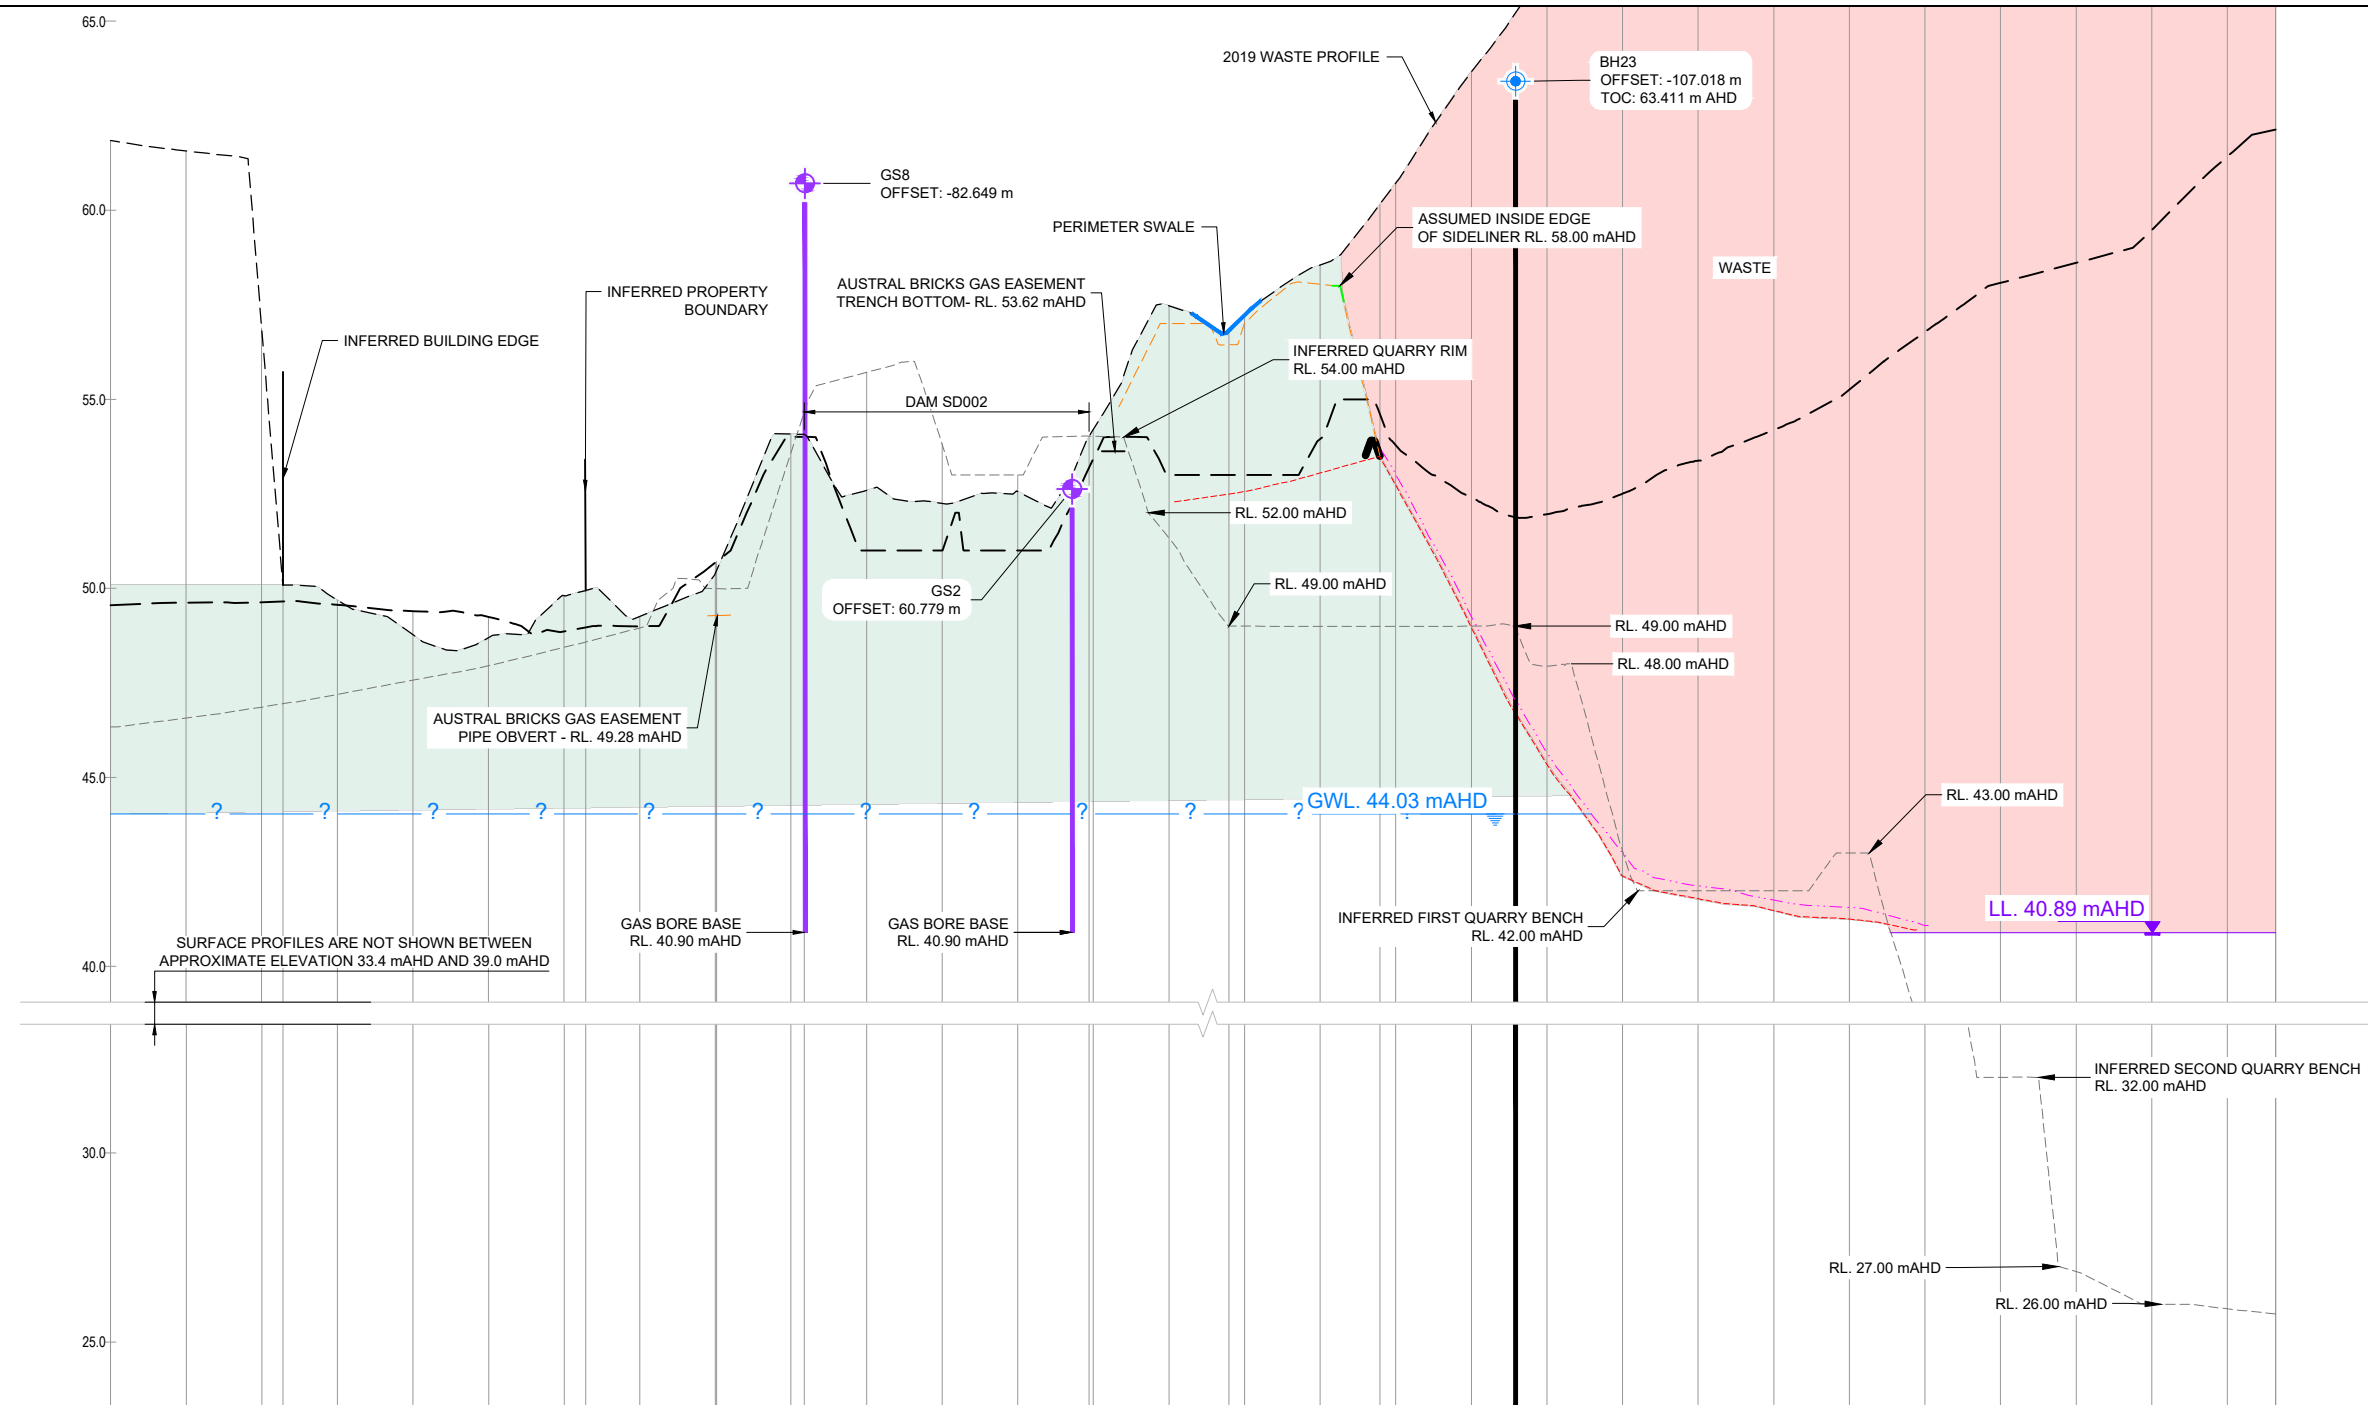
- NOTES:**
1. SECTION PLOTTED WITH A VERTICLE EXAGGERATION OF 5:1
  2. LEACHATE BLANKET INSTALLED NEAR QUARRY RIM AND OVER FIRST QUARRY BENCH.
  3. SURFACE PROFILES ARE NOT SHOWN BETWEEN APPROXIMATE ELEVATION 33.4 mAHD AND 39.0 mAHD
