**G**EOTECHNIQUE<sup>®</sup>  
PTY LTD

Job No: 14577/1  
Our Ref: 14577/1-AA  
8 January 2020

re: **Proposed Industrial Development**  
**Lot 14 in DP286568 - 7 Renshaw Street, Cranebrook**  
**Geotechnical Investigation**

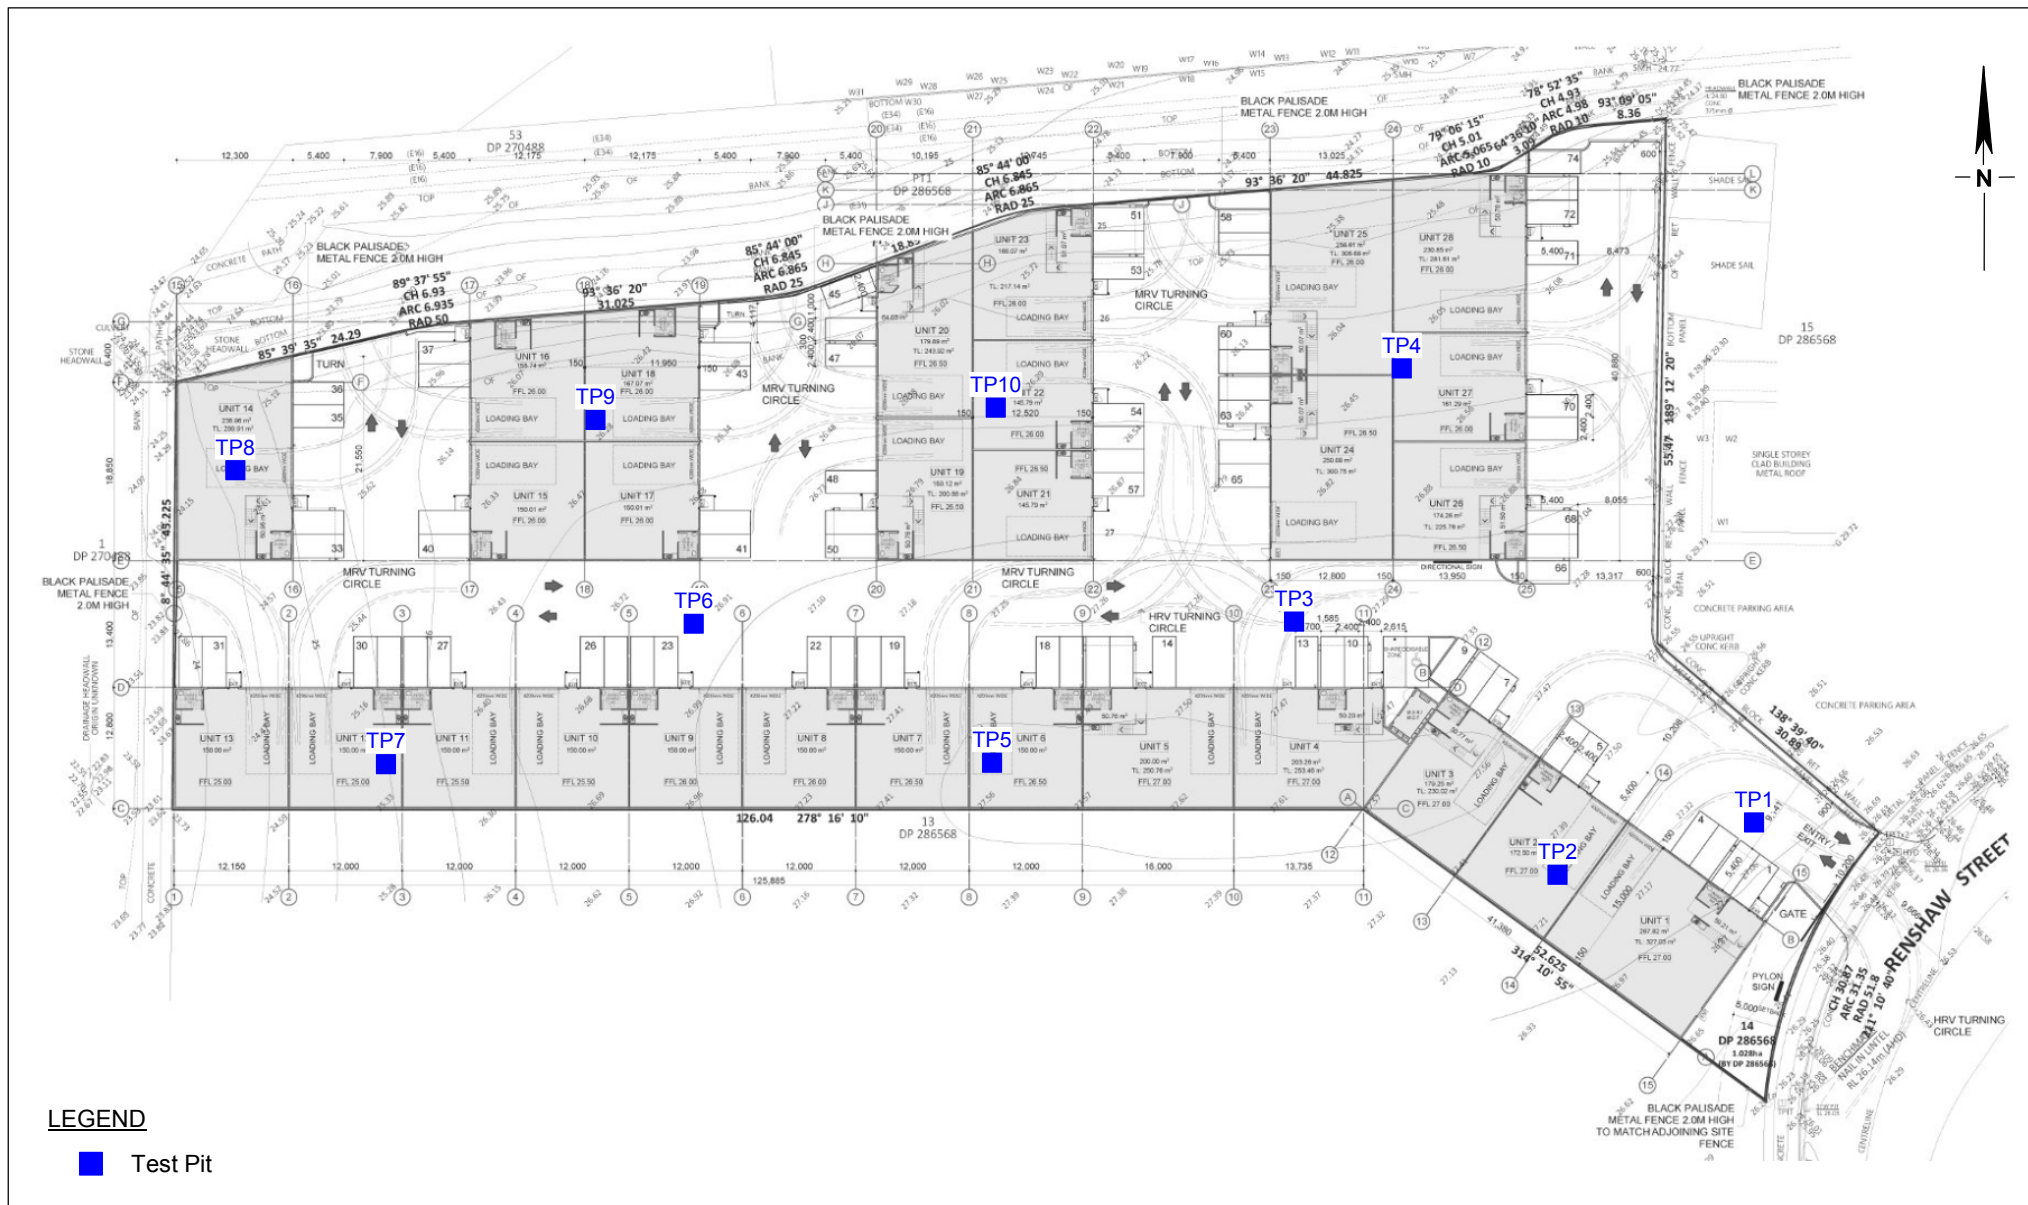
- Excavate ten (10) test pits to depths ranging from 1.5m to 2.5m, using a 5t excavator equipped with an auger. Engineering test pit logs and explanatory notes are attached to the report. Test pit locations are shown on the attached Drawing No 14577/1-AA1.

# LEGEND

■ Test Pit
