# GEOTECHNICAL INVESTIGATION REPORT

230-242 ALDINGTON ROAD, KEMPS CREEK, NSW

Report E23529.G03  
22 September 2017

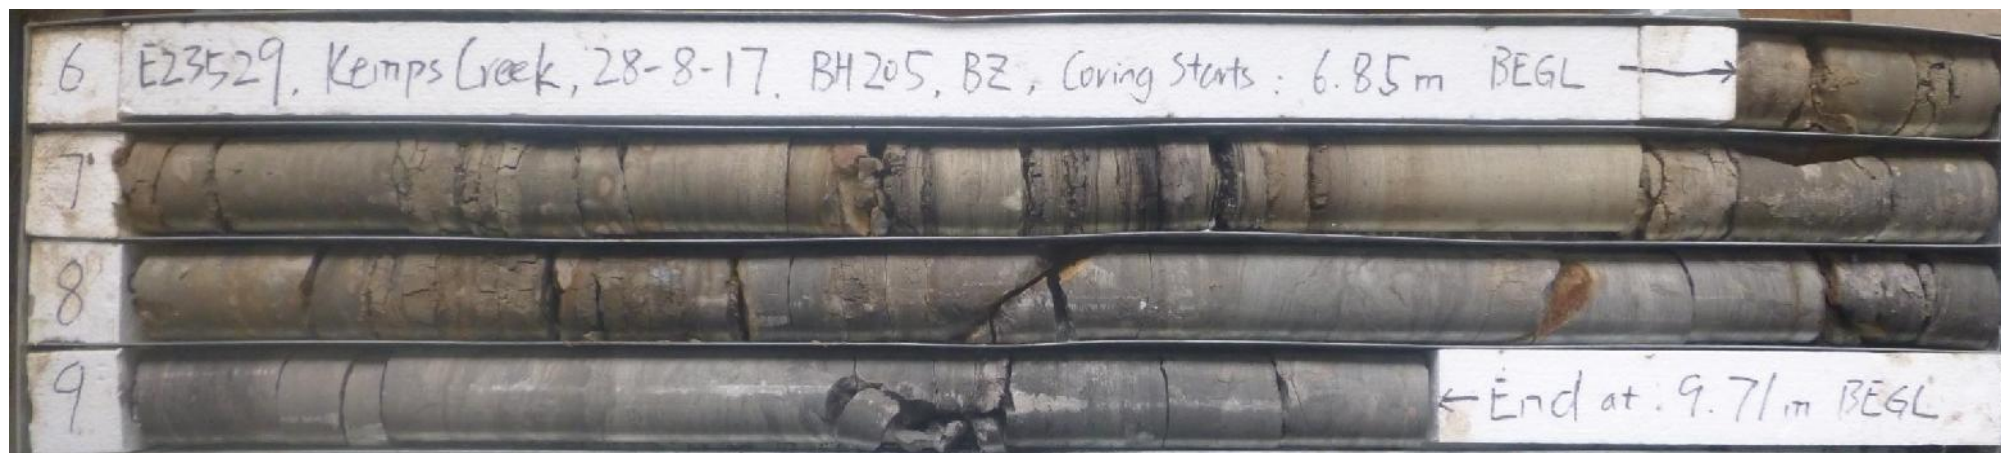
## CORE PHOTOGRAPH OF BOREHOLE: BH205

Depth Range: 6.85 m to 9.71 m  
Contractor: Geosense Drilling Pty Ltd  
Drill Rig: Hanjin DB8  
LOGGED: BZ DATE: 28/8/17  
CHECKED: JZ DATE: 21/9/17

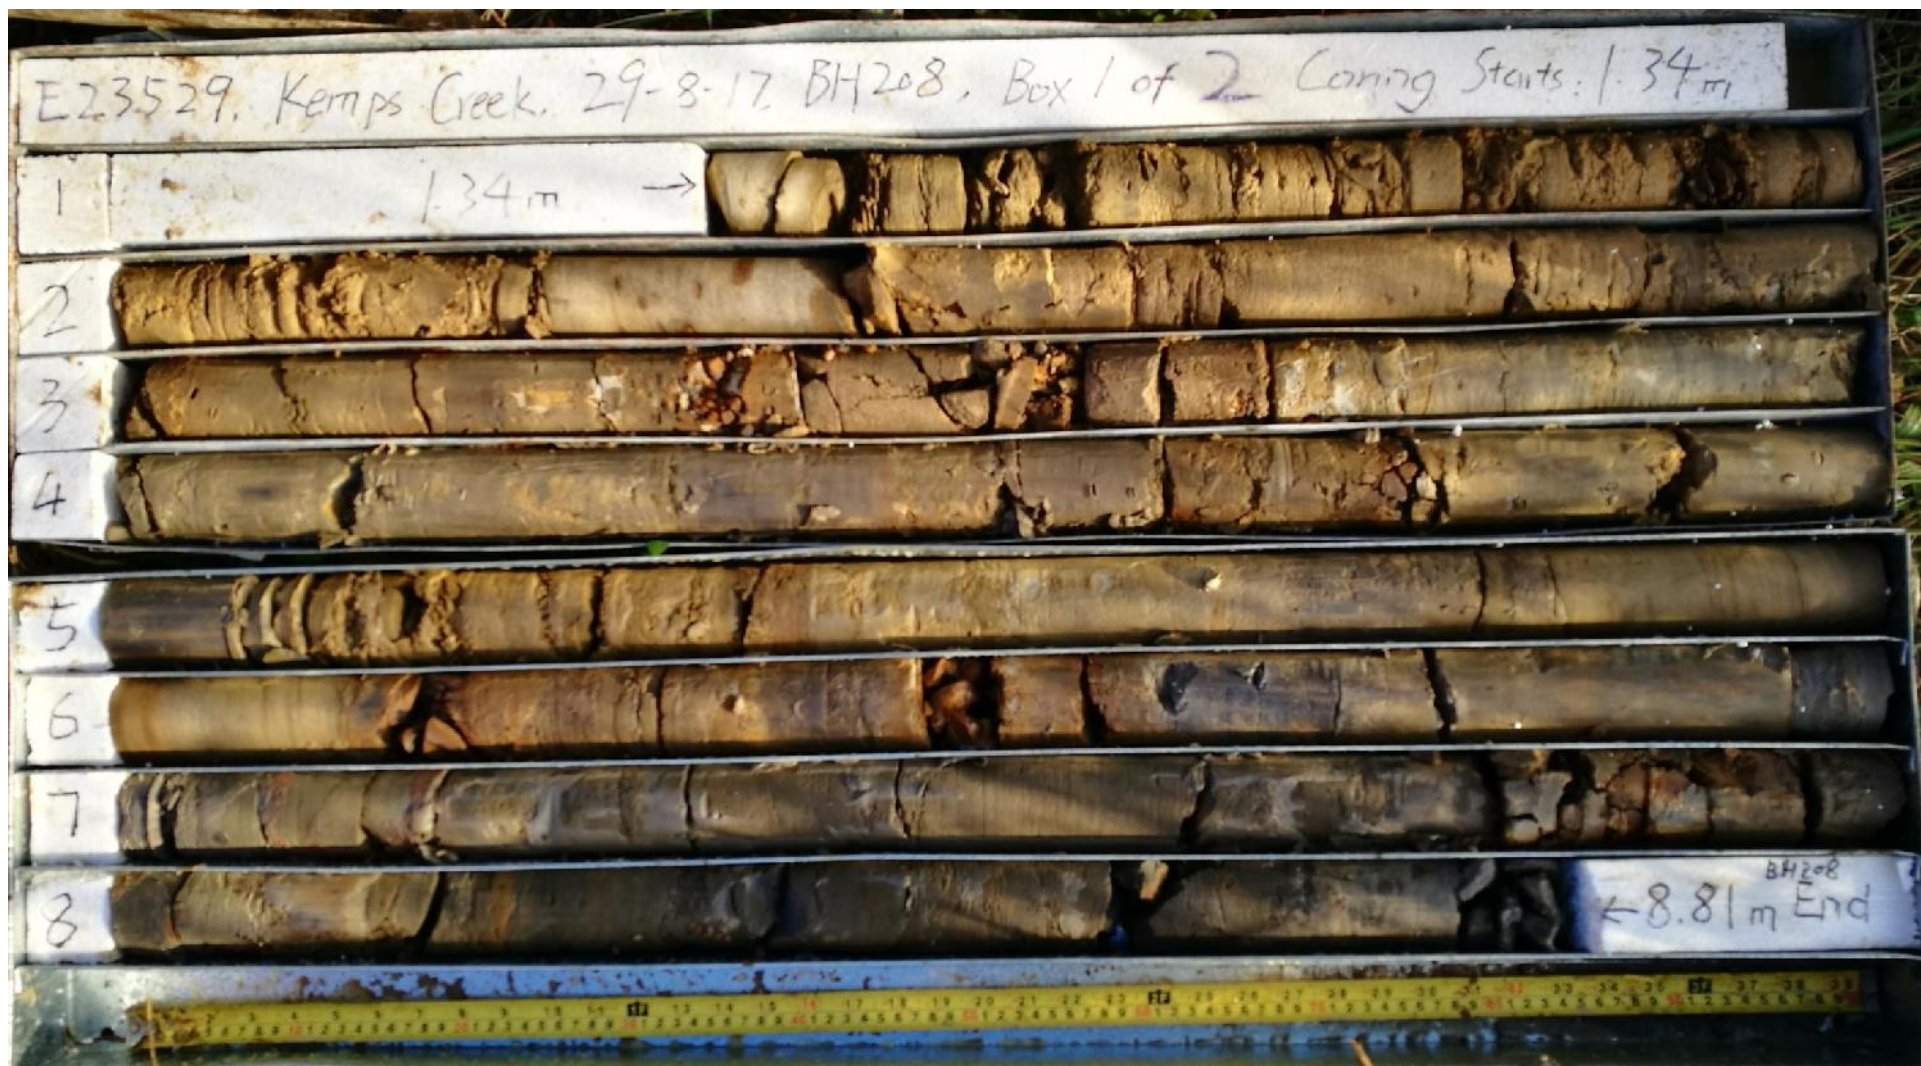
## CORE PHOTOGRAPH OF BOREHOLE: BH208

Depth Range: 1.34 m to 8.81 m  
Contractor: Geosense Drilling Pty Ltd  
Drill Rig: Hanjin DB8  
LOGGED: BZ DATE: 29/8/17  
CHECKED: JZ DATE: 21/9/17
