GEOTECHNICAL INVESTIGATION REPORT

Geotechnical Investigation

Proposed New Childcare Centre

110-112 Mount Vernon Rd, Mount Vernon 2178 NSW

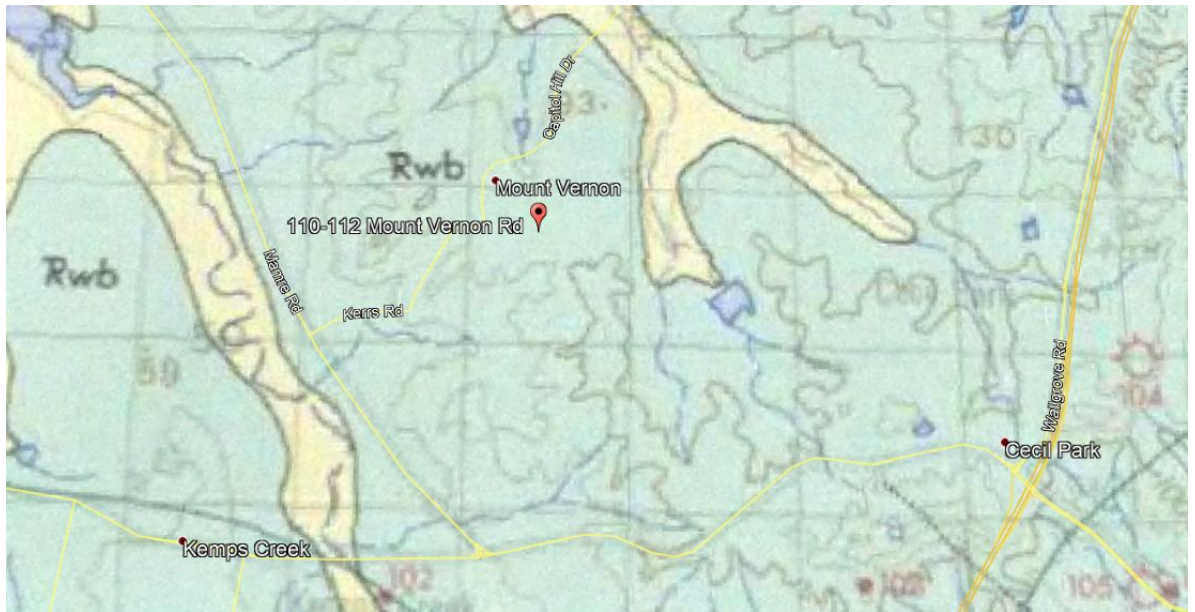
Figure 1 Geology Map Excerpt

The 1:100,000 scale Penrith Geological Series Sheet (Geological Survey of NSW, Department of Minerals and Energy, Sheet 9130, 1983) indicates that the proposed development site is underlain by Bringelly Shale of the Wianamatta Group. This stratum occurs extensively throughout the Penrith Basin and comprises of shale, carbonaceous claystone, claystone, laminate, fine to medium grained lithic sandstone with rare coal and tuff. A map excerpt of the Penrith Geological map is provided in **Figure 1** below.

Rwb - Bringelly Shale of the Wianamatta Group

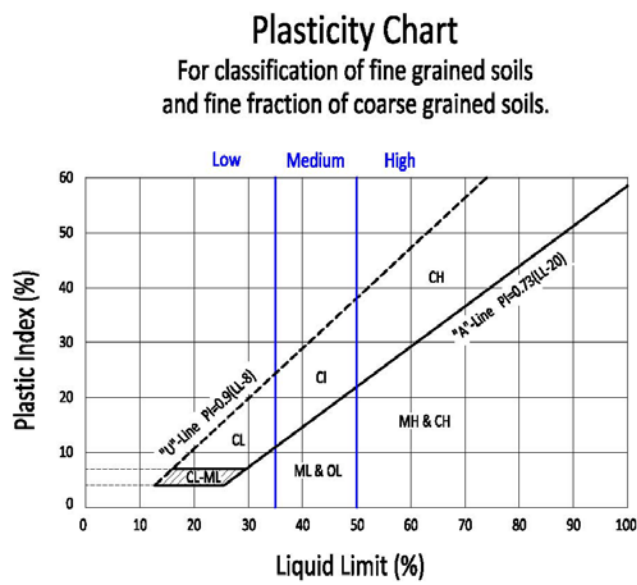
fine	_____2.36	GM	Silty gravels, gravel-sand-silt mixtures (1)	12-50	Below 'A' line or PI<4	—	—	
				GC	Clayey gravels, gravel-sand-clay mixtures (1)	12-50	Above 'A' line and PI>7	—	—	
	SANDS (more than half of coarse fraction is smaller than 2.36 mm)	coarse	_____0.6	SW	Well graded sands and gravelly sands, little or no fines	0-5	—	>6	Between 1 and 3	
		medium	_____0.2	SP	Poorly graded sands and gravelly sands, little or no fines	0-5	—	Fails to comply with above		
		fine	0.075	SM	Silty sands, sand silt mixtures (1)	12-50	Below 'A' line or PI<4	—	—	
				SC	Clayey sands, sand-clay mixtures (1)	12-50	Above 'A' line and PI>7	—	—	
FINE GRAINED SOILS (more than half of material less than 63 mm is smaller than 0.075 mm)	SILTS & CLAYS (Liquid Limit ≤50%)		ML	Inorganic silts, very fine sands, rock flour, silty or clayey fine sands or clayey silts with slight plasticity	Use the gradation curve of material passing 63 mm for classification of fractions according to the criteria given in 'Major Divisions'. Plasticity Chart For classification of fine grained soils and fine fraction of coarse grained soils.

CL	Inorganic clays of low to medium plasticity, gravelly clays, sandy clays, silty clays, lean clays						
			CI	Inorganic clays of high plasticity, fat clays						
	SILTS & CLAYS (Liquid Limit >50%)		OL	Organic silts and clays of low plasticity						
			MH	Inorganic silts, mic-aceous or diato-maceous fine sands or silts, elastic silts						
			CH	Inorganic clays of high plasticity, fat clays						
		OH	Organic silts and clays of high plasticity							
HIGHLY ORGANIC SOILS		PT	Peat and other highly organic soils

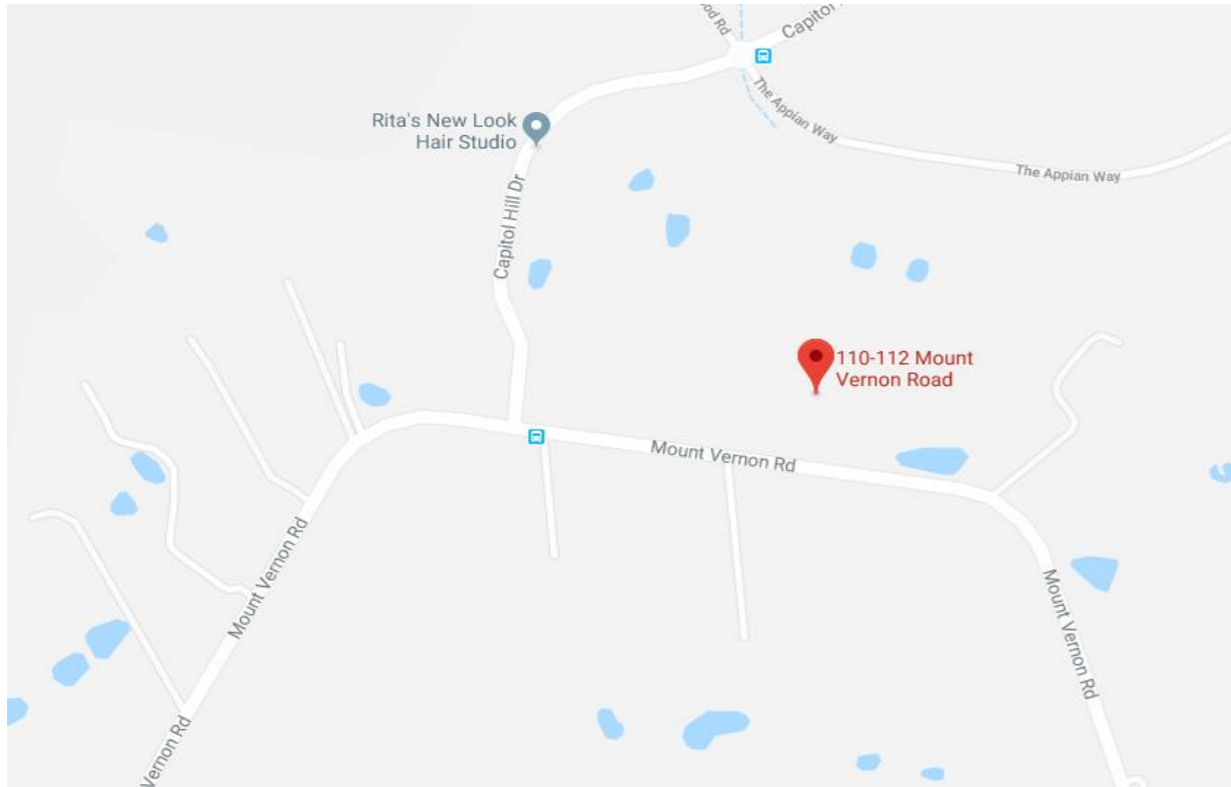
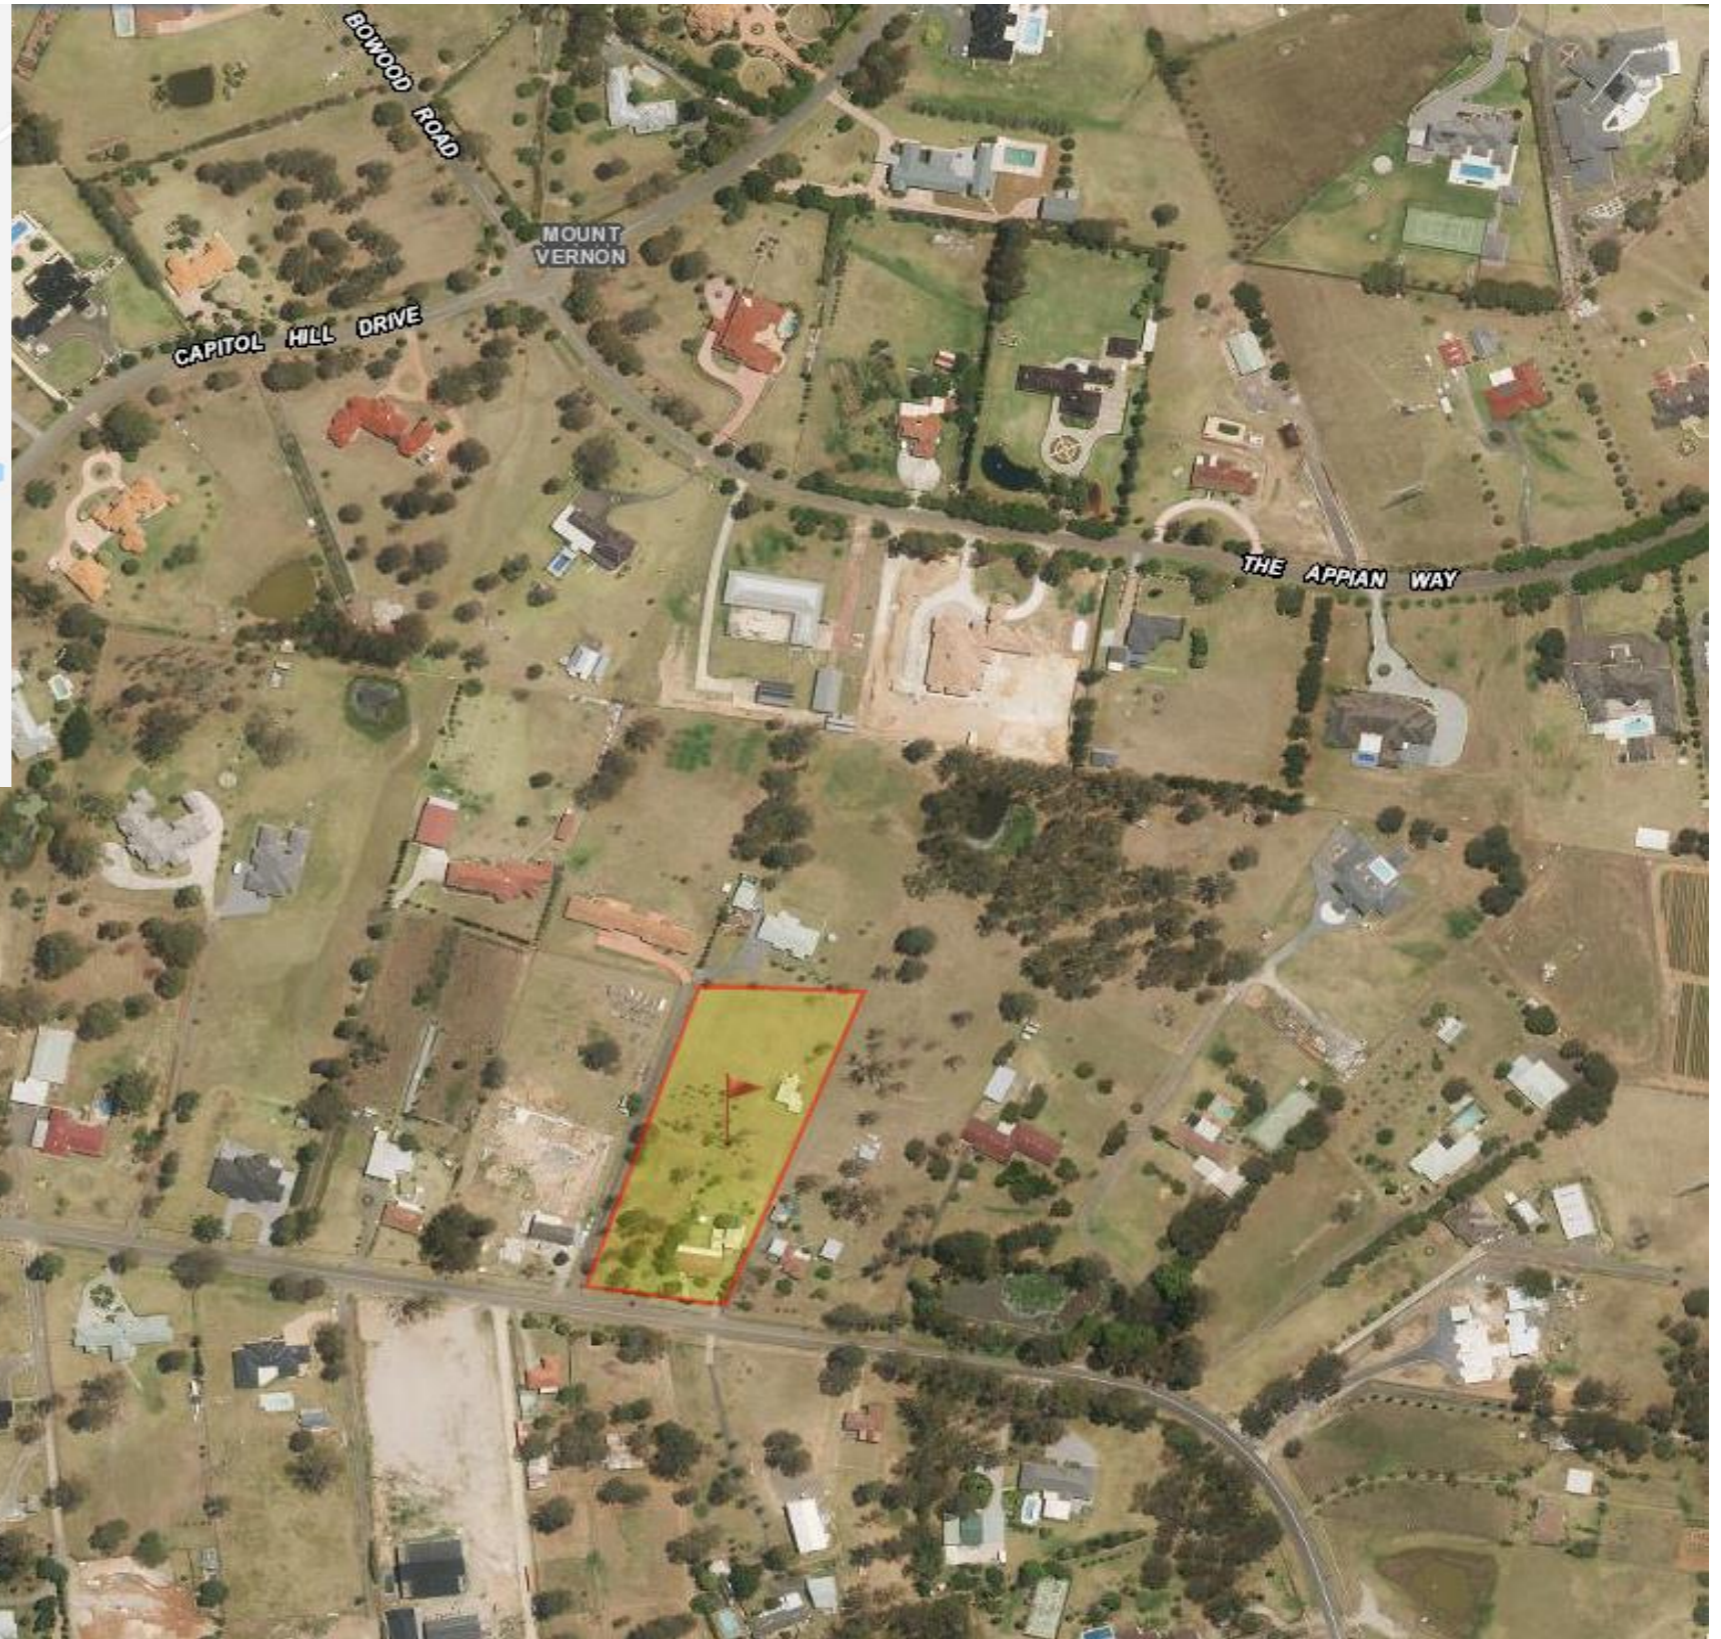
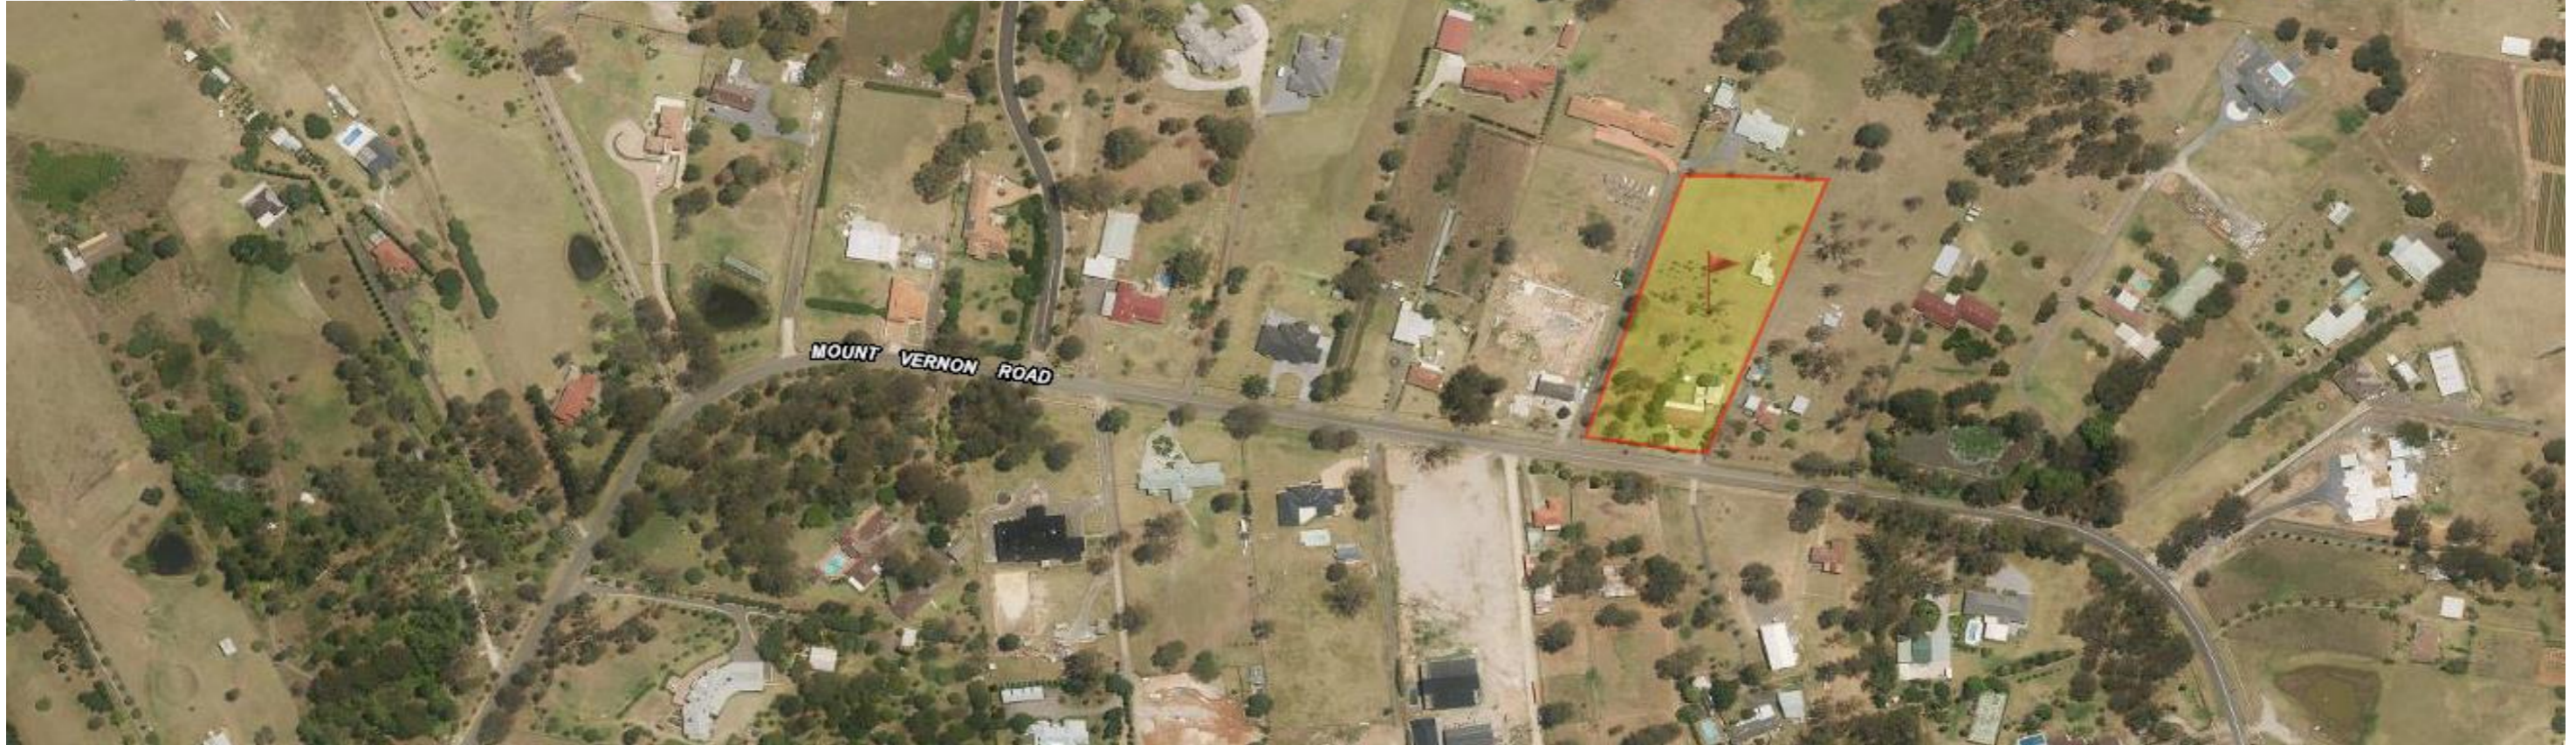
Figure 2

SITE LOCALITY PLAN

The subject site (**Figure 2** contained in **Appendix B**) being considered for development is part of an existing property comprising of a single storey brick type structure, most likely supported on shallow foundations founded on residual clay soils. Other notable structures include a detached car port structure adjacent to the eastern boundary line. The site located at 110-112 Mount Vernon Road, Mount Vernon, is approximately 1.8km northeast of Kemps Creek.

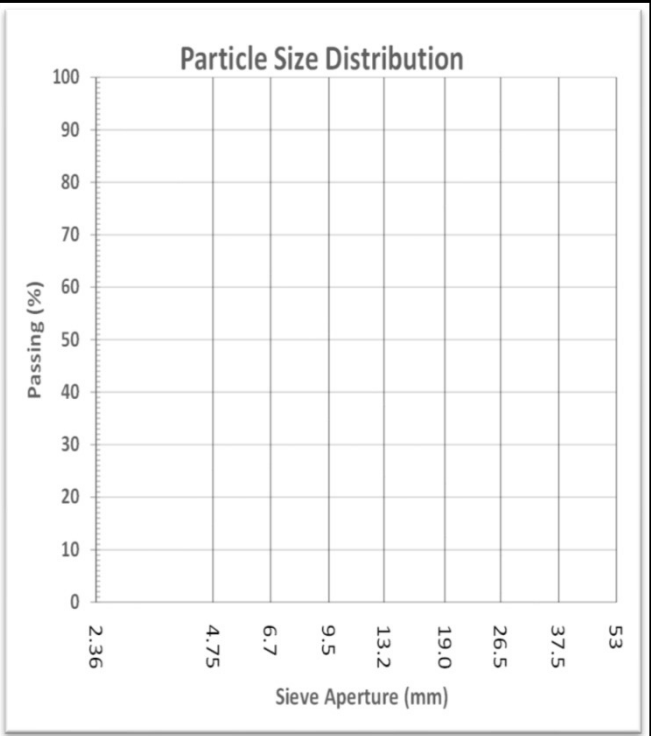
Retained 53.0mm Sieve	%			
Pretreatment by Weathering	%			
Pretreatment by Compaction	%			
Particle Size Distribution	Units	Result	Specification Limits	
Passing Sieve - 150mm	%			
Passing Sieve - 125mm	%			
Passing Sieve - 100mm	%			
Passing Sieve - 75mm	%			
Passing Sieve - 53mm	%			
Passing Sieve - 37.5mm	%			
Passing Sieve - 26.5mm	%			
Passing Sieve - 19.0mm	%			
Passing Sieve - 13.2mm	%			
Passing Sieve - 9.5mm	%			
Passing Sieve - 6.7mm	%			
Passing Sieve - 4.75mm	%			
Passing Sieve - 2.36mm	%			
Passing Sieve - 1.18mm	%			
Passing Sieve - 0.600mm	%			
Passing Sieve - 0.425mm	%			
Passing Sieve - 0.300mm	%			
Passing Sieve - 0.150mm	%			
Passing Sieve - 0.075mm	%

Sampling & Test Methods	Report Remarks & Endorsement
AS 1289.1.4.2: Stratified Random Number Method AS1141.3.1, Cl 9.3: Sampling aggregates - Powered - Backblading AS 1289.1.1: Preparation of disturbed soil samples for testing AS 1289.3.6.1: Particle Size Distribution of a soil (Standard, by Sieving) AS 1289.3.1.1: Liquid Limit, Four point Casagrande AS 1289.3.2.1: Plastic Limit of a soil AS 1289.3.3.1: Plasticity Index of a soil AS 1289.3.4.1: Linear Shrinkage of a soil
