# Geotechnical Site Investigation Report

St Marys Detention Basins C and V6

5017200065

Prepared for  
Lendlease

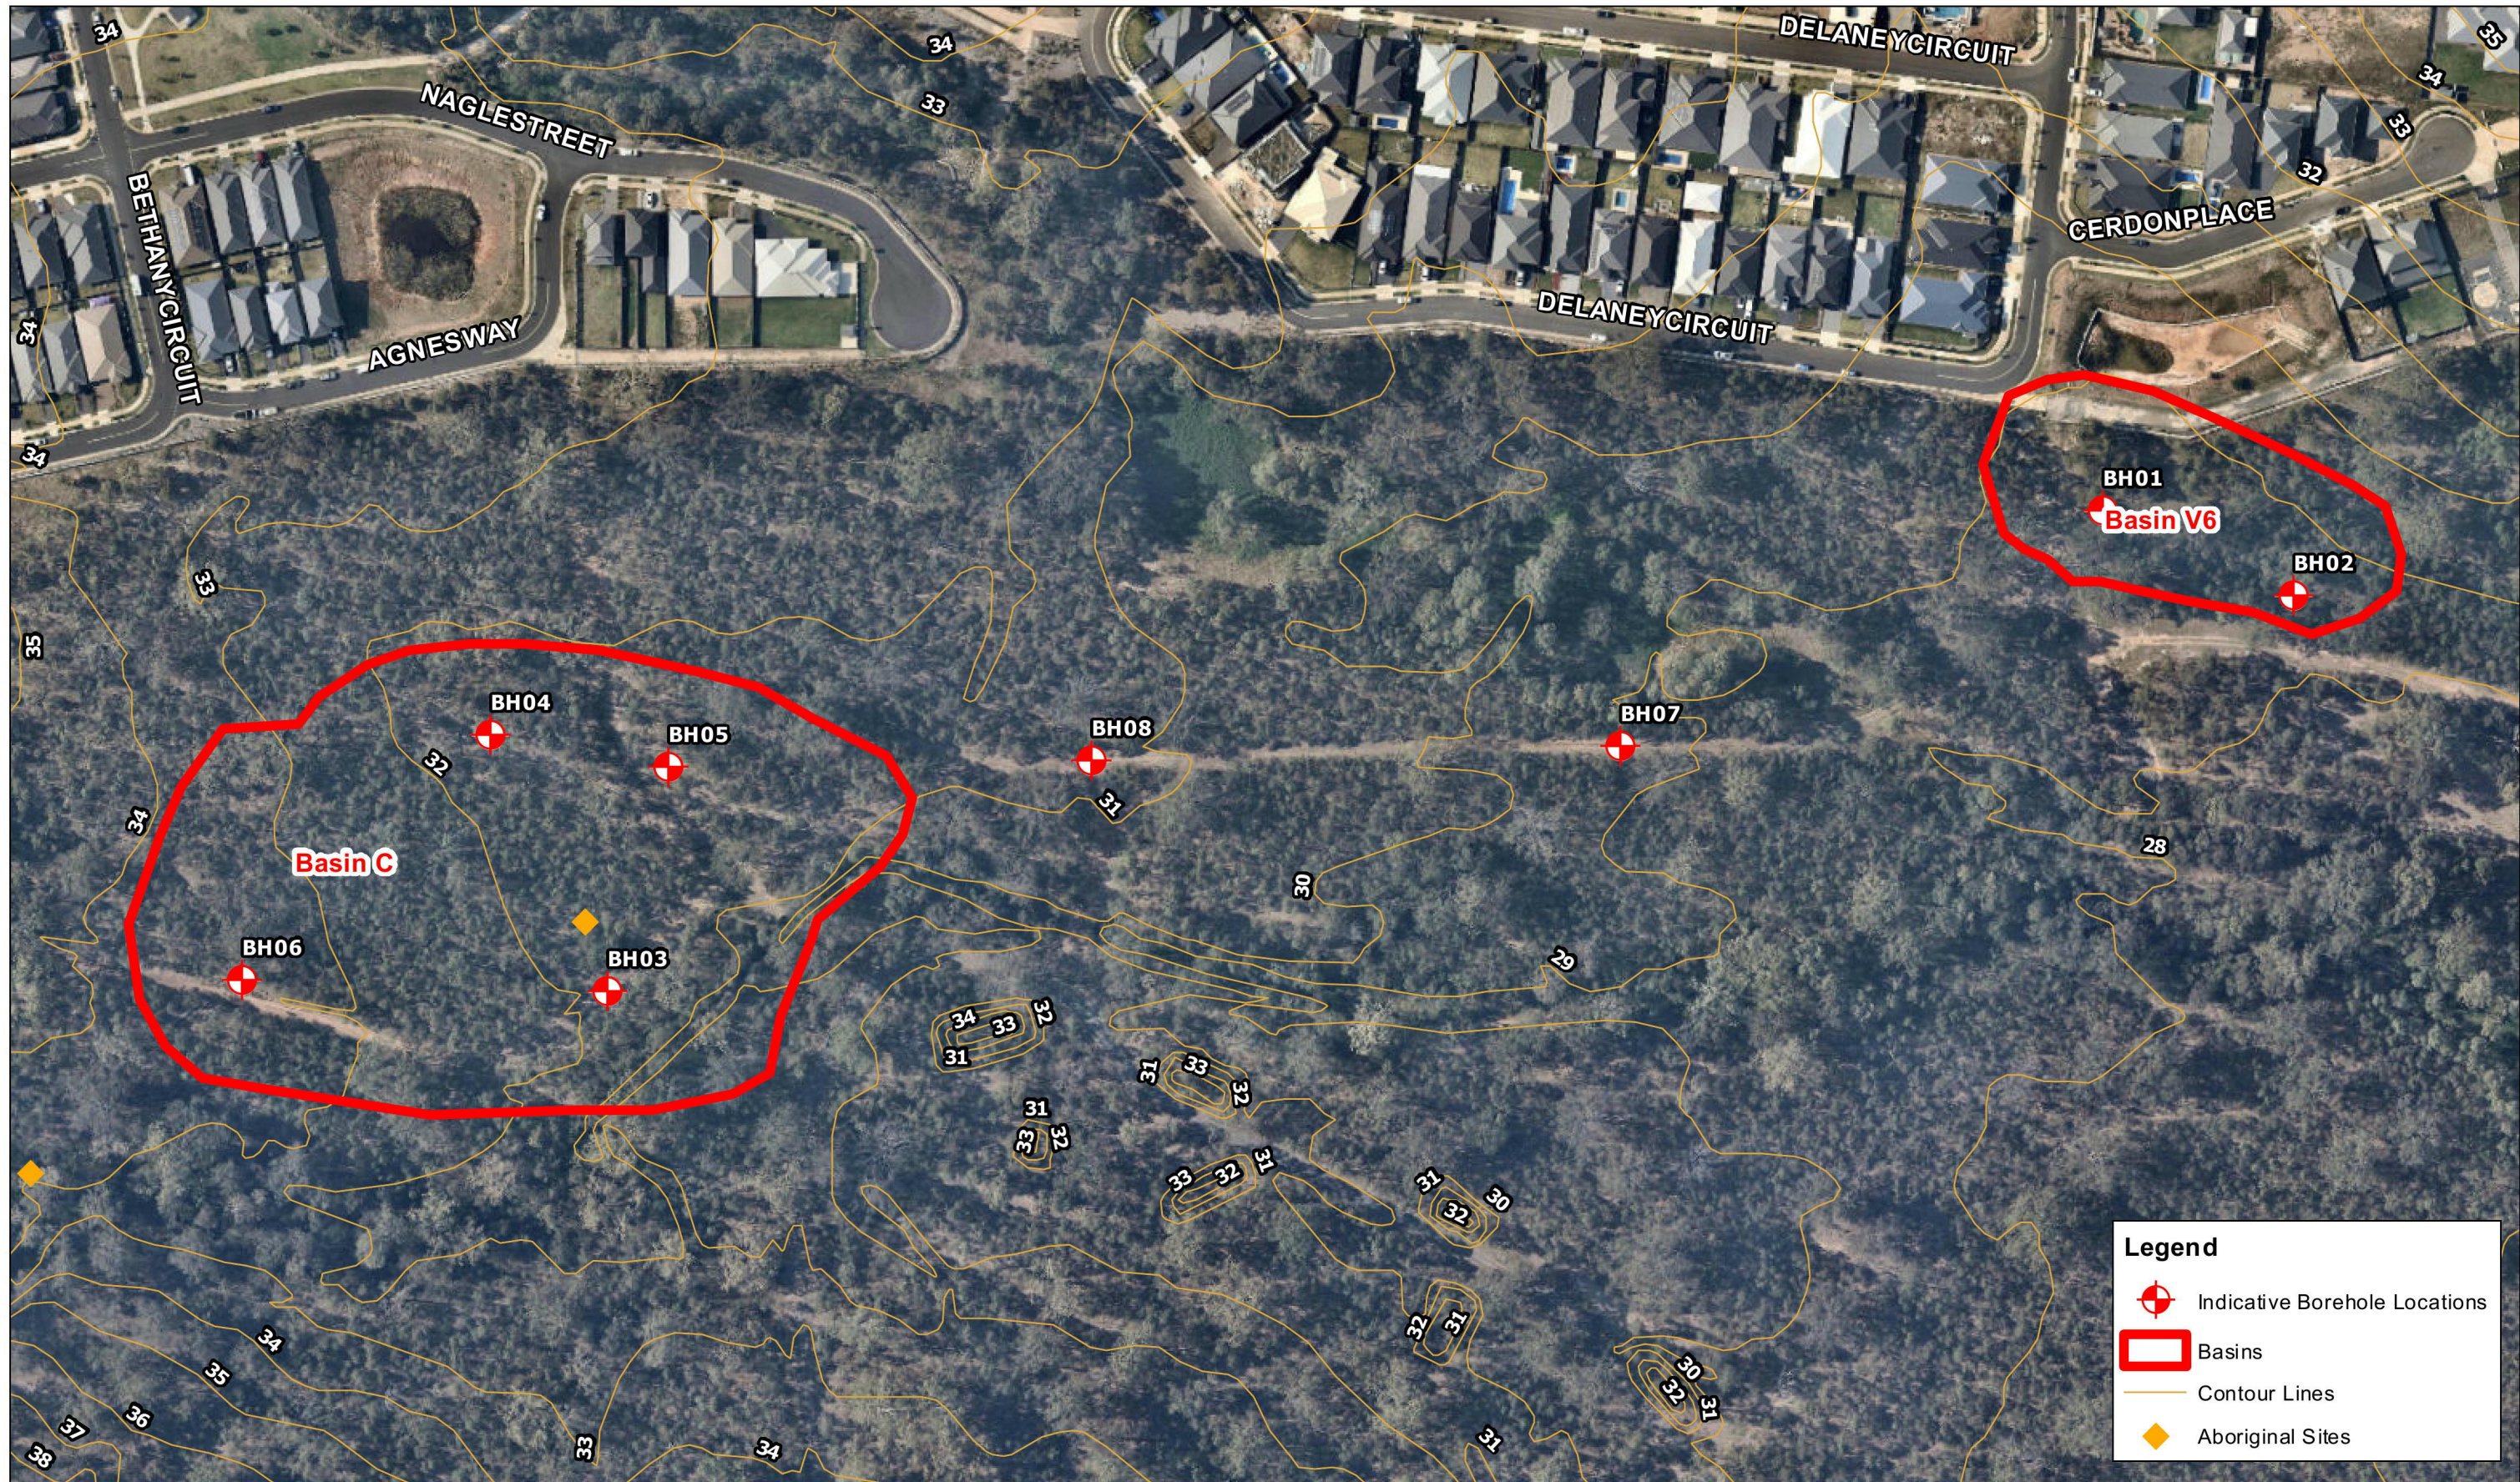
SITE PLAN

# St Mary's Basins Geotechnical Investigation

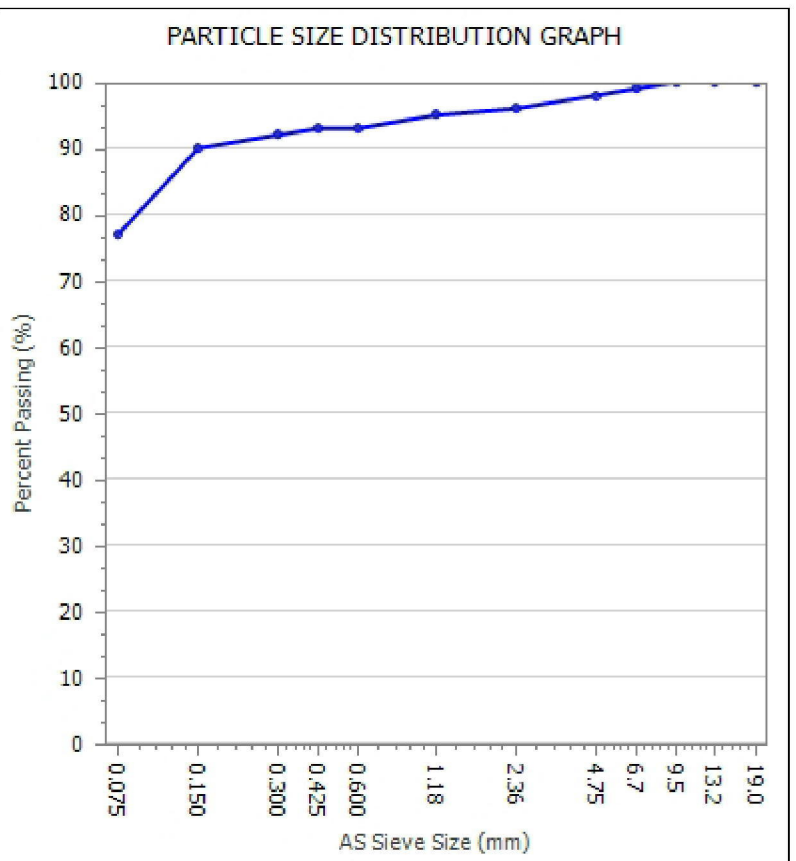
<b>Sample Location</b>		<b>Client Sample ID</b>	BH01		2-2.5m	<b>Material Type</b> Silty CLAY	
<b>Sample Location</b>									
<b>Client Sample ID</b>	BH01								
	2-2.5m								
<b>Material Type</b> Silty CLAY

AS Sieve (mm)	Specification Minimum	Percent Passing (%)	Specification Maximum
19.0		100	
13.2		100	
9.5		100	
6.7		99	
4.75		98	
2.36		96	
1.18		95	
0.600		93	
0.425		93	
0.300		92	
0.150		90	
0.075		77

BH ID	Depth (m BSL)	Sand & Gravel (%)	Clay & Silt (%)	Moisture Content (%)	Liquid Limit (%)	Plastic Limit (%)	Plasticity Index(%)	Linear Shrinkage (%)	Emerson Crumb
BH01	2.0-2.5	23	77	13.6	46	17	29	15.0	2
BH04	2.5-3.0	38	62	17.0	38	16	22	12.0	2
BH03	2.0-2.5	44	72	65.0	44	16	28	14.5	2

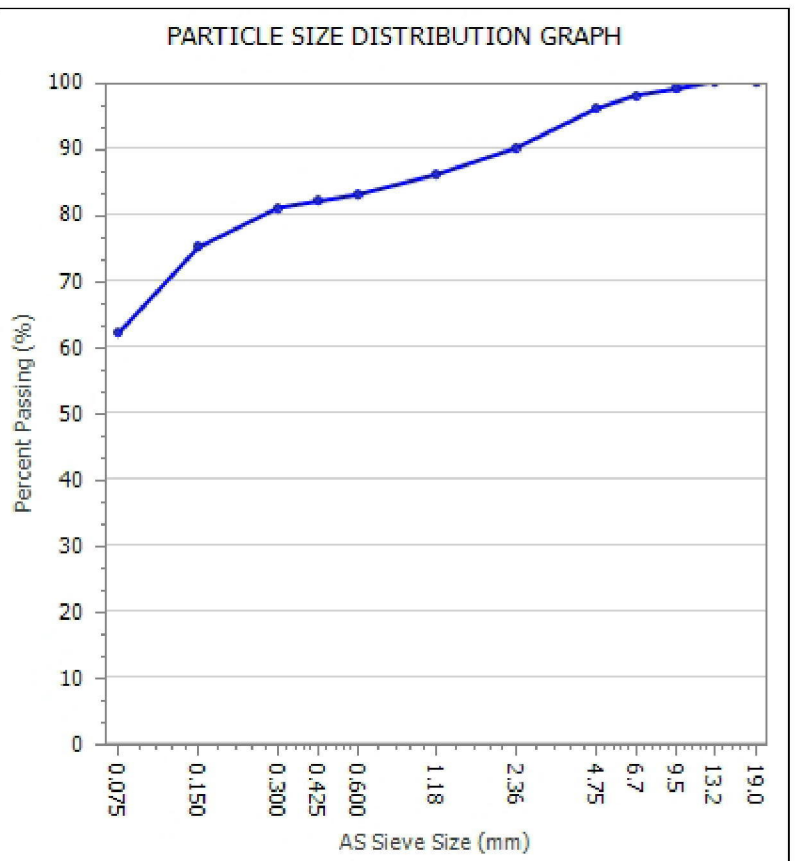
<b>Material Type</b> Silty CLAY	<b>Sample Location</b>		<b>Client Sample ID</b>	BH04		2.5-3m
<b>Sample Location</b>							
<b>Client Sample ID</b>	BH04						
	2.5-3m

AS Sieve (mm)	Specification Minimum	Percent Passing (%)	Specification Maximum
19.0		100	
13.2		100	
9.5		99	
6.7		98	
4.75		96	
2.36		90	
1.18		86	
0.600		83	
0.425		82	
0.300		81	
0.150		75	
0.075		62

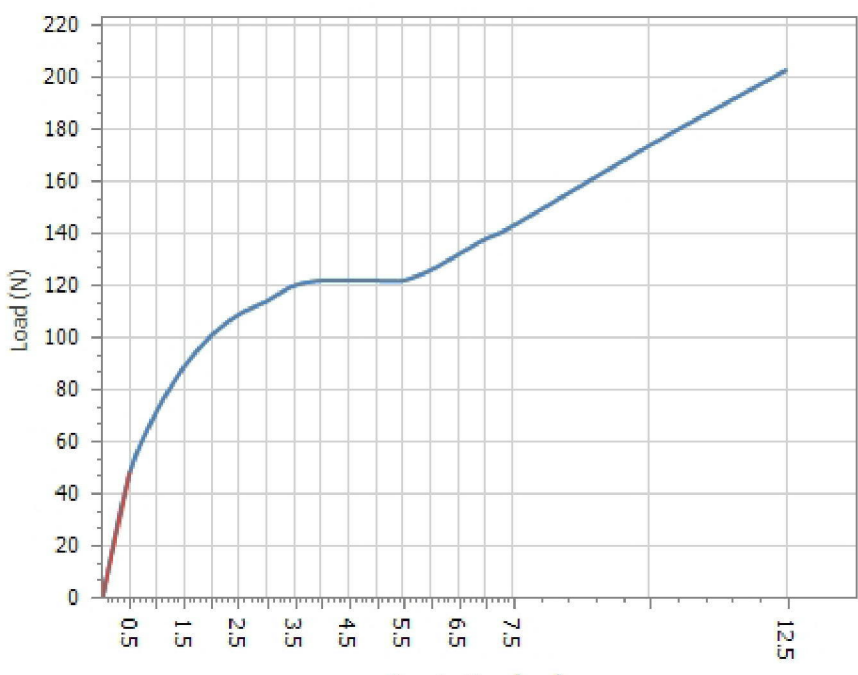
<table style="width: 100%; border-collapse: collapse;"> <tr><td>Maximum Dry Density (t/m<sup>3</sup>):</td><td style="text-align: right;">1.72</td></tr> <tr><td>Optimum Moisture Content (%):</td><td style="text-align: right;">13.0</td></tr> <tr><td>Field Moisture Content (%):</td><td style="text-align: right;">11.6</td></tr> <tr><td>Sample Percent Oversize (%):</td><td style="text-align: right;">0.0</td></tr> <tr><td>Oversize Included / Excluded</td><td style="text-align: right;">Excluded</td></tr> <tr><td>Target Density Ratio (%):</td><td style="text-align: right;">95</td></tr> <tr><td>Target Moisture Ratio (%):</td><td style="text-align: right;">100</td></tr> <tr><td>Placement Dry Density (t/m<sup>3</sup>):</td><td style="text-align: right;">1.62</td></tr> <tr><td>Placement Dry Density Ratio (%):</td><td style="text-align: right;">94.5</td></tr> <tr><td>Placement Moisture Content (%):</td><td style="text-align: right;">13.0</td></tr> <tr><td>Placement Moisture Ratio (%):</td><td style="text-align: right;">101.0</td></tr> <tr><td>Test Condition / Soaking Period:</td><td style="text-align: right;">Soaked / 4 Days</td></tr> <tr><td>CBR Surcharge (kg)</td><td style="text-align: right;">4.5</td></tr> <tr><td>Dry Density After Soak (t/m<sup>3</sup>):</td><td style="text-align: right;">1.57</td></tr> <tr><td>Total Curing Time (hrs)</td><td style="text-align: right;">51</td></tr> <tr><td>Liquid Limit Method</td><td style="text-align: right;">Estimation</td></tr> <tr><td>Moisture (top 30mm) After Soak (%)</td><td style="text-align: right;">26.5</td></tr> <tr><td>Moisture (remainder) After Soak (%)</td><td style="text-align: right;">22.1</td></tr> <tr><td>CBR Swell (%):</td><td style="text-align: right;">3.5</td></tr> <tr><td>Minimum CBR Specification (%):</td><td style="text-align: right;">-</td></tr> <tr><td><b>CBR Value @ 2.5mm (%):</b></td><td style="text-align: right;"><b>1.0</b></td></tr> </table>	Maximum Dry Density (t/m <sup>3</sup> ):	1.72	Optimum Moisture Content (%):	13.0	Field Moisture Content (%):	11.6	Sample Percent Oversize (%):	0.0	Oversize Included / Excluded	Excluded	Target Density Ratio (%):	95	Target Moisture Ratio (%):	100	Placement Dry Density (t/m <sup>3</sup> ):	1.62	Placement Dry Density Ratio (%):	94.5	Placement Moisture Content (%):	13.0	Placement Moisture Ratio (%):	101.0	Test Condition / Soaking Period:	Soaked / 4 Days	CBR Surcharge (kg)	4.5	Dry Density After Soak (t/m <sup>3</sup> ):	1.57	Total Curing Time (hrs)	51	Liquid Limit Method	Estimation	Moisture (top 30mm) After Soak (%)	26.5	Moisture (remainder) After Soak (%)	22.1	CBR Swell (%):	3.5	Minimum CBR Specification (%):	-	<b>CBR Value @ 2.5mm (%):</b>	<b>1.0</b>	<div style="text-align: center;"> <b>CBR PENETRATION PLOT</b> </div>

<table style="width: 100%; border-collapse: collapse; margin-top: 10px;"> <tr> <th style="text-align: left;">Load (N)</th> <th style="text-align: left;">Penetration (mm)</th> </tr> <tr><td>0</td><td>0</td></tr> <tr><td>20</td><td>0.5</td></tr> <tr><td>40</td><td>1.0</td></tr> <tr><td>60</td><td>1.5</td></tr> <tr><td>80</td><td>2.0</td></tr> <tr><td>100</td><td>2.5</td></tr> <tr><td>120</td><td>3.0</td></tr> <tr><td>120</td><td>3.5</td></tr> <tr><td>120</td><td>4.0</td></tr> <tr><td>120</td><td>4.5</td></tr> <tr><td>120</td><td>5.0</td></tr> <tr><td>120</td><td>5.5</td></tr> <tr><td>140</td><td>6.0</td></tr> <tr><td>160</td><td>7.0</td></tr> <tr><td>180</td><td>8.0</td></tr> <tr><td>200</td><td>12.5</td></tr> </table>	Load (N)	Penetration (mm)	0	0	20	0.5	40	1.0	60	1.5	80	2.0	100	2.5	120	3.0	120	3.5	120	4.0	120	4.5	120	5.0	120	5.5	140	6.0	160	7.0	180	8.0	200	12.5

As presented in **Table 4-4**, laboratory soaked CBR tests indicate that the subgrade material has a swell of 2.0% - 3.5%. The material therefore has a "moderate" expansiveness for pavement design purposes. The test result for the specimens indicate CBR values in the range of 1.0% to 2.0%. Taking this into consideration a pavement design CBR of 1% is recommended for the site locality. Should field conditions at the time of construction indicate that field CBR is less than 1%, Cardno should be consulted to provide additional advice

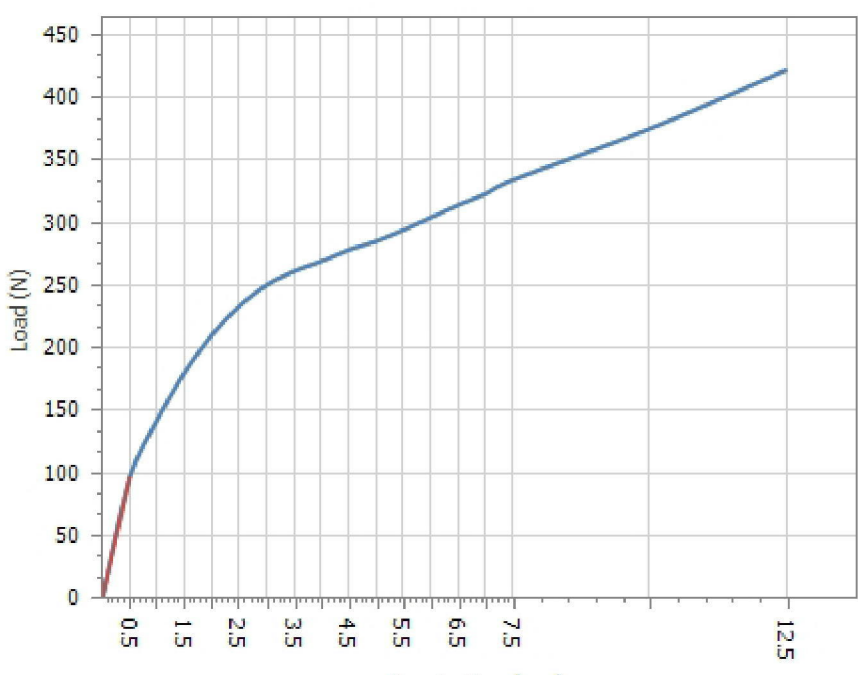
<table style="width: 100%; border-collapse: collapse;"> <tr><td>Maximum Dry Density (t/m<sup>3</sup>):</td><td style="text-align: right;">1.85</td></tr> <tr><td>Optimum Moisture Content (%):</td><td style="text-align: right;">11.5</td></tr> <tr><td>Field Moisture Content (%):</td><td style="text-align: right;">9.3</td></tr> <tr><td>Sample Percent Oversize (%):</td><td style="text-align: right;">0.0</td></tr> <tr><td>Oversize Included / Excluded</td><td style="text-align: right;">Excluded</td></tr> <tr><td>Target Density Ratio (%):</td><td style="text-align: right;">95</td></tr> <tr><td>Target Moisture Ratio (%):</td><td style="text-align: right;">100</td></tr> <tr><td>Placement Dry Density (t/m<sup>3</sup>):</td><td style="text-align: right;">1.75</td></tr> <tr><td>Placement Dry Density Ratio (%):</td><td style="text-align: right;">95.0</td></tr> <tr><td>Placement Moisture Content (%):</td><td style="text-align: right;">11.4</td></tr> <tr><td>Placement Moisture Ratio (%):</td><td style="text-align: right;">100.0</td></tr> <tr><td>Test Condition / Soaking Period:</td><td style="text-align: right;">Soaked / 4 Days</td></tr> <tr><td>CBR Surcharge (kg)</td><td style="text-align: right;">4.5</td></tr> <tr><td>Dry Density After Soak (t/m<sup>3</sup>):</td><td style="text-align: right;">1.72</td></tr> <tr><td>Total Curing Time (hrs)</td><td style="text-align: right;">48</td></tr> <tr><td>Liquid Limit Method</td><td style="text-align: right;">Estimation</td></tr> <tr><td>Moisture (top 30mm) After Soak (%)</td><td style="text-align: right;">18.3</td></tr> <tr><td>Moisture (remainder) After Soak (%)</td><td style="text-align: right;">18.6</td></tr> <tr><td>CBR Swell (%):</td><td style="text-align: right;">2.0</td></tr> <tr><td>Minimum CBR Specification (%):</td><td style="text-align: right;">-</td></tr> <tr><td><b>CBR Value @ 2.5mm (%):</b></td><td style="text-align: right;"><b>2.0</b></td></tr> </table>	Maximum Dry Density (t/m <sup>3</sup> ):	1.85	Optimum Moisture Content (%):	11.5	Field Moisture Content (%):	9.3	Sample Percent Oversize (%):	0.0	Oversize Included / Excluded	Excluded	Target Density Ratio (%):	95	Target Moisture Ratio (%):	100	Placement Dry Density (t/m <sup>3</sup> ):	1.75	Placement Dry Density Ratio (%):	95.0	Placement Moisture Content (%):	11.4	Placement Moisture Ratio (%):	100.0	Test Condition / Soaking Period:	Soaked / 4 Days	CBR Surcharge (kg)	4.5	Dry Density After Soak (t/m <sup>3</sup> ):	1.72	Total Curing Time (hrs)	48	Liquid Limit Method	Estimation	Moisture (top 30mm) After Soak (%)	18.3	Moisture (remainder) After Soak (%)	18.6	CBR Swell (%):	2.0	Minimum CBR Specification (%):	-	<b>CBR Value @ 2.5mm (%):</b>	<b>2.0</b>	<div style="text-align: center;"> <b>CBR PENETRATION PLOT</b> </div>

<table border="1" style="width: 100%; border-collapse: collapse; margin-top: 10px;"> <caption>Approximate Data Points from CBR Penetration Plot</caption> <thead> <tr> <th>Penetration (mm)</th> <th>Load (N)</th> </tr> </thead> <tbody> <tr><td>0.5</td><td>100</td></tr> <tr><td>1.5</td><td>180</td></tr> <tr><td>2.5</td><td>240</td></tr> <tr><td>3.5</td><td>270</td></tr> <tr><td>4.5</td><td>290</td></tr> <tr><td>5.5</td><td>310</td></tr> <tr><td>6.5</td><td>330</td></tr> <tr><td>7.5</td><td>350</td></tr> <tr><td>8.5</td><td>370</td></tr> <tr><td>9.5</td><td>390</td></tr> <tr><td>10.5</td><td>410</td></tr> <tr><td>11.5</td><td>420</td></tr> </tbody> </table>	Penetration (mm)	Load (N)	0.5	100	1.5	180	2.5	240	3.5	270	4.5	290	5.5	310	6.5	330	7.5	350	8.5	370	9.5	390	10.5	410	11.5	420
