PRELIMINARY SITE INVESTIGATION

Prepared For: Architecture Design Studio (NSW) Pty Ltd Address: 118-120 Station Street Penrith, NSW, 2750 Job No: AG-533_1 Date: 18-09-20

This executive summary presents a synopsis of the Preliminary Site Investigation (PSI) Assessment for 118-120 Station Street Penrith, NSW, 2750.

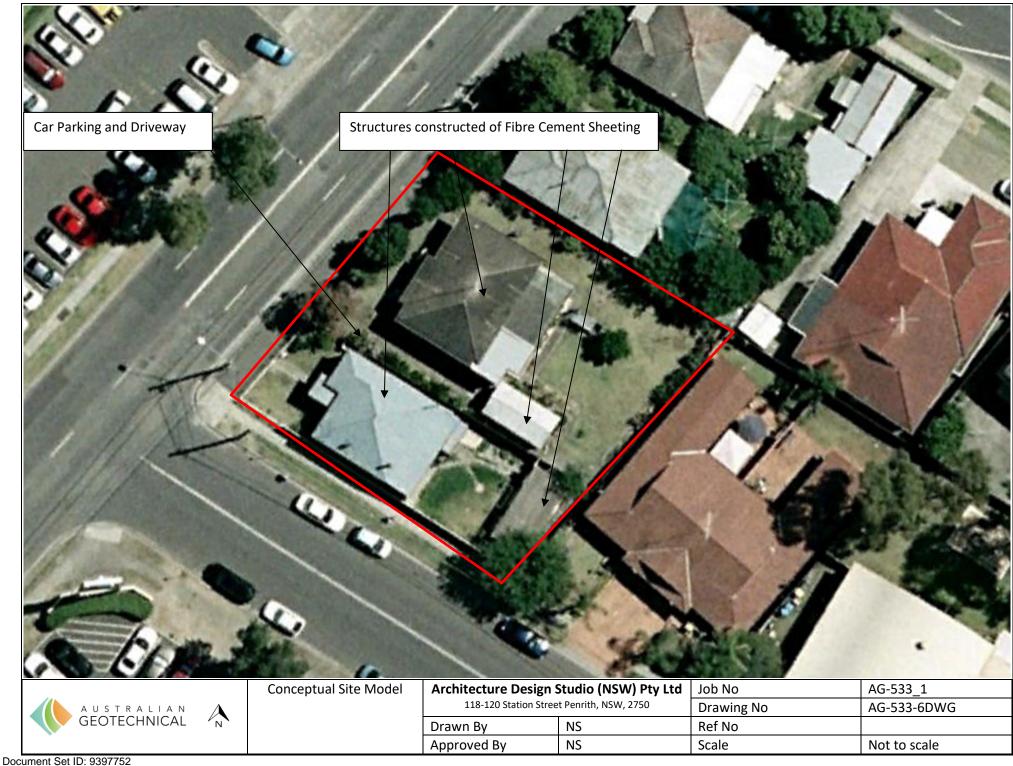
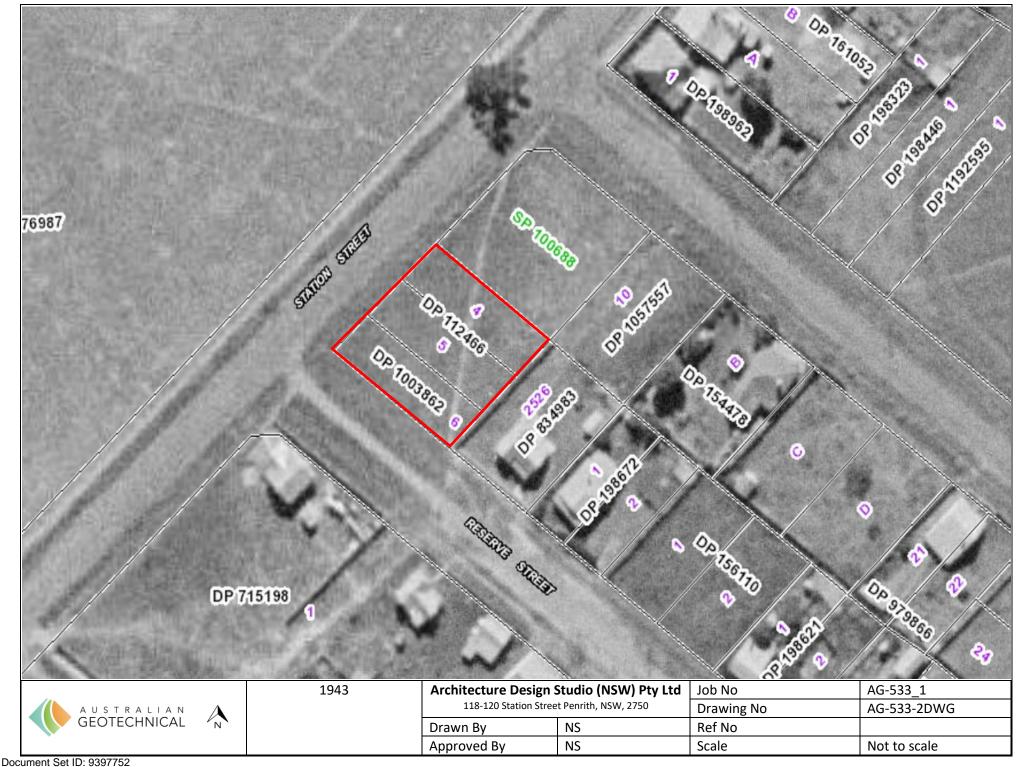
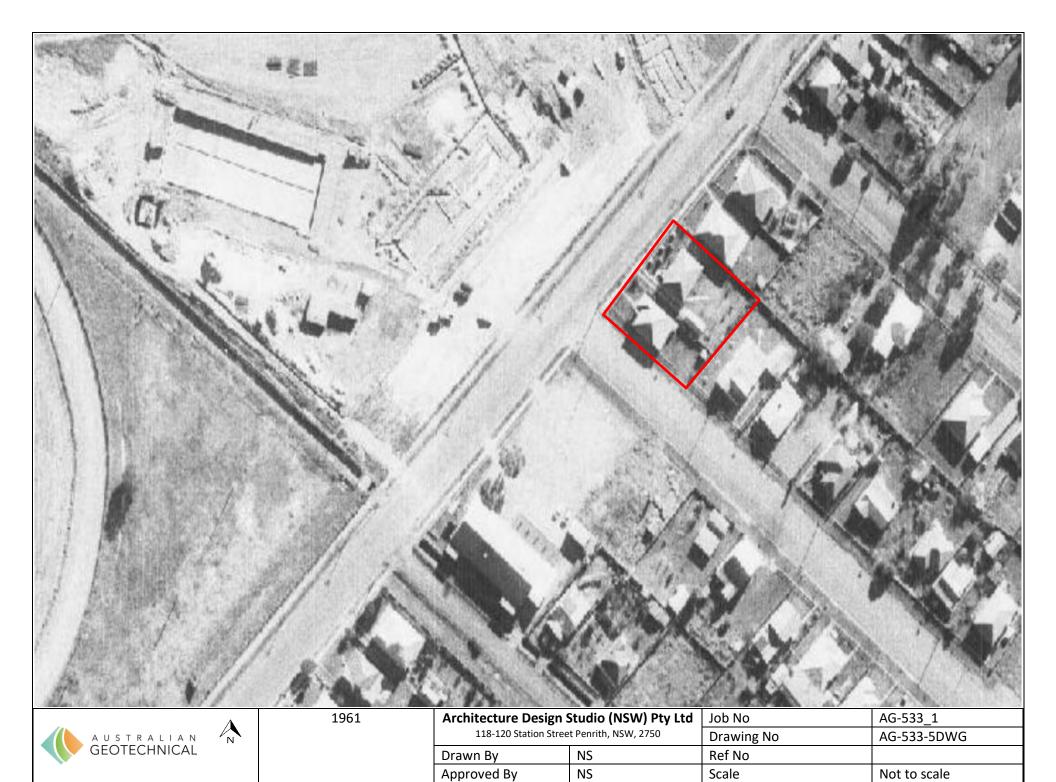
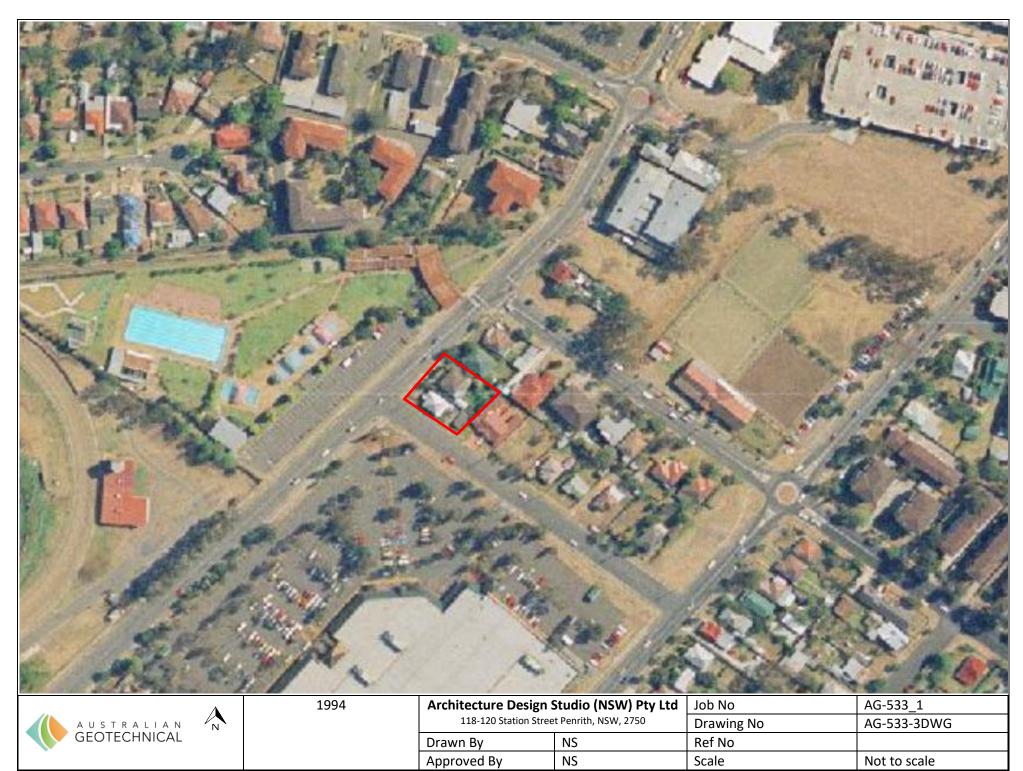
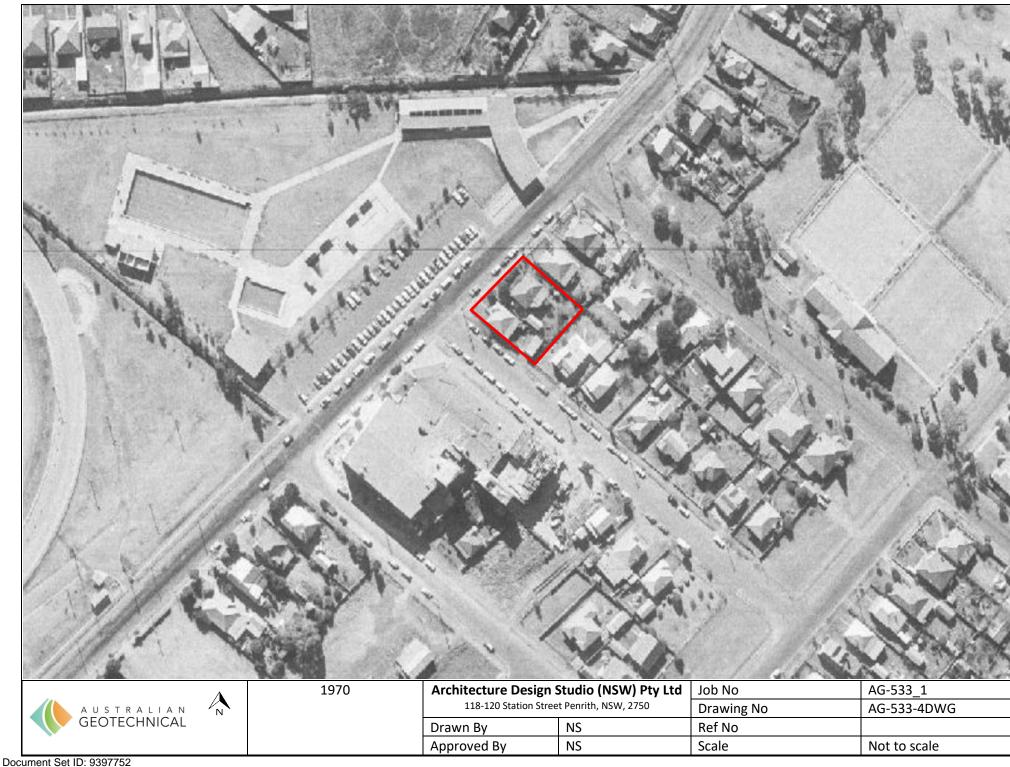
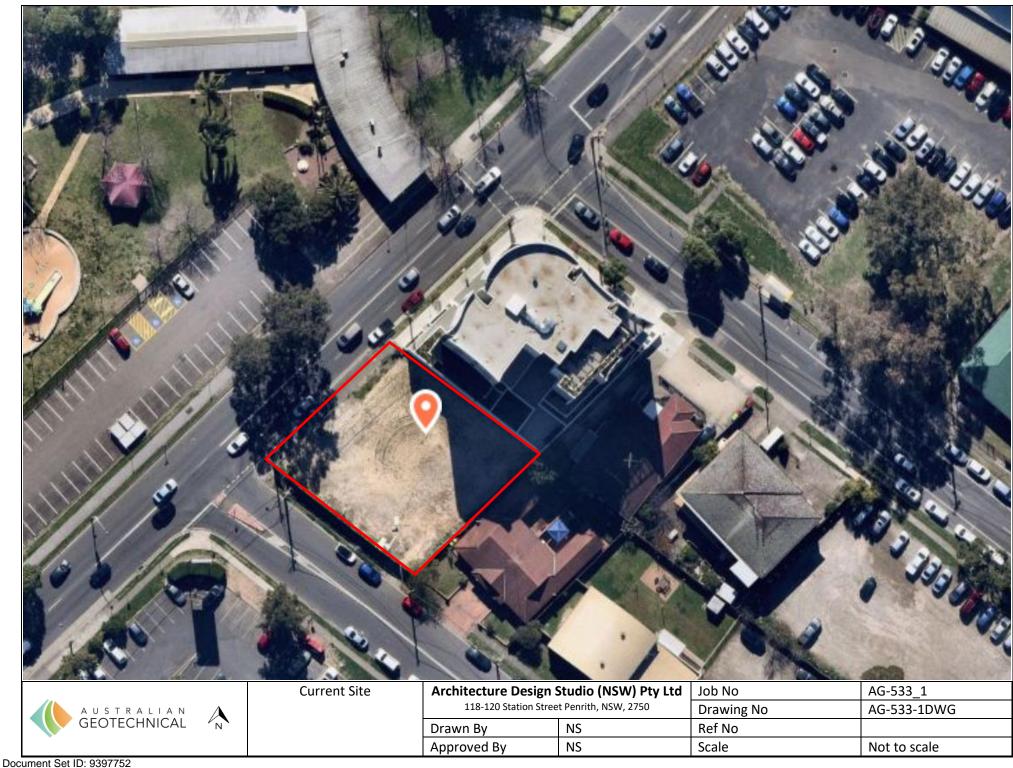
1943 – The site appears to be vacant. Some residential development can be seen around the subject site. Reserve and Station Street has been formed;

1961- Two (2) low density residential structures appear to occupy the north-western portion of site. A detached garage can be seen adjacent to the residential structures;

1970– Generally the same as 1961. An additional detached structure (garage) can be seen within the southern portion of site, additional vegetation growth can be observed;

1994 – The image isn't clear, however no change can be seen across the site;

2009 – No change from the 1994 image;

Current – The site is vacant, it is understood that structures occupying the site were demolished in 2018.

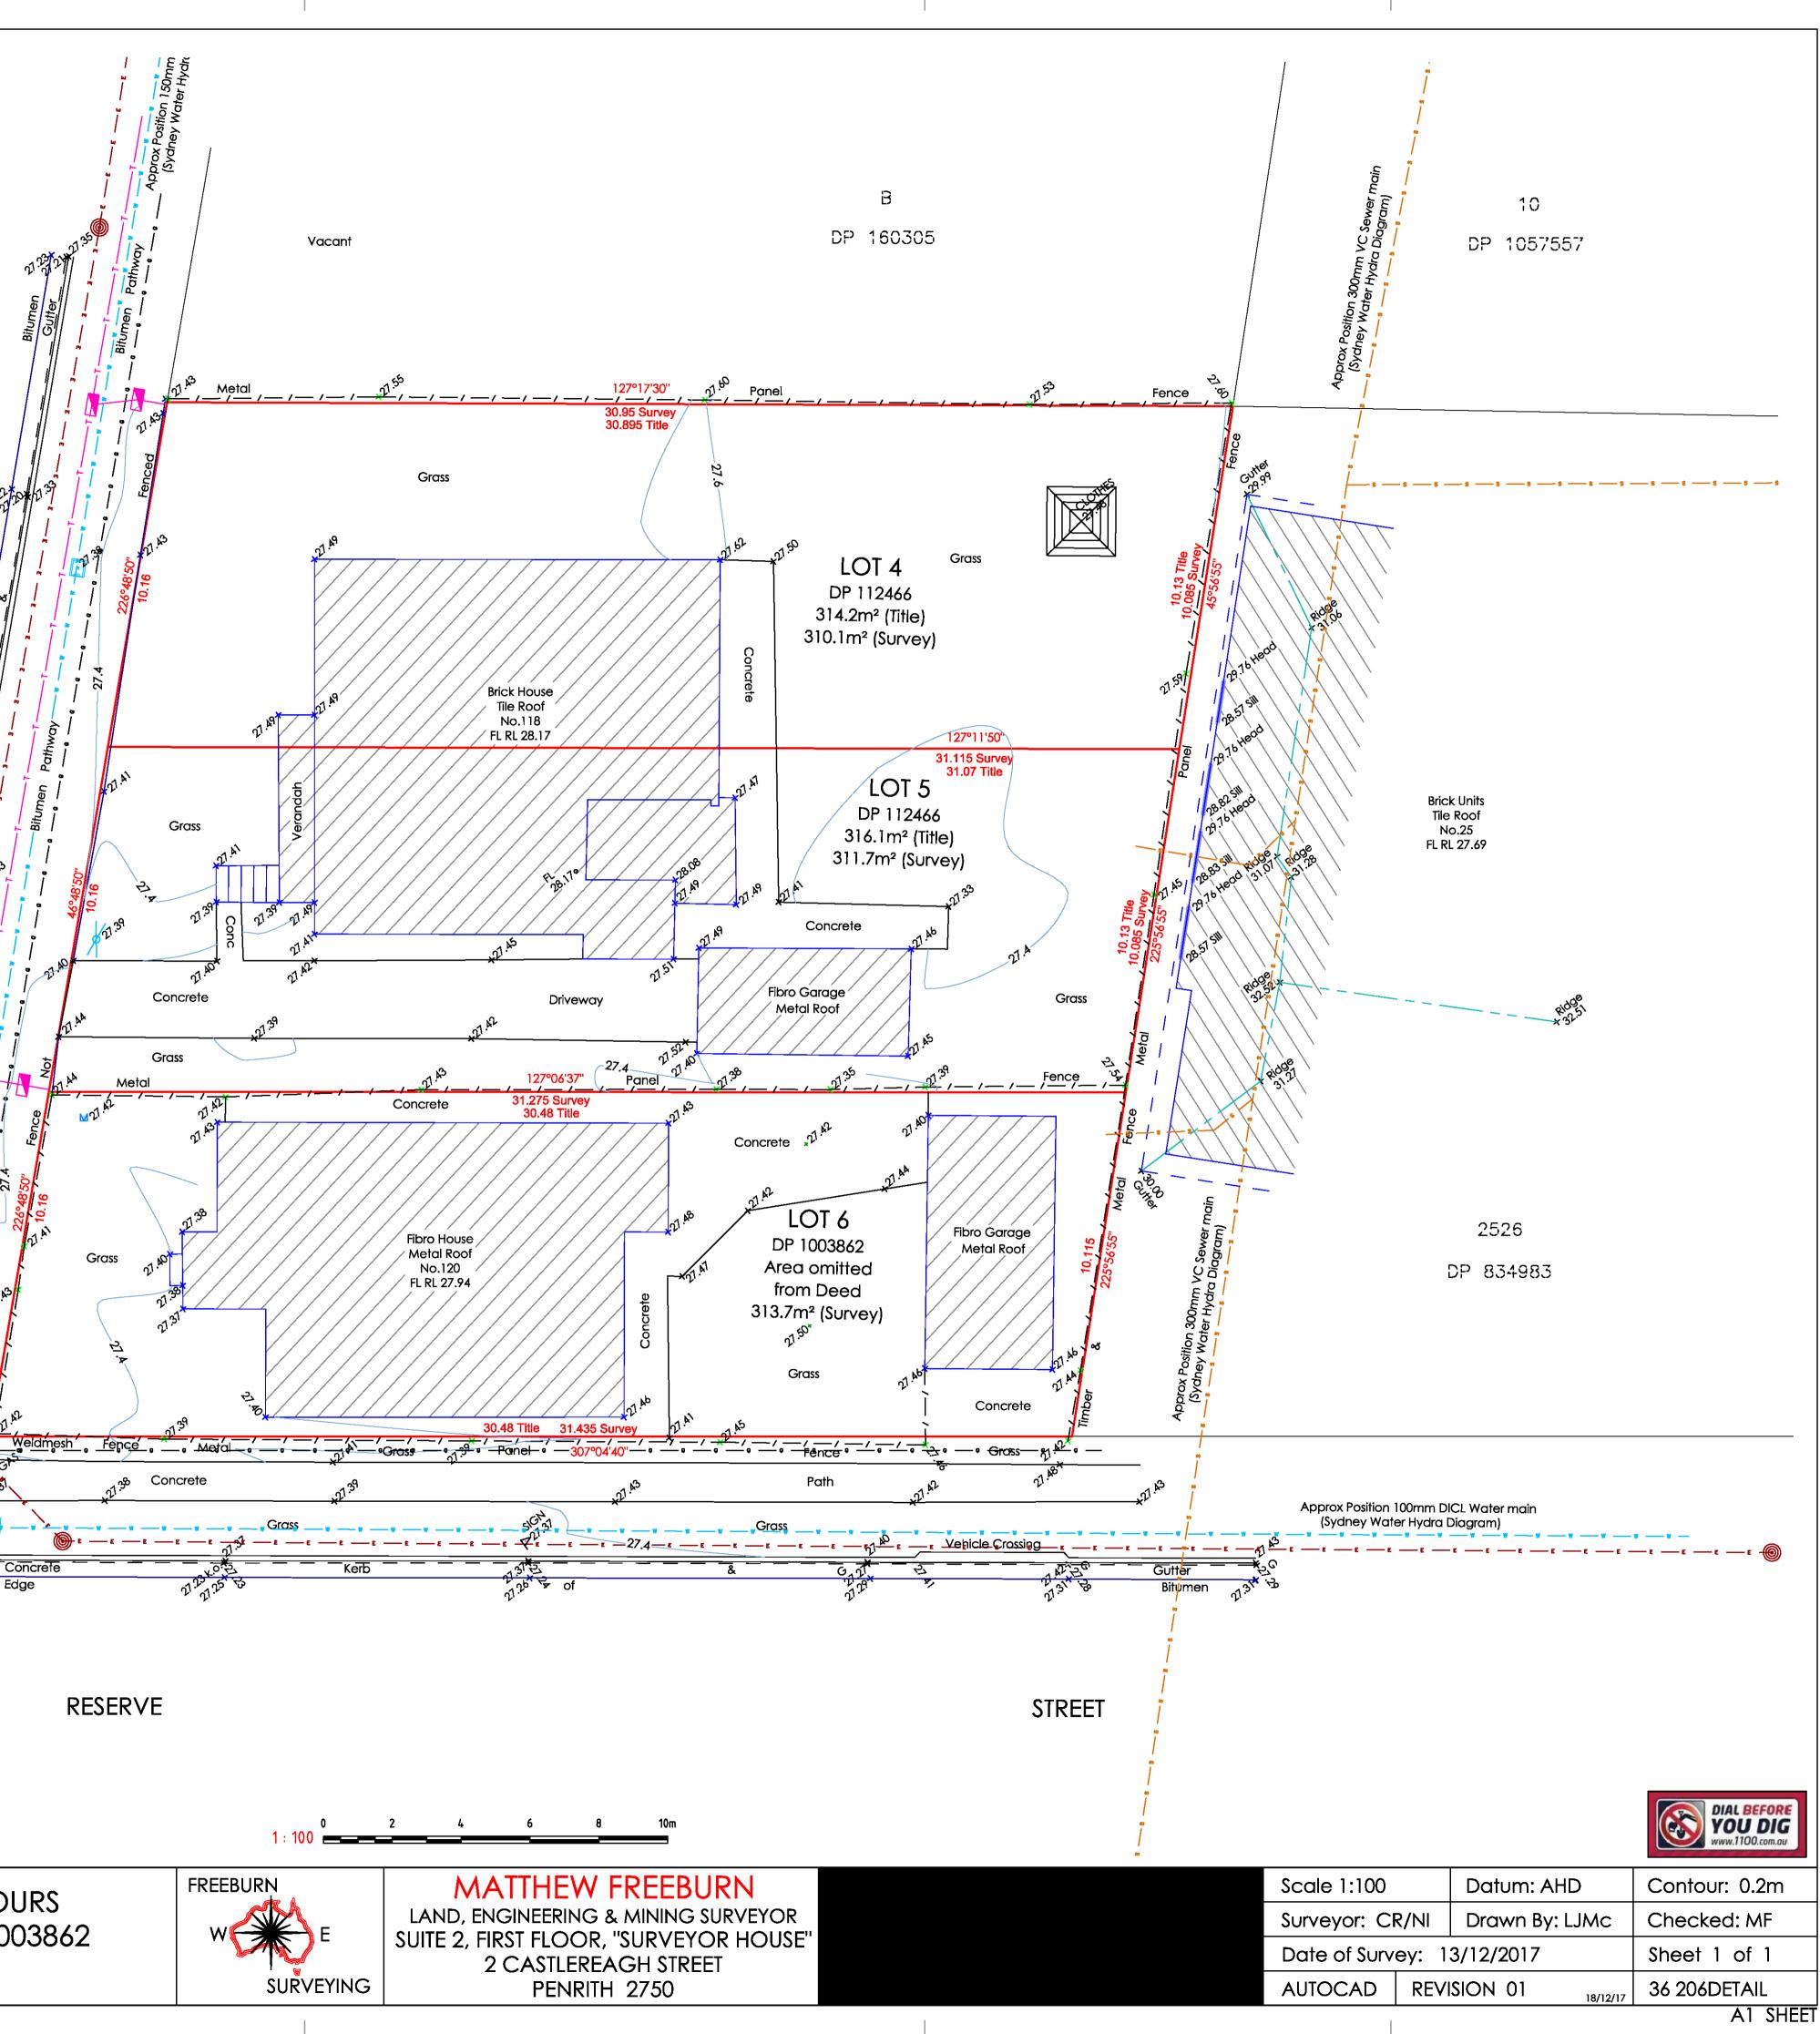
Project: PLAN OF DETAIL SURVEY, LEVELS & CONTOURS OVER LOTS 4 & 5 IN DP 112466 & LOT 6 DP 1003862 118-120 STATION STREET, PENRITH

Dimensions shown have been taken from the dimensions & adjoining plans, noted as "Survey" as per above.

Freeburn surveying recommends a plan of redefinition survey be prepared & lodged at Land Registry Services before any design and construction commences
