Stage 2 Road Safety Audit prepared by Bitzios Consulting

# **JORDAN SPRINGS RESIDENTIAL** SUBDIVISION PRELIMINARY DESIGN RSA

Version No: 002 29 May 2018 Project No: P3494 Issue date:

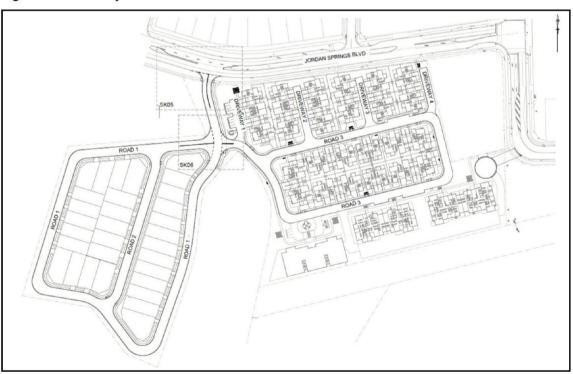
Figure 1.2: Proposed Residential Development Road Network

Figure 1.1 below shows the location of the subject site and Figure 1.2 shows the preliminary design of the proposed development primary intersection with Jordan Springs Boulevard including the proposed internal road network.

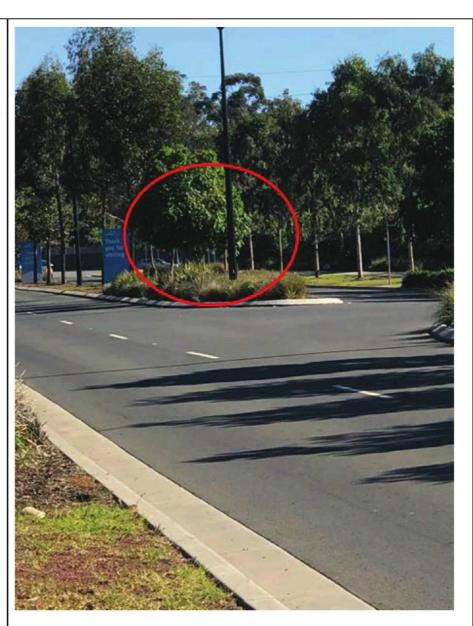
The existing vegetation and a tree with low branches may potentially obstruct the sightlines of drivers of any approaching eastbound vehicle on Jordan Springs Boulevard.

Consider clearing the vegetation including the removal of the tree to improve the sight lines.

Vegetation will be removed during construction.
