REMEDIAL ACTION PLAN

6 EDITH STREET, KINGSWOOD NSW 2747

Job Number: JN00869
Issued date: 19 June 2020
Prepared for: Liquid Gold 888 Pty Ltd
Client Address: Unit 1, 26-28 Cann Street, Guilford NSW 2161
Report by: Craig Wellings; Principal Environmental Scientist
Total No of pages: 36

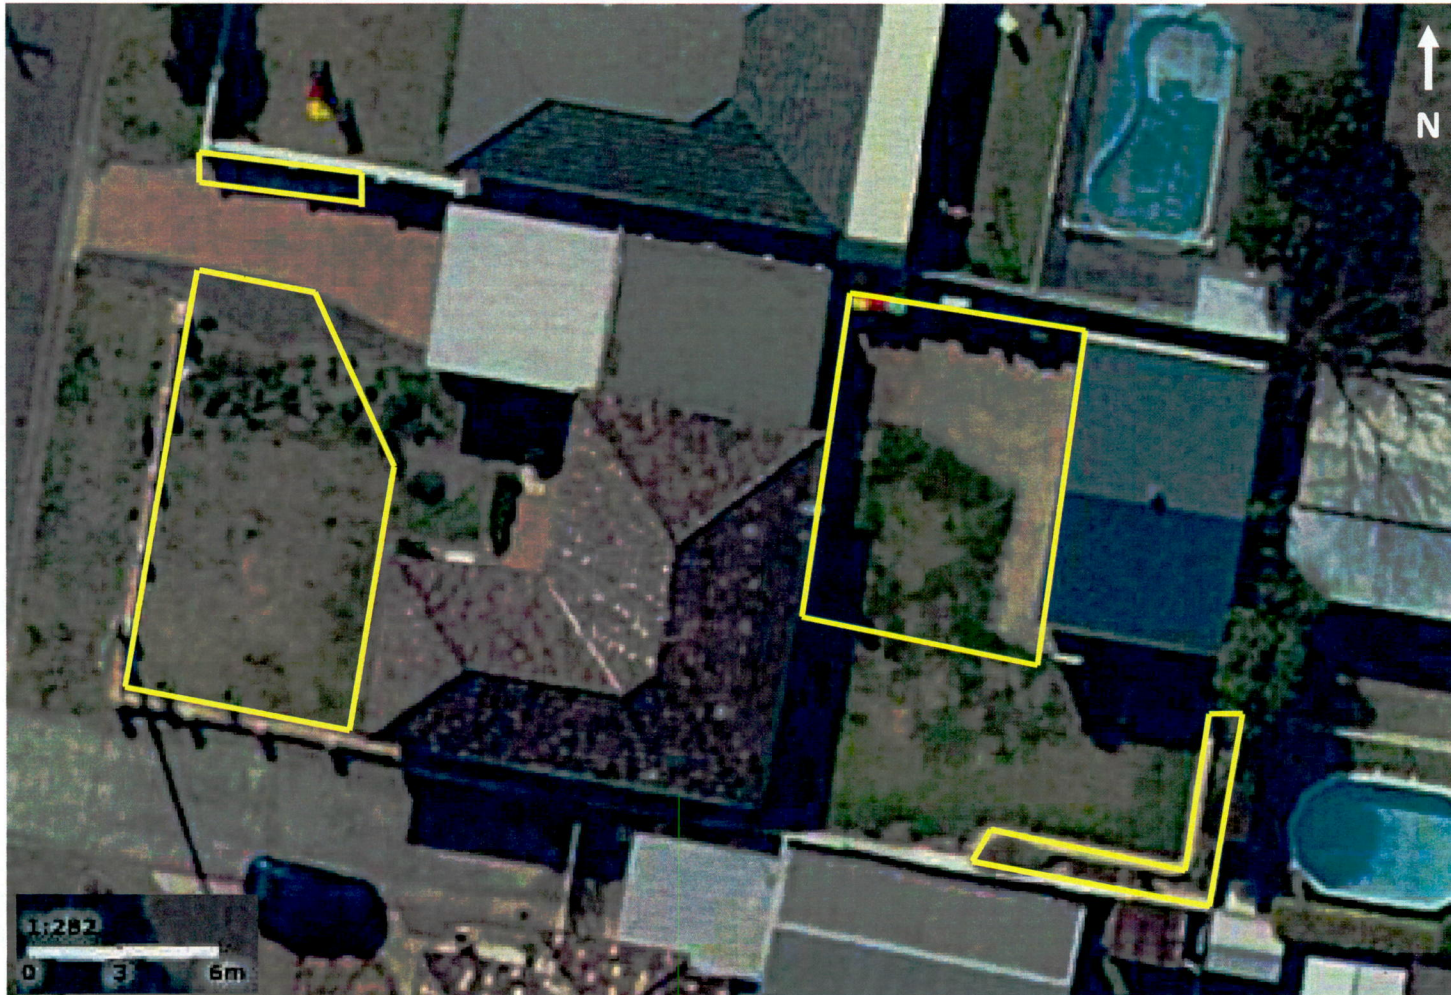
FIGURE 3 – AREAS OF OBSERVED FILL
6 EDITH STREET, KINGSWOOD NSW 2747

Area of Observed Fill

The investigations of the property located at 6 Edith Street, Kingswood NSW 2747, has found that fill has been used for the purposes of levelling the front yard within the fence line, constructing the front and rear driveways and in formation of garden beds.

Based on the bore logs and observations of the surrounding topography, it is estimated that the uncontrolled fill covers an area of approximately 100 m², to an average depth of 0.25 m below the existing surface of the front yard. As the fill has been observed to have been placed directly over natural material is recommended that a minimum of 50 mm of the surface of the natural material from the contaminated area is removed with the fill to ensure that all unsuitable material is removed from site. This means that for the purposes of these calculations the average depth of material to be remediated is approximately 0.3 m. Based on the above the total estimated volume of the uncontrolled fill is in the order of 30 m³.

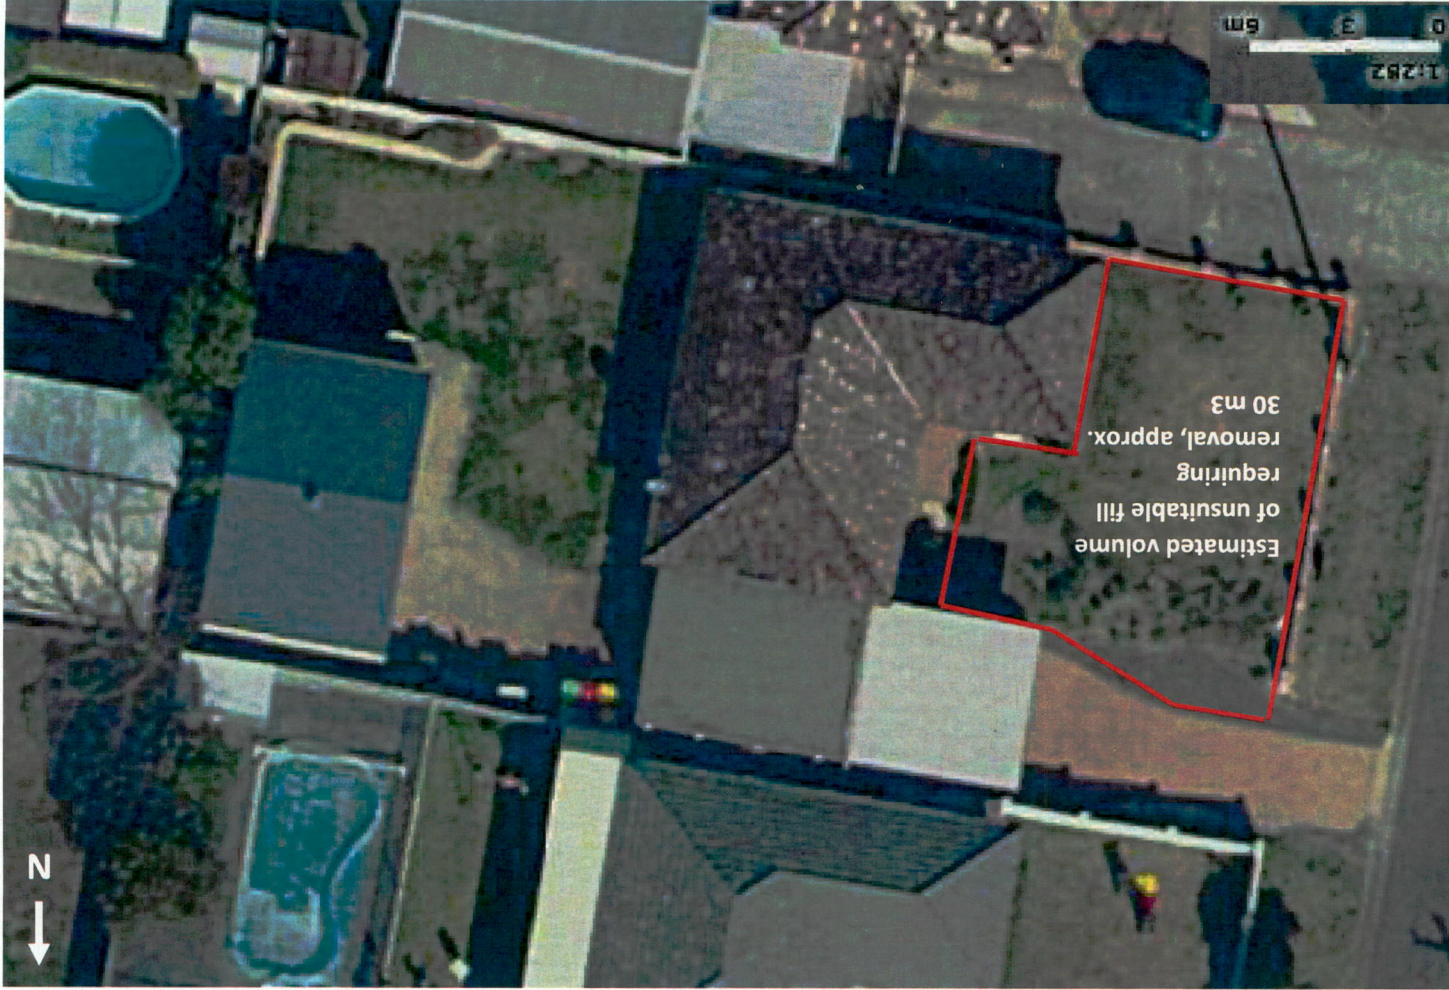
FIGURE 3 - POTENTIAL REMEDIATION AREA
6 EDITH STREET, KINGSWOOD NSW 2747

Potential Remediation Area

- the fill material used to level the south western portion of the Site (the front yard) which has been found to unsuitable for both the current and proposed site use due to the presence of friable asbestos / asbestos fines (FA/AF).

Based on the bore logs and observations of the surrounding topography, it is estimated that the uncontrolled fill covers an area of approximately 100 m², to an average depth of 0.25 m below the existing surface of the front yard. As the fill has been observed to have been placed directly over natural material is recommended that a minimum of 50 mm of the surface of the natural material from the contaminated area is removed with the fill to ensure that all unsuitable material is removed from site. This means that the for the purposes of these calculations the average depth of material to be remediated is approximately 0.3 m. Based on the above the total estimated volume of the uncontrolled fill is in the order of 30 m³.
