ENVIRONMENTAL SITE ASSESSMENT

Proposed Subdivision of Lot 3991 in DP 1190132
Corner Jordan Springs Boulevard & Lakeside Parade
Jordan Springs NSW 2747

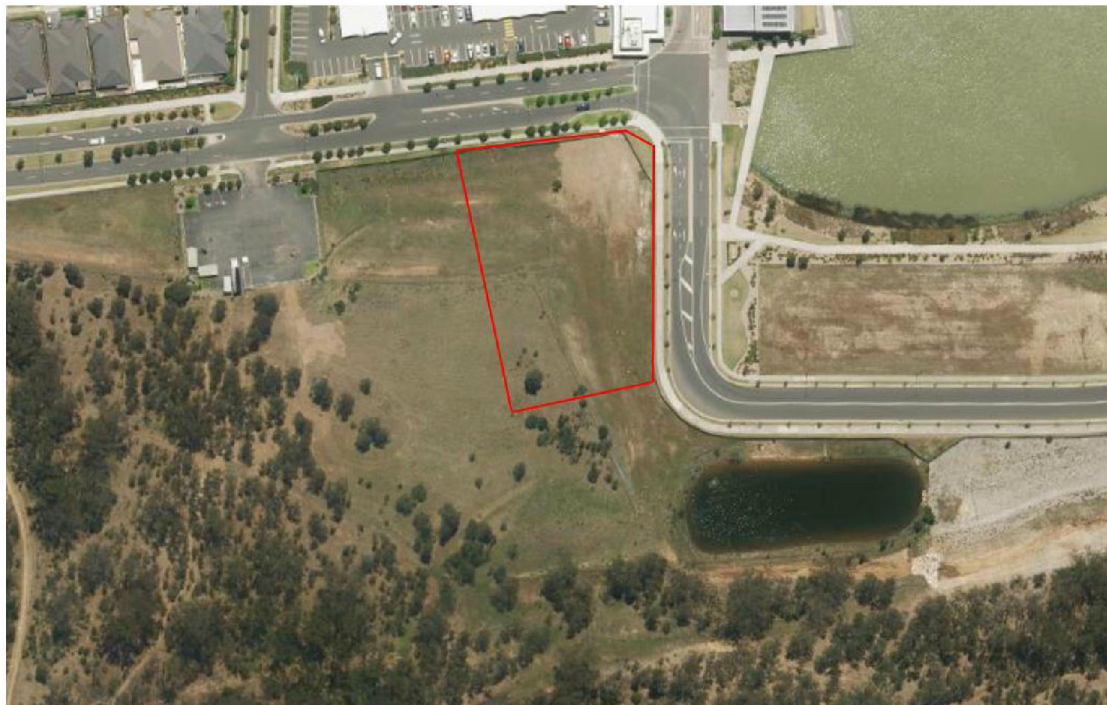
The Site is located at the intersection of Jordan Springs Boulevard and Lakeside Parade and has an area of 5004m². Proposed Lot 2 is outlined in red on Figure 2 – Site Plan (Six Maps).

The site is irregular in shape with the western boundary being approximately 91m long, the eastern boundary approximately 78m long and with an 58m frontage to Jordan Springs Boulevard.

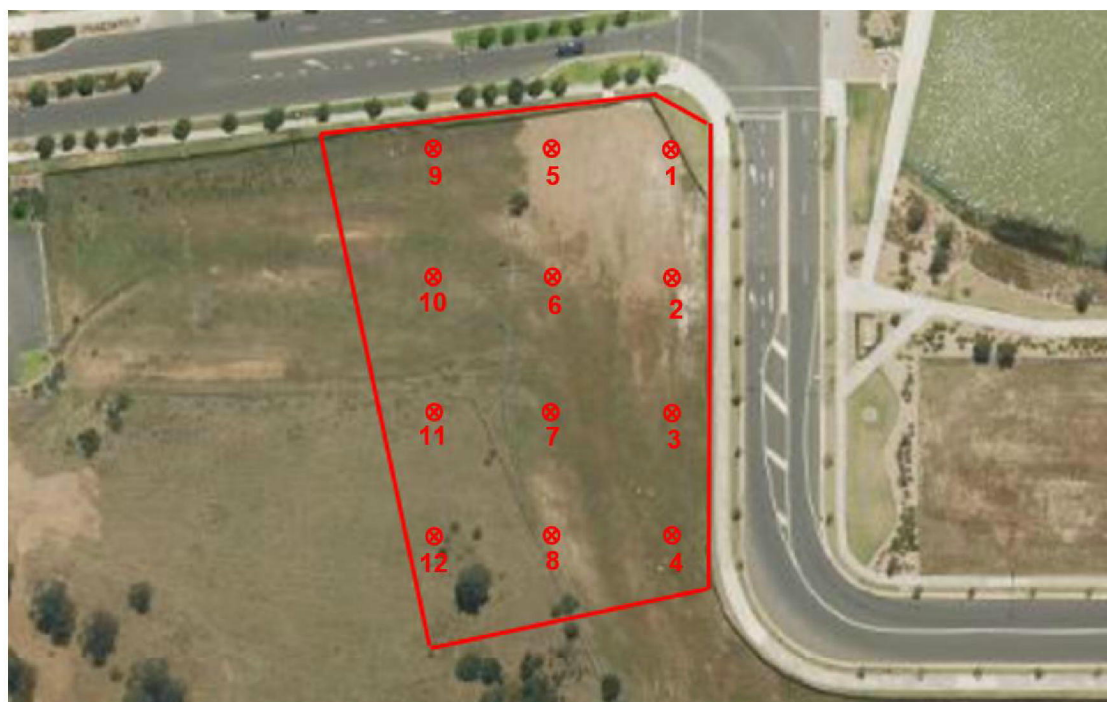
Figure 3 – Sampling Locations

The locations of the test pits are presented on Figure 3 – Sampling Locations.

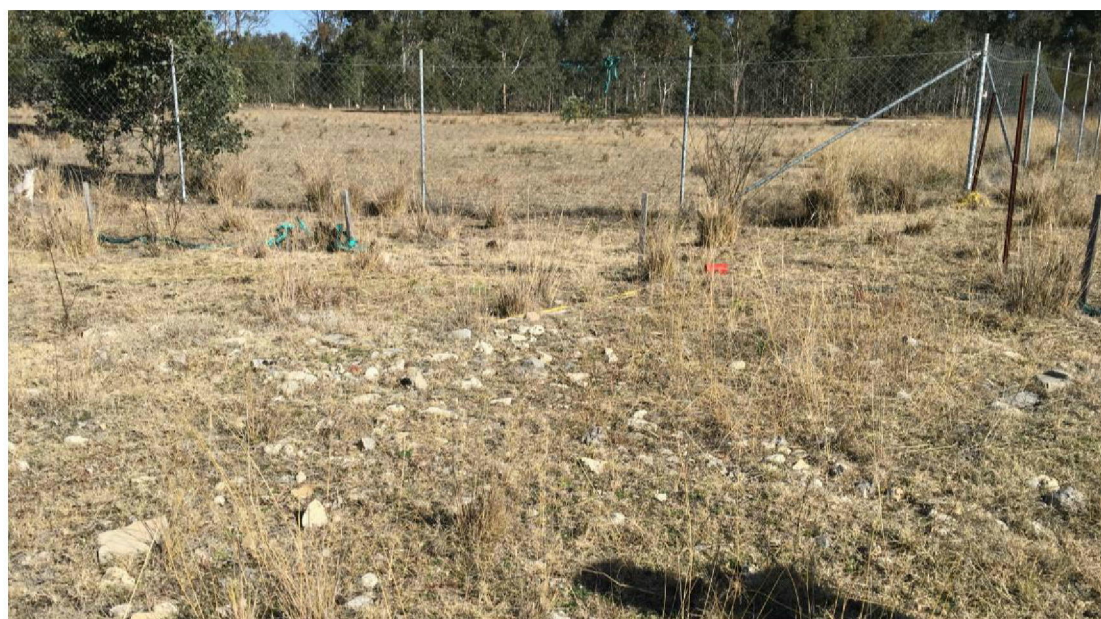
Figure 4 – Concrete Debris

Minor areas of fill material were observed on the surface of the Site. In general, the fill observed consisted of fragments of concrete and gravel scattered across the Site surface. The concrete debris observed near test pit location 7 is shown on Figure 4.

During development activities excavated material that is surplus to requirement should be disposed of to an approved facility. The surface fill and concrete debris is considered to be General Solid Waste - CT1 and the underlying natural clay is Virgin Excavated Natural Material (VENM) for disposal purposes.

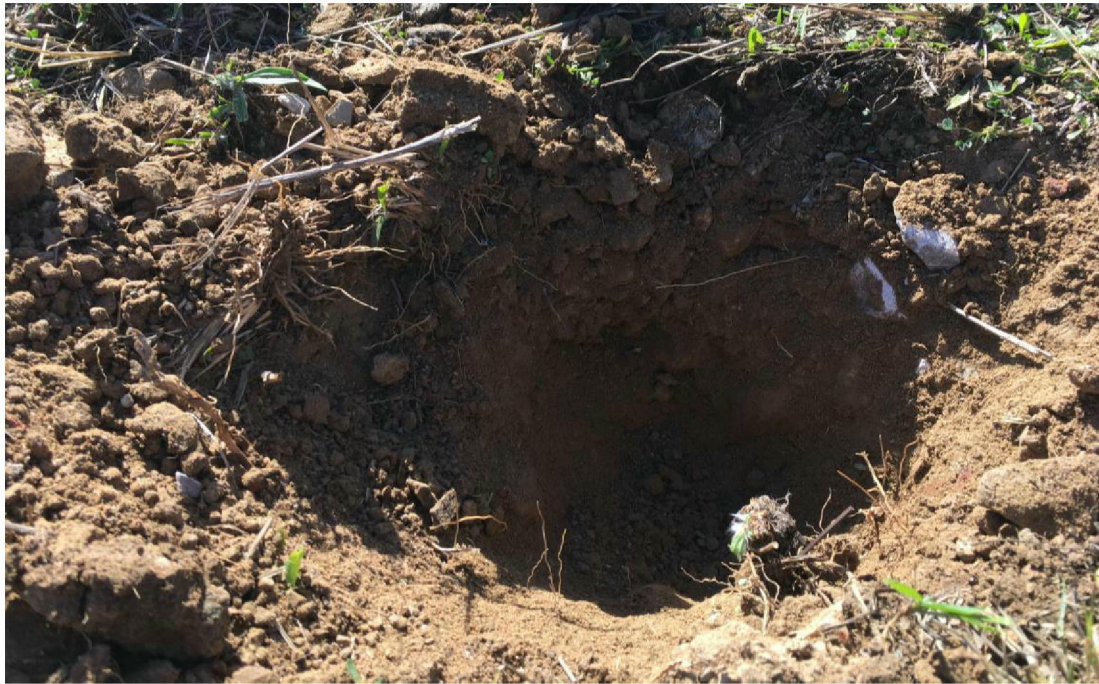
Figure 5 – Sandstone Fill

Placed fill material associated with the construction of infrastructure was observed along the northern and eastern Site boundaries. The placed fill typically appeared to be sandstone material of up to 0.1m thickness. The surface conditions encountered in the test pits are summarised in Table 5 and the sandstone fill material encountered at test pit location 3 is shown on Figure 5.
