**ROAD SAFETY ROAD SAFETY AUDIT REPORT**  
**Stage 3 - Detailed Design Stage Road Safety Audit**

**ROAD SAFETY AUDIT FOR**  
**PROPOSED RETIREMENT VILLAS**  
**LOT AND DRAINAGE WORKS**

**JORDAN SPRINGS (STAGE 2)**

Ref. 19028 RSA Stage 3

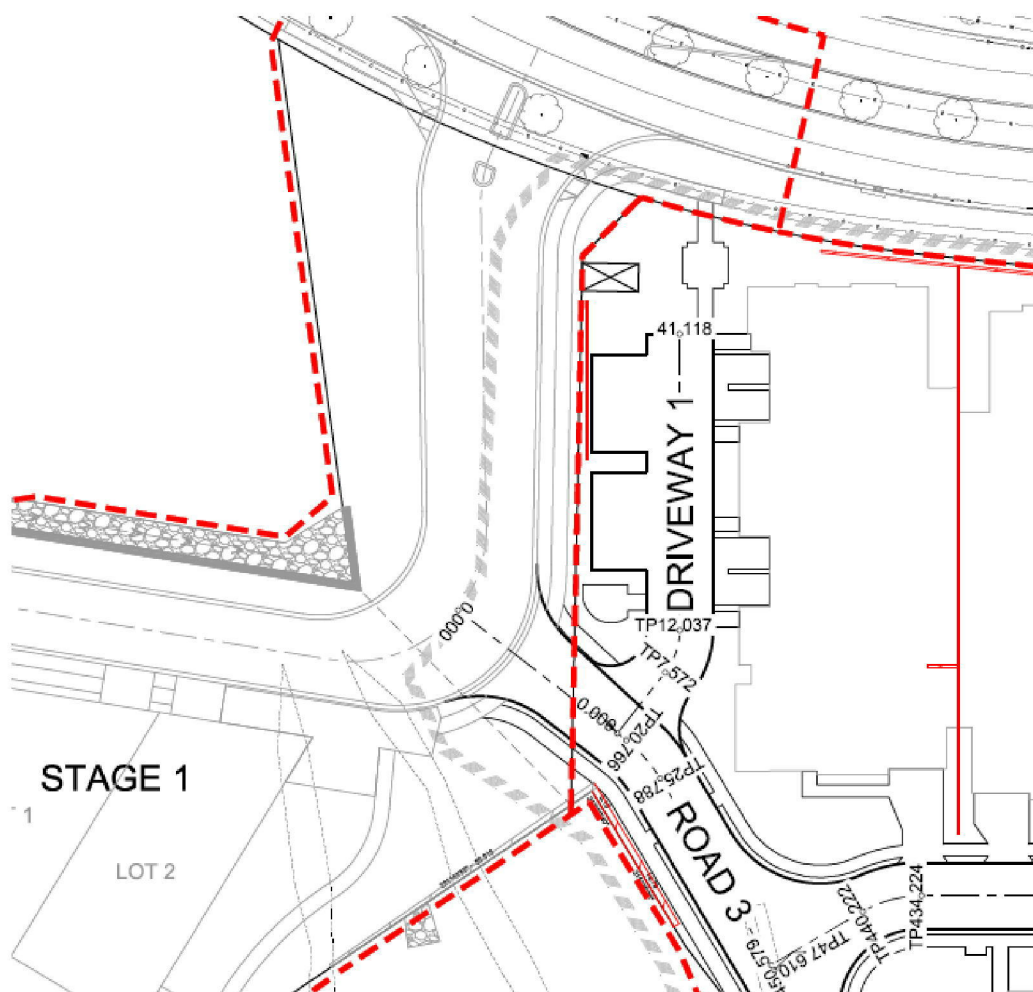
Sight lines at intersection of Road 3 and Driveway 1

The proposed T-intersection of Road 3 and Driveway 1 is located within 20m of the intersection of Road 3 / Road 1 (Stage 1). The intersection of Road 1 / Road 3 is the only entry point to the Retirement Villa Development.

Sight lines to southbound vehicles entering Road 3 from Road 1 will be limited for vehicles turning right from Driveway 1 due to the road geometry and close proximity of the intersections, which is a potential safety issue.

Consider options to improve sight distance.

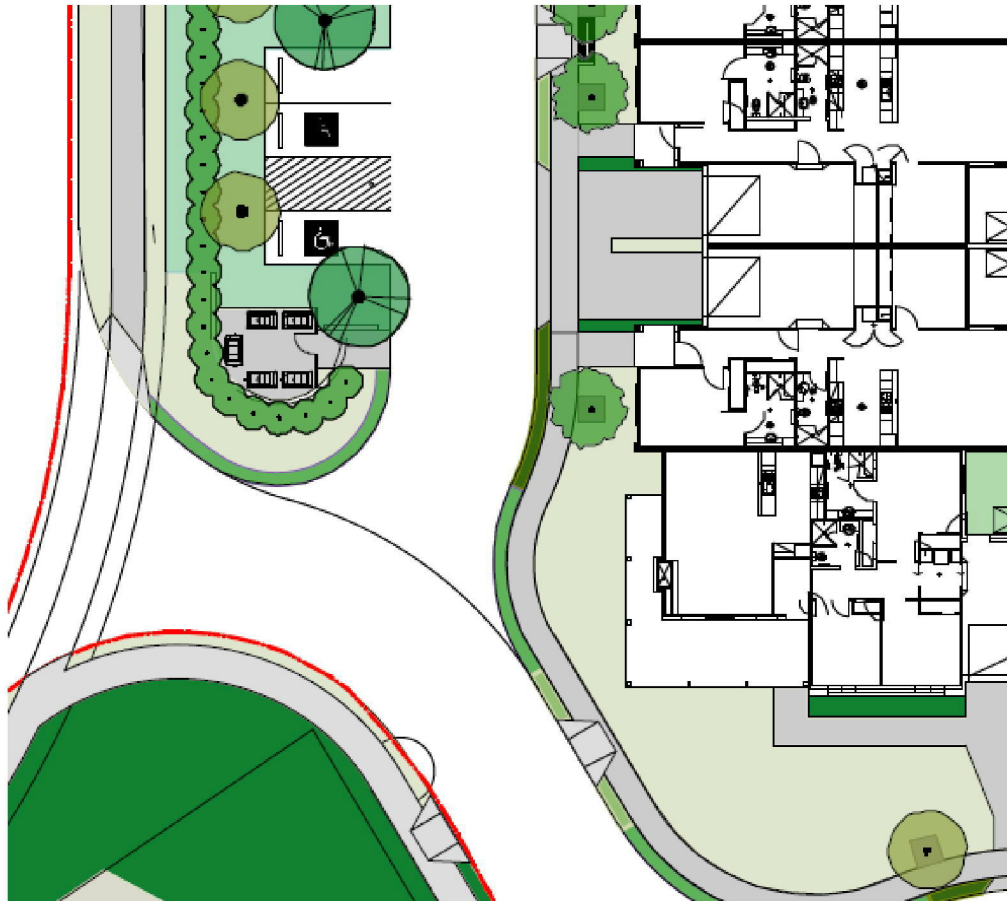
Proposed landscaping at intersection of Road 3 and Road 1

Proposed landscaping on the north eastern corner of the intersection of Road 3 / Road 1 has the potential, when mature, to obscure sightlines for vehicles turning right from Driveway 1. The proposed large shrub has a mature height of up to 5m.

If Driveway 1 remains in the current location, consider replacing proposed plantings on north eastern corner of Road 3 / Road 1 with plant species having mature height less than driver eye height or <1.2m.
