# **Limited Preliminary Site Investigation**

## **49 Gibbes Street, Regentville NSW**

**Grace Village Early Learning**

**(Ref: J001619 Limited PSI – 49 Gibbes Street, Regentville NSW 1.0)**

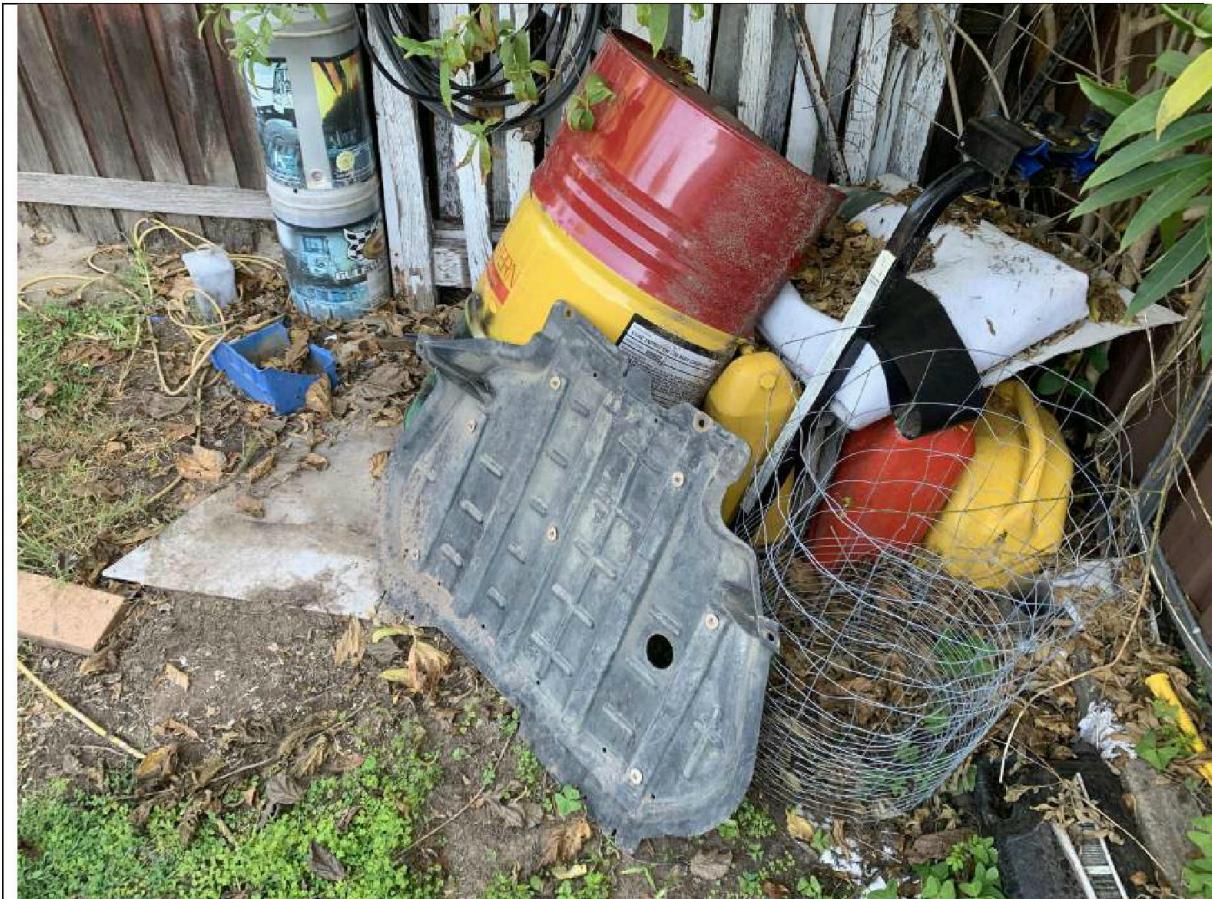
Photo 3.

Suspected ACM sheets observed near BH5. Containers potentially storing or having stored fuel or oil.

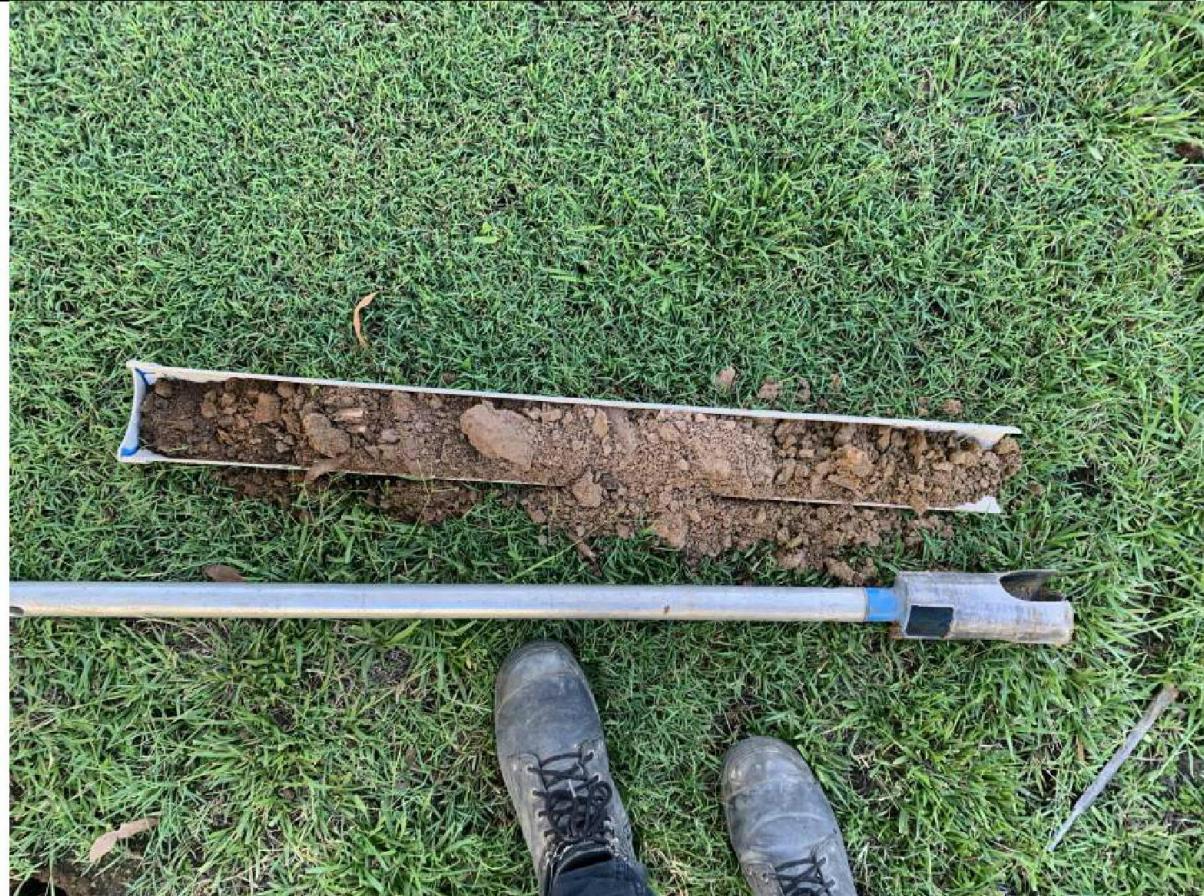
Photo 4.

Close-up of the soil profile for BH6.
