Remediation Action Plan

28-32 Evan Street, Penrith NSW

Morson Group Pty Ltd

December 2019

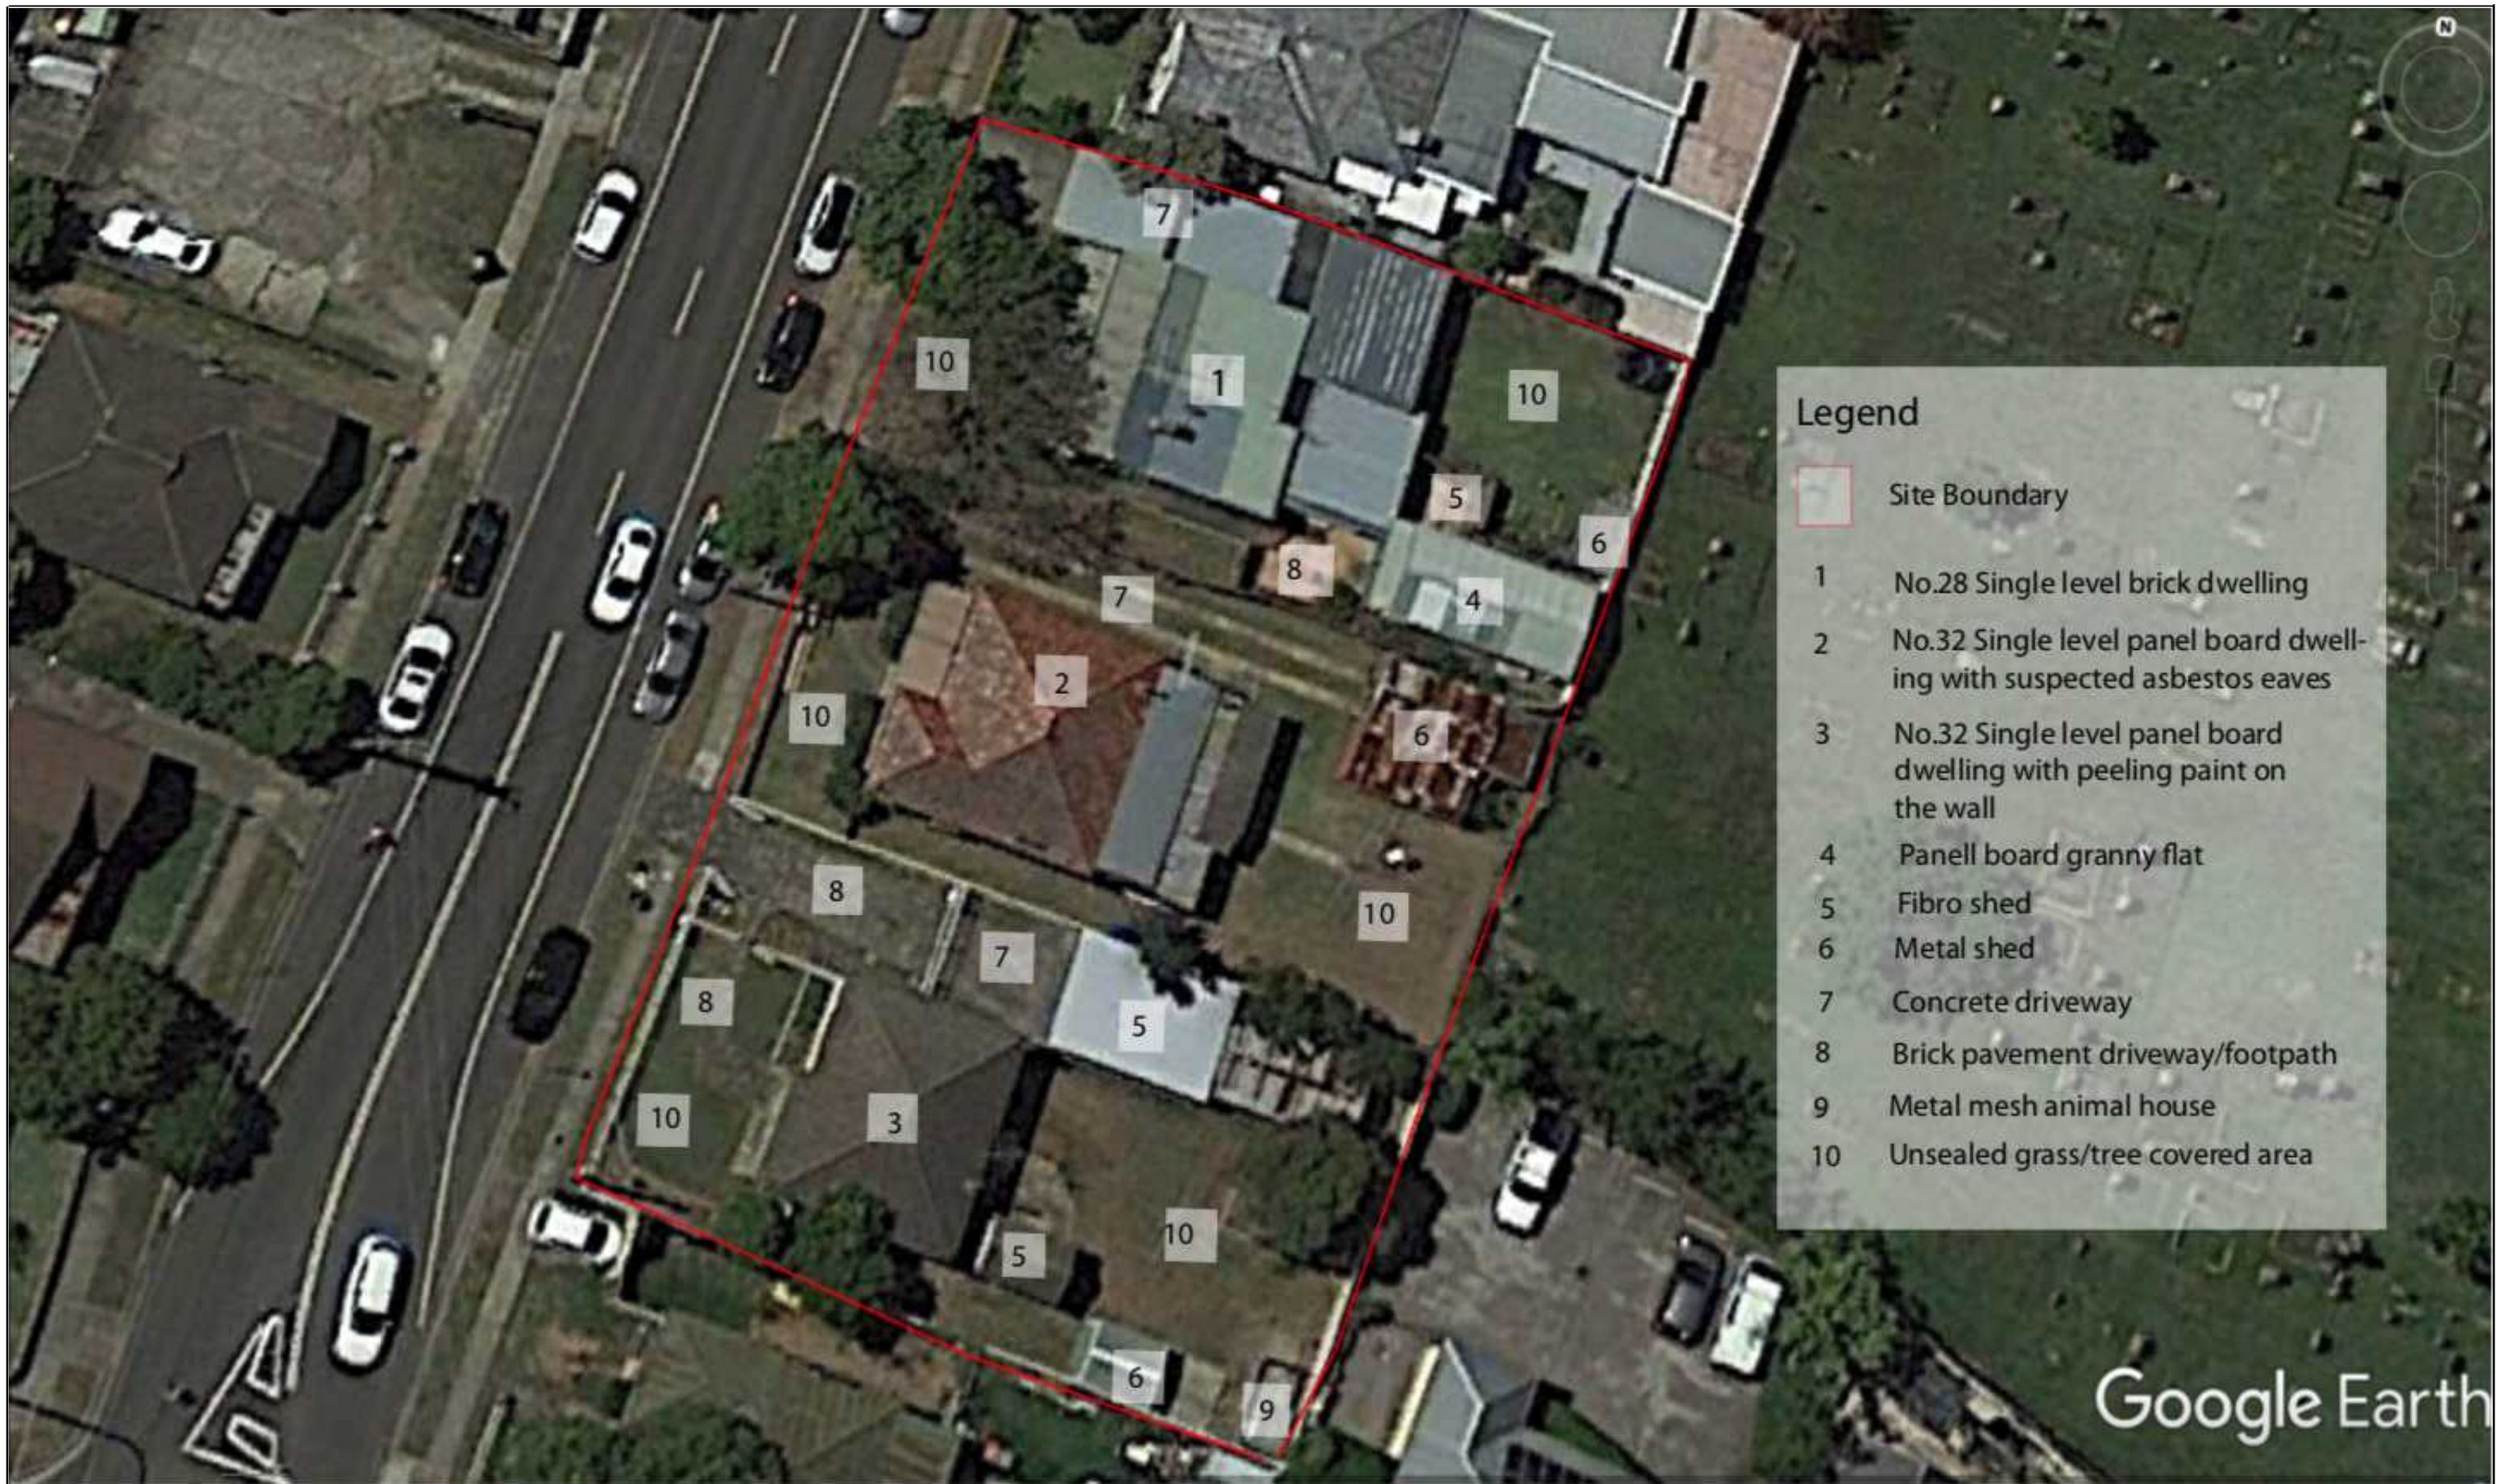
Figure 2

- Site Boundary
- 1 No.28 Single level brick dwelling
- 2 No.32 Single level panel board dwelling with suspected asbestos eaves
- 3 No.32 Single level panel board dwelling with peeling paint on the wall
- 4 Panell board granny flat
- 5 Fibro shed
- 6 Metal shed
- 7 Concrete driveway
- 8 Brick pavement driveway/footpath
- 9 Metal mesh animal house
- 10 Unsealed grass/tree covered area
