DETAILED SITE CONTAMINATION INVESTIGATION

**11a Canopus Close
ERSKINE PARK NSW 2759**

REPORT NUMBER: 11538.02.TSCA

DATE OF REPORT: 3 May 2021

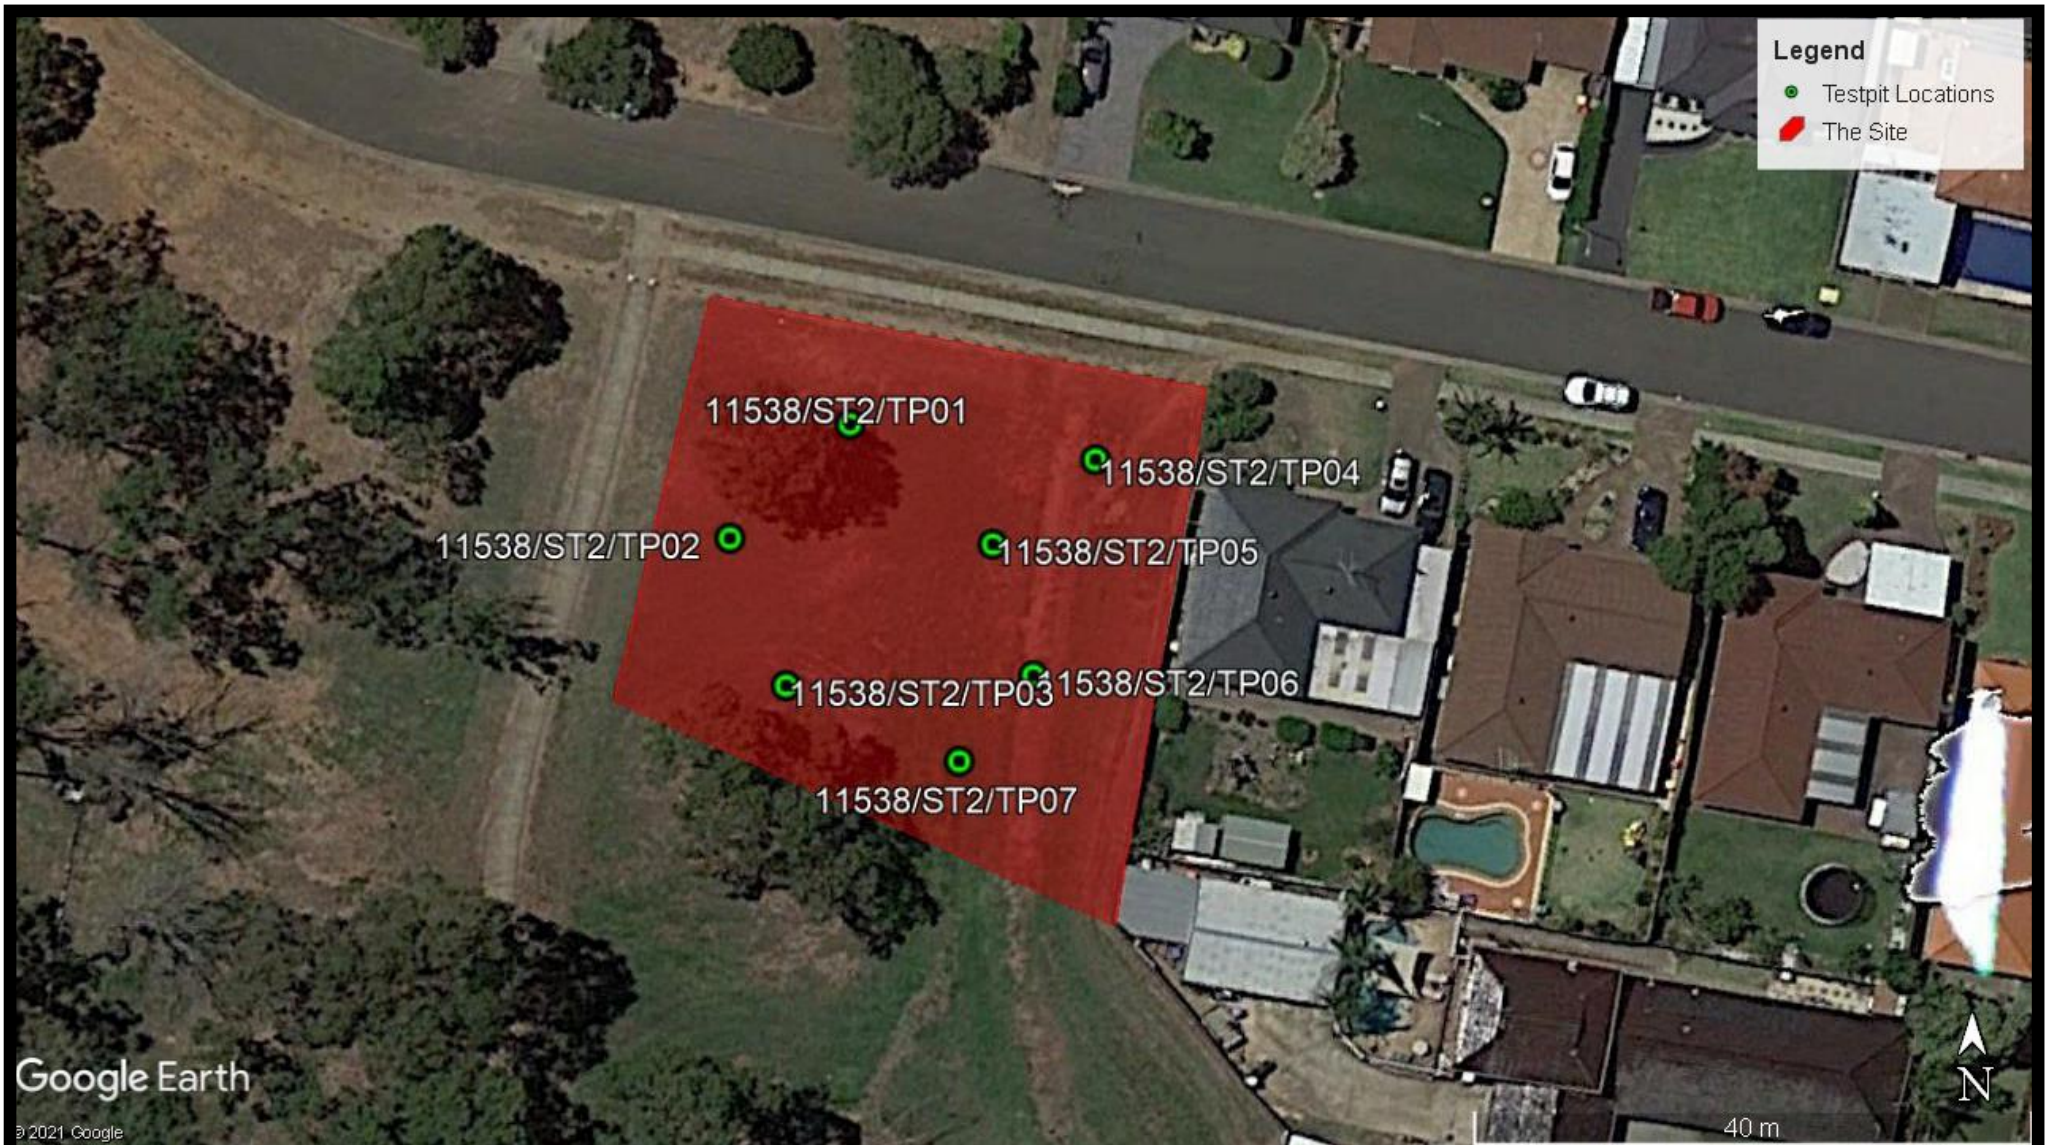
Figure 2: Site Map
 11a Canopus Close, ERSKINE PARK NSW 2759

The following table lists potential contaminants based on site activities and conditions identified during the site historical review and walkover inspection (refer to Sections 5 to 7). Refer to **Appendix I** for Site Map of the sources.
