Geotechnical Investigation Report

Proposed Retirement Village (51 Villas)
Lot 3991 of DP 1190132, Jordan Springs Boulevard, Jordan Springs,
NSW 2747

Report Number: 6715-GR-1-2-Rev A

Report Date: 30th May 2018

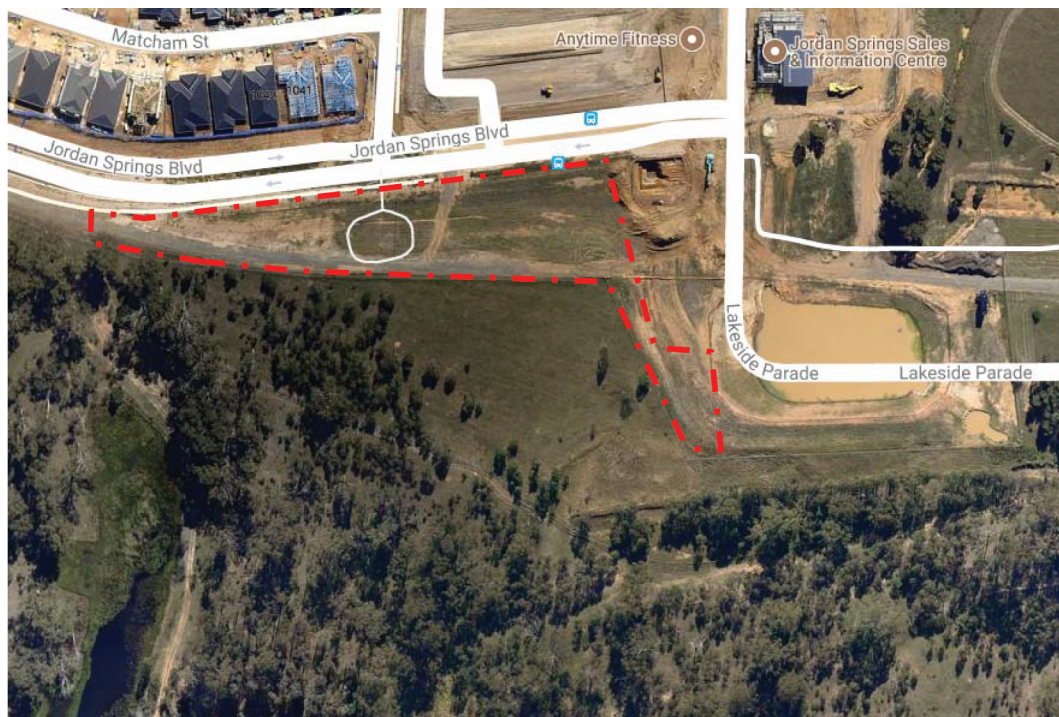
Figure 2- The earthwork in the site during Jordan Springs Bulverde construction in 2011– Extracted from Nearmap

A portion of the site has been filled with fill material during the roadworks during the construction of Jordan Springs Bulverde. This area is marked with red line in Figure 2.

Based on the subsurface profile encountered in the excavated test pits (as summarised in Section 4) and DCP tests, the preliminary assessment indicates the site is mainly underlain by alluvial and residual soils. It has been confirmed during test pit investigation that the area with fill material is just limited to the northern side of the site as is illustrated in Figure 2.

The existing fill which has been placed as a part of Jordan Spring Bulverde road construction works, has been assessed as a well-compacted fill referring to AG's DCP tests.
