Heritage Impact Statement

Demolition works and construction of an industrial warehouse building
34-36 Preston Street, Jamisontown

June 2020
EHC2020/0124

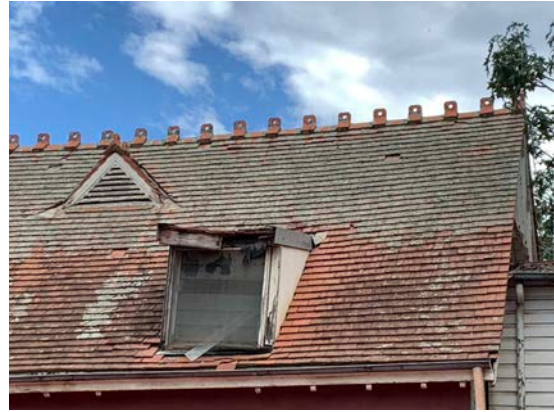
Figure 10: View of the eastern roof plane and dormers.

- Failure of rainwater goods;
- Extensive microbial growth on the terracotta shingle roof cladding, with evidence of localised failure of individual shingle tiles and water penetration.

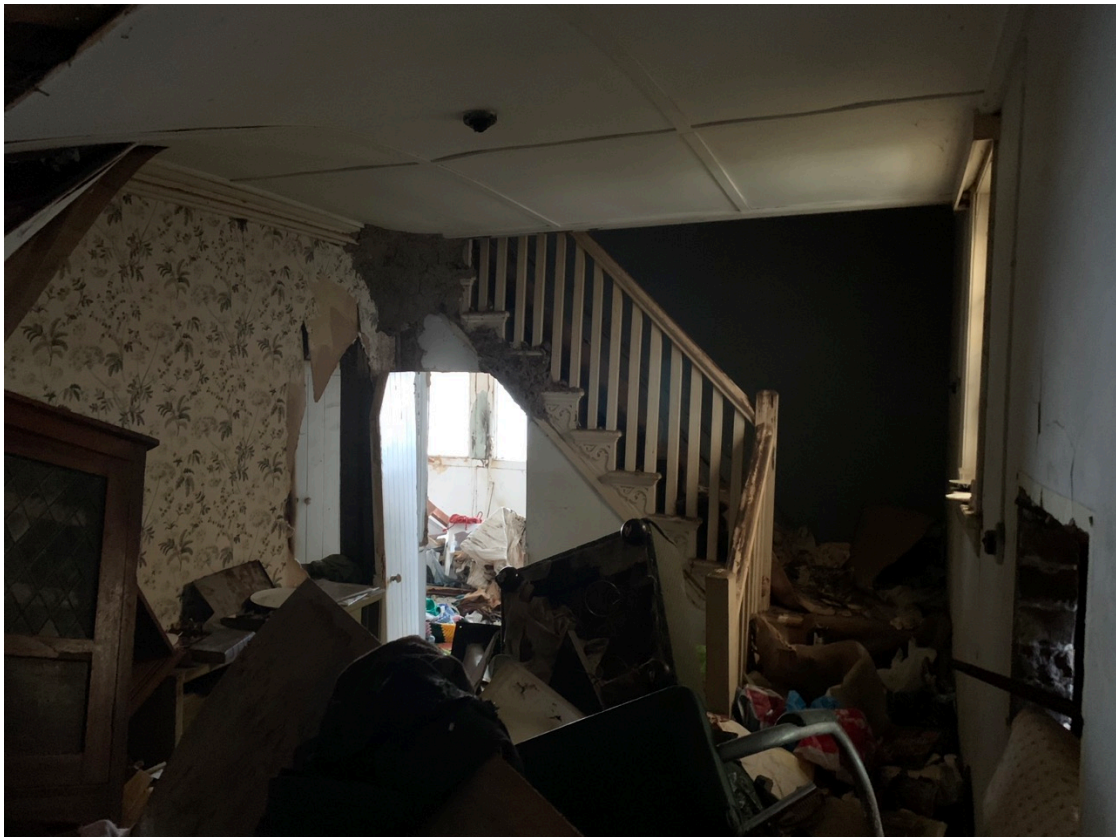
Figure 12: View of the former church sanctuary on the ground floor

Owing to the present condition of the building and its interior, internal inspection of the building was severely limited. Notably, the failure and collapse of the first floor flooring system and the mass accumulation of personal effects and detritus, presented a very high occupational health and safety risk and hazard and so entry was deemed unsafe.

Internal stair access is provided in two locations: a timber framed staircase within the former church sanctuary area and a timber staircase with iron balustrade within the later additions on the northern elevation.

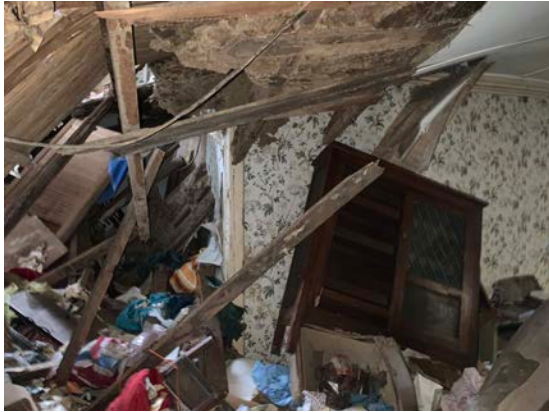
Figure 13: View of the collapsed first floor.

- Extensive vandalism to the building generally, with the loss of architectural elements, malicious damage to fabric and graffiti;
- Failure and collapse of the timber flooring system of the first floor;
- Evidence of extensive previous termite activity and damage to timber fabric;
- Missing timber louvres to the gablet on the western roof plane;
- Partial collapse of the gabled roof form with visible sagging;
- Evidence of differential settlement with 'staircase cracking' to masonry walls in multiple locations;

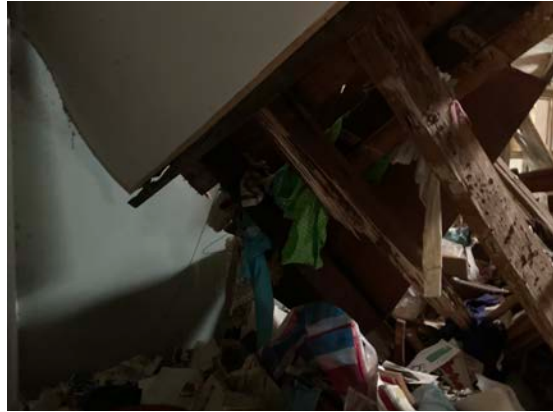
Figure 14: View of the collapsed first floor.

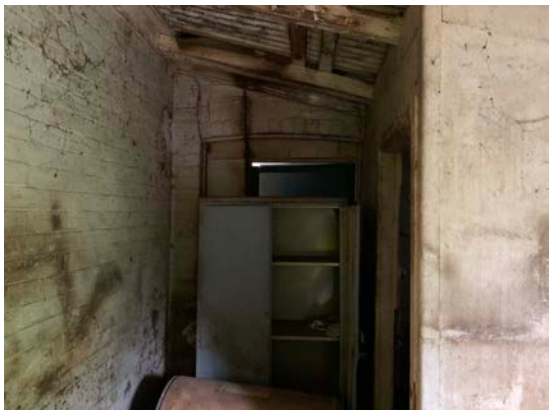
Figure 17: View of the semi-enclosed verandah on the western elevation, looking through to the remnant original brick vestry.

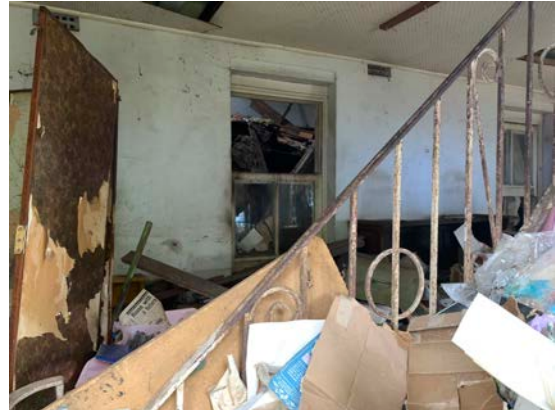
Figure 20: View of the ground floor on the northern elevation, showing the internal stair access to the first floor and masonry wall of the original church building.

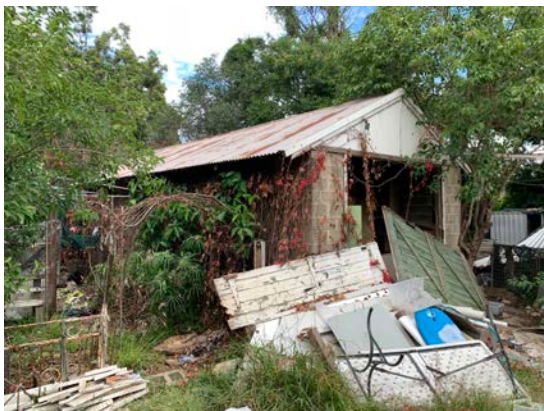
Figure 21: View of the detached garage structure.

Situated at the southern rear elevation of the building, is a detached garage structure, of concrete block construction, with a low-pitched timber framed roof and corrugated sheet metal cladding. An additional shed structure is located towards the southwestern corner of the site.

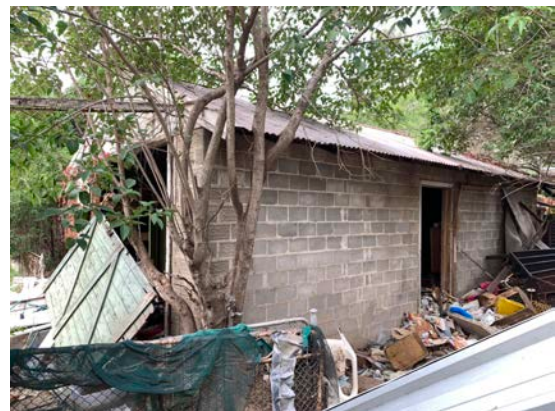
Figure 22: View of the detached garage structure.

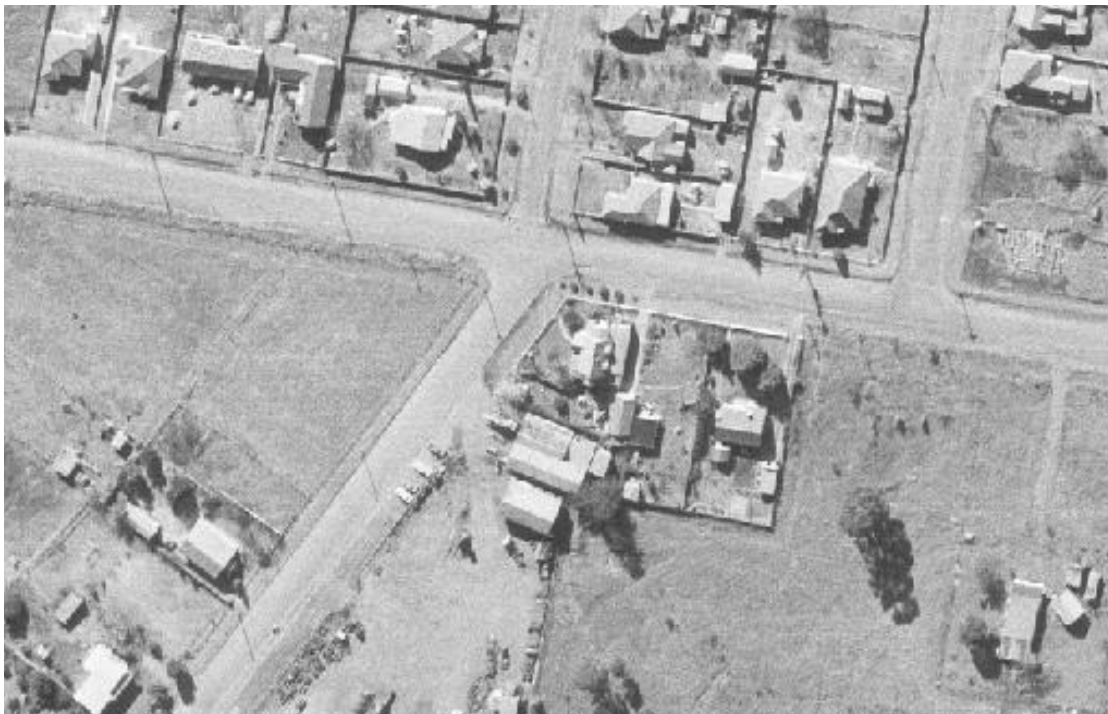
Figure 37: Aerial view of the site in January 1970, showing the mid-20th century residential additions. [Source: NSW Land and Property Information, 2020]

Around this time, it is likely that a new garage structure was built in the southeastern corner of the land. It is also likely that Grace, Jean and Phyllis Jones were responsible for establishing the landscaped gardens around the property during their tenure, with the planting of additional trees and shrubs.

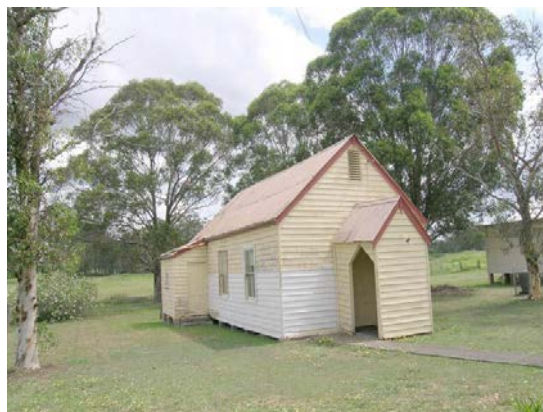
Figure 47: St David's Anglican Church. [Source: NSW State Heritage Inventory, 2020]

Consideration	Response	Similar ✓/X
Class of building	Church	✓
Level of significance	Local	✓
Date of construction	1899	X
Context	Rural	X
Design integrity	Highly intact	X
Condition	In reasonable repair and condition	X
Use	Church (disused)	✓
Architectural Style	Federation ecclesiastical vernacular	X
Materiality	Timber frame with weatherboard cladding, corrugated sheet metal roof	X
Scale	Small rural church	✓
Architectural form	Rectangular form with front entry and side vestry, gabled roof.	✓

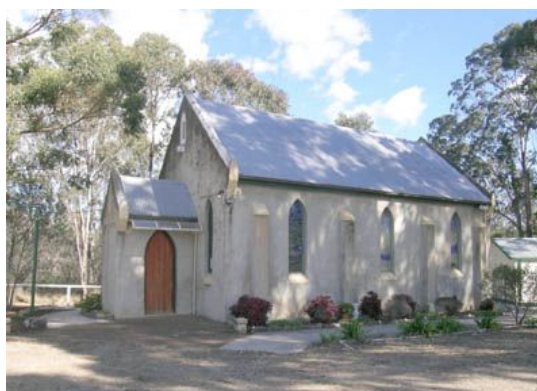
Figure 48: Luddenham Uniting Church. [Source: NSW State Heritage Inventory, 2020]

Consideration	Response	Similar ✓/X
Class of building	Church	✓
Level of significance	Local	✓
Date of construction	1886	X
Context	Rural	X
Design integrity	Highly intact with some cosmetic changes	X
Condition	In good repair and condition	X
Use	Church (in use)	X
Architectural Style	Late Victorian Gothic Revival	X
Materiality	Rendered brick walls with corrugated sheet metal roofing	X
Scale	Small rural church	✓
Architectural form	Rectangular with front entry, lancet windows, gabled roof form	X
