Maryland Development Company Pty Ltd
Remedial Action Plan for Basin C and V6

St Marys Development Site, NSW

20 November 2019

57591/ 125864 (Rev 0)

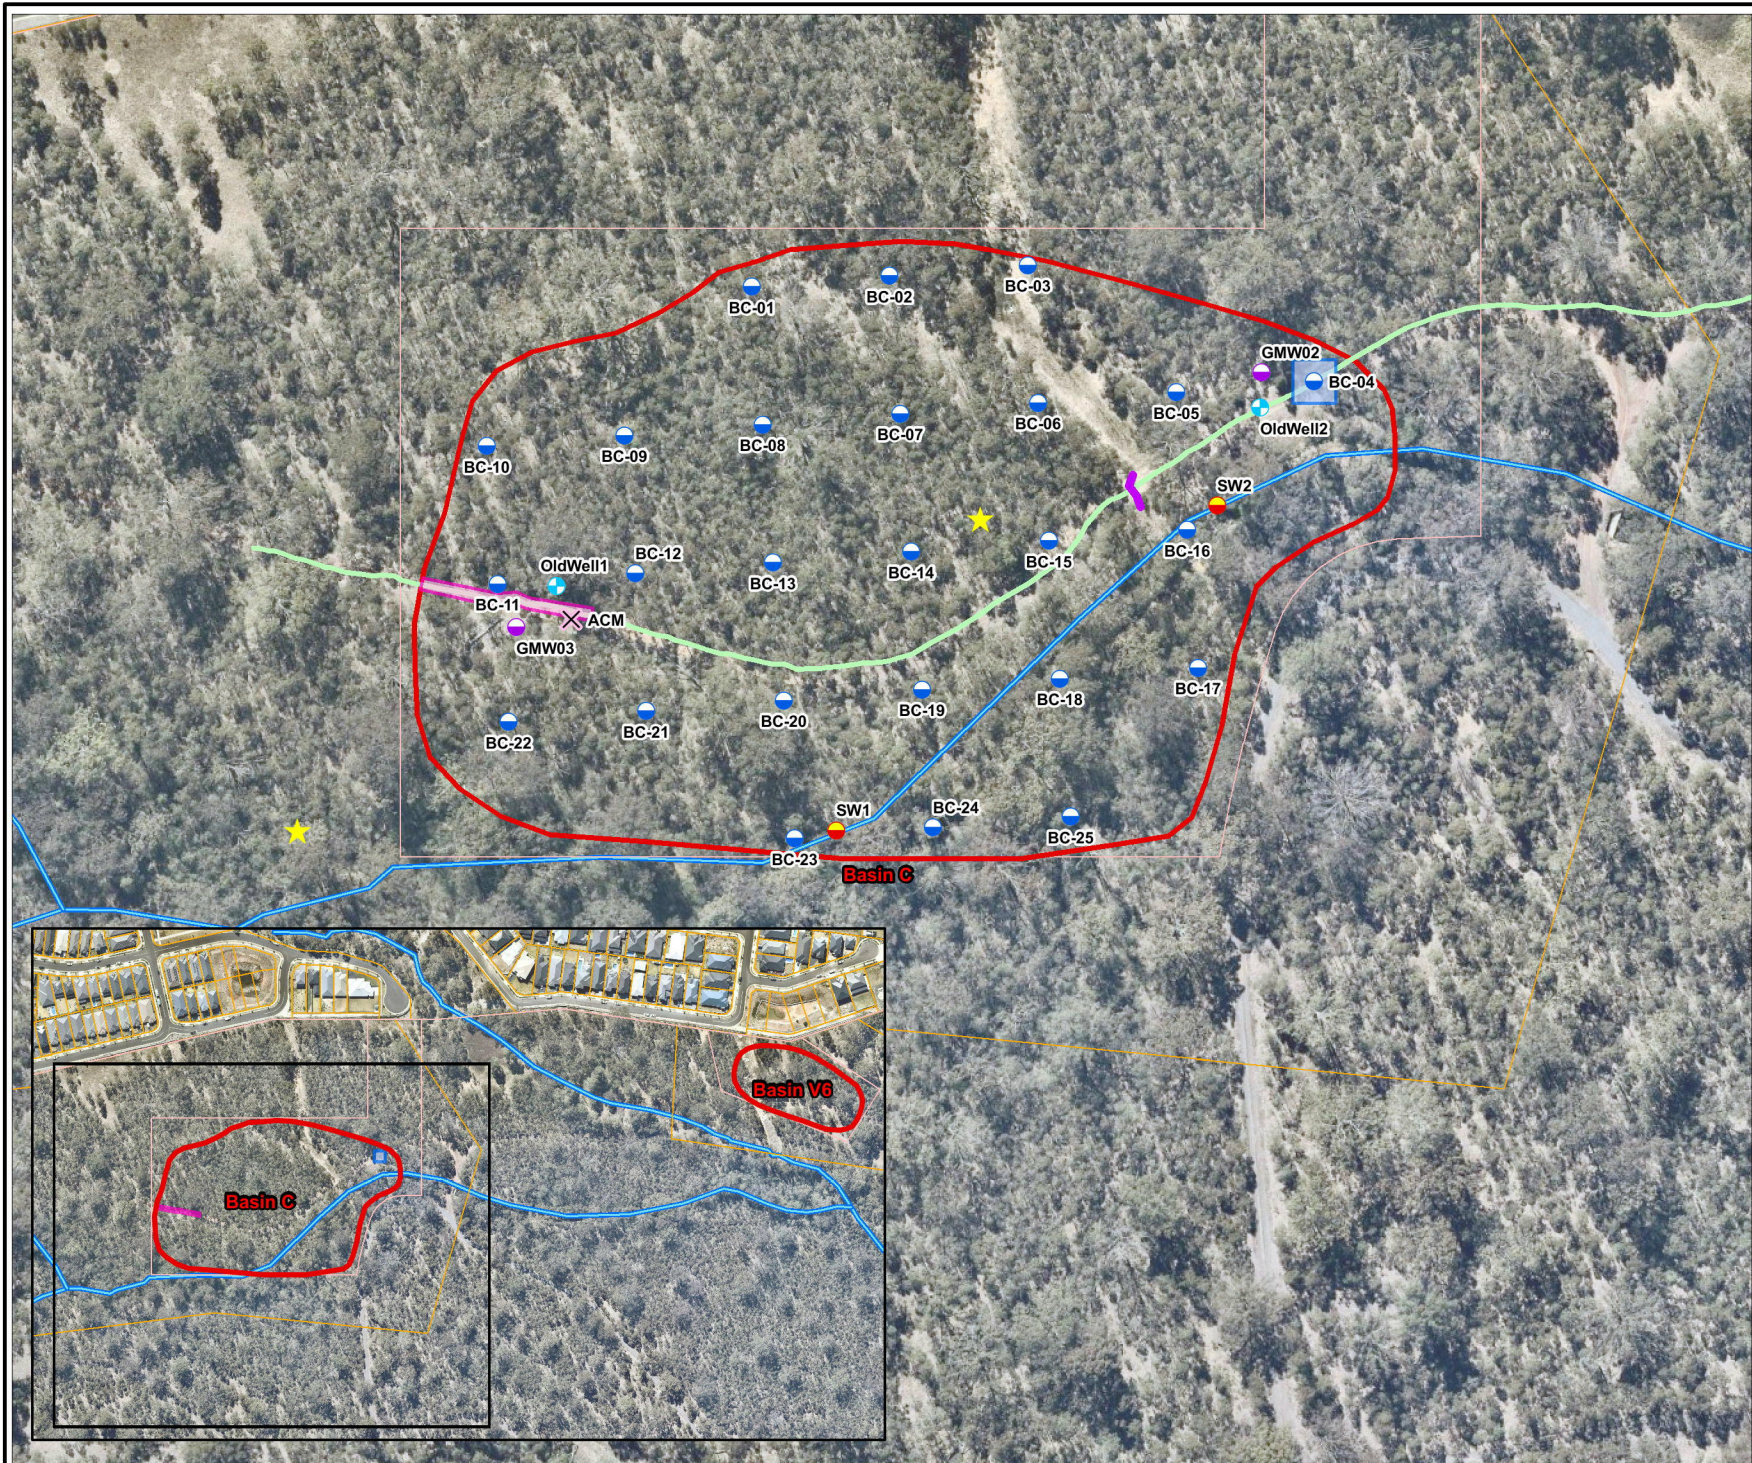
- Legend:**
- Approximate Site Boundary
 - Cadastre (NSW LPI, 2019)
 - Proposed Cadastre
 - South Creek Tributary
 - ★ Aboriginal Heritage Sites
 - Access Road
 - Drainage Culvert
 - Sample Locations
 - Groundwater Monitoring Wells
 - Surface Water Locations
 - ⊕ Old Groundwater Monitoring Wells
 - ✕ ACM Fragments
- Approximate Areas of Impact**
- Asbestos Impact
 - B(a)P/B(a)PTEQ and TRH Impact

Asbestos containing materials (ACM) consisting of fragments of non-friable ACM were identified within the western portion of the access track within the Basin C location. Approximately 5 to 10, 2-5 cm fragments were identified at the surface of the access track within the areas shown on **Figure 3**.

- Asbestos impacted fill materials - identified in the western portion of the Basin C access track as identified on **Figure 3**. An approximate volume of 100 m³ asbestos impacted fill is estimated;

The approximate lateral extent of PAH and asbestos impacted areas are shown on **Figure 3**. However, the final lateral and vertical extent of remediation required in these areas will be contingent upon visual/olfactory observations, and validation sampling.

The following remediation works shall be undertaken on impacted soils identified at location BC04 within the area shown on **Figure 3**:

The following remediation works shall be undertaken on asbestos impacted soils identified within the western portion of Basin C area shown on **Figure 3**:
