Legacy Property  
Environmental Site Assessment Report

Stage 2 Development  
Caddens, NSW

27 October 2016

52116-105322

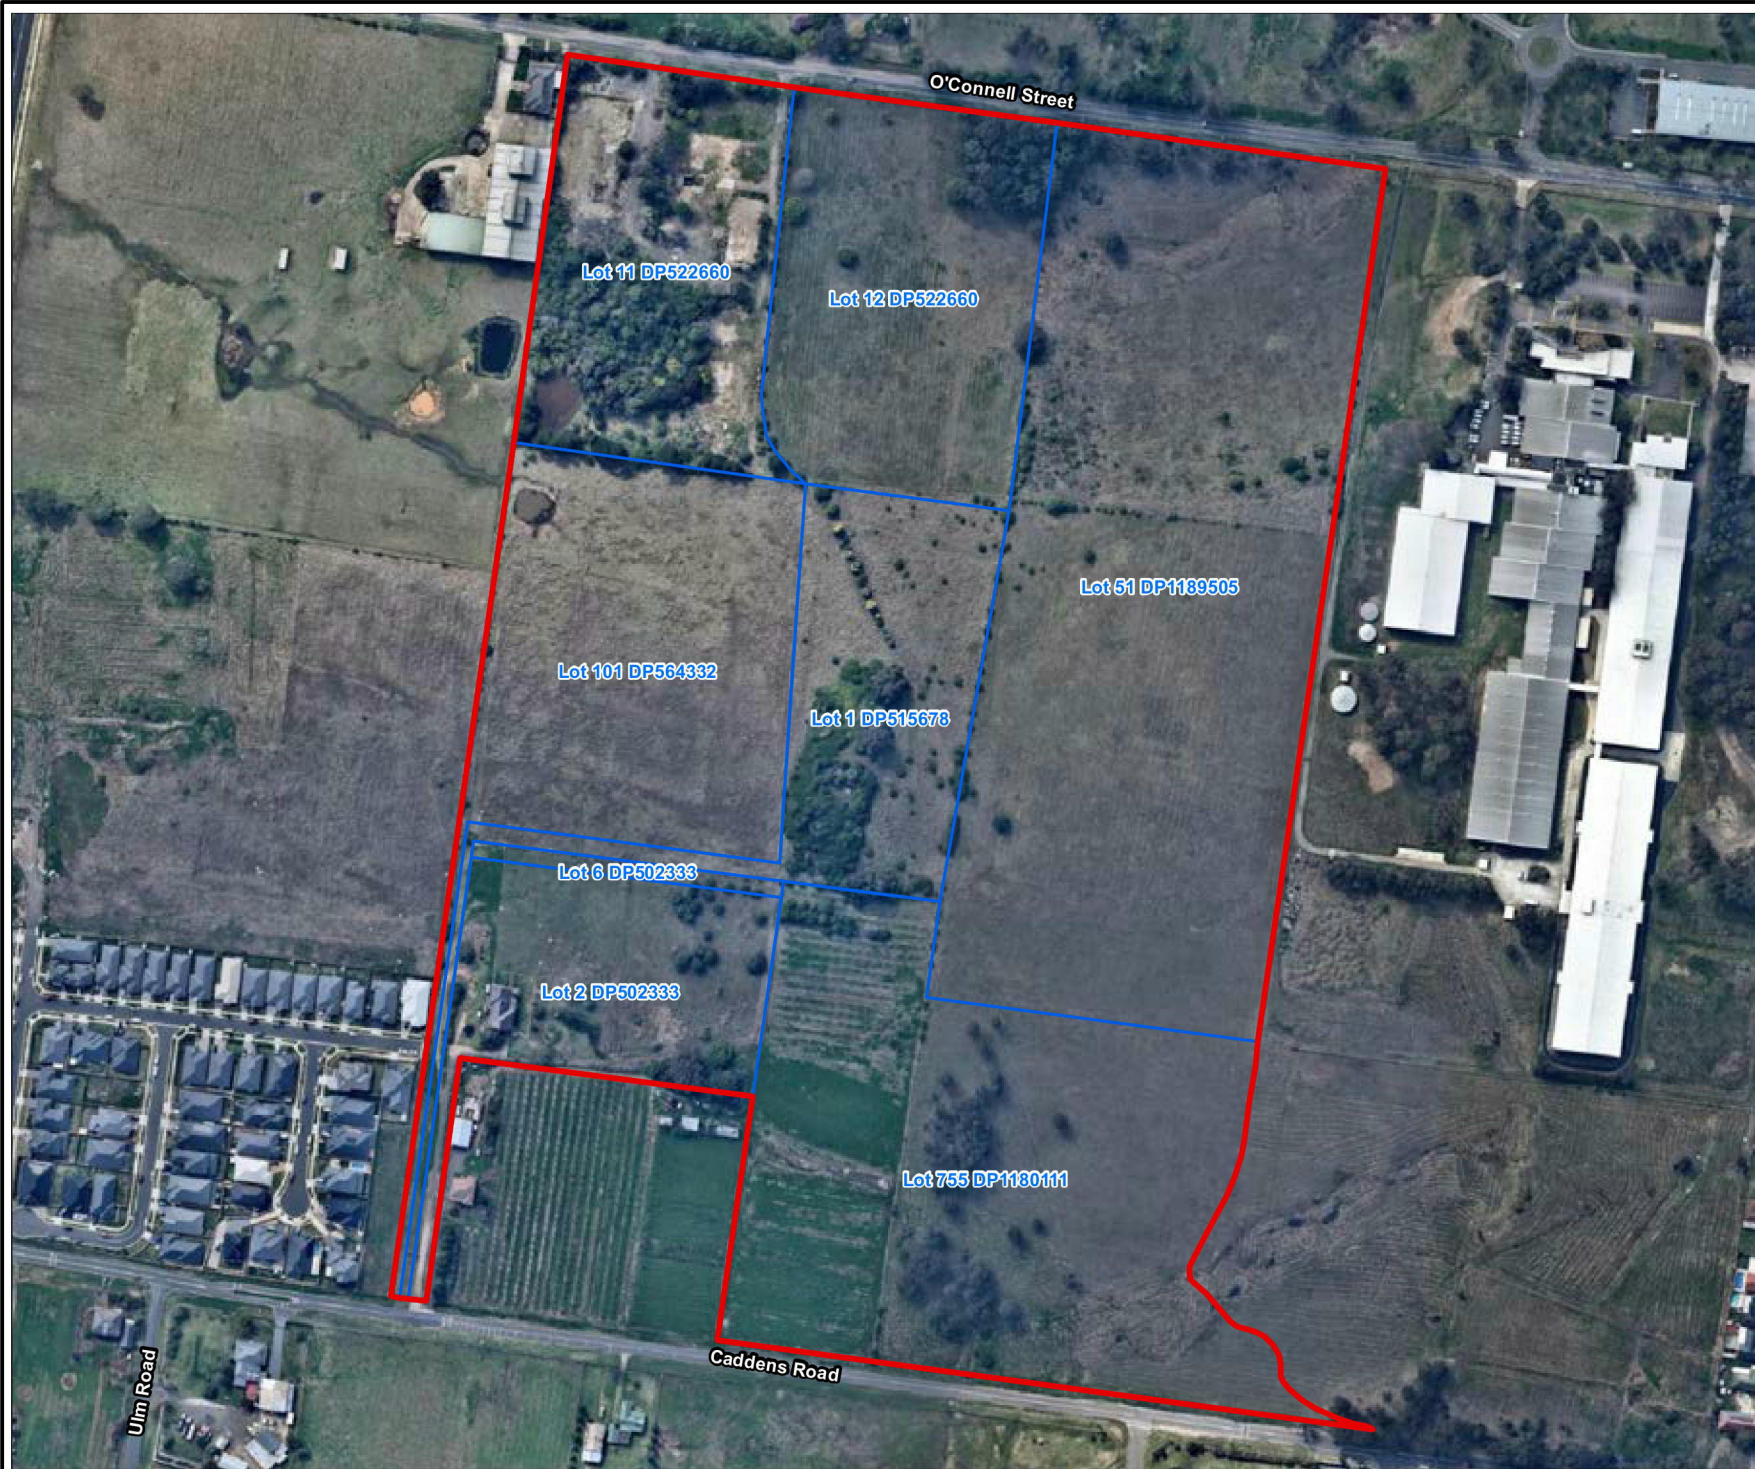
**FIGURE 2**

**SITE LAYOUT**

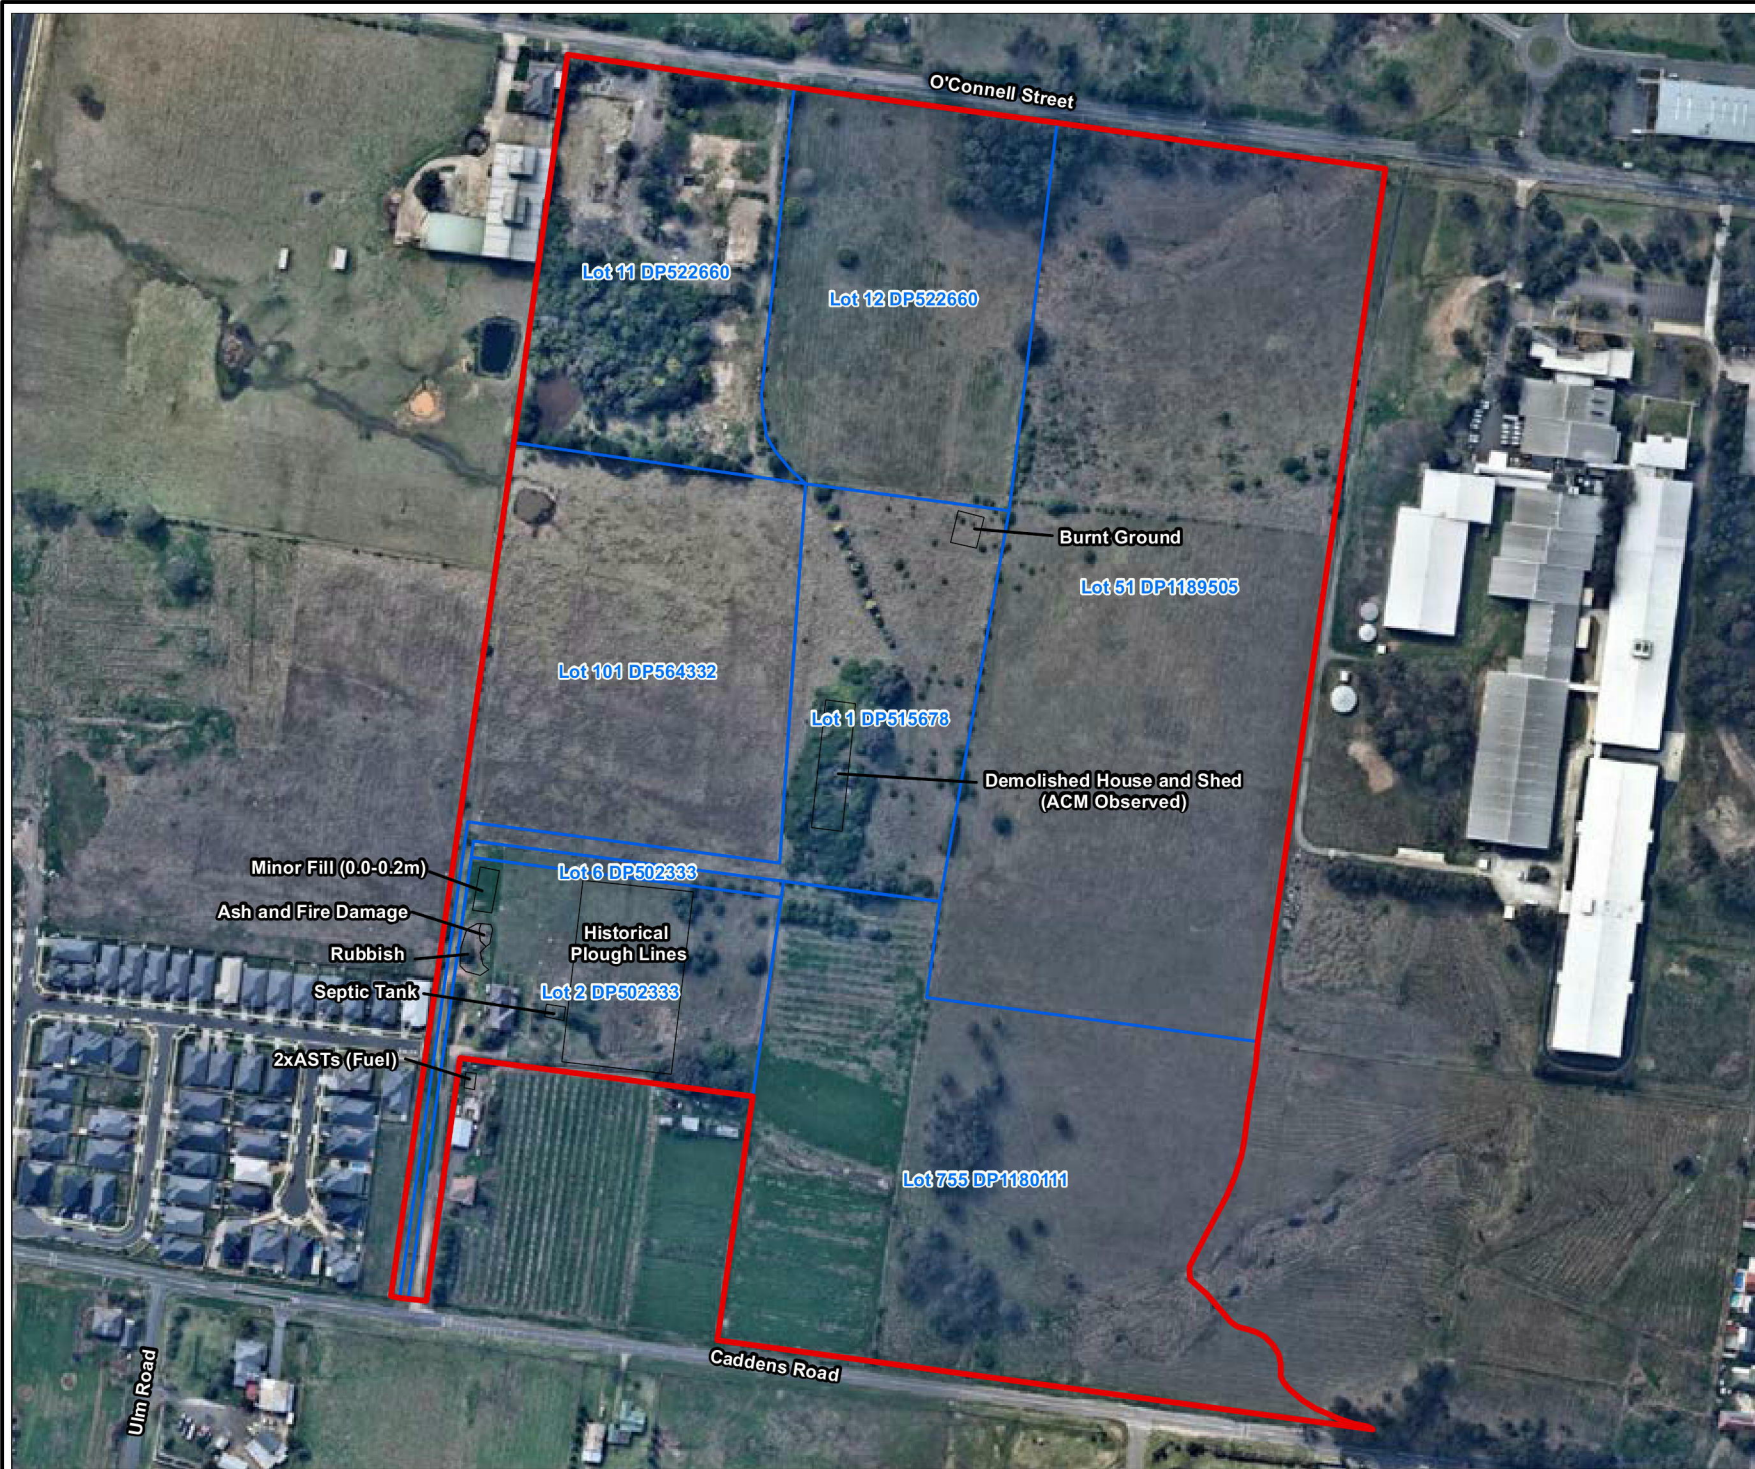
**FIGURE 3**

Surficial ACM was observed at some locations within the rubble from an historical demolition of onsite structures as indicated on **Figure 3**. Odourous surficial soil was observed within the vicinity of the septic tank identified to the east of the residence on Lot 2.

Visible ACM in the form of fibre cement fragments were observed in the vicinity of the demolished residential building. This poses an unacceptable aesthetic issue which will require management prior to the site being utilised for the proposed land use.

**SITE FEATURES**

For the overall site, and based on the scope of work completed for this assessment and subject to the limitations in **Section 8**, it is recommended that work, health, safety and environmental management controls (including protocols to manage unexpected finds) should be implemented during any future ground disturbance works.

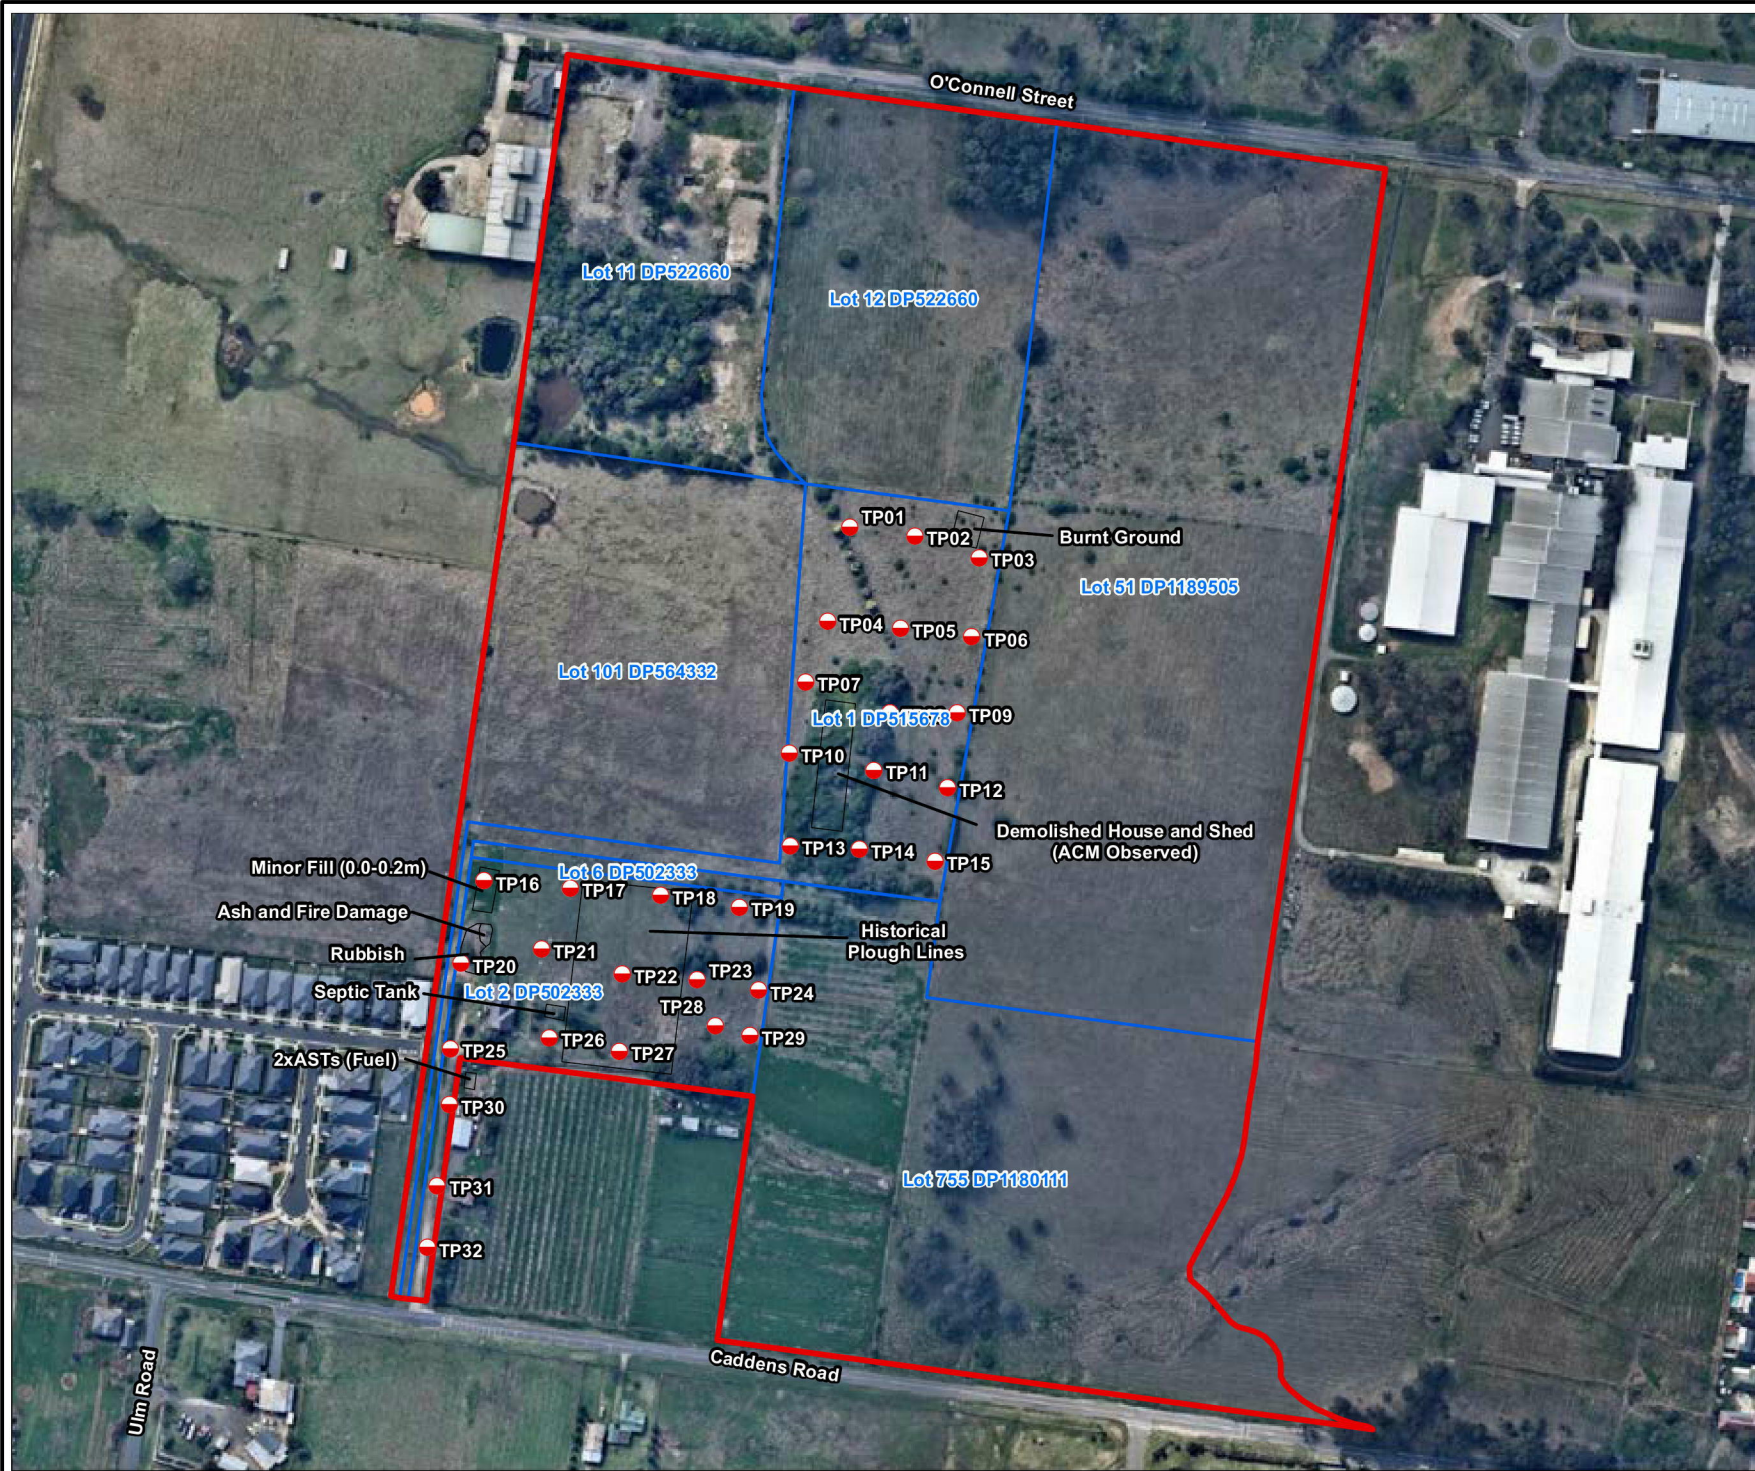
A summary of soil conditions present at the site is presented as follows. A total of 31 test pits and one hand auger borehole were advanced from the ground surface to natural material. Test pits generally encountered natural clays and silty clays at the ground surface with the exception of three locations. At two locations (TP13 and TP16) shallow fill (0.2 m bgs) was encountered and at one location (TP26) deep fill was encountered (0.8 m bgs). Fill material at all three locations encountered was the result of anthropogenic items mixed with natural soils being laid in small stockpiles, slightly elevated from the surrounding ground surface. No burial of fill material was encountered at any of the test pit locations. Fill material generally comprised site won natural materials (clayey silts and silty clays varying in colour, primarily brown, red and orange with low to no plasticity and varying in consistency from soft to hard) silty clay with inclusions of anthropogenic materials in the form of bricks, tiles, sandstone, concrete cobbles, glass, igneous gravels and concrete boulders. No ACM, odours or staining was observed within the soil profile at any investigation location.

Bonded ACM was observed on site surfaces during investigation within the vicinity of the demolished residential structure present on Lot 1. An asbestos fragment was also detected in the surface soil sample submitted for analysis from location TP16 0-0.1 on Lot 2.

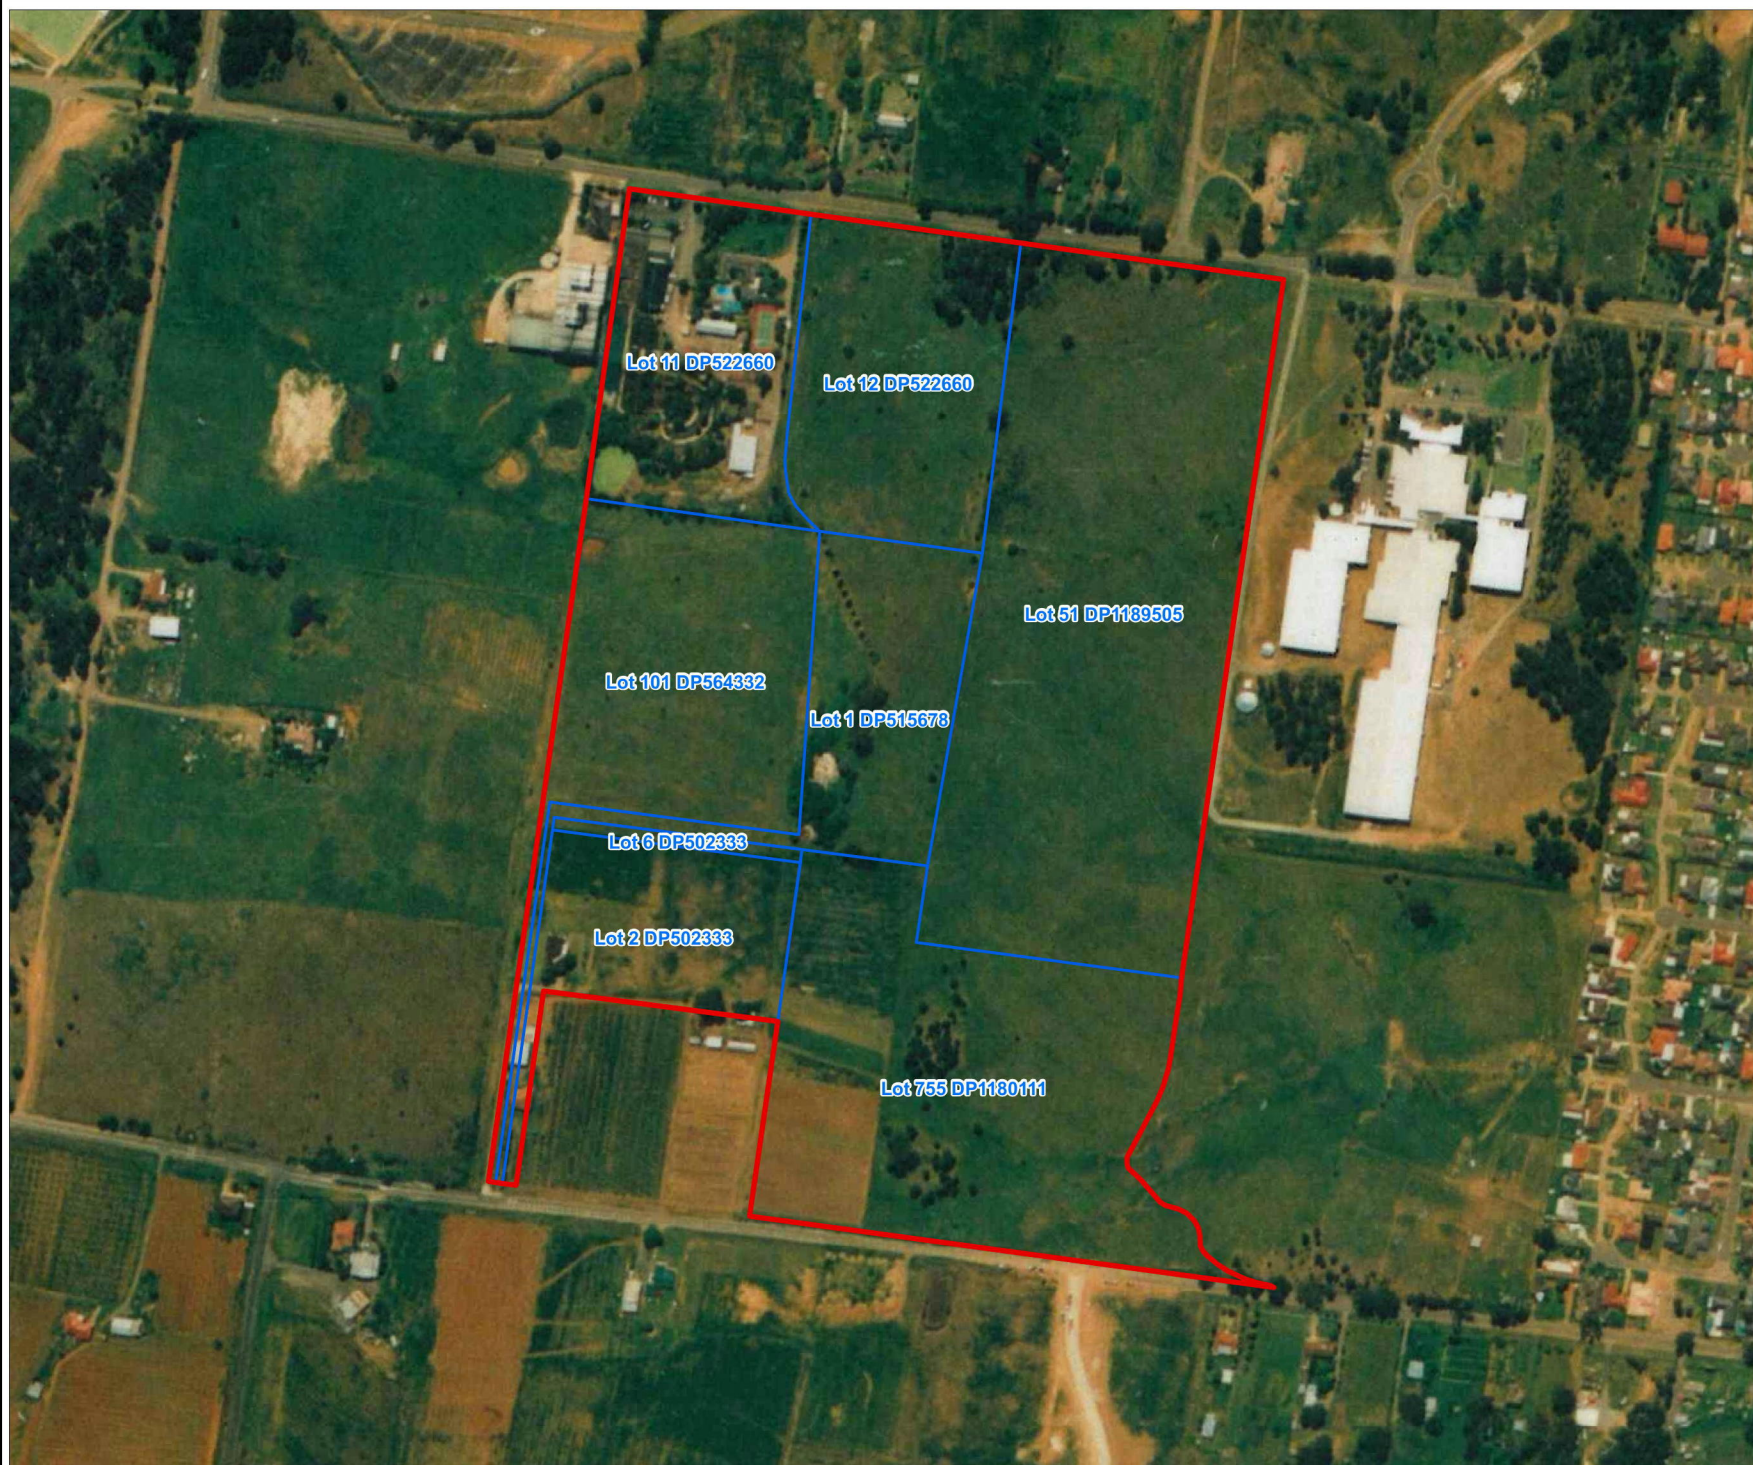
**AERIAL PHOTOGRAPH 1986**

1986	Similar to 1978, although the garden centre on Lot 11 now appears to operate over the whole lot, and the eastern area of Lot 2 appears to be under active cultivation.	The footprint of the State Archives development has been expanded, and the building west of Lot 11 has been enlarged.
1998	Similar to 1986, although the dwelling on Lot 1 appears to have been demolished.	The footprint of the State Archives has been further expanded. The cultivated fields south of Lot 2 has been replaced by orchard plantings on the western half.
2011	Similar to 1998, however, active cultivation on Lot 2 has reduced.	The footprint of the State Archives has been further expanded.
2014	There appears to be no orchards or cultivated fields within the site, and the area is likely to be used for grazing only. The garden centre on Lot 11 appears inactive.	Similar to 2011, however, the area west of Lots 2 and 6 has been or is the progress of being developed for residential uses.
