**PROPOSED RESIDENTIAL SUBDIVISION  
LOTS 11 & 12 IN DP522660 AND PART LOT 101 IN DP564332  
O'CONNELL STREET AND CADDENS ROAD  
ORCHARD HILLS (KINGSWOOD)**

**DETAILED CONTAMINATION ASSESSMENT & REMEDIAL ACTION PLAN**

**REPORT NO 12486/2-AA    10 OCTOBER 2011**

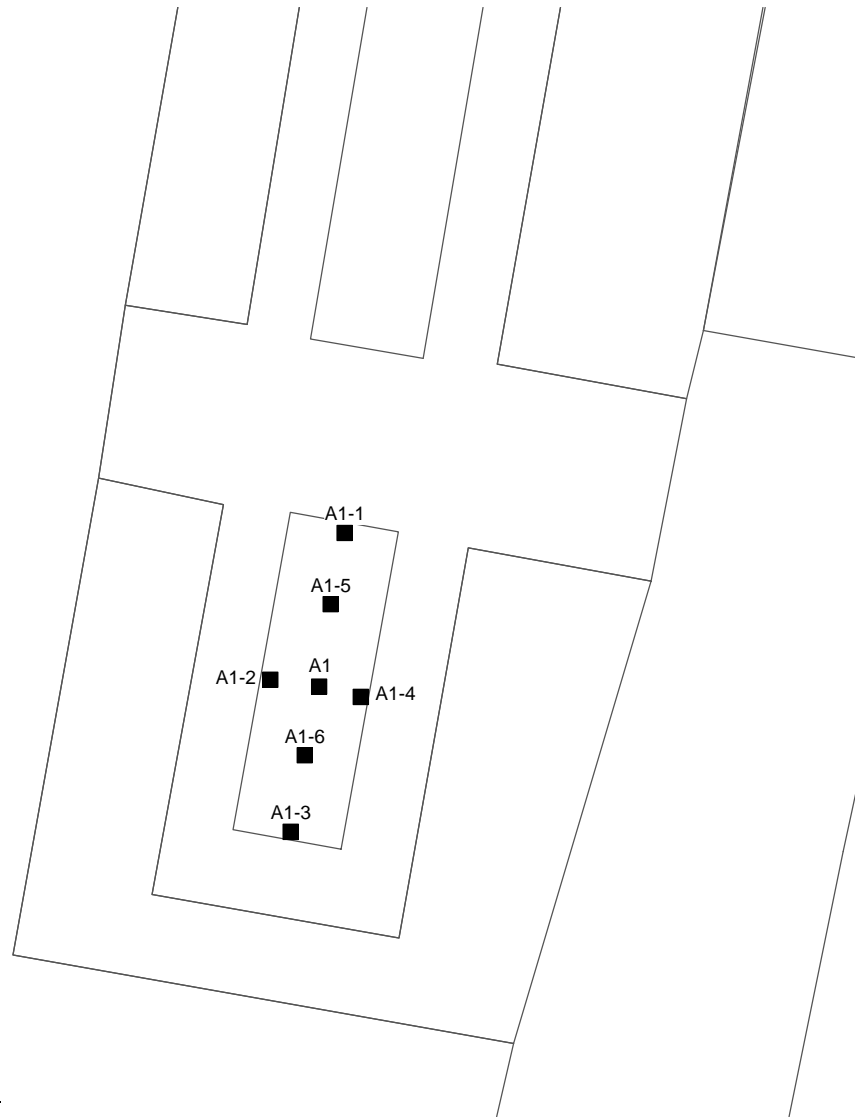
Asbestos cement pieces were noted, and asbestos was detected at surface soil in Area 6. Remediation of the area by landfill disposal would be appropriate.

Analyte		Result
Sample Location	Depth (m)	
<b>Fibro-cement Piece</b>		
A1	-	<b>Chrysotile Asbestos Detected</b>
<b>Soil Sample</b>		
A1	0-0.1	<b>Chrysotile Asbestos Detected</b>
A1-1	0-0.1	No Asbestos Detected
A1-2	0-0.1	<b>Chrysotile Asbestos Detected</b>
A1-3	0-0.1	No Asbestos Detected
A1-4	0-0.1	No Asbestos Detected
A1-5	0-0.1	<b>Chrysotile Asbestos Detected</b>
A1-6	0-0.1	No Asbestos Detected
