Montessori Academy

Geotechnical Investigation Report

170 Derby Street
Penrith NSW 2750

G20231-1-Rev A

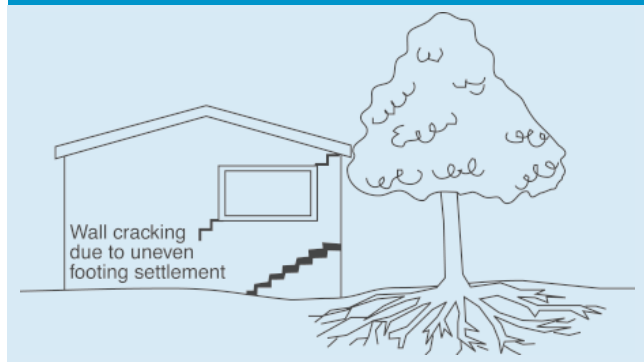
Trees can cause shrinkage and damage

As the weather pattern changes and the soil begins to dry out, the external footings will be first affected, beginning with the locations where the sun's effect is strongest. This has the effect of lowering the external footings. The doming is accentuated and cracking reduces or disappears where it occurred because of dishing, but other cracks open up. The roof lines may become convex.

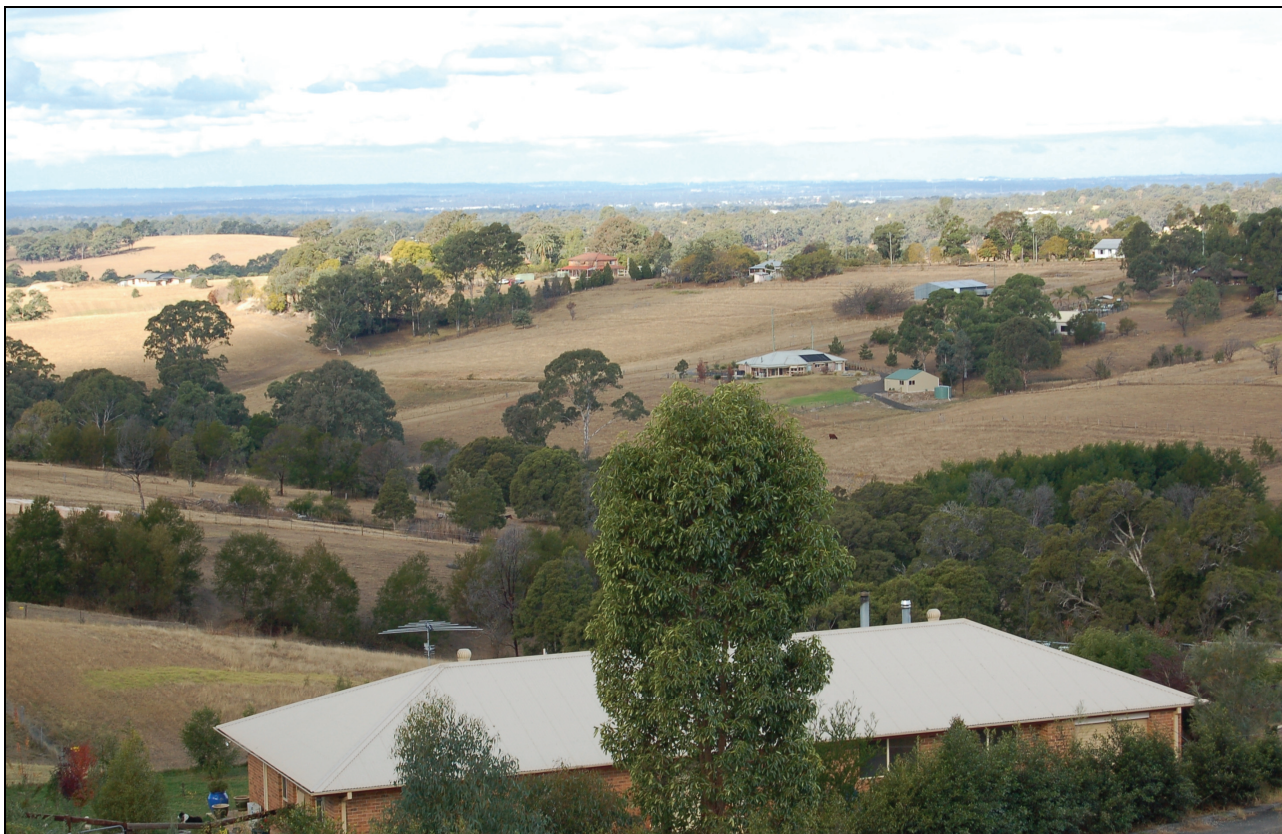
APPENDIX H

Landscape—undulating to rolling low hills on Wianamatta Group shales, often associated with Minchinbury Sandstone. Local relief 50–80 m, slopes 5–20%. Narrow ridges, hillcrests and valleys. Extensively cleared tall open forest (wet sclerophyll forest).

Soils—shallow (<100 cm) dark podzolic soils (Dd3.51) or massive earthy clays (Uf6.71) on crests; moderately deep (70–150 cm) red podzolic soils (Dr2.11, Dr2.41, Dr3.11) on upper slopes; moderately deep (<150 cm) yellow podzolic soils (Dy4.22) and prairie soils (Gn3.26) on lower slopes and drainage lines.
