Report on Geotechnical Investigation

Proposed Hotel Development 28 - 32 Somerset Street, Kingswood

Project 99851.00

May 2021

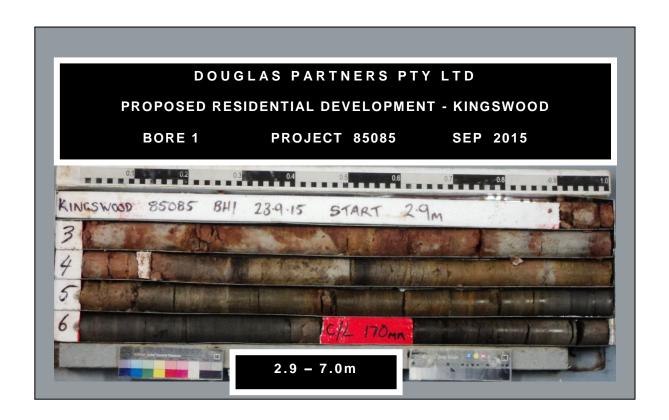
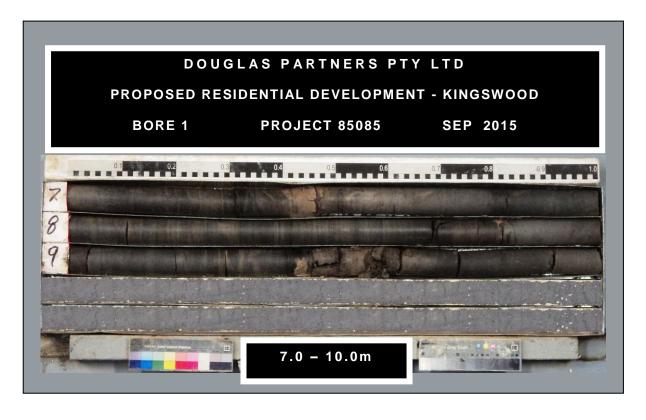
Details of the subsurface conditions encountered during the 2015 and 2021 investigations are given in the borehole logs in Appendix C, together with colour photographs of the rock core and notes defining classification methods and descriptive terms.
