# **Remedial Action Plan (RAP)**

# 40-42 Mamre Road, St Marys NSW 2760

Prepared For:	V Homes Developments Pty Ltd	
Reference:	21-1178	
Date:	03 June 2021

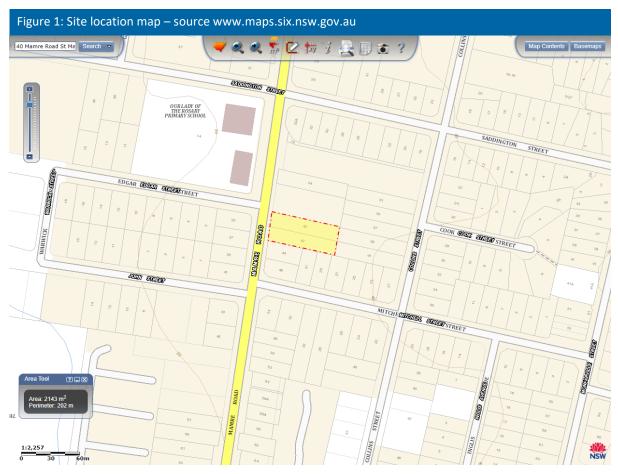
The study sites are 40-42 Mamre Road, St Marys NSW 2760 (Figure 1). Both sites can be identified as rectangular shaped allotments surrounded by low density residential properties on all boundaries. Figure 2 shows an aerial photograph of the site and the surrounding land.

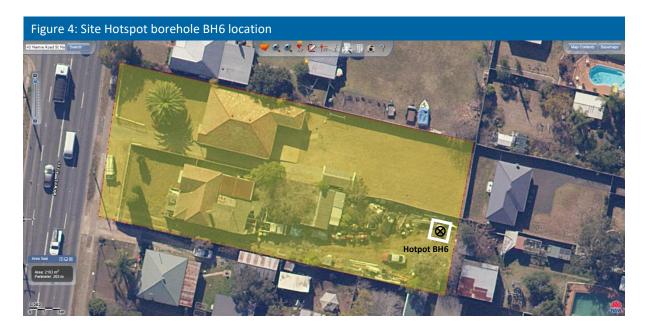
- excavate the area 3m x 3m x 0.5m depth est. volume 4.5m<sup>3</sup> (7.2 tonnes)
- o excavated soil surfaces should be visibly clean residual soil material
- unless tested and proven otherwise, the contaminated material from Hotspot BH5 location will be disposed of offsite at a licensed facility as **Restricted Solid Waste**.
- if the material is transported interstate or within NSW to an appropriate licenced facility it must be tracked and monitored using an NSW EPA approved tracking waste system.

Table 6: Hotspot BH6 excavations				
Borehole Sample	Hotspot Dimensions	Approximate Volume (m <sup>3</sup> )	Latitude	Longitude
BH6	3m x 3m x 0.5m	4.5	-33.774624293	150.773577212
