Report on
Detailed Site Investigation for Contamination

Nepean Creative and Performing Arts High School
- Multi-Purpose Hall
115 - 119 Great Western Highway, Emu Plains, NSW

Prepared for
School Infrastructure NSW

Project 92407.02
November 2020

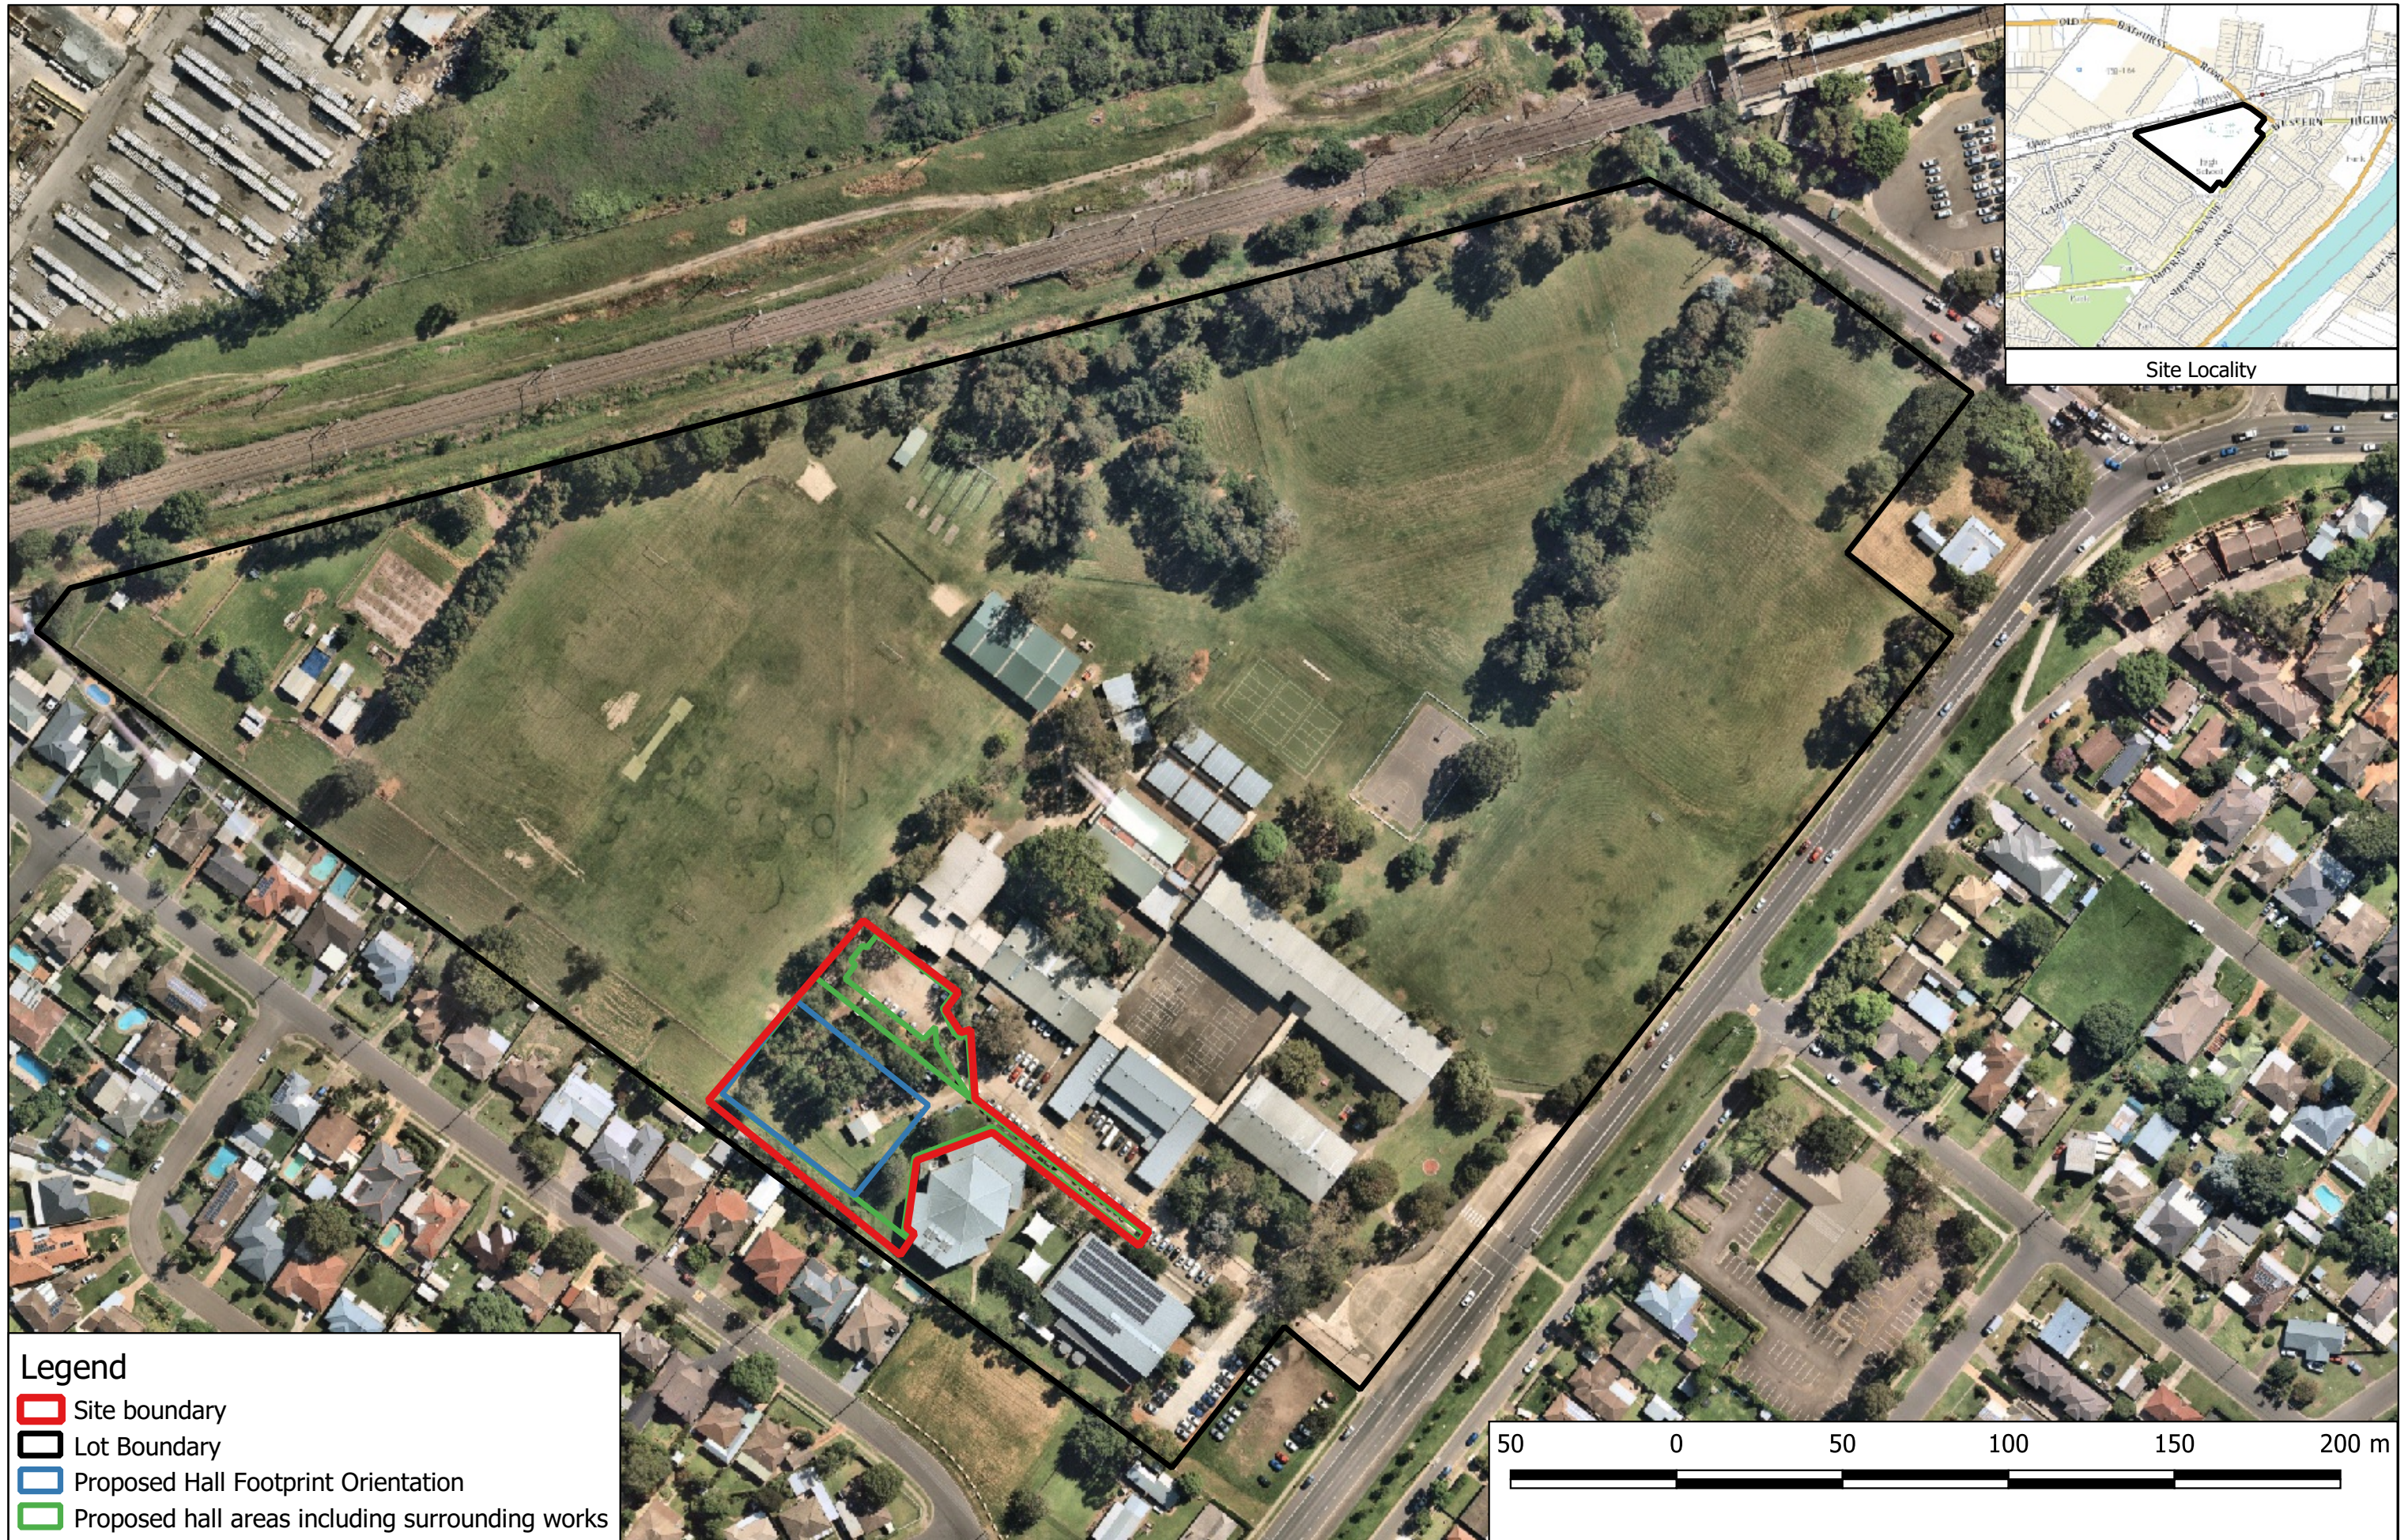
PROJ. #: 92407.02
DRAWING No: 1
REVISION: 0

- Site boundary
- Lot Boundary
- Proposed Hall Footprint Orientation
- Proposed hall areas including surrounding works

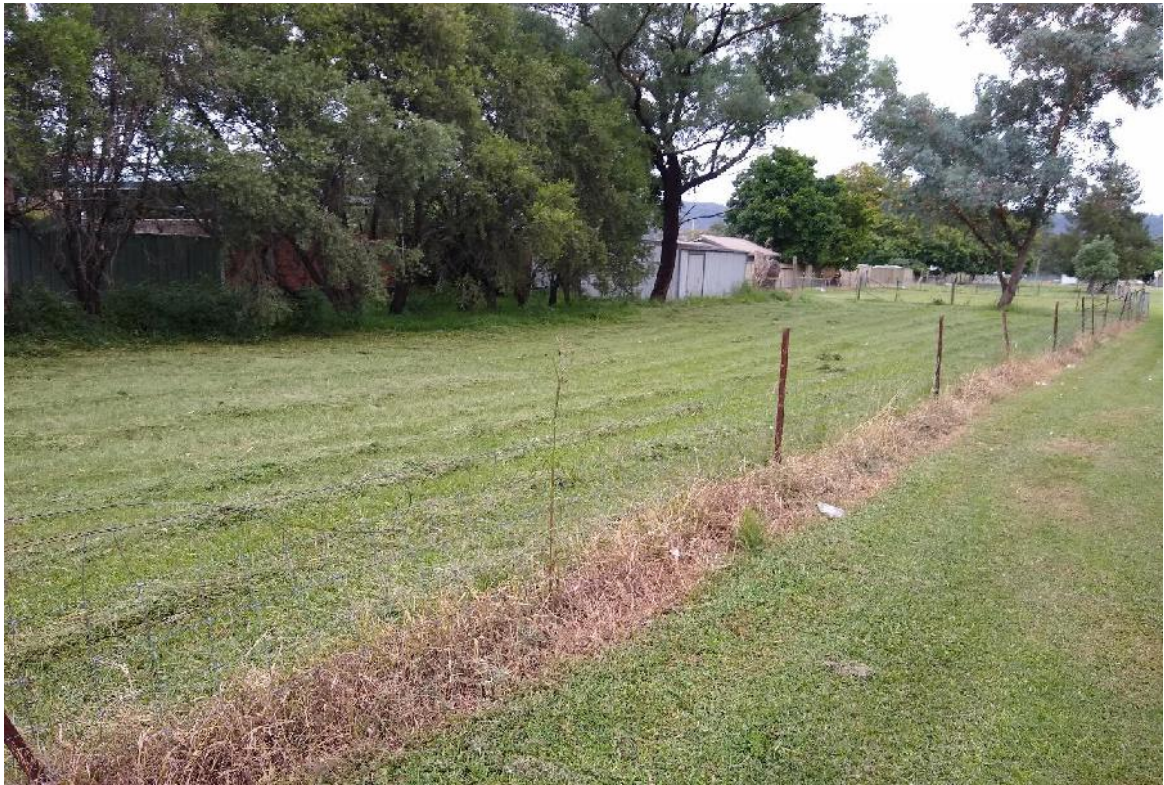
Photo 1 - Southern portion of site

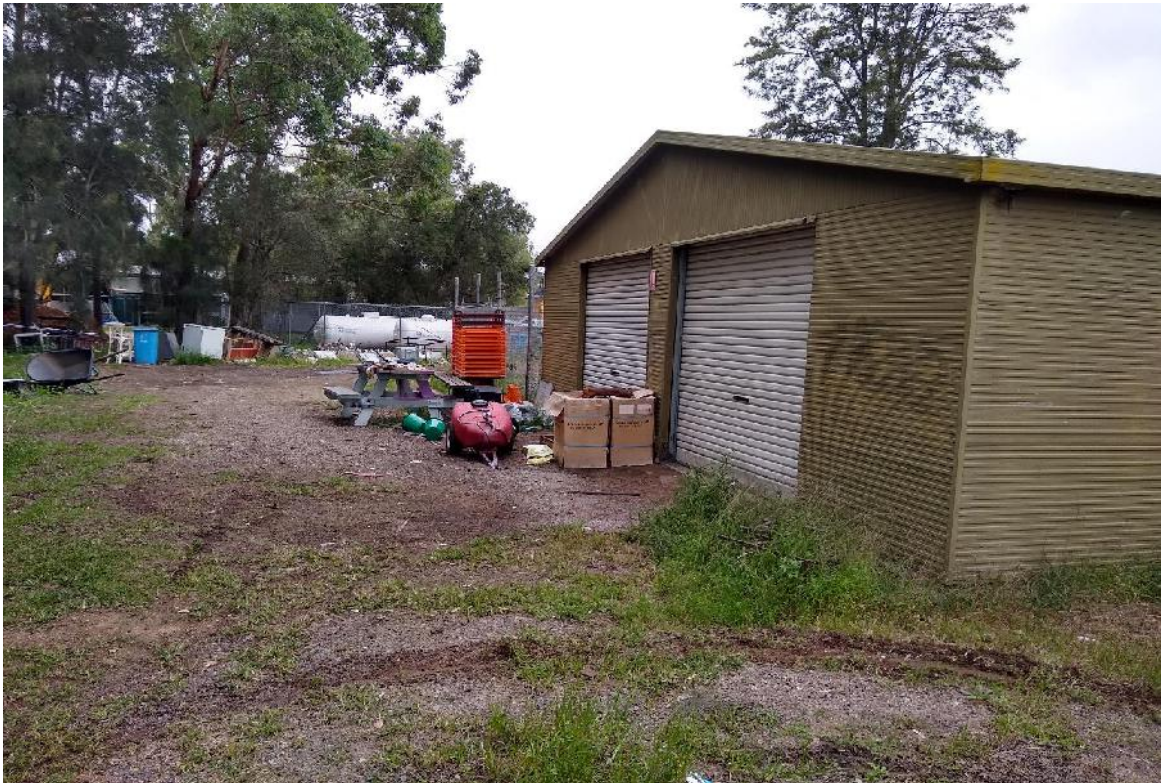
The area consists mostly of vacant land covered by either grassed lawn or unsealed gravel. A shed, constructed of metal sheeting walls and roof on a concrete slab floor, is located in the south western portion of the site. Several scrap metal items and general equipment were observed in the immediate vicinity of the shed including metal gates, a car trailer, plastic spray tank for weed spraying and a number of plastic crates and buckets.

Photo 2 - Shed in central portion of site

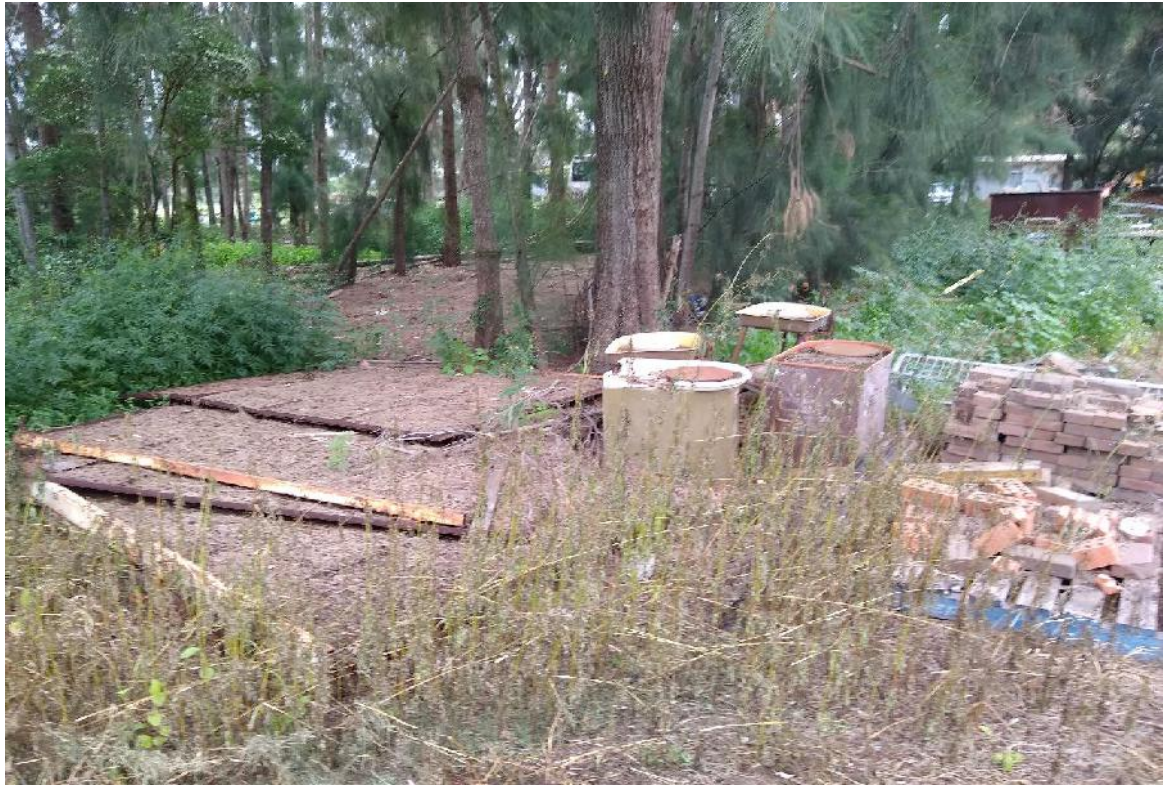
An elevated fill mound is located in the western portion of the site to the west of the shed area and is mostly covered with grass and large trees. Several items of scrap metal and general discarded building materials were observed in the vicinity of the fill mound including metal sheeting, bricks, timber, and furniture.

Photo 3 - Building materials and area of elevated fill in western portion of site

It is therefore recommended that an Unexpected Finds Protocol be prepared and implemented to provide a formal contingency to be followed in the event of an unexpected find with respect to potential site contamination issues encountered during any bulk earthworks.

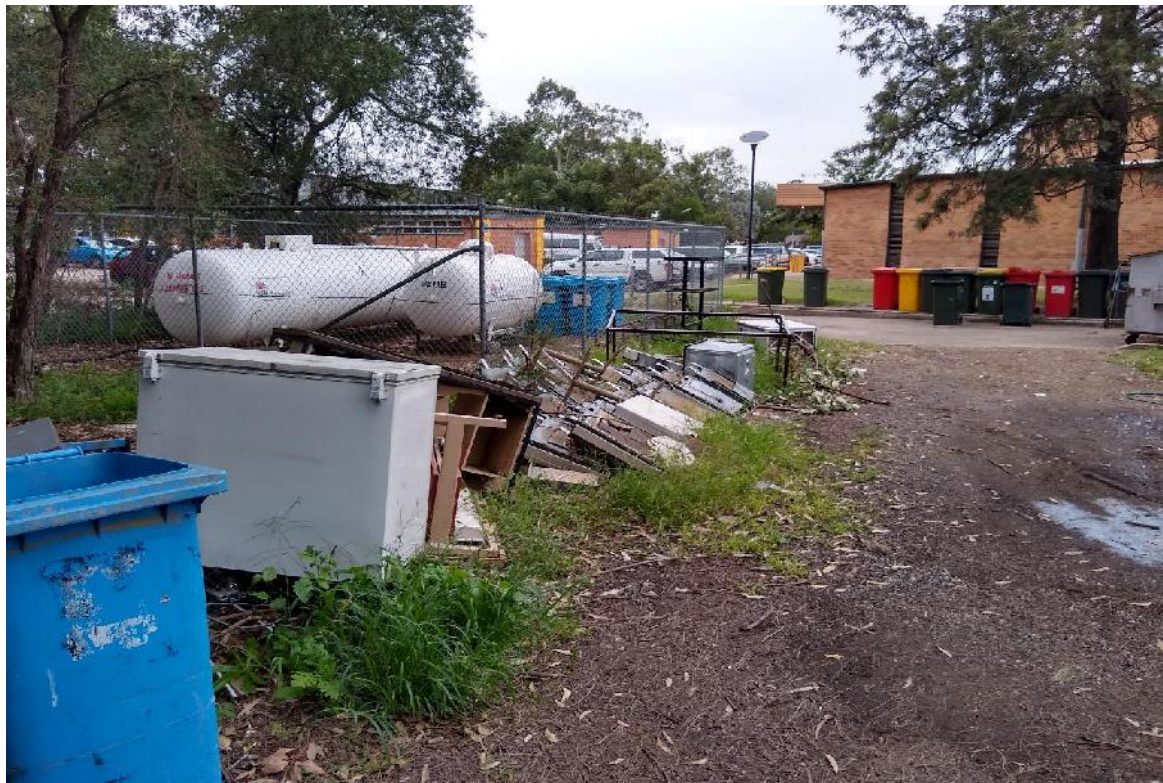
Photo 4 - Scrap metal and building materials with LPG tanks beyond

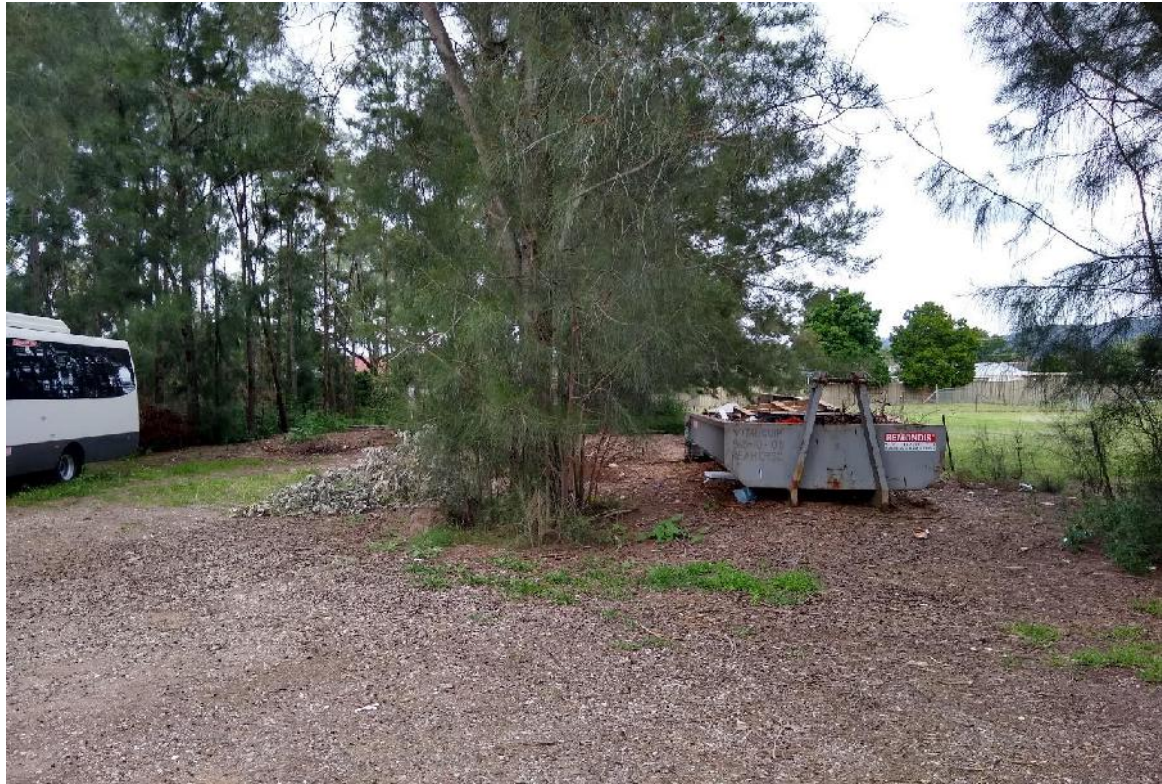
Photo 5 - Skip bin with building materials in northwest portion of site

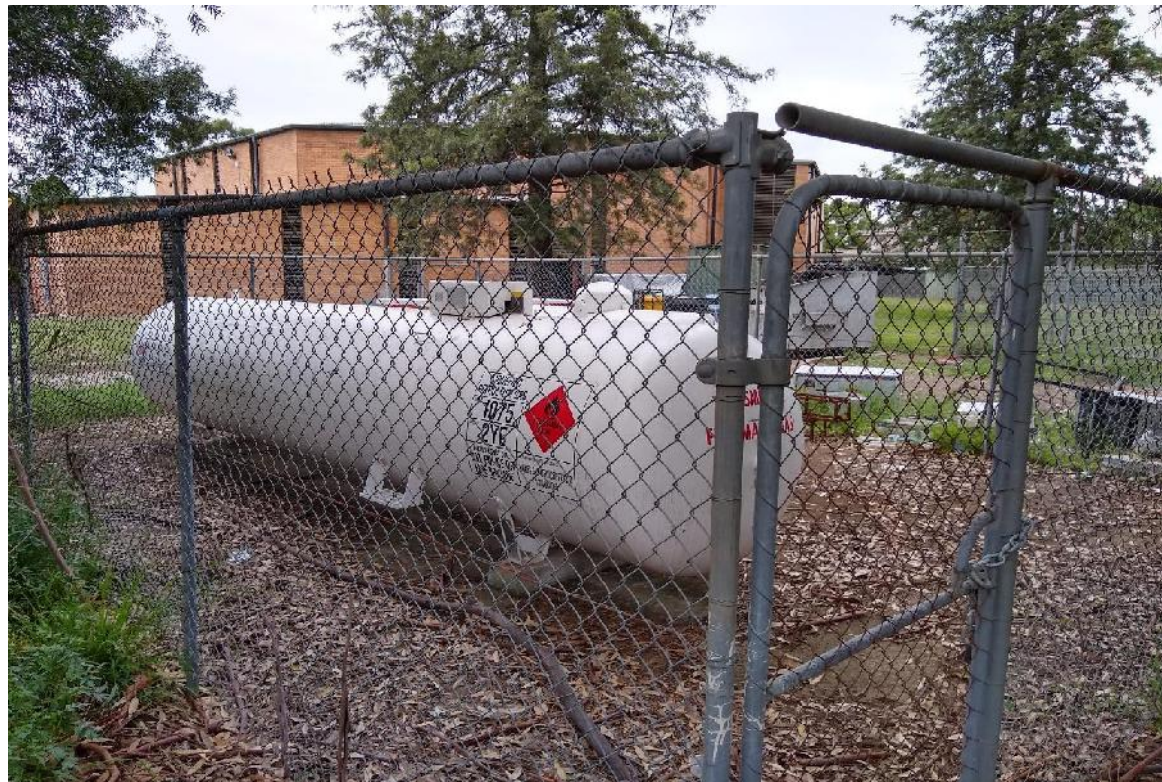
- o BH9 located in the vicinity of the LPG tanks to investigate potential for impact to shallow soil from fuel/chemical spillages/leakages and storage malpractice; and

Photo 6 - LGP ASTs in central northern portion of site
