re: **Proposed Open Space**  
**Lot 754 in DP1180111 - 754 Caddens Road, Caddens**  
**Salinity Assessment**

13851/1-AA  
Lot 754 in DP1180111 - 754 Caddens Road, Caddens

Test Pit Locations

Drawing No: 13851/1-AA1  
Job No: 13851/1  
Drawn By: MH  
Date: 12 October 2016  
Checked By: JH/ER

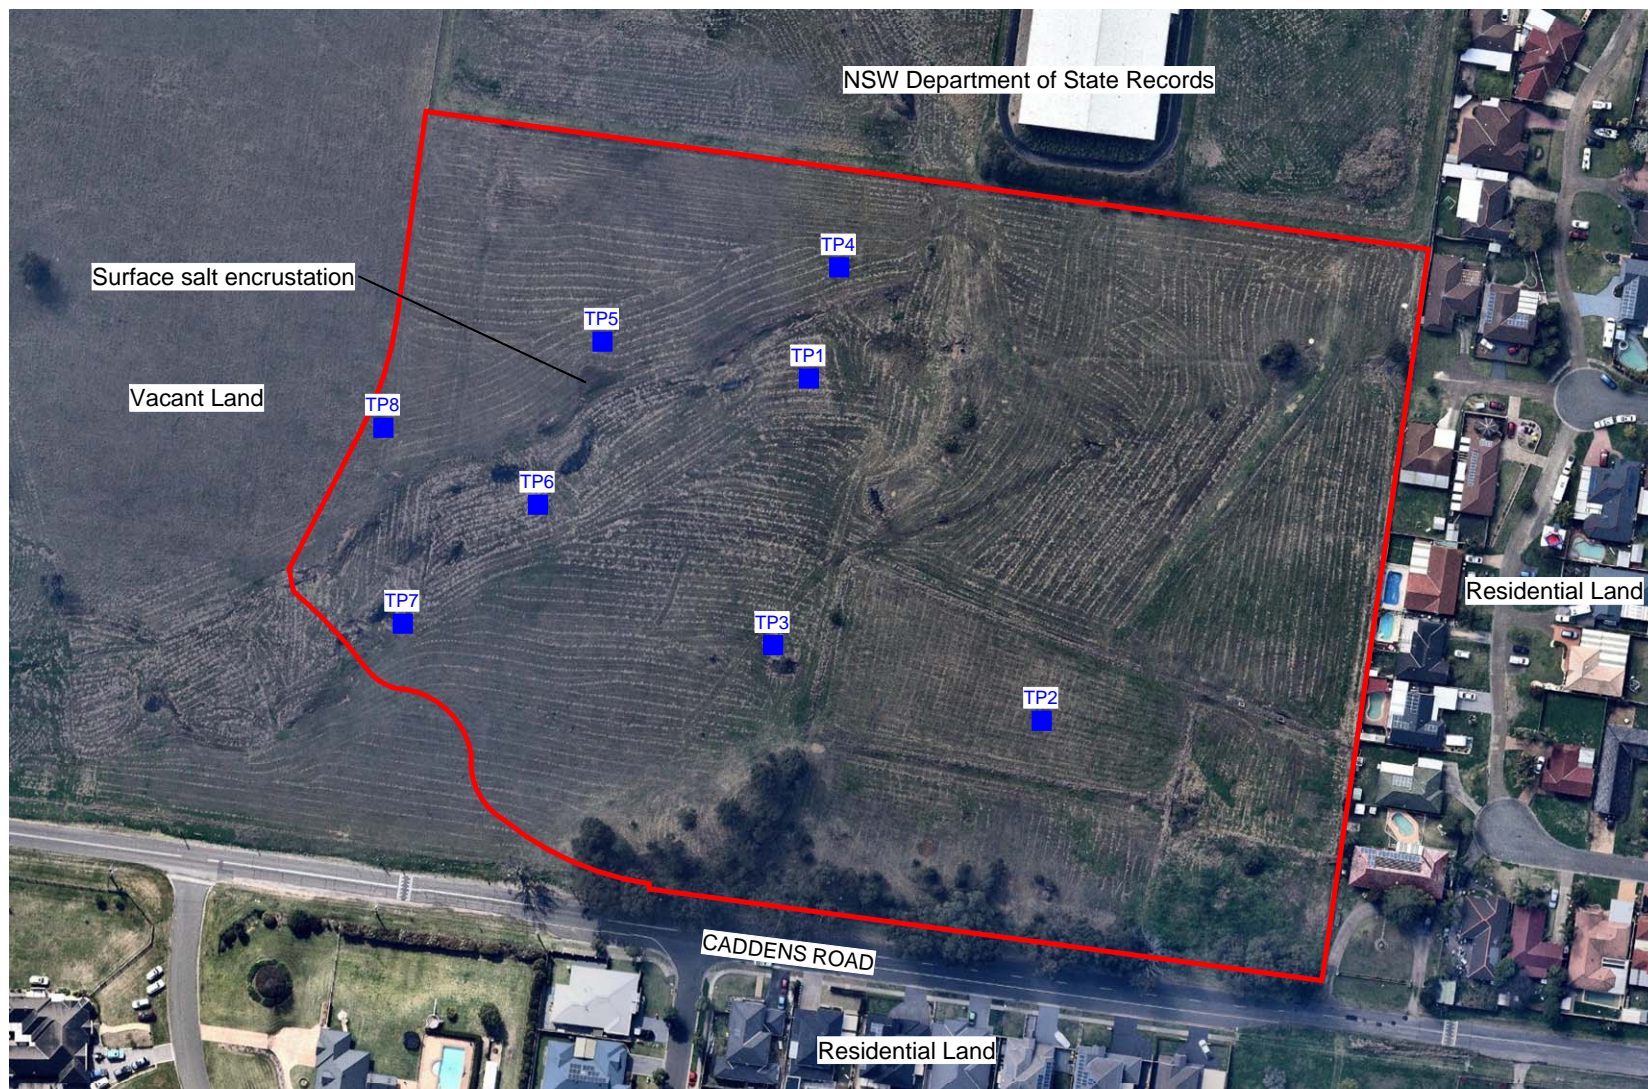
At the time, during the field work on 12 October 2016, there was salt encrustation observed on the bare ground surface of a local depression that is visual indicators of soil salinity. A vacant neighbouring land to the west was vacant, NSW Department of state records to the north and residential to the south and east. General site features are indicated on the attached Drawing No 13851/1-AA1.
