GEOTECHNICAL INVESTIGATION REPORT

Proposed Residential Development

96-98 Lethbridge Street & 42-46 Evan Street

Penrith, NSW

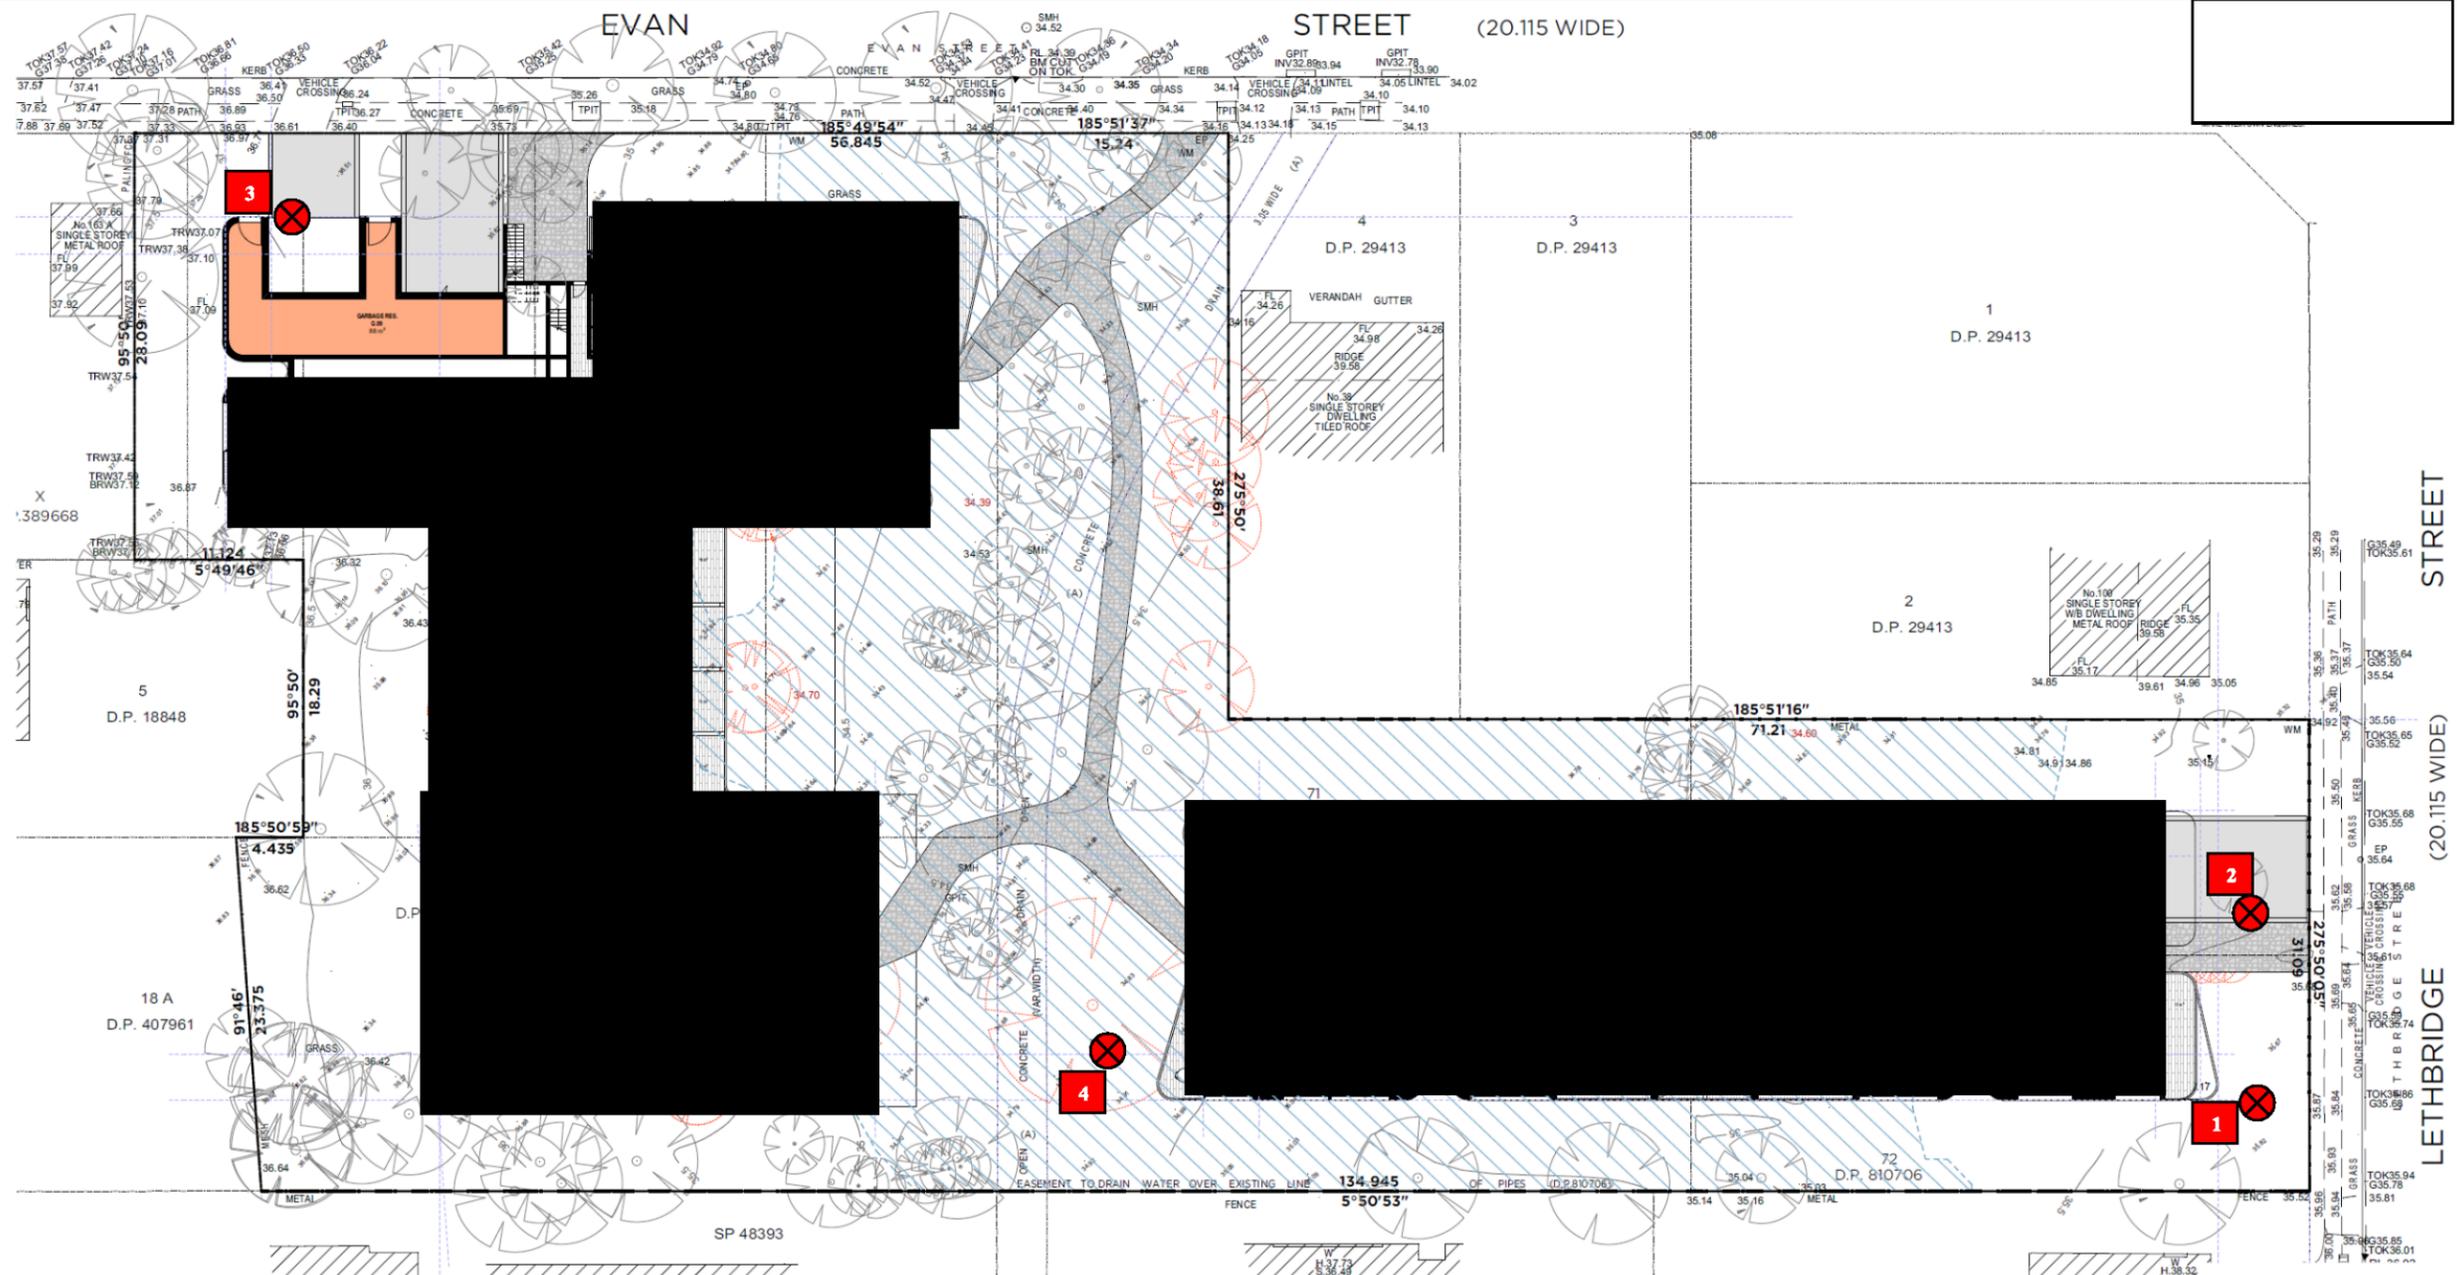
Borehole Location Plan

Source: Project 19107 Drawing DA-103 prepared by Urbanlink Pty Ltd

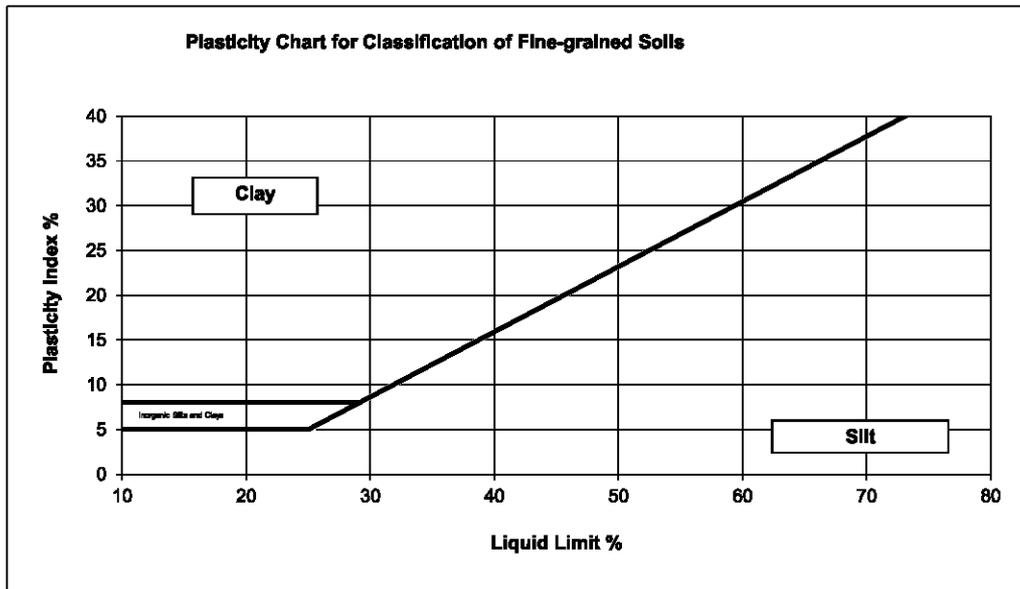
Liquid Limit (%) 71	Linear Shrinkage (%) 17.5
Plastic Limit (%) 22	Plasticity Index 49

The results of the Atterberg Limits and linear shrinkage testing undertaken by Macquarie Geotech indicated that the sample tested was of high plasticity, with a high potential for reactivity to changes in moisture content.
