Preliminary Site Investigation:
Lot 11 DP1087962, 22-23 Lambridge Place
Penrith, NSW

P1706245JR01V01
November 2017

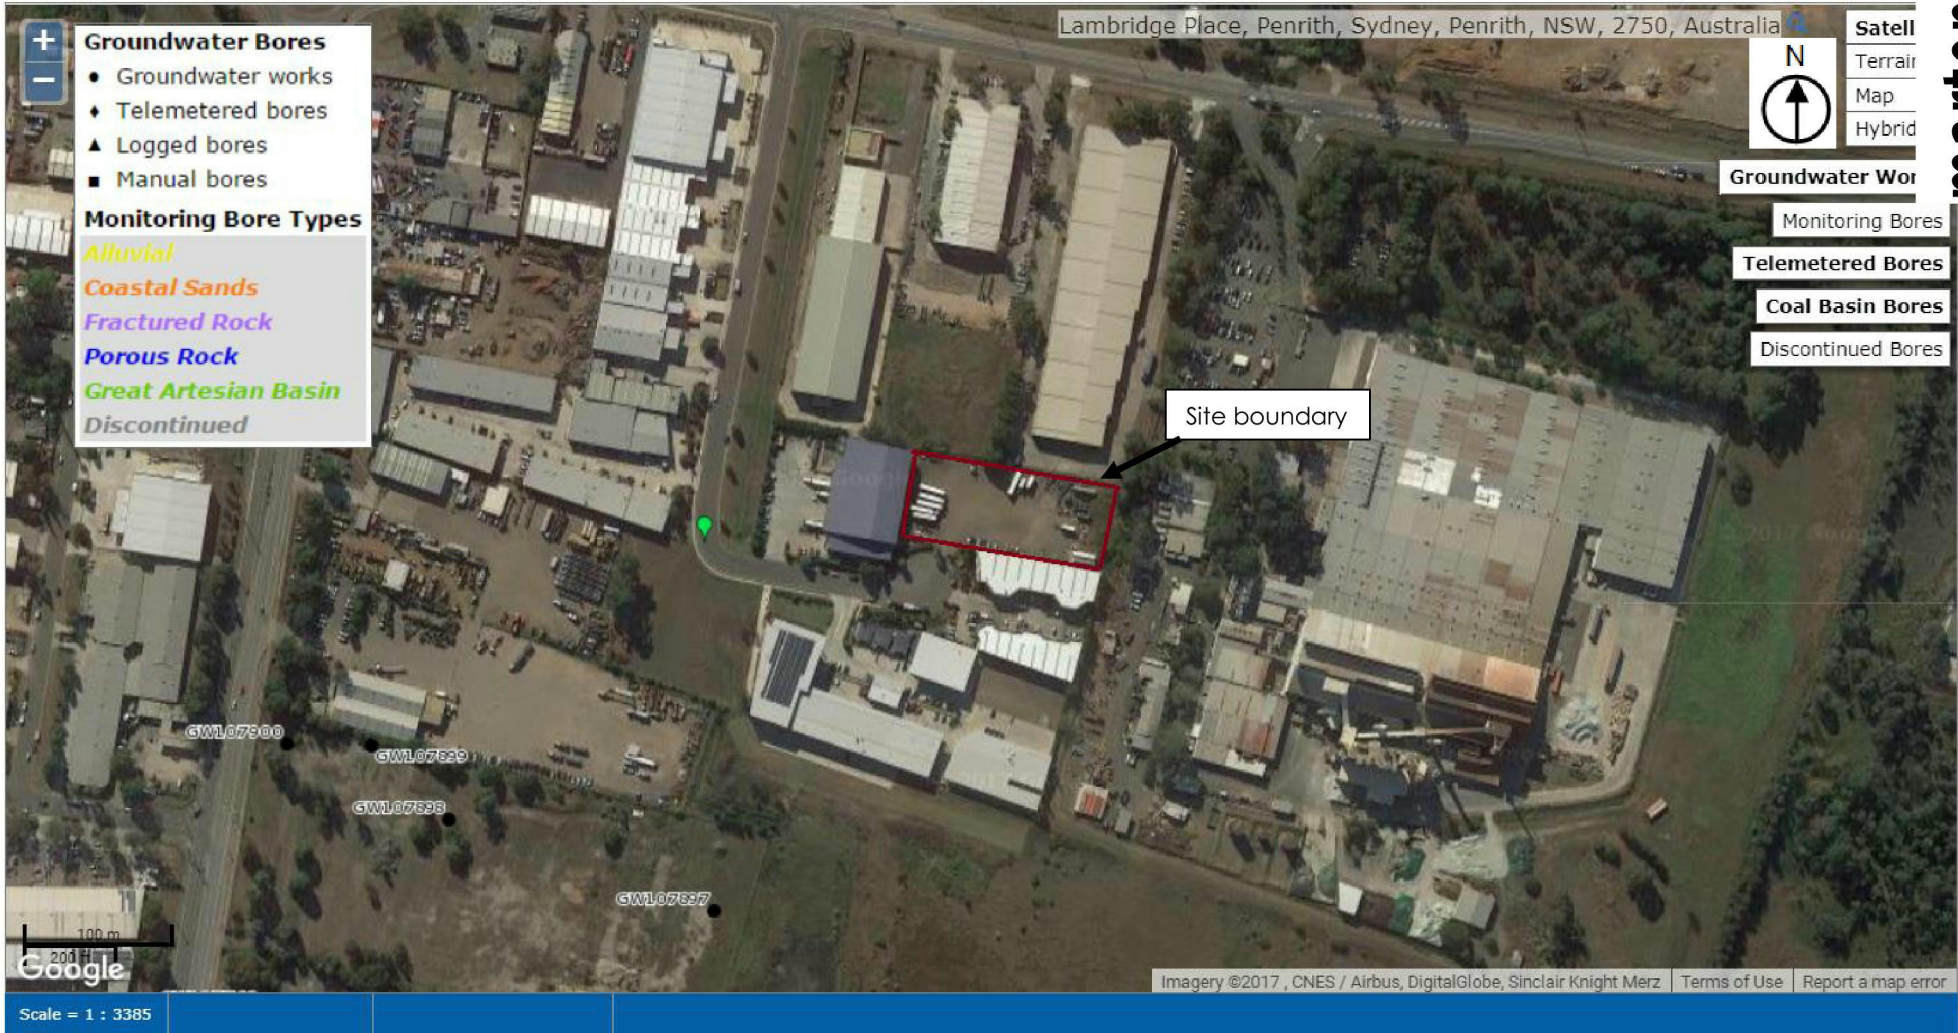
Review of NSW Department of Primary Industries Water database indicated active groundwater bores within 500 m of the site, listed below are the closest monitoring bores (Table 2). The Groundwater bore locations are shown in Figure 2 (Attachment B).

Groundwater Bore Identification	Distance / Orientation From Site	Depth To Groundwater (mBGL)	Intended Use	Water Bearing Zone Substrate
GW107897	300m south	7.00	Monitoring Bore	Gravel
GW107898	400m southwest	7.00	Monitoring Bore	Gravel

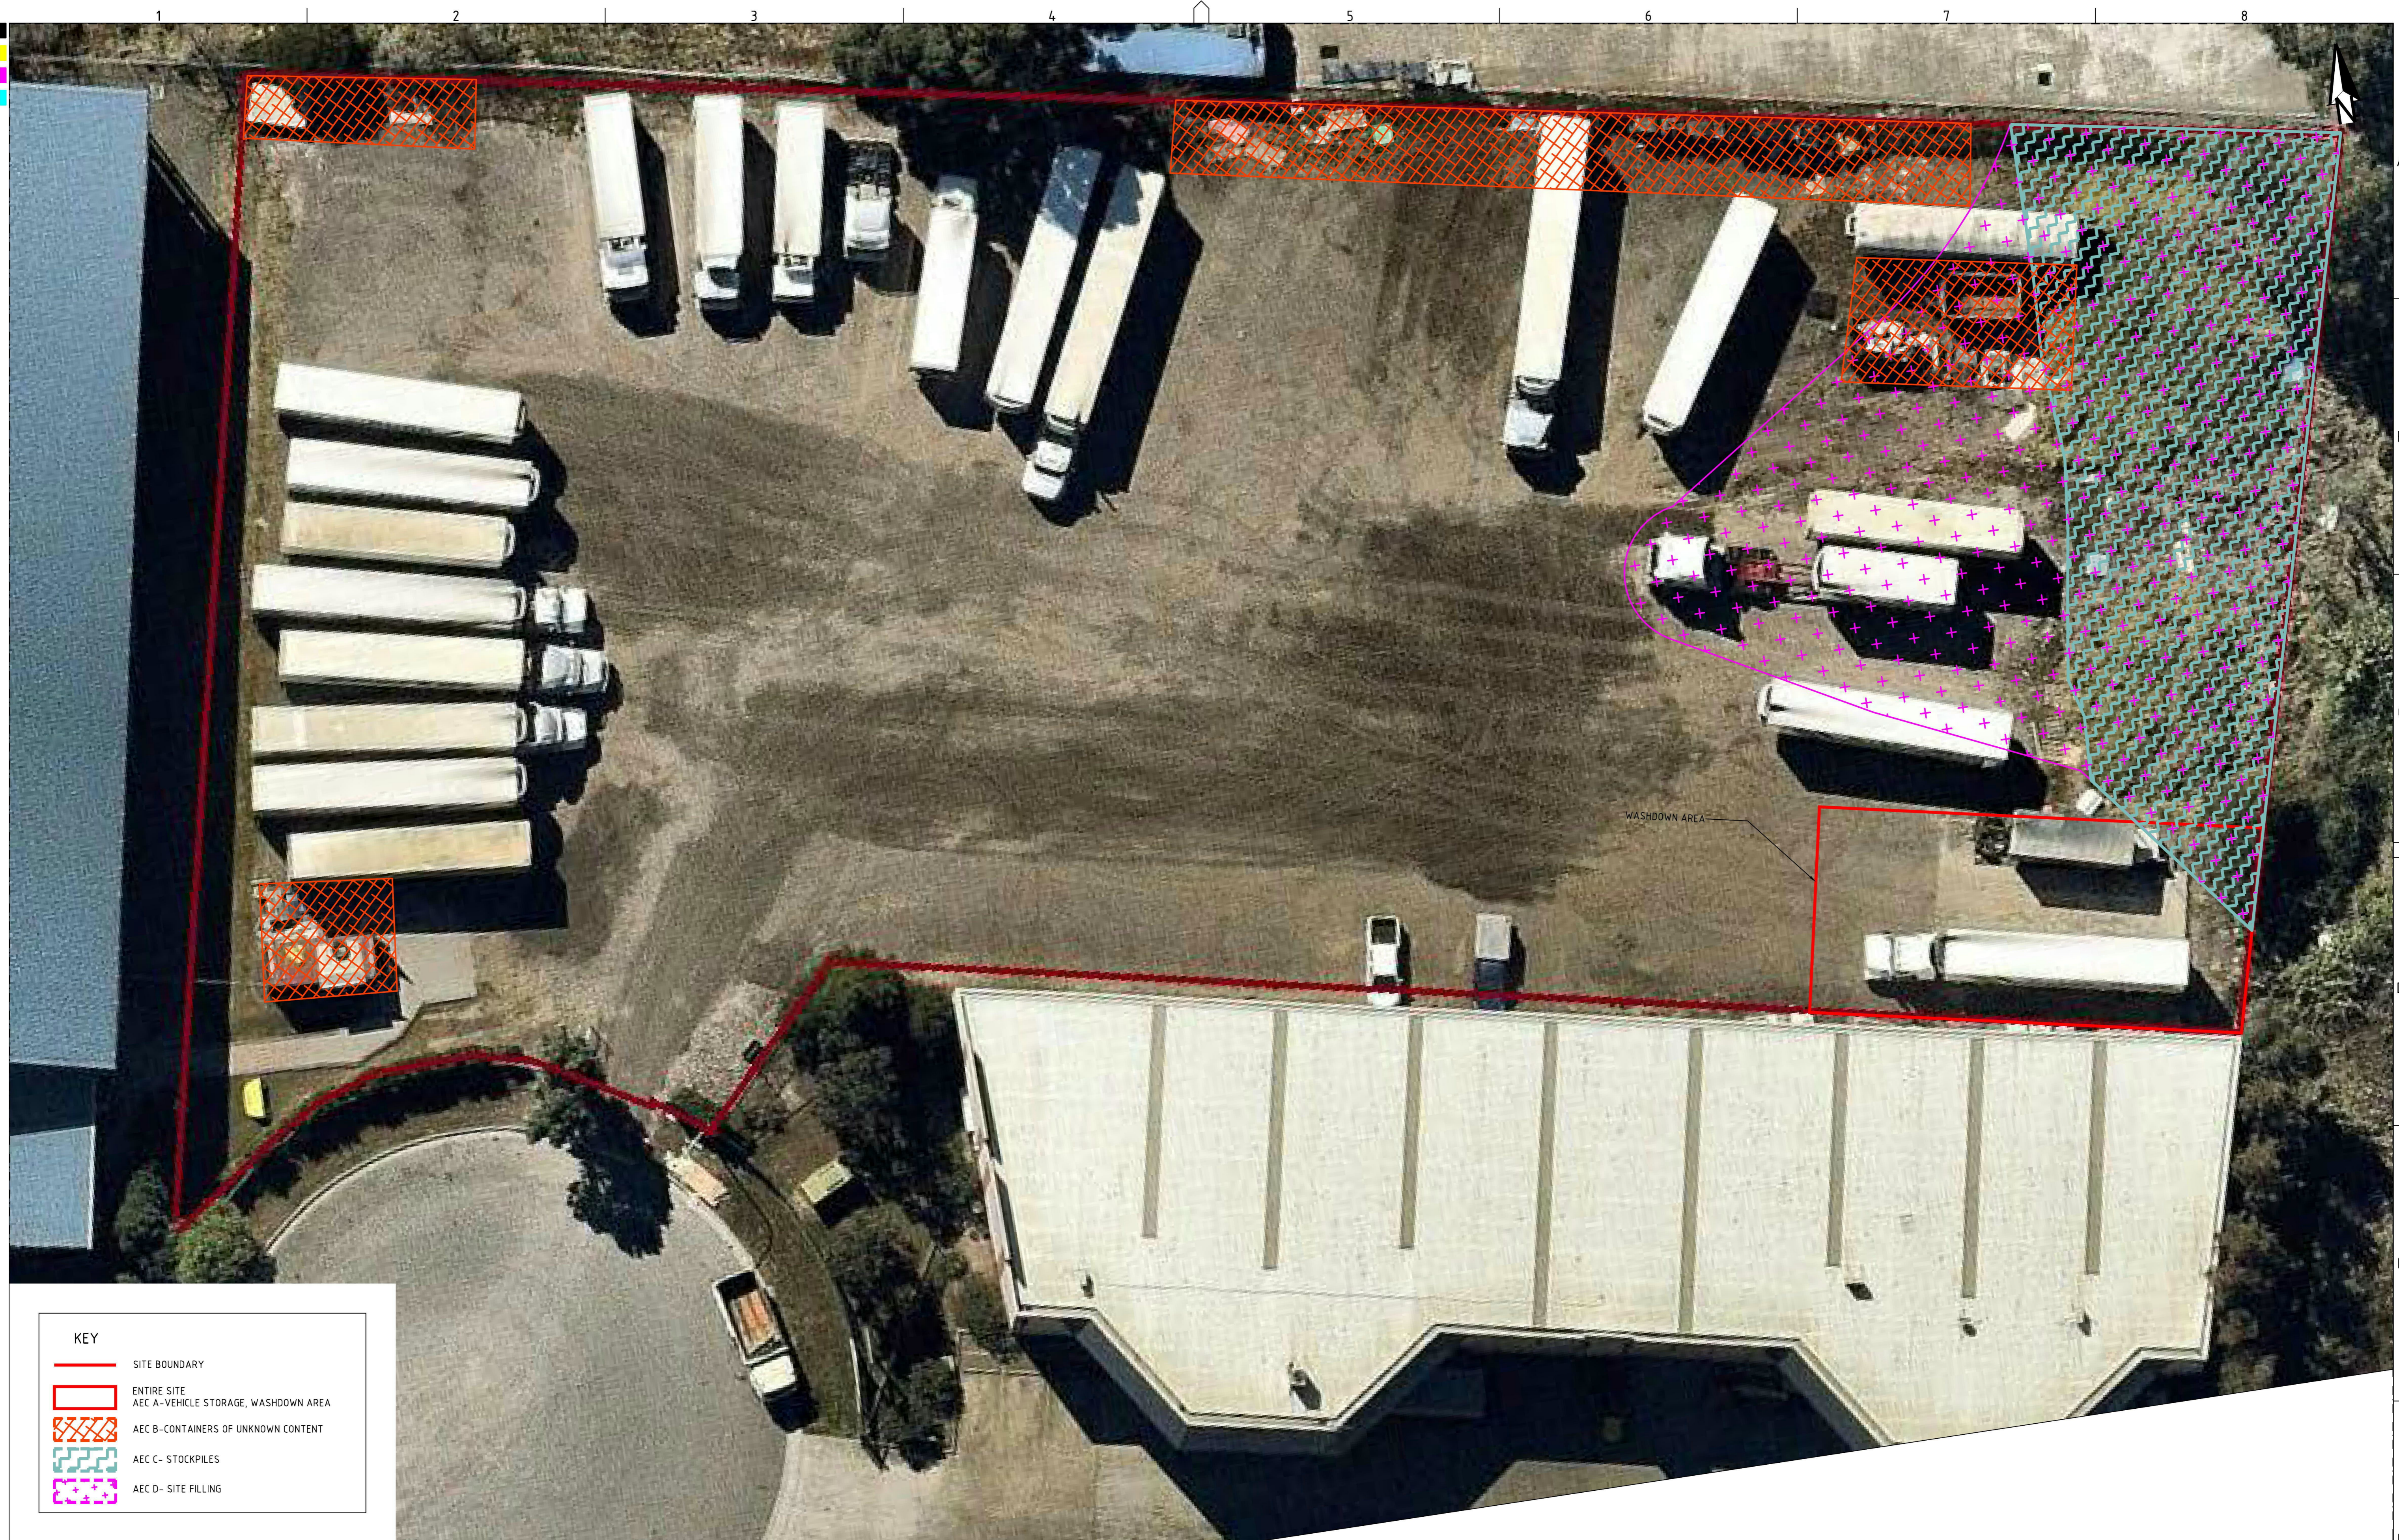
DRAWING TITLE				
AEC SITE LOCATIONS SOURCE: NEARMAP (2017)				
PROJECT NO.	PLANSET NO.	RELEASE NO.	DRAWING NO.	REVISION
P1706245	PS01	R01	PS01-J100	A

AEC ¹	Potential for Contamination	COPC	Contamination Likelihood
AEC A – Storage of vehicles, truck trailers and batteries	Fuel, oil or battery acid containing lead from vehicles/ trailers parked and washed on site may have contaminated soil.	HM, TRH, PAH and BTEXN	Low - medium
AEC B- Containers of unknown content	Potentially contaminating chemicals may have spilled or leaked onto underlying soil.	HM, TRH, BTEXN, PAH and OCP/OPP	Medium
AEC C – Stockpiles	Contaminants from unknown contents of stockpiles (observed in 2007 aerial photo) and general refuse may have spilled or leaked onto underlying soil.	HM, TRH, BTEXN, PAH, OCP/OPP and asbestos	Low - medium
AEC D – Site Filling	Application of fill of unknown origin within previous drainage depression.	TRH, BTEXN, PAH, HM, OCP/OPP and asbestos	Medium

KEY	
	SITE BOUNDARY
	ENTIRE SITE
	AEC A- VEHICLE STORAGE, WASHDOWN AREA
	AEC B- CONTAINERS OF UNKNOWN CONTENT
	AEC C- STOCKPILES
	AEC D- SITE FILLING

Prior to the proposed development, assessment of the AECs and COPCs as noted in this PSI should be undertaken.

To address potential identified AECs and COPCs, a detailed site investigation (DSI) including intrusive soil sampling and testing is recommended and may be made a condition of development consent.

The DSI plan is to be developed in accordance with NSW EPA (1995) *Sampling Design Guidelines* and a risk based assessment. Assessment shall address each of the identified AECs and associated COPC (Table 6). Results of the site testing shall be assessed against site acceptance criteria (SAC) developed with reference to ASC NEPM (1999, amended 2013).

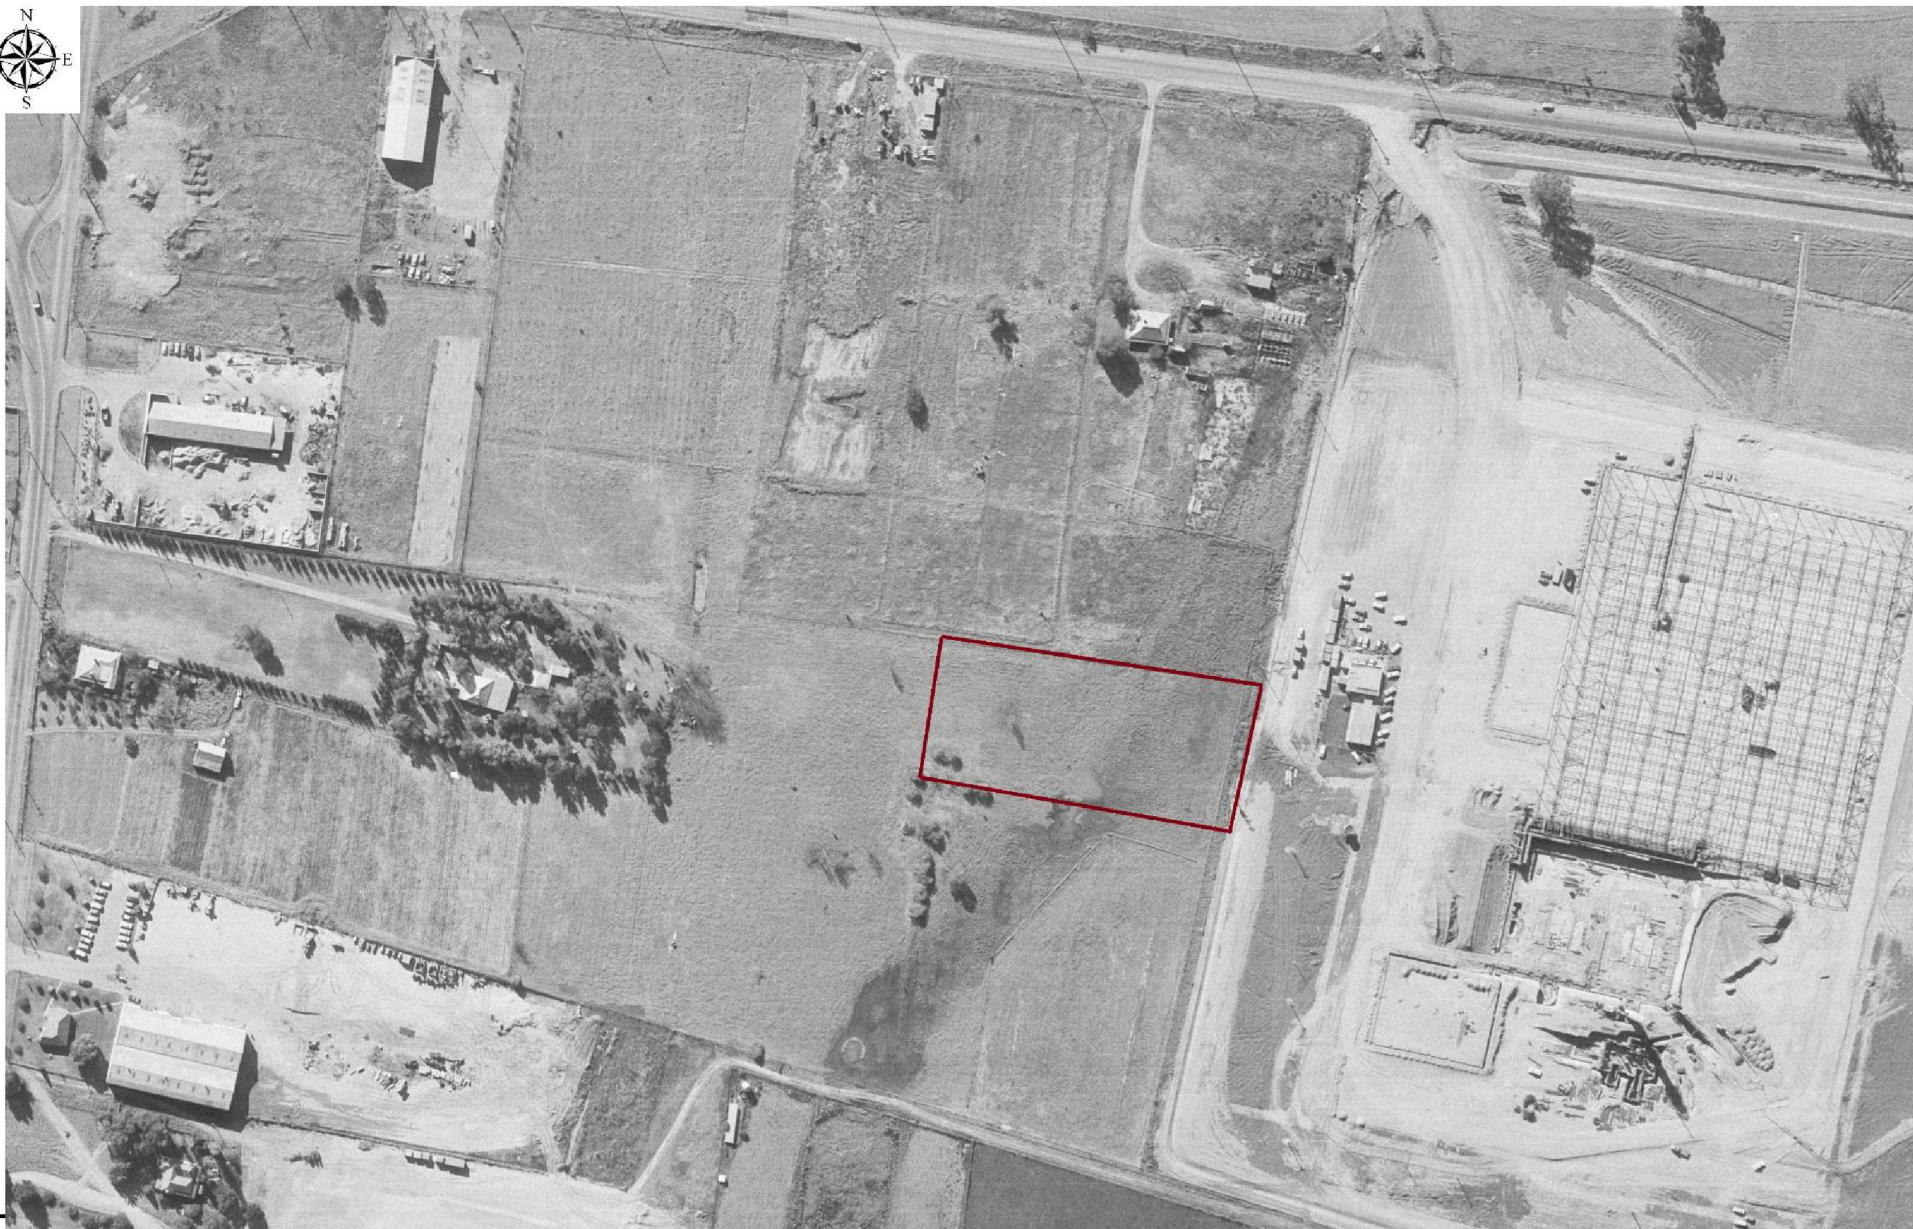
Martens & Associates Pty Ltd ABN 85 070 240 890		Environment Water Wastewater Geotechnical Civil Management	
Drawn:	MV	Aerial photo 1970 22-23 Lambridge Place, Penrith, NSW Source: NSW LPI	Drawina No:
Approved:	GT		Figure 4
Date:	10.10.2017		Job No: P1706245
Not to Scale

Year	Lambridge Place, Penrith (Lot 11 DP1087962)	Surrounding Land Use
1970	Site is undeveloped agricultural land. Small drainage depression transects the south eastern portion of the site.	To the south, west and north are agricultural and market gardens or rural residential dwellings. To the east of the site is a large glass manufacturing factory. Several large industrial/agricultural buildings occupy blocks to the west of the site.
1984	Little change since 1970 photo.	Adjacent blocks to the west and south remain as per 1970 photo. Factory directly to the east has increased in size and has several new buildings located on the block. Block directly to the north and several to the west has been cleared to make way for new industrial development.
1991	Little change since 1984 photo.	Large Industrial buildings constructed on adjacent blocks to the north. Expansion of industrial development in the area.

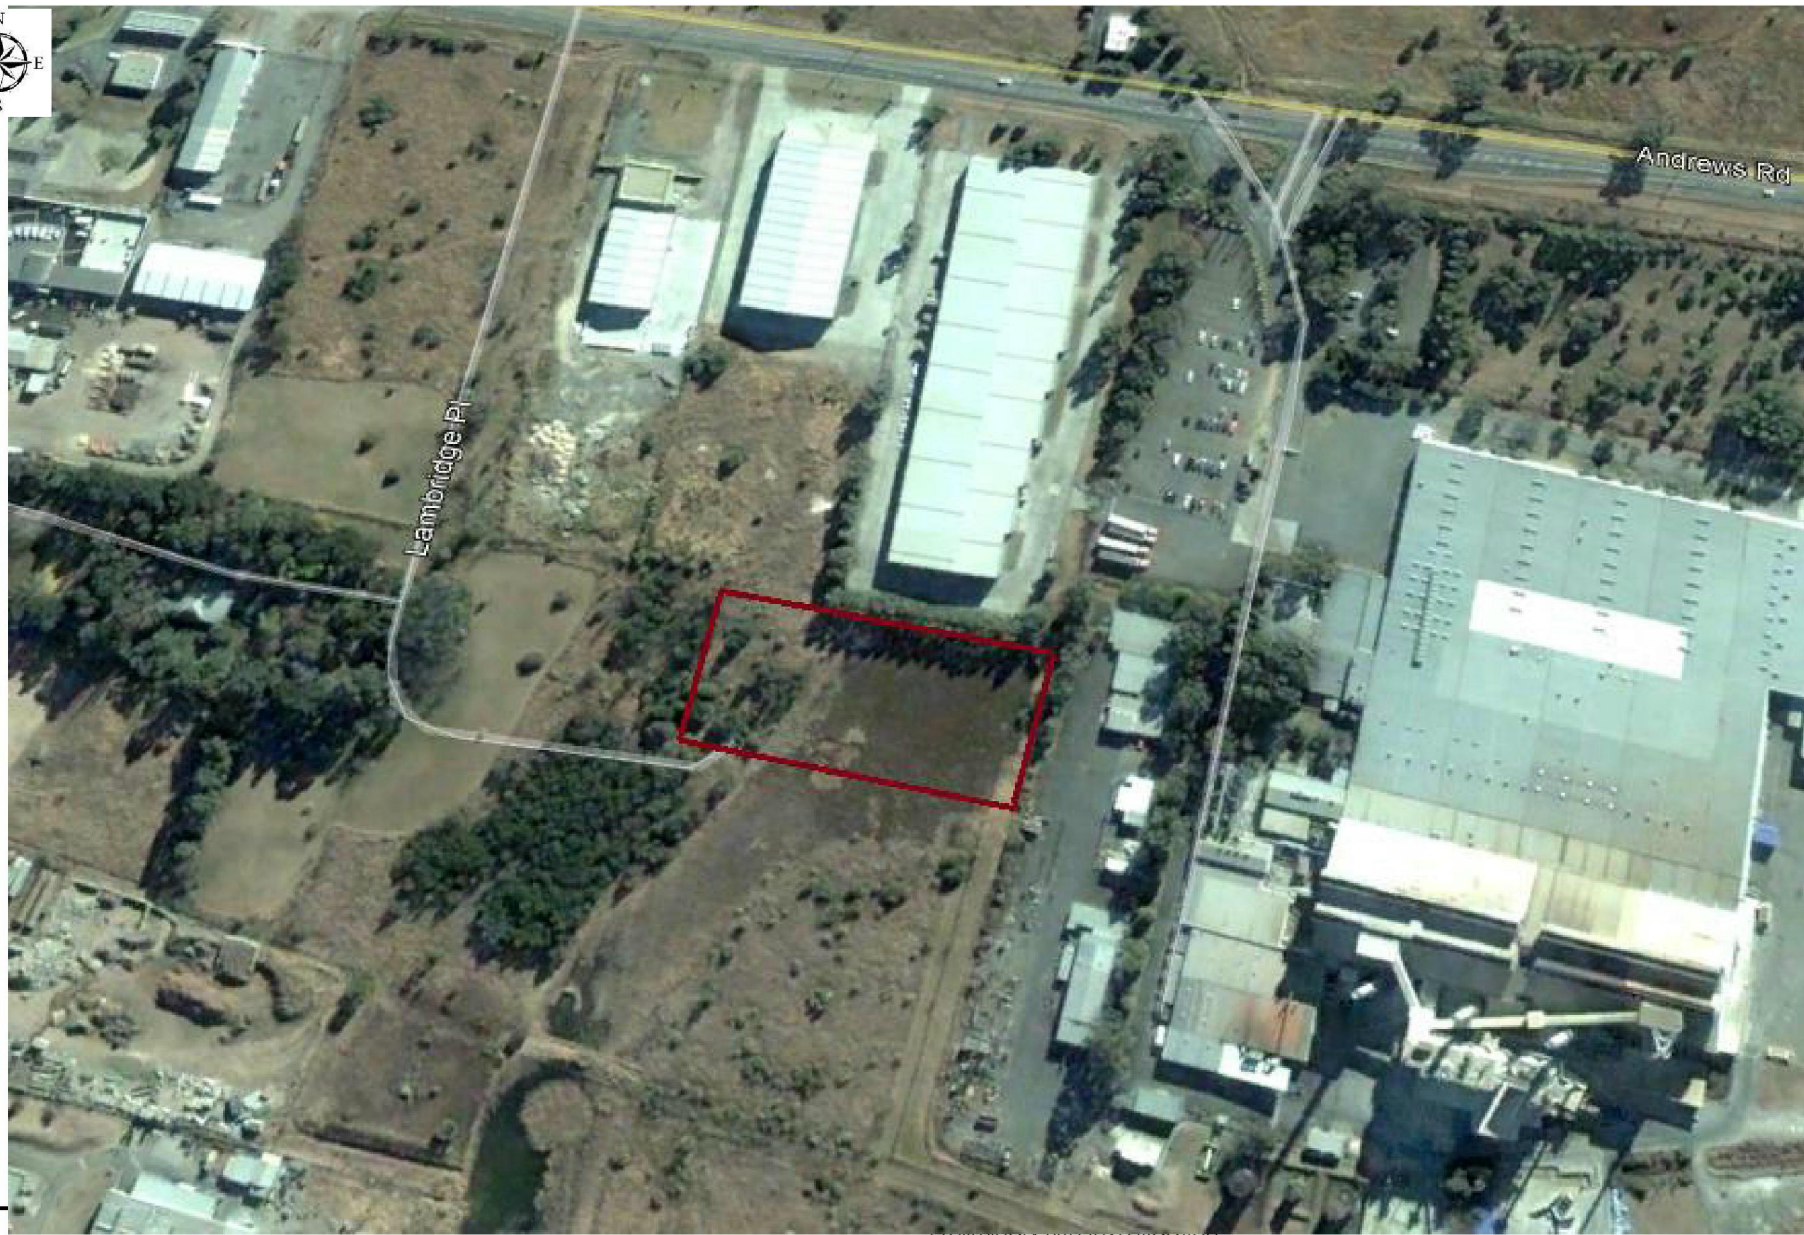
Martens & Associates Pty Ltd ABN 85 070 240 890		Environment Water Wastewater Geotechnical Civil Management	
Drawn:	MV	Aerial photo 2002 22-23 Lambridge Place, Penrith, NSW Source: Google Earth	Drawing No: Figure 7
Approved:	GT		Job No: P1706245
Date:	10.10.2017		
Not to Scale

2002	Little change since 1991 photo with exception of increase in vegetation in western portion of site.	Little change from 1991 photo. Slight change to configuration of factory to the east.
2007 (Google Earth Maps)	Site access via Lambridge Place. Change in groundcover on site, likely earthworks taken place. Storage containers, trailers, stockpiles and pallets stored on western portion of block.	Lambridge Place constructed. Additional light industrial complex to the south and new cold storage facility to the west. Further increase in commercial development at both sides of Lambridge Place.
2017 (Nearmap)	Gravel (roadbase) covering majority of site. Numerous truck trailers and vehicles parked / stored around perimeter of site.	Increase in development along Lambridge Place with commercial developments and aquatic centre. Further increase in commercial development to the south and southwest of the site.
