GEOTECHNICAL REPORT FOR 36-38 RODLEY AVENUE, PENRITH NSW

INGLOW INVESTMENT TWO PTY LTD

Reference: P1720_01 rev1

13 August 2019

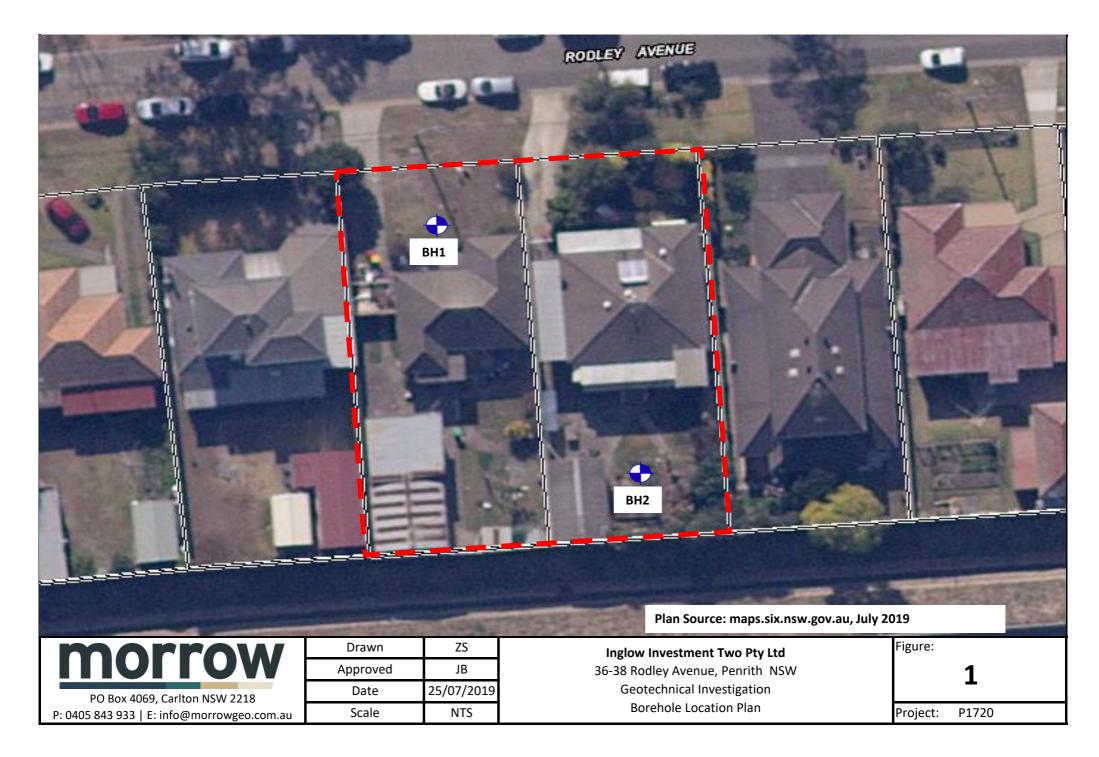
- Drilling of two boreholes (BH1 and BH2) by a track mounted drill rig using solid flight augers equipped with a tungsten-carbide bit (TC bit) and rock rolling. The boreholes were extended beyond rock rolling by NMLC coring techniques to depths of 15.81, and 13.54 m below ground level (mBGL) respectively. Rock core was boxed and photographed and point load tests were undertaken on selected core sample to assess rock strength. Borehole locations are shown on Figure 1 and borehole logs are presented in Appendix A;
