# Regional Detention Basins C and V6, SMDS

## Archaeological Technical Report

Report prepared for Maryland Development Company

October 2020

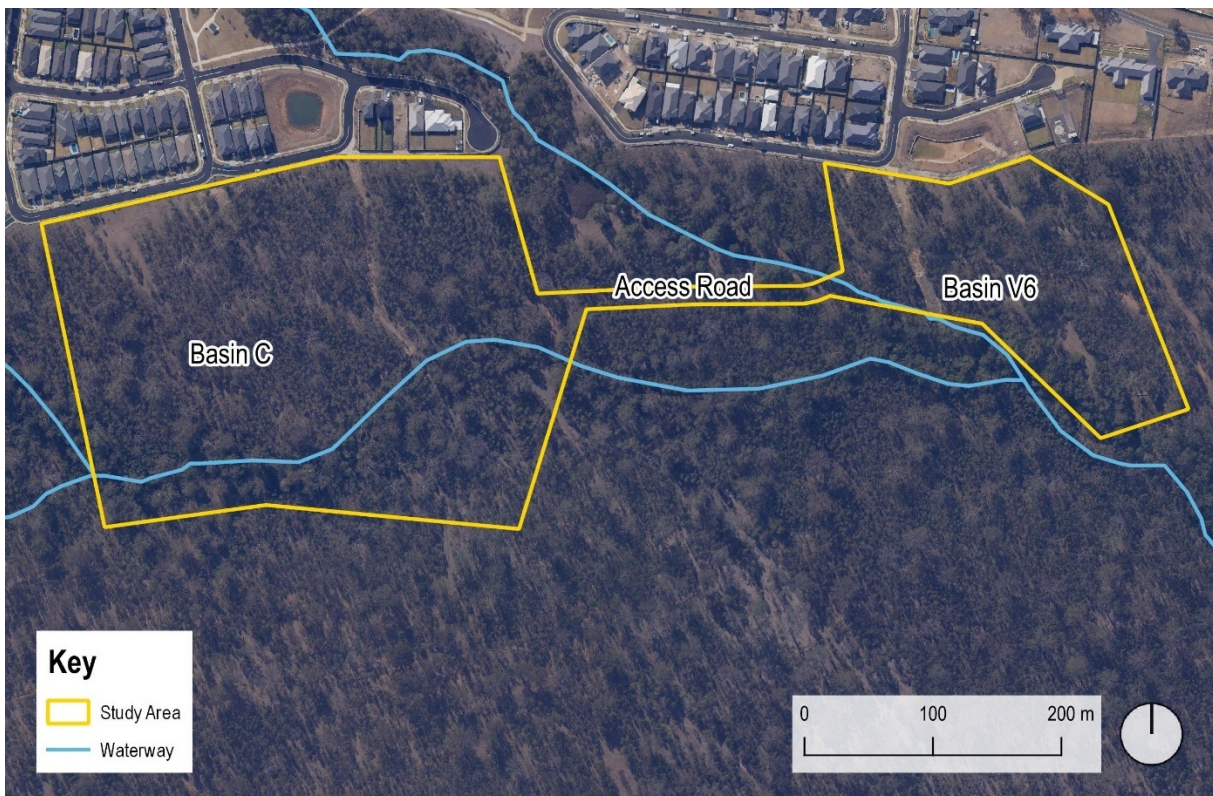
Figure 1.3 Plan showing the proposed AHIP boundary (outlined in yellow), with each basin site labelled. (Source: NSW LPI with GML additions 2019)

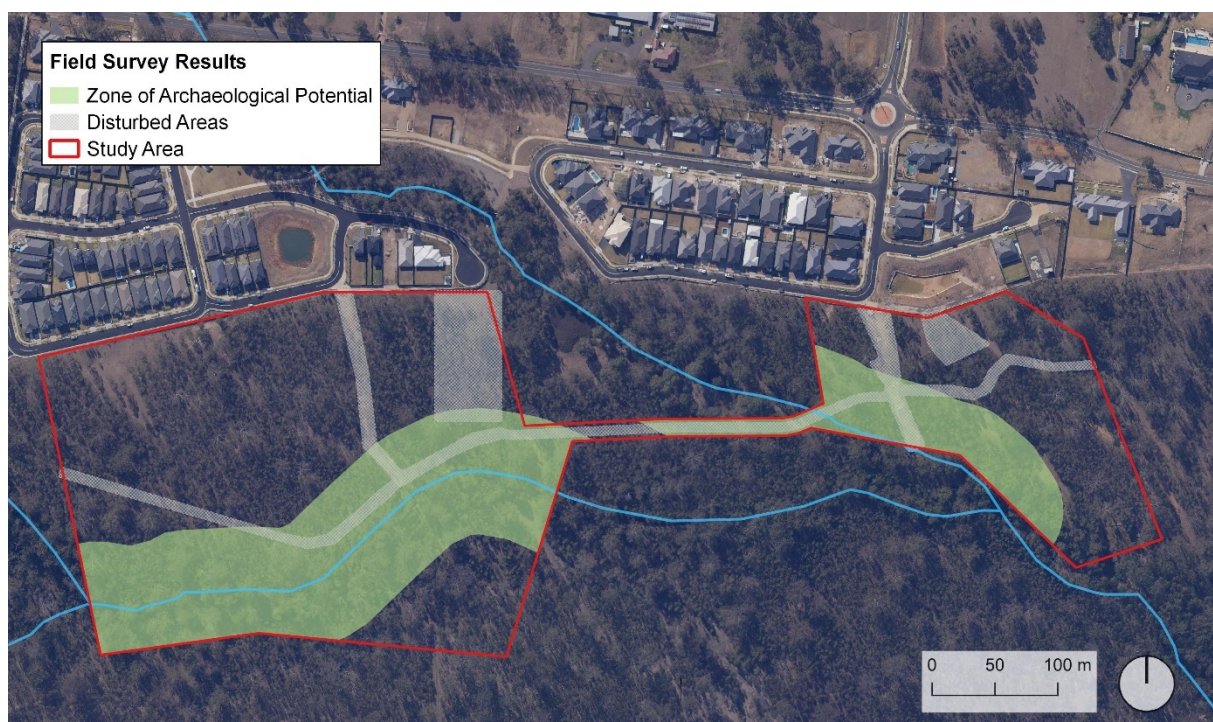
**Figure 2.11** Summary of Aboriginal heritage predictive modelling for the project area. (Source: NSW LPI with GML additions 2020)

The outcomes from the modelling, contrasted against the history of recent land use, provide an indication of locations and landforms that could be connected with physical (tangible) aspects of Aboriginal heritage. These locations are presented in Figure 2.11.

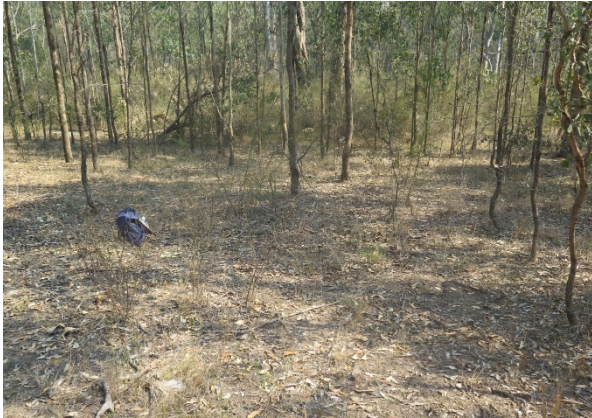
**Figure 3.3** Looking north across the location of Basin C AS3 in Survey Unit 3. (Source: GML 2019)

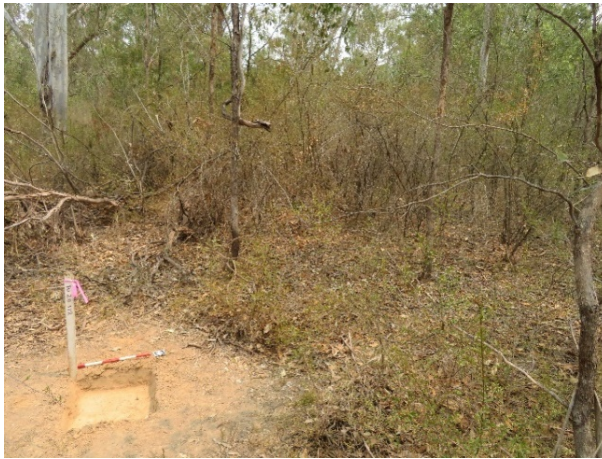
Figure 5.2 Looking south from TU28 into thick vegetation along the creek margin.

The landform at this location is a very gentle flat that slopes down (1.5% gradient) towards the east (Figure 5.2, Figure 5.3). The soils in this area are characterised as the Luddenham soil profile (Figure 5.4). The A<sub>1</sub> horizon was not observed in any of the TUs. A new A<sub>1</sub> layer was in the process of forming and contained frequent fine rootlets. The A<sub>2</sub> horizon comprised a heavily compacted greyish brown (10YR 6/3) or yellow brown (10YR 5/4) fine silty clay or silty loam, on average 300–400mm thick. This overlies a yellow brown waxy clay (7.5YR 4/4), or dull reddish-brown clay/silty clay B horizon. The A<sub>2</sub>/B transition is gradual (50–100mm) (Figure 5.5). Evidence of bioturbation from insect burrows and tree roots was noted in many of the test pits.

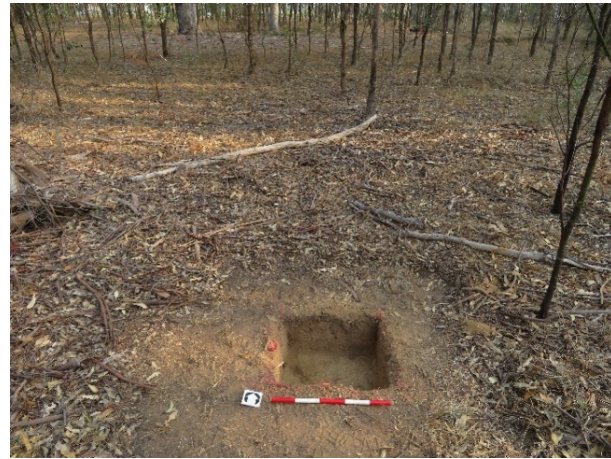
Figure 5.3 The typical landscape across much of Basin C Area 1 showing sparse tree regrowth and dense leaf litter covering the ground surface. As8

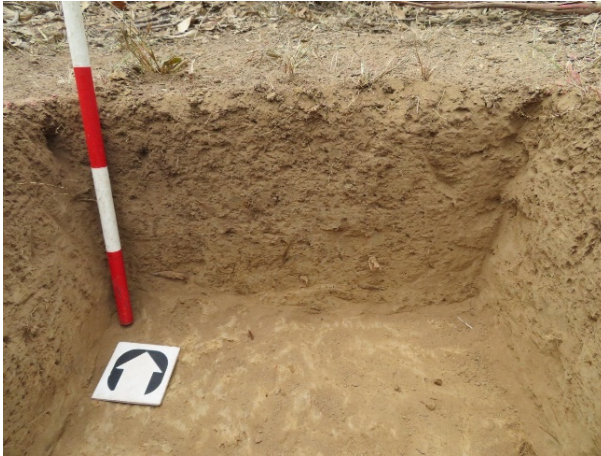
**Figure 5.4** North wall of TU8 showing typical Luddenham soil profile encountered across Basin C Area 1, with truncated A<sub>2</sub>.

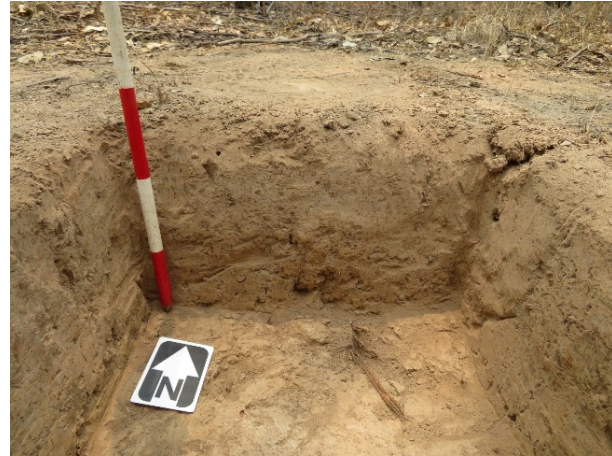
**Figure 5.5** North wall of TU34, showing gradual transition from A<sub>2</sub> to B horizon.

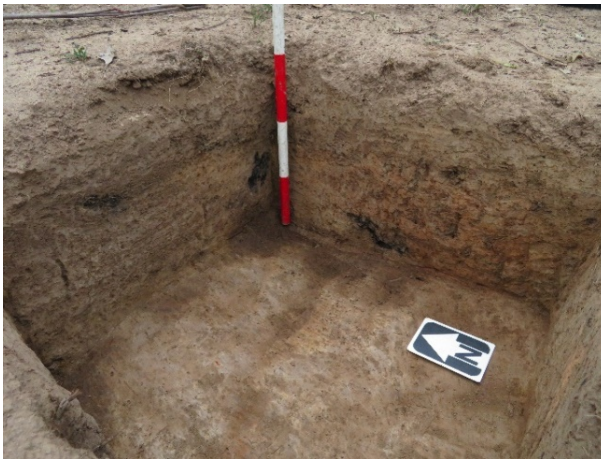
**Figure 5.6** North and east walls of TU11 showing redeposited soil overlying an intact A<sub>2</sub> horizon (transition indicated by grey lines).

Evidence for past ground disturbance was noted in multiple areas. TU11 contained 100mm of redeposited A<sub>2</sub> soil and 150mm of silty clay was identified overlying a truncated but intact A<sub>2</sub> horizon (Figure 5.6). This is likely associated with the creation of an access route across the study area that is visible on a 1955 aerial of the site (Figure 2.5). TU21, located 45m south of TU11, also showed evidence of disturbance, with 100mm of redeposited bright orange silty clay capping an intact soil profile (Figure 5.7). This also appears to relate to the grading of an access road visible on the 1955 aerial (Figure 2.5).

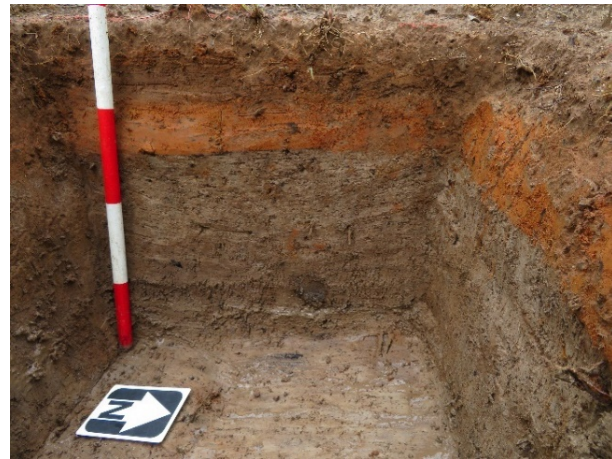
**Figure 5.7** West wall of TU21 showing clay fills associated with road construction overlying intact A<sub>2</sub> horizon.

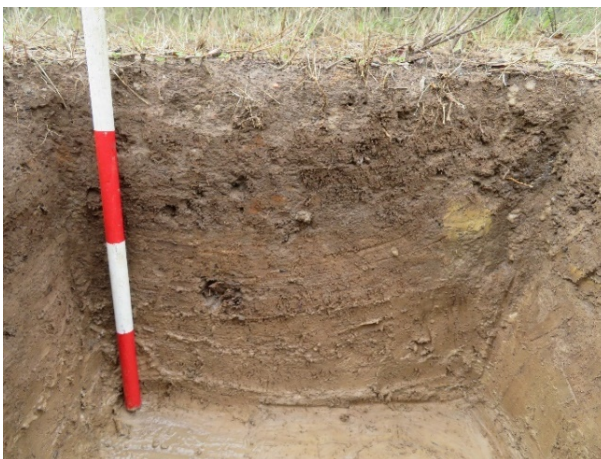
**Figure 5.8** Wall of TU36 showing redeposited material overlying intact A<sub>2</sub> horizon.

TUs 24, 27, 35, 36, and 39 are located within a few metres of the access road that runs through the Basin C study area. Evidence of disturbance associated with construction of the road was observed at these test pits. This generally consisted of 100–200mm of fill (redeposited or reworked A<sub>2</sub> soils) overlying a truncated but intact A<sub>2</sub> soil horizon (Figure 5.8).

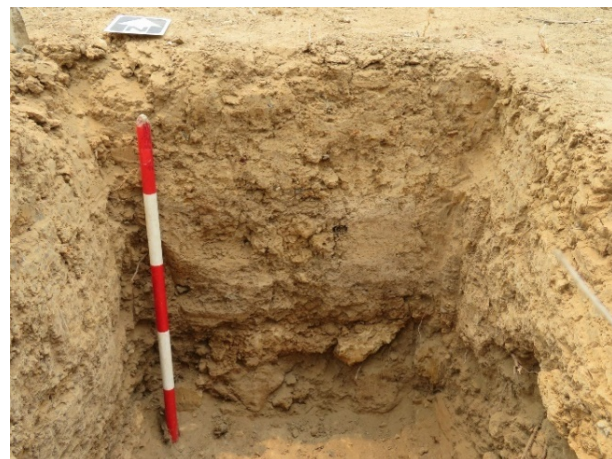
**Figure 5.9** Northern wall of TU46 showing fill to 500mm depth.

TU46 was also heavily disturbed. The pit was excavated to a depth of 0.55m below the modern ground level, with the fill containing concrete, brick and redeposited clay. The pit was located in a depression that had been backfilled and may relate to an old stormwater drain or infilled creek (Figure 5.9).

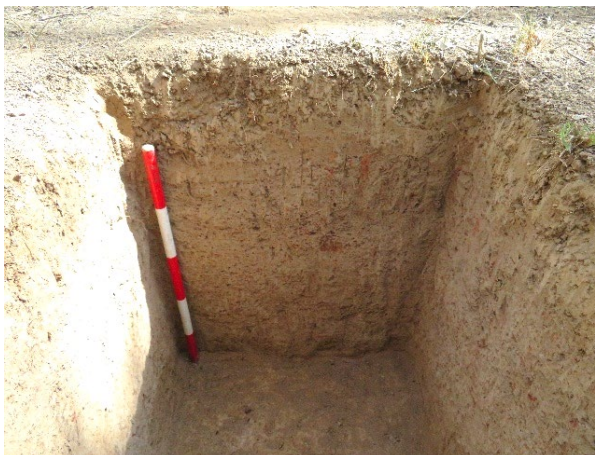
**Figure 5.12** Wall of TU71 showing deeper soil profile encountered in this part of the study area.

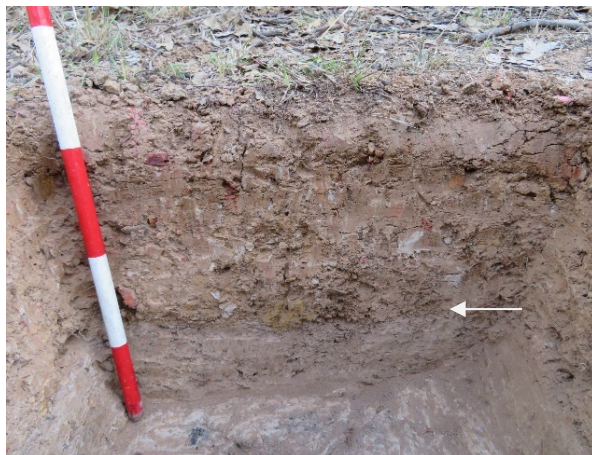
**Figure 5.13** Wall of TU83 showing 250mm of introduced clay fill overlying a truncated A<sub>2</sub> soil profile (arrow).

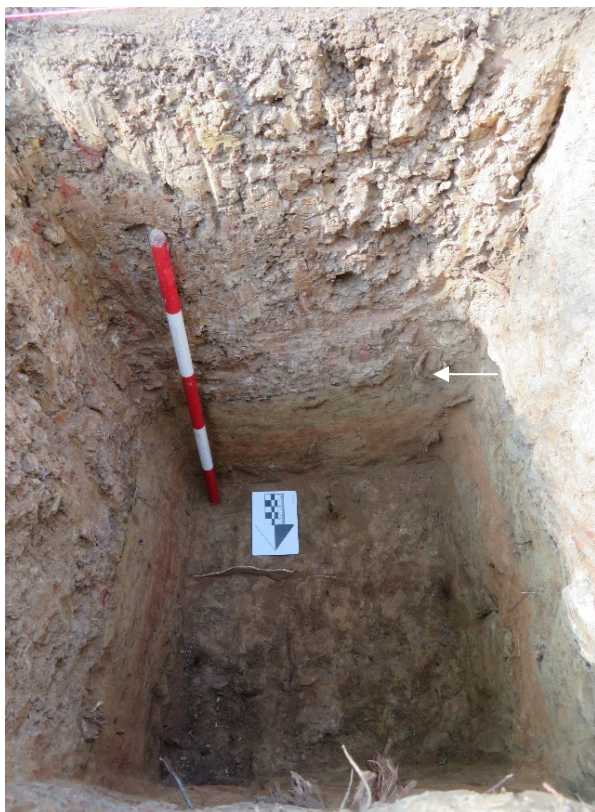
**Figure 5.14** South wall of TU84 showing a deep layer (~500mm) of imported fill overlying a truncated A<sub>2</sub> soil profile. The top of the A<sub>2</sub> is indicated (arrow).

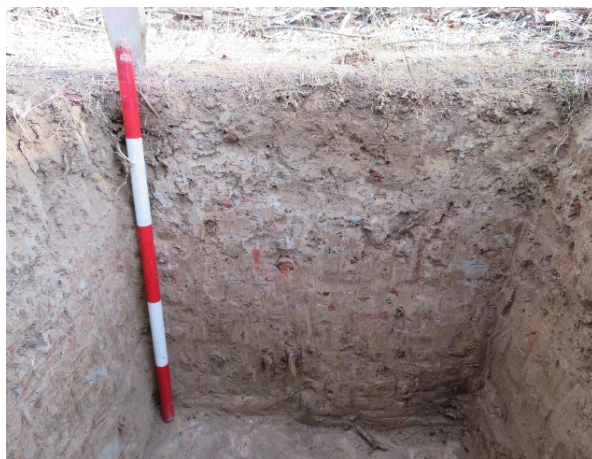
**Figure 5.15** Wall of TU90 showing imported fill directly overlying the B horizon clay. The A<sub>2</sub> horizon was not present.

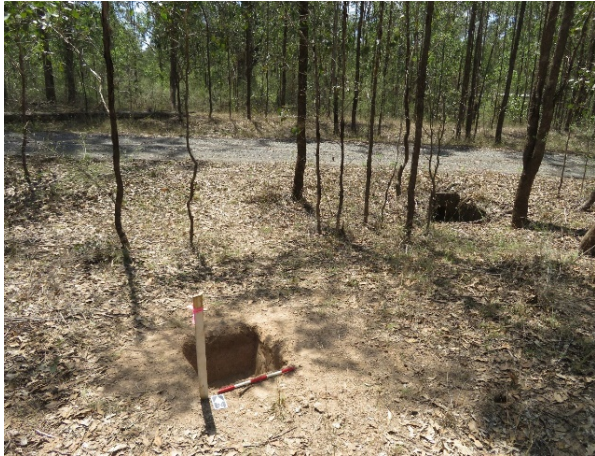
**Figure 5.16** Looking north at TU88 showing a typical landscape across Basin C Area 2.

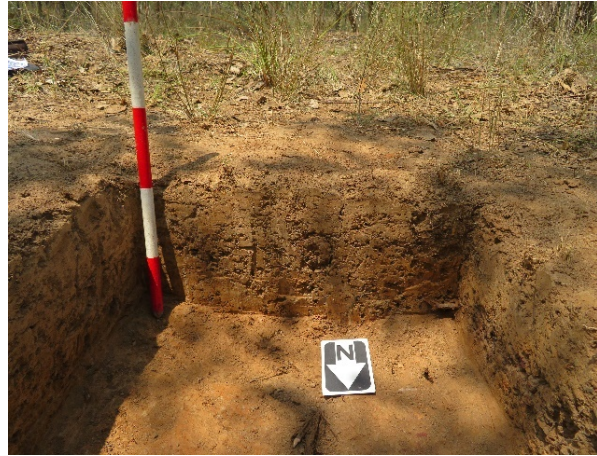
**Figure 5.17** South wall of TU66 showing shallow soil profile found in TUs 62–66, 68–69.

At the western end of Basin C Area 2, the shallow profile noted in TUs 63 and 64 (<10mm) is likely the result of sheet erosion associated with historic land clearance (Figure 5.17).

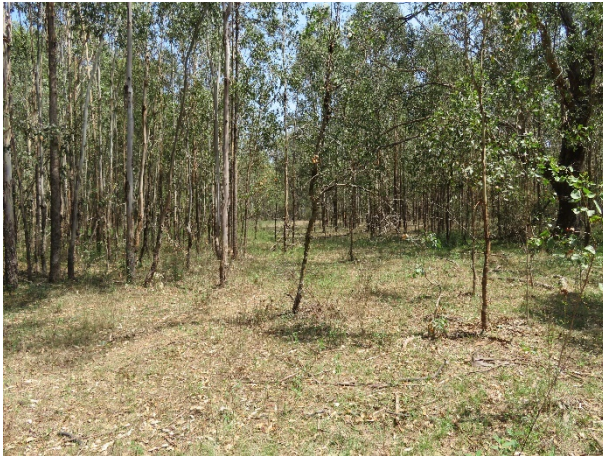
**Figure 5.19** Looking northwest from the centre of Basin V6 showing typical vegetation cover.

The landform at this location is a flat bordering the creek (Figure 5.19). TUs 112, 113 and 121 are located in an open depression adjacent to the creek. TUs 125 and 126 are located at the base of a simple slope that rises up towards the northeast. Local relief across the area is between 27m–29m AHD.

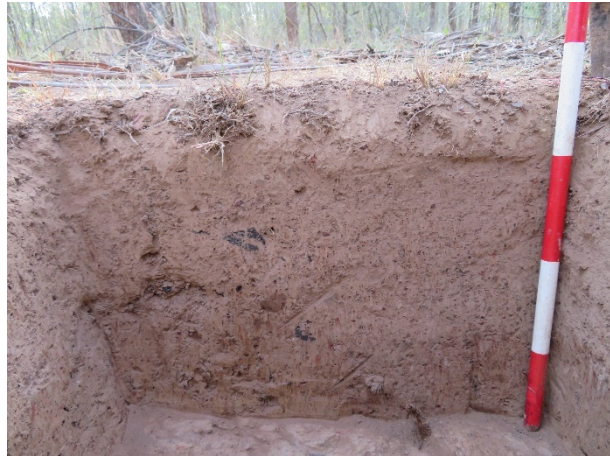
**Figure 5.20** Wall of TU111 showing Luddenham soil profile consistent with Basin C. Scale is 0.1m increments.

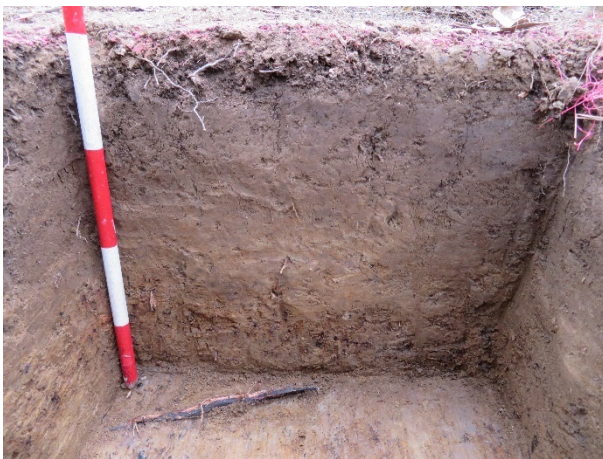
**Figure 5.21** Wall of TU113, located in an open depression adjacent to the creek. TU113 and TU121 exhibited more clayey soil profiles.

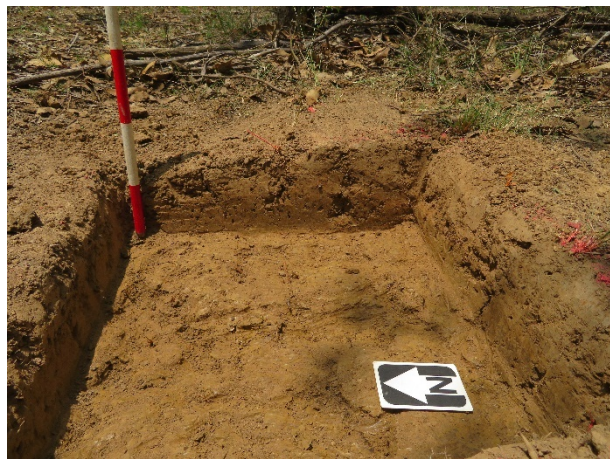
**Figure 5.22** TU112 showing shallow profile, likely truncated by road construction in the mid-twentieth century. Scale is 0.1m increments.

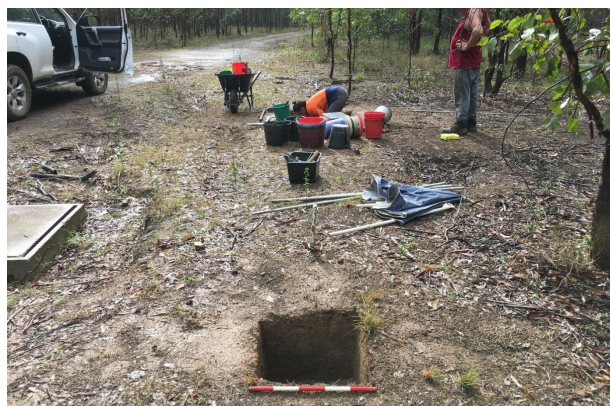
**Figure 5.24** Looking east at TU129 (foreground) and TU110 (background), with the excavation team in action.

At TU110 the testing recovered a concentration of artefacts. The initial TU (TU110B) yielded 34 artefacts, triggering the expansion to a 1m<sup>2</sup> pit. Due to the proximity of a tree to the southeast, the TU was expanded to the west and south. A letter was assigned to each of the four 50cm x 50cm units as shown in Figure 5.23. A total of 139 artefacts were recovered from the expanded TU110. Three additional pits were located to the east (TU128), south (TU127) and west (TU129) to identify the extent of the deposit (Figure 5.24). Two artefacts were recovered from TU128 and one from TU129. This would suggest that TU110 is the center of a discrete artefact site.

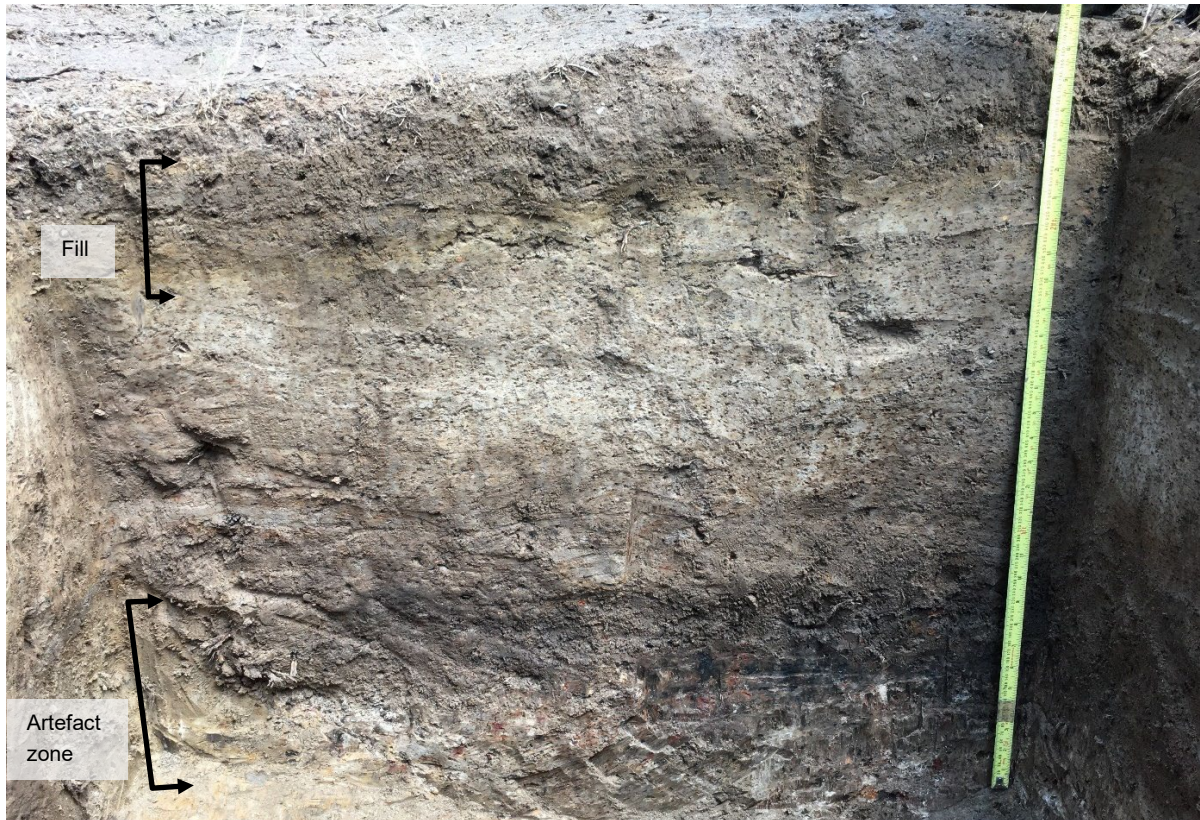
**Figure 5.25** East-facing section in TU110 showing the depth of fill capping the intact soil profile, and lower spits (6–8) from which the artefact assemblage was recovered.

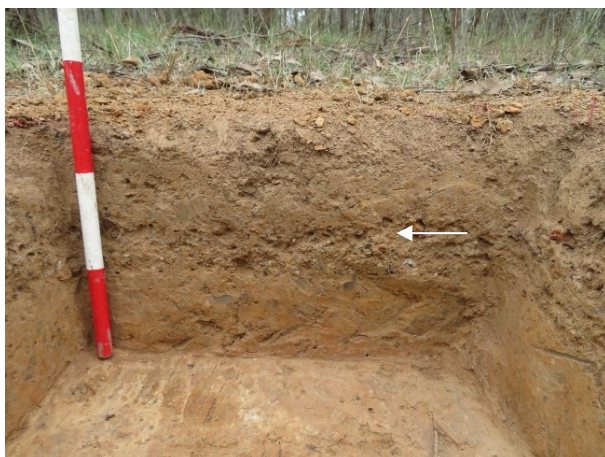
**Figure 5.28** Wall of TU94 with the former road base layer indicated (arrow).

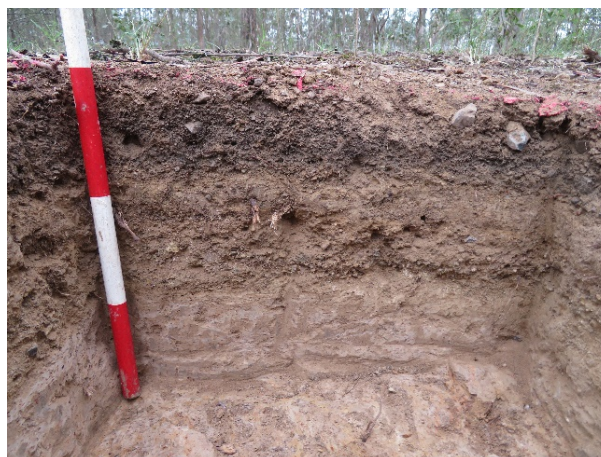
**Figure 5.29** Wall of TU106 gravel-rich fill overlying a truncated A<sub>2</sub> horizon.

The access road crosses a second order creek that runs through the eastern part of the study area and a culvert was constructed at this location. Evidence for raising of the ground surface associated with construction of the culvert was identified in TUs 105 and 106. TU105 contained a 300mm-thick fill layer, consisting of a compact mid-greyish brown silty clay with frequent large gravel inclusions overlying a thin layer of greyish yellow silty clay at 300mm below the current ground surface. This overlay an intact, albeit truncated, A<sub>2</sub> horizon (clayey silt). TU106 had a similar, although shallower, profile with a 200mm-thick gravelly mid-greyish brown sandy silt layer overlying 100mm of moderately compact mid-greyish brown silty clay (A<sub>2</sub> horizon) (Figure 5.29).

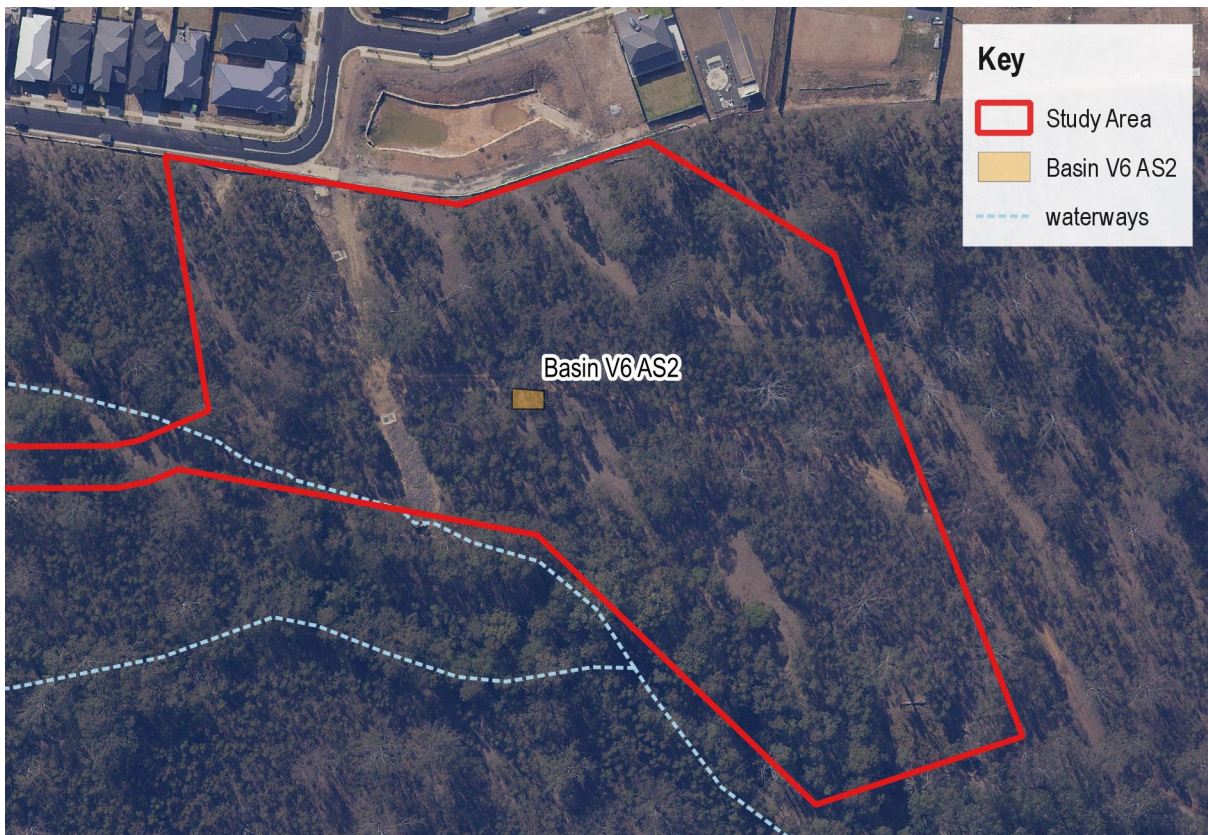
Figure 5.30 Location of Aboriginal site Basin V6 AS2. (Source: NSW LPI with GML additions)

- Basin V6 AS2 (AHIMS #45-5-5369).

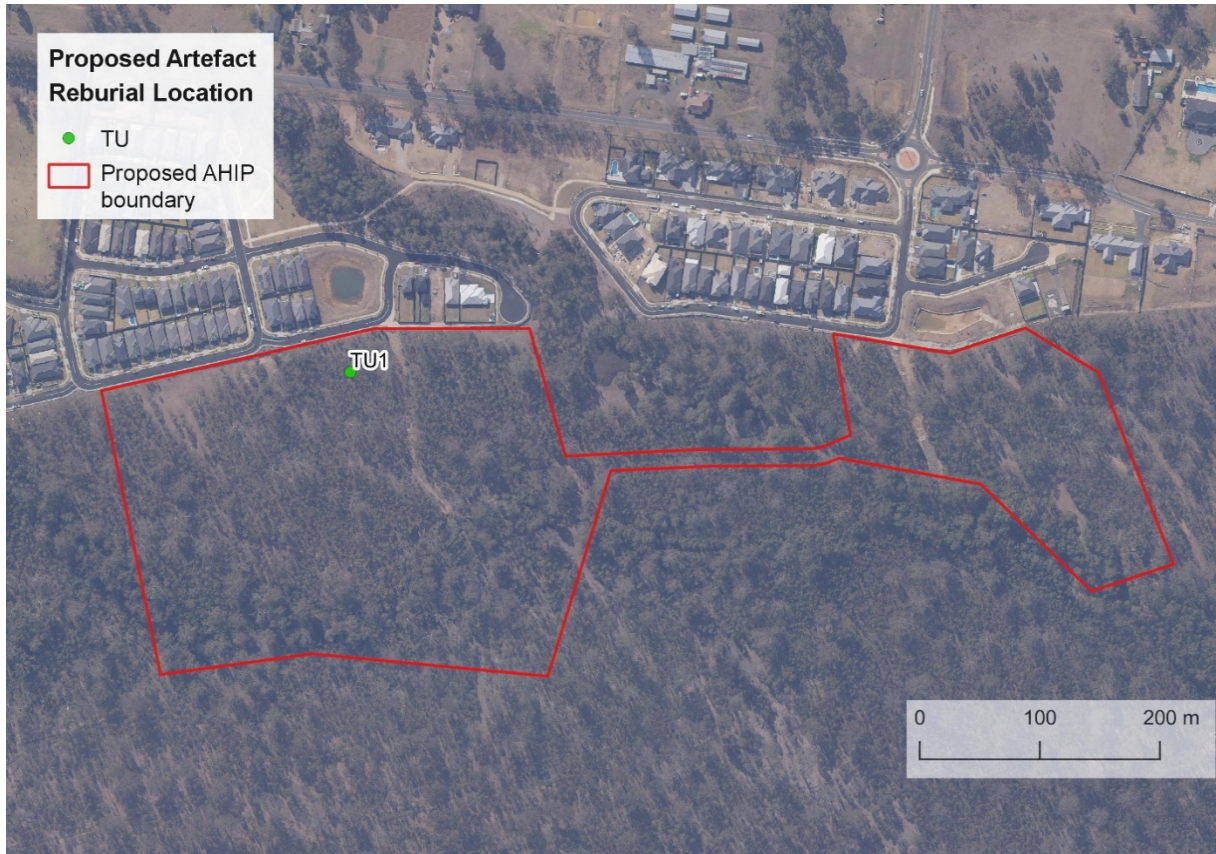
Figure 8.1 Proposed location for the reburial of Aboriginal objects.

6. The stone objects recovered during the test excavation, and any artefacts from the community collection, should be reburied on Country. A location which will be part of the Wianamatta Regional Park has been identified. The location is not associated with any Aboriginal objects. The location is identified in Figure 8.1 (and Figure 5.1 with reference to other test units and recovered Aboriginal object density). The location is TU1; it was excavated during the testing phase and contained no Aboriginal artefacts. The test units surrounding the reburial location also contained zero artefacts. The coordinates of the location are: 290324E, 6267034N (MGA Zone 56).

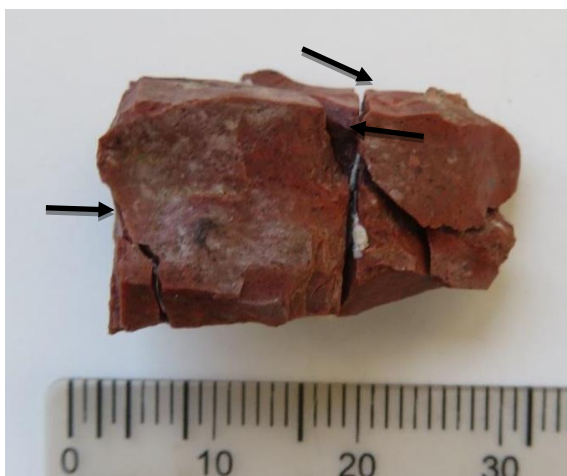
**Figure 2** Artefacts 233 to 237 refit from bipolar percussion. Left to right: core is largest piece #233.

**Figure 3** Artefacts 233 to 237 refit from bipolar percussion. Left to right: core is largest piece #233. Red arrow shows fracture along internal flaw plane, and white arrow shows potlid heat exploded feature.

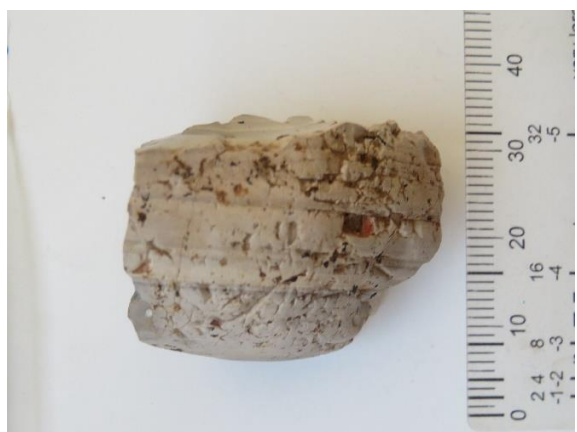
**Figure 5** Mudstone banded core Artefact 123, gravels.

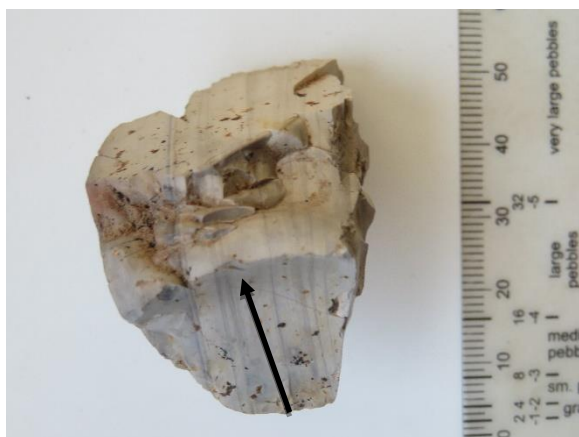
**Figure 6** Mudstone banded core Artefact 123. Arrows indicate alternating flaking direction producing bifacial core type.

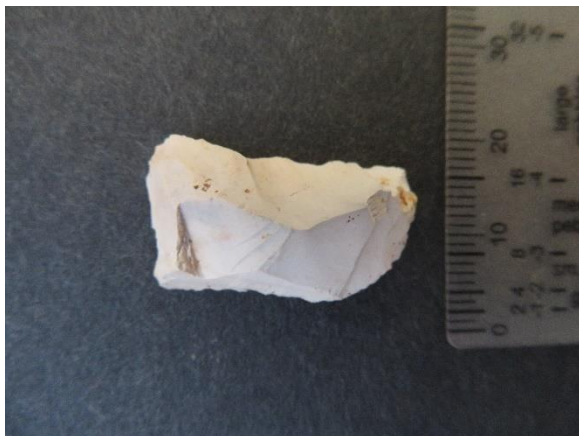
Figure 7 Notch tool, Artefact 206 dorsal.

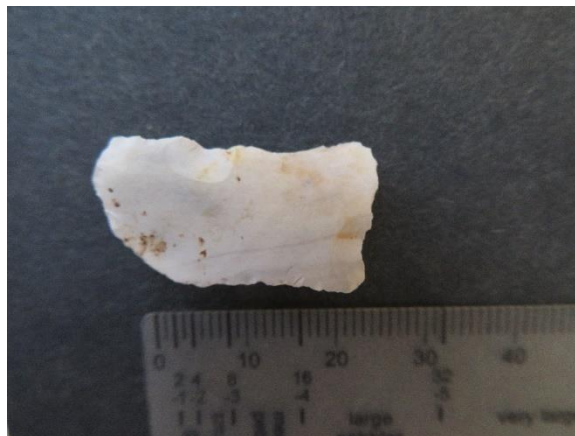
Figure 8 Notch tool, Artefact 206 ventral.

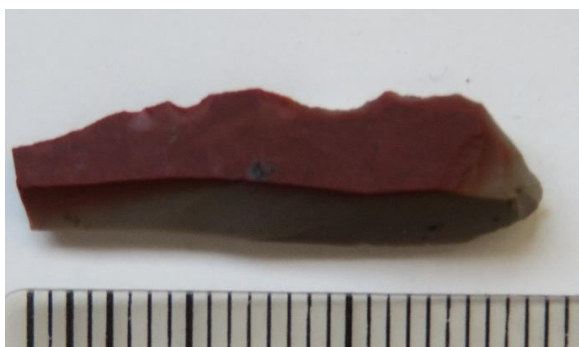
Figure 9 Backed blade on chert, Artefact 205 dorsal.

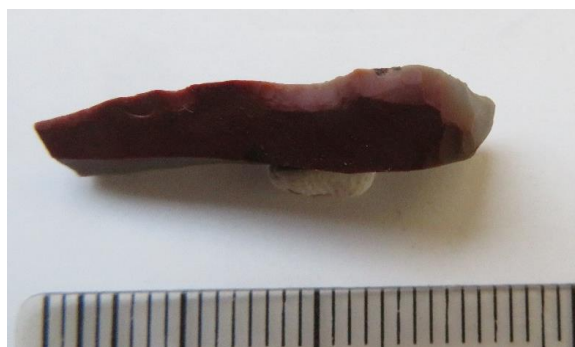
Figure 10 Backed blade on chert, Artefact 205 ventral.
