PRELIMINARY SITE INVESTIGATION

Prepared For: Architecture Design Studio (NSW) Pty Ltd
Address: 118-120 Station Street Penrith, NSW, 2750
Job No: AG-533_1
Date: 18-09-20

This executive summary presents a synopsis of the Preliminary Site Investigation (PSI) Assessment for 118-120 Station Street Penrith, NSW, 2750.

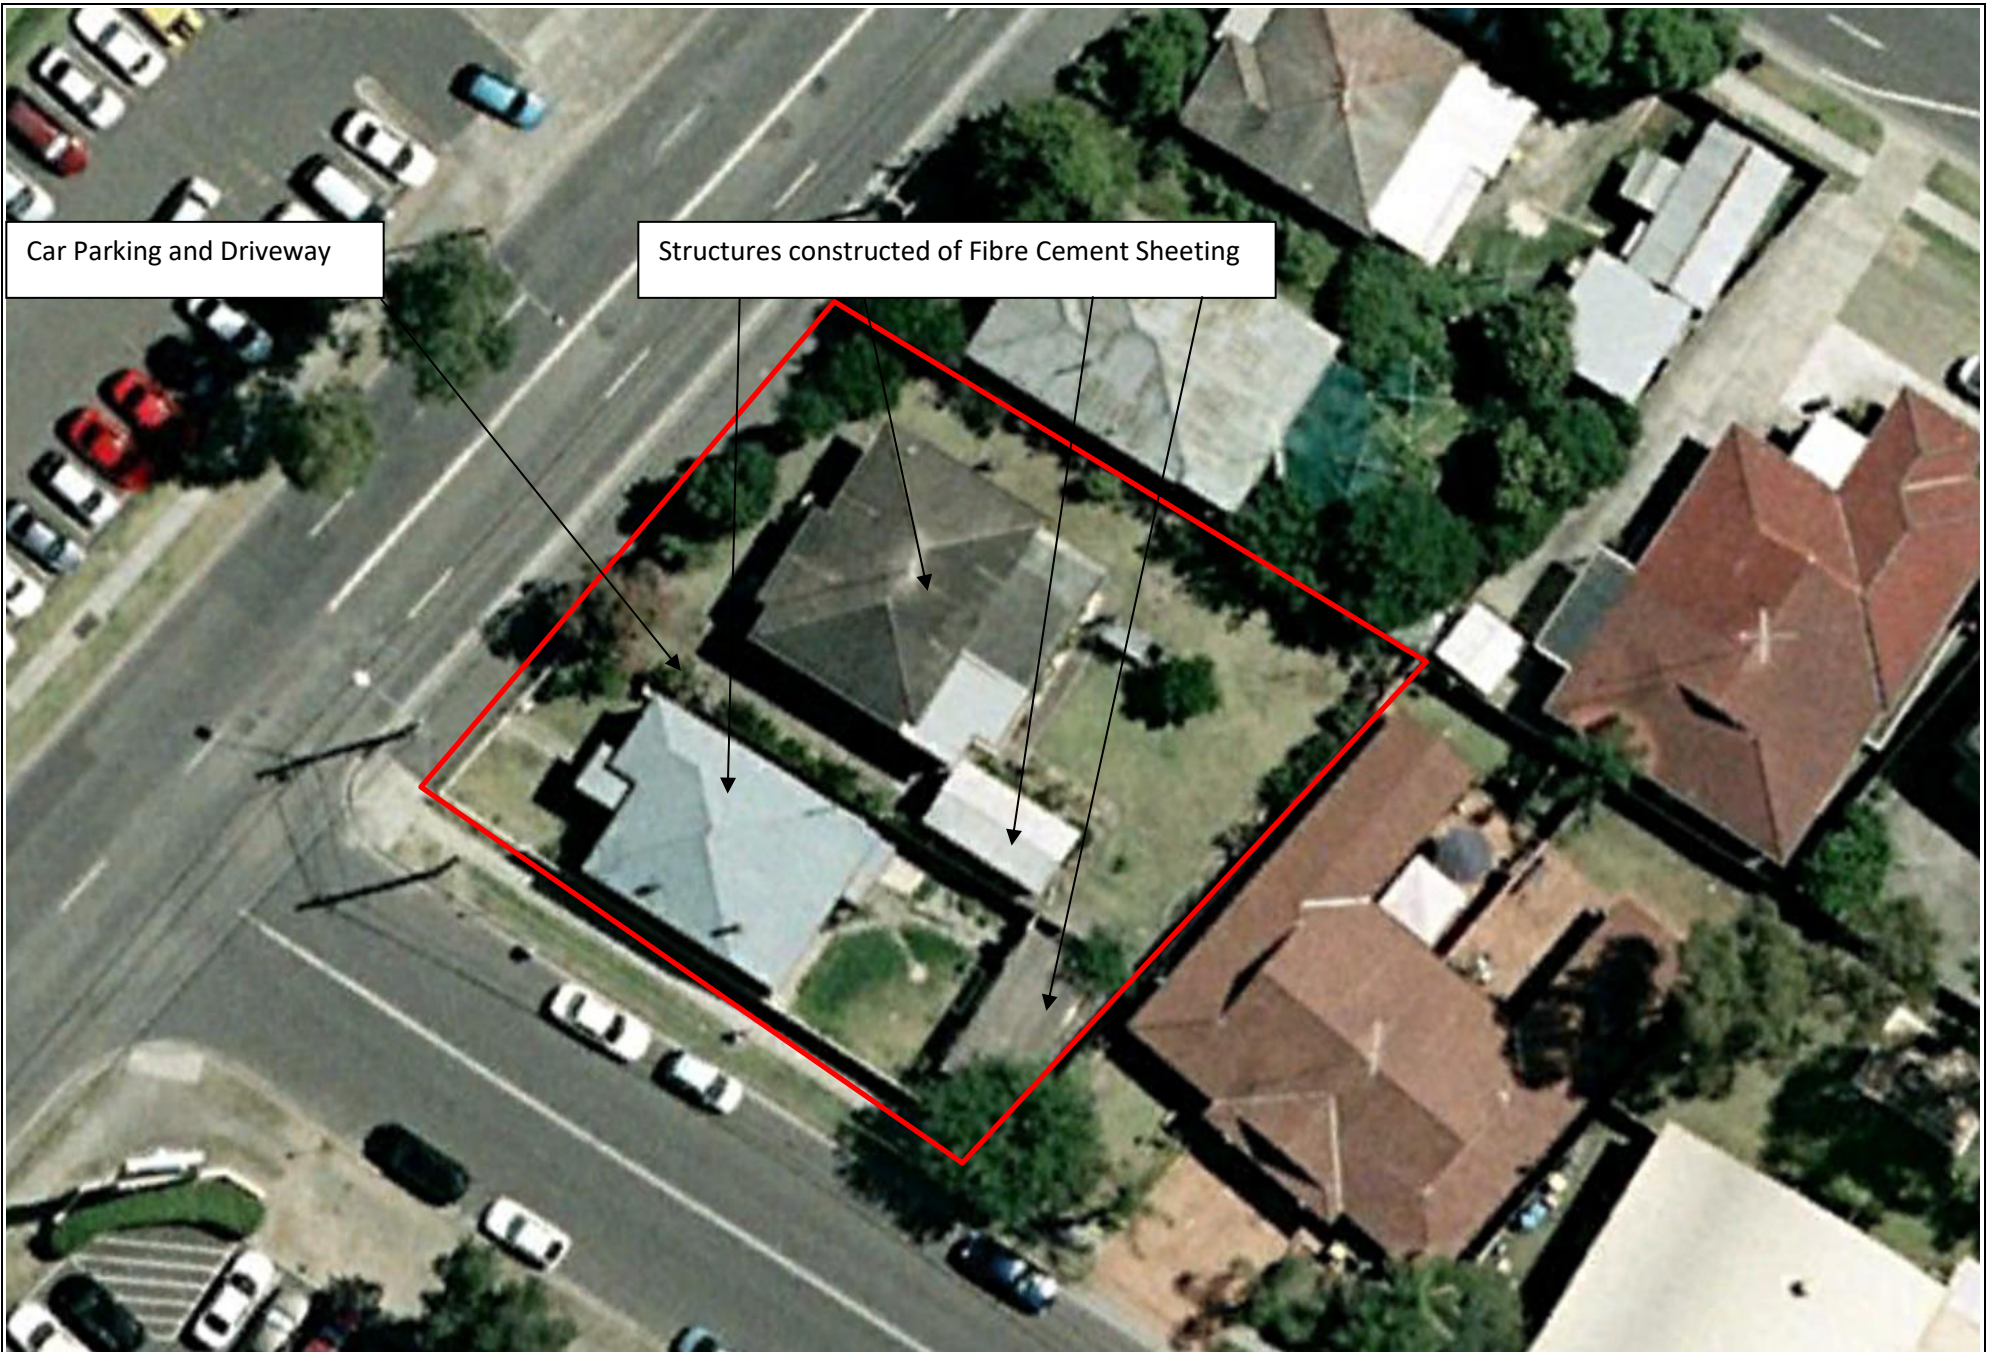
Conceptual Site Model		Architecture Design Studio (NSW) Pty Ltd		Job No	AG-533_1
			118-120 Station Street Penrith, NSW, 2750		Drawing No	AG-533-6DWG
	Drawn By	NS			Ref No	
	Approved By	NS			Scale	Not to scale

Car Parking and Driveway

Structures constructed of Fibre Cement Sheeting

- Building degradation from previous site structures, which includes potential heavy metal and asbestos contamination;
- Importation of fill material that may contain various contaminants; and
- Car park areas where leaks and spills from cars may have occurred.

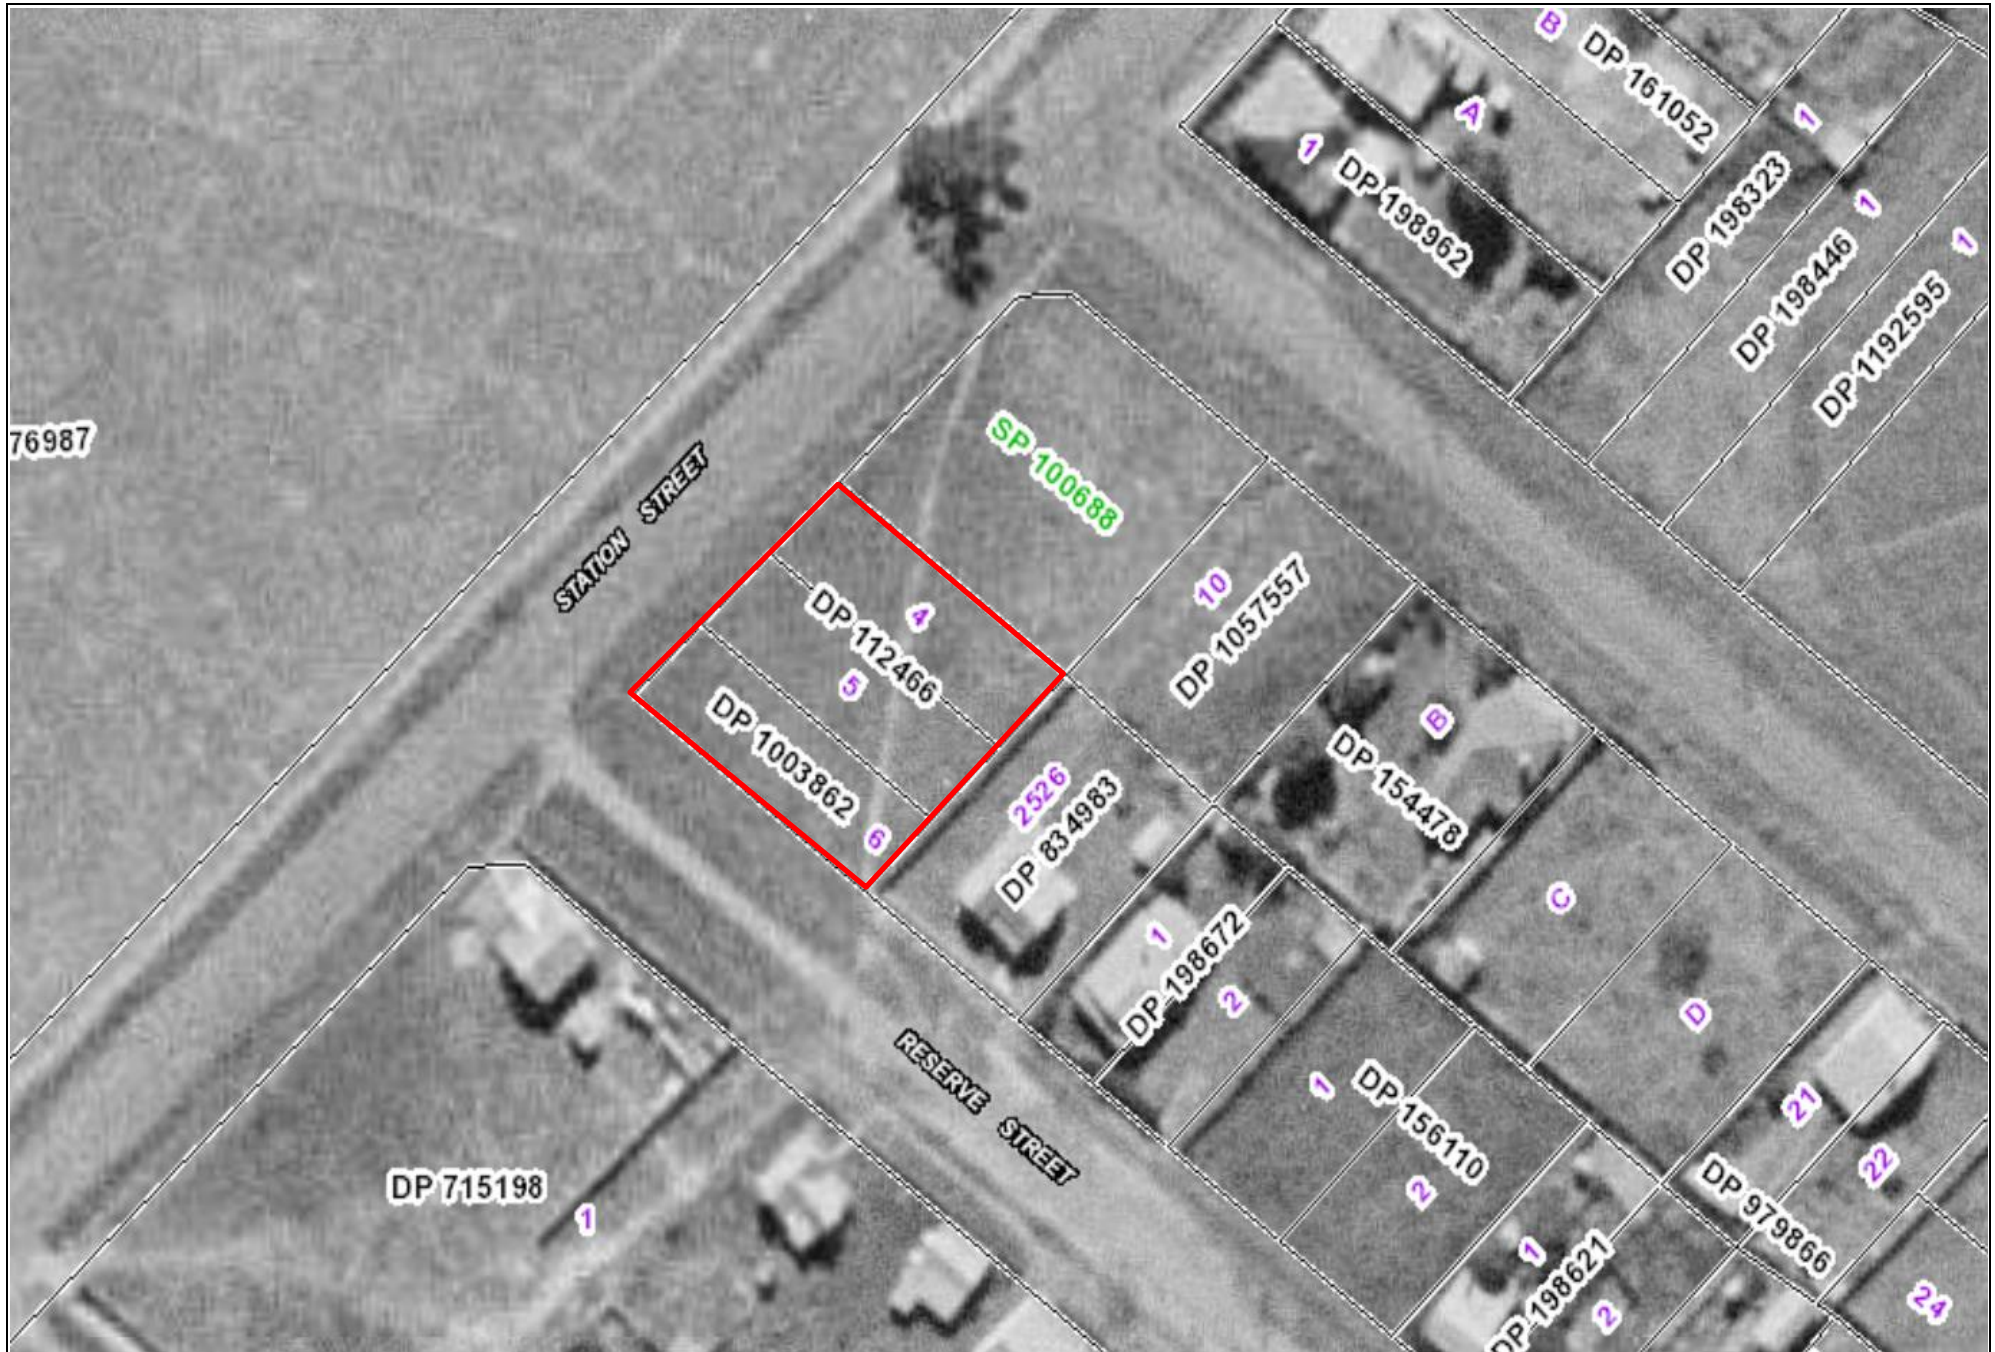
1943		Architecture Design Studio (NSW) Pty Ltd		Job No		AG-533_1
			118-120 Station Street Penrith, NSW, 2750		Drawing No		AG-533-2DWG
	Drawn By		NS		Ref No		
	Approved By		NS		Scale		Not to scale

1943 – The site appears to be vacant. Some residential development can be seen around the subject site. Reserve and Station Street has been formed;

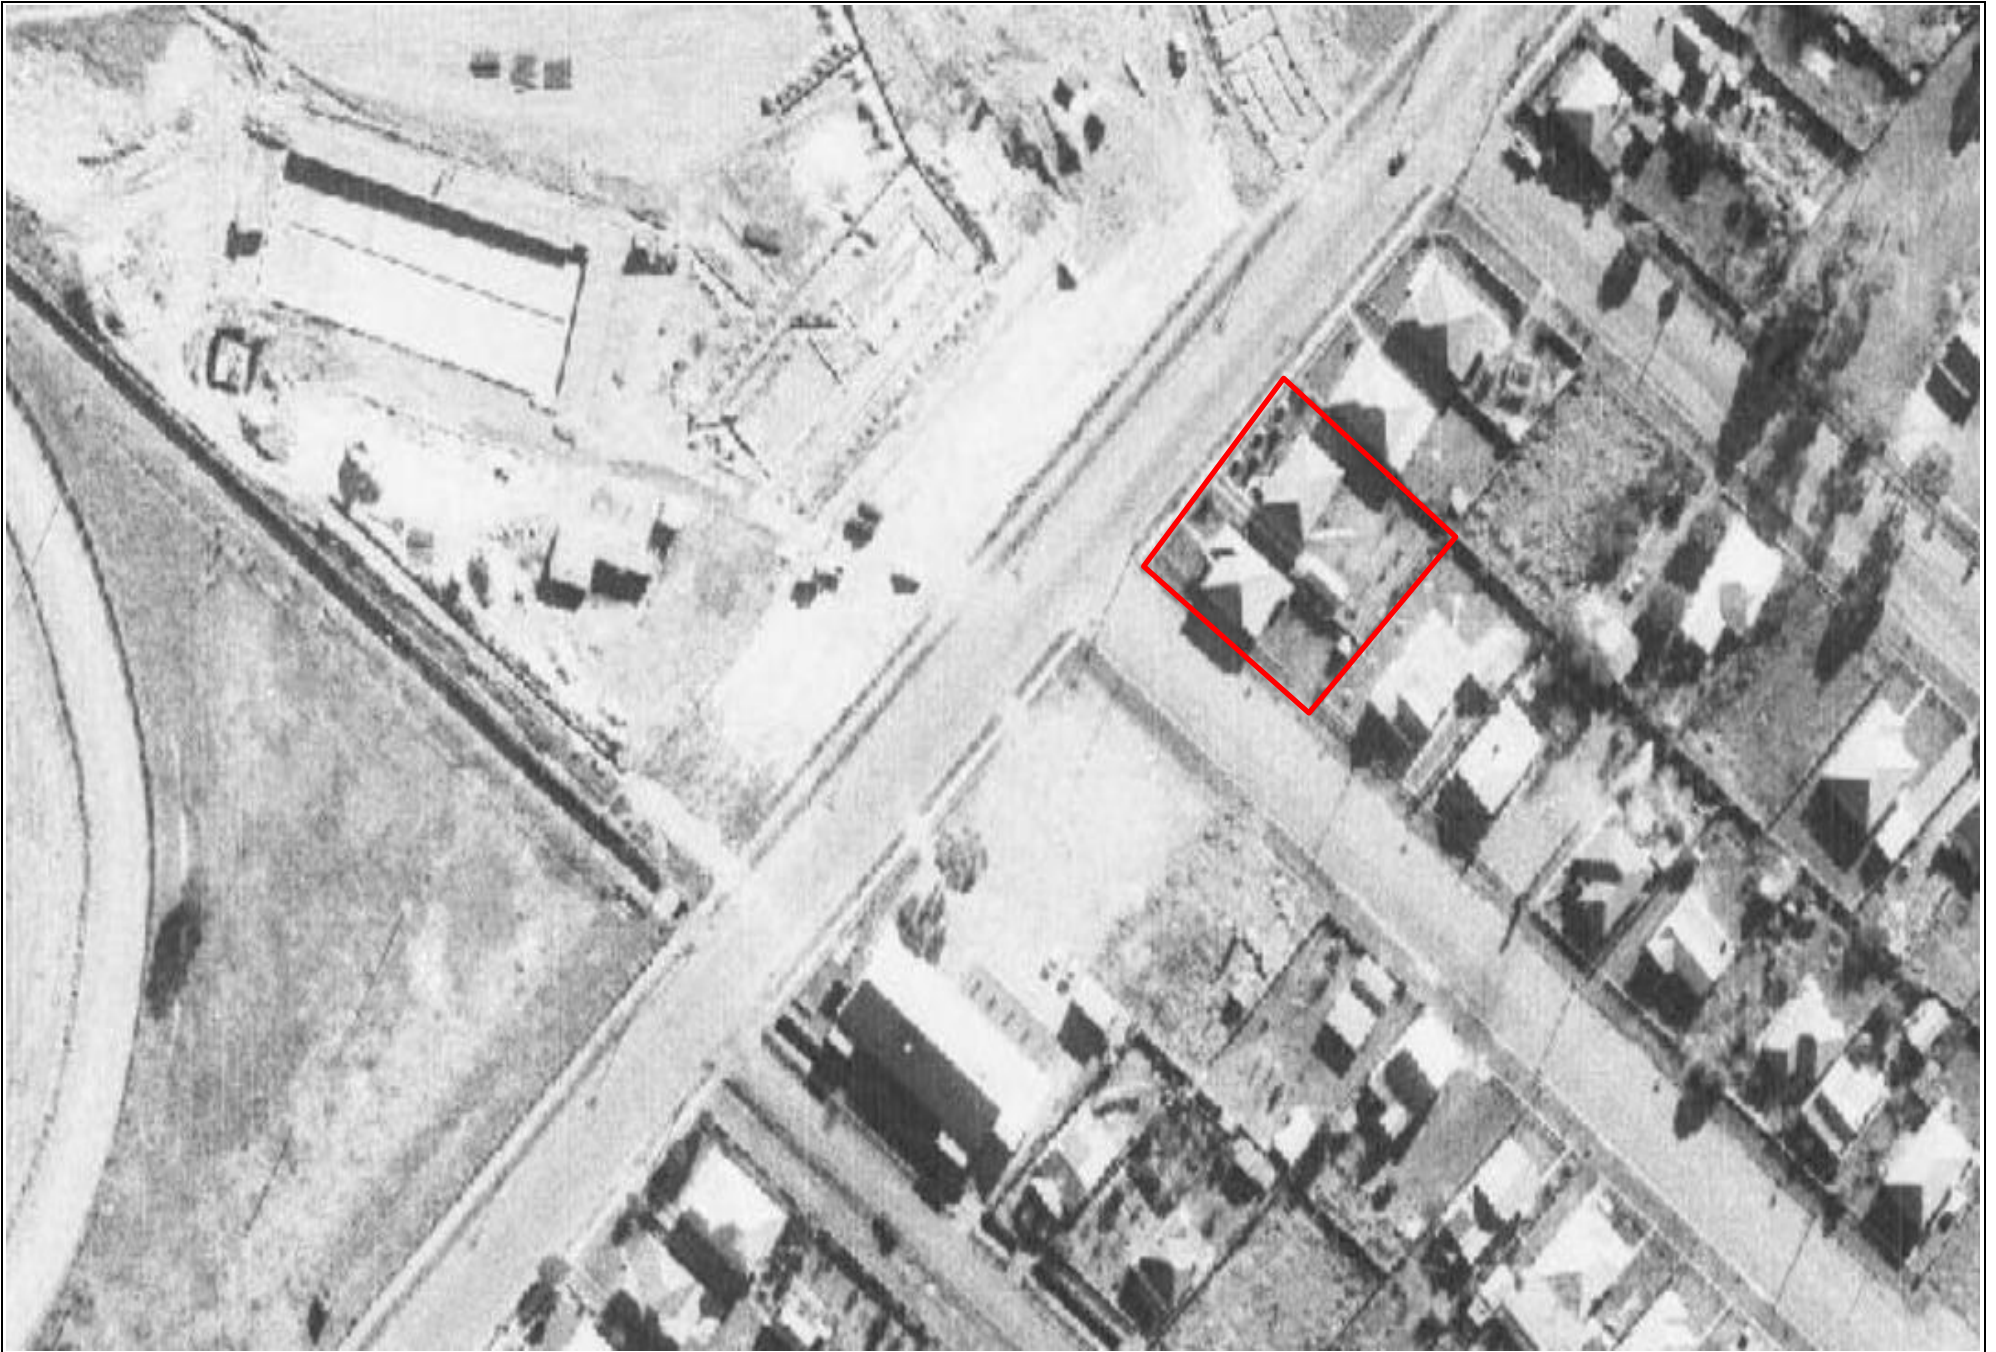
1961	Architecture Design Studio (NSW) Pty Ltd		Job No	AG-533_1
		118-120 Station Street Penrith, NSW, 2750		Drawing No	AG-533-5DWG
		Drawn By	NS	Ref No	
		Approved By	NS	Scale	Not to scale

1961- Two (2) low density residential structures appear to occupy the north-western portion of site. A detached garage can be seen adjacent to the residential structures;

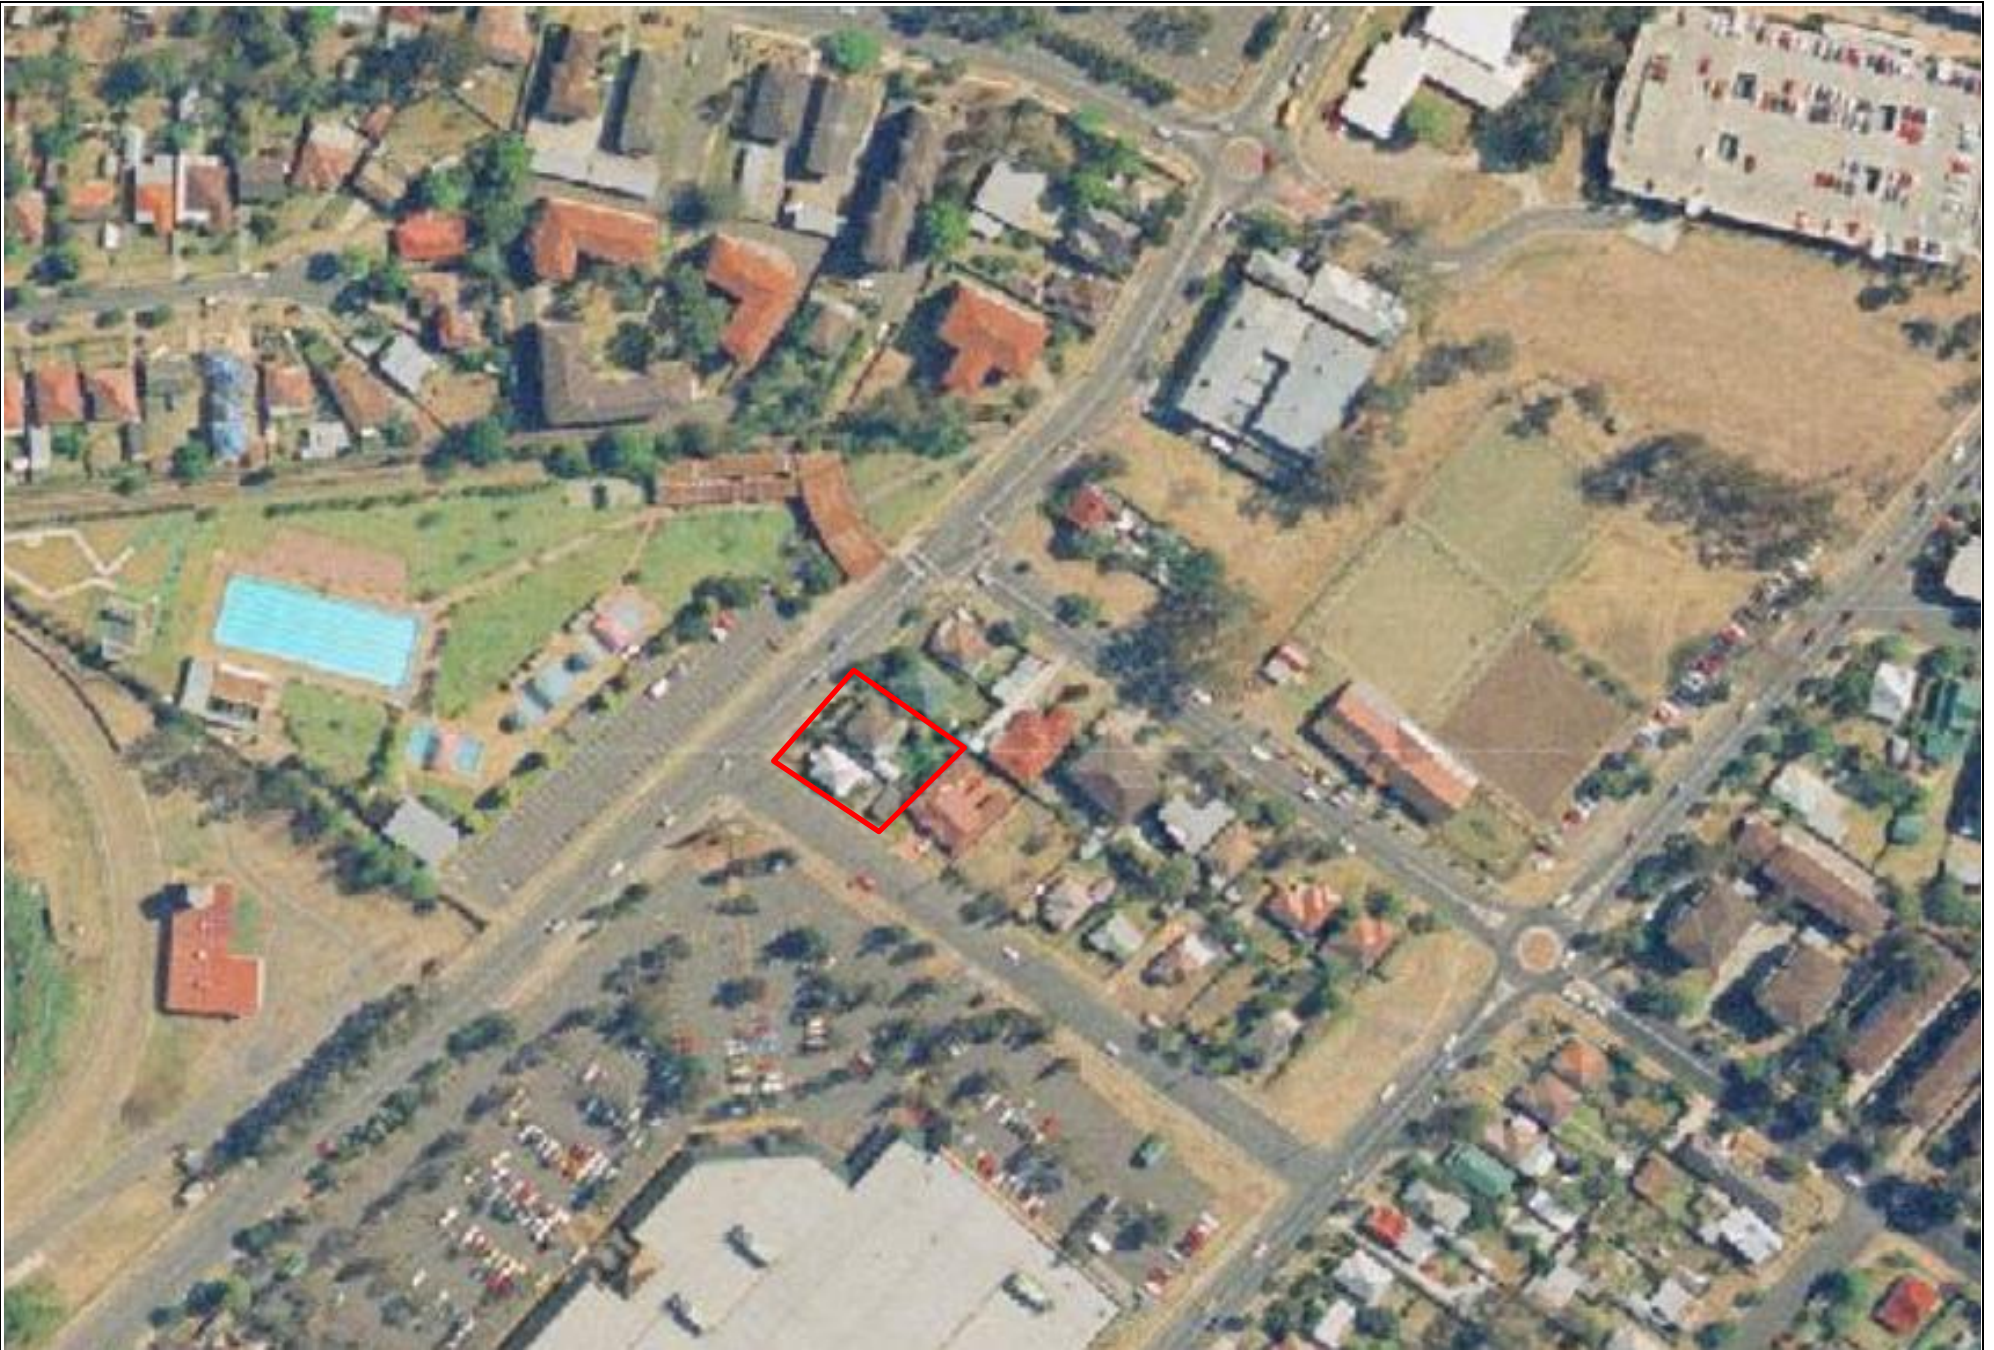
1994	Architecture Design Studio (NSW) Pty Ltd		Job No	AG-533_1
		118-120 Station Street Penrith, NSW, 2750		Drawing No	AG-533-3DWG
		Drawn By	NS	Ref No	
		Approved By	NS	Scale	Not to scale

1994– The image isn't clear, however no change can be seen across the site;

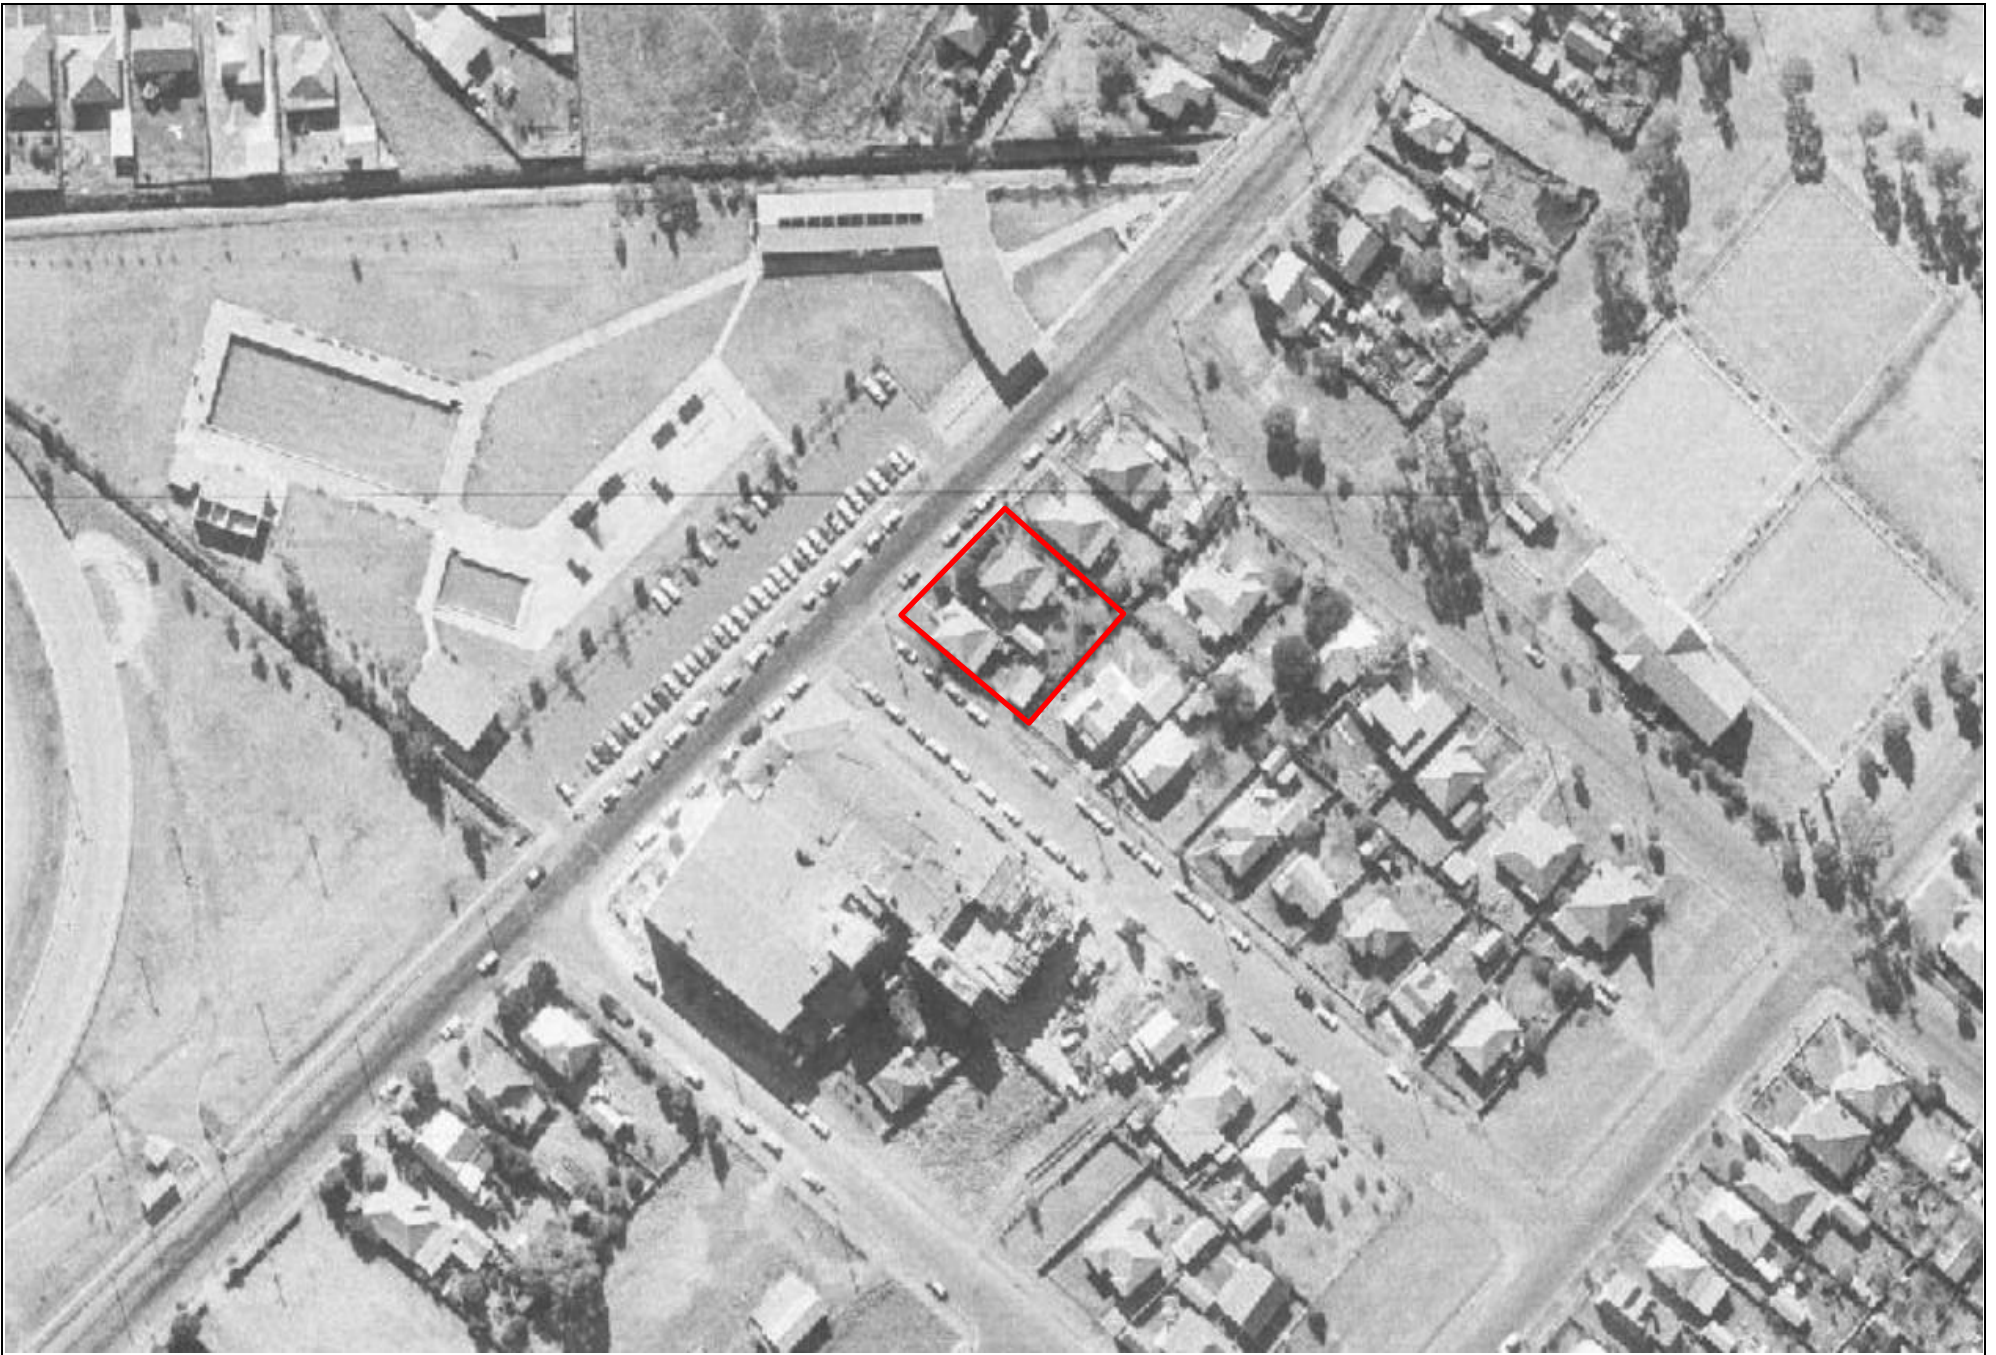
1970	Architecture Design Studio (NSW) Pty Ltd		Job No	AG-533_1
		118-120 Station Street Penrith, NSW, 2750		Drawing No	AG-533-4DWG
	Drawn By	NS	Ref No		
	Approved By	NS	Scale	Not to scale

1970– Generally the same as 1961. An additional detached structure (garage) can be seen within the southern portion of site, additional vegetation growth can be observed;

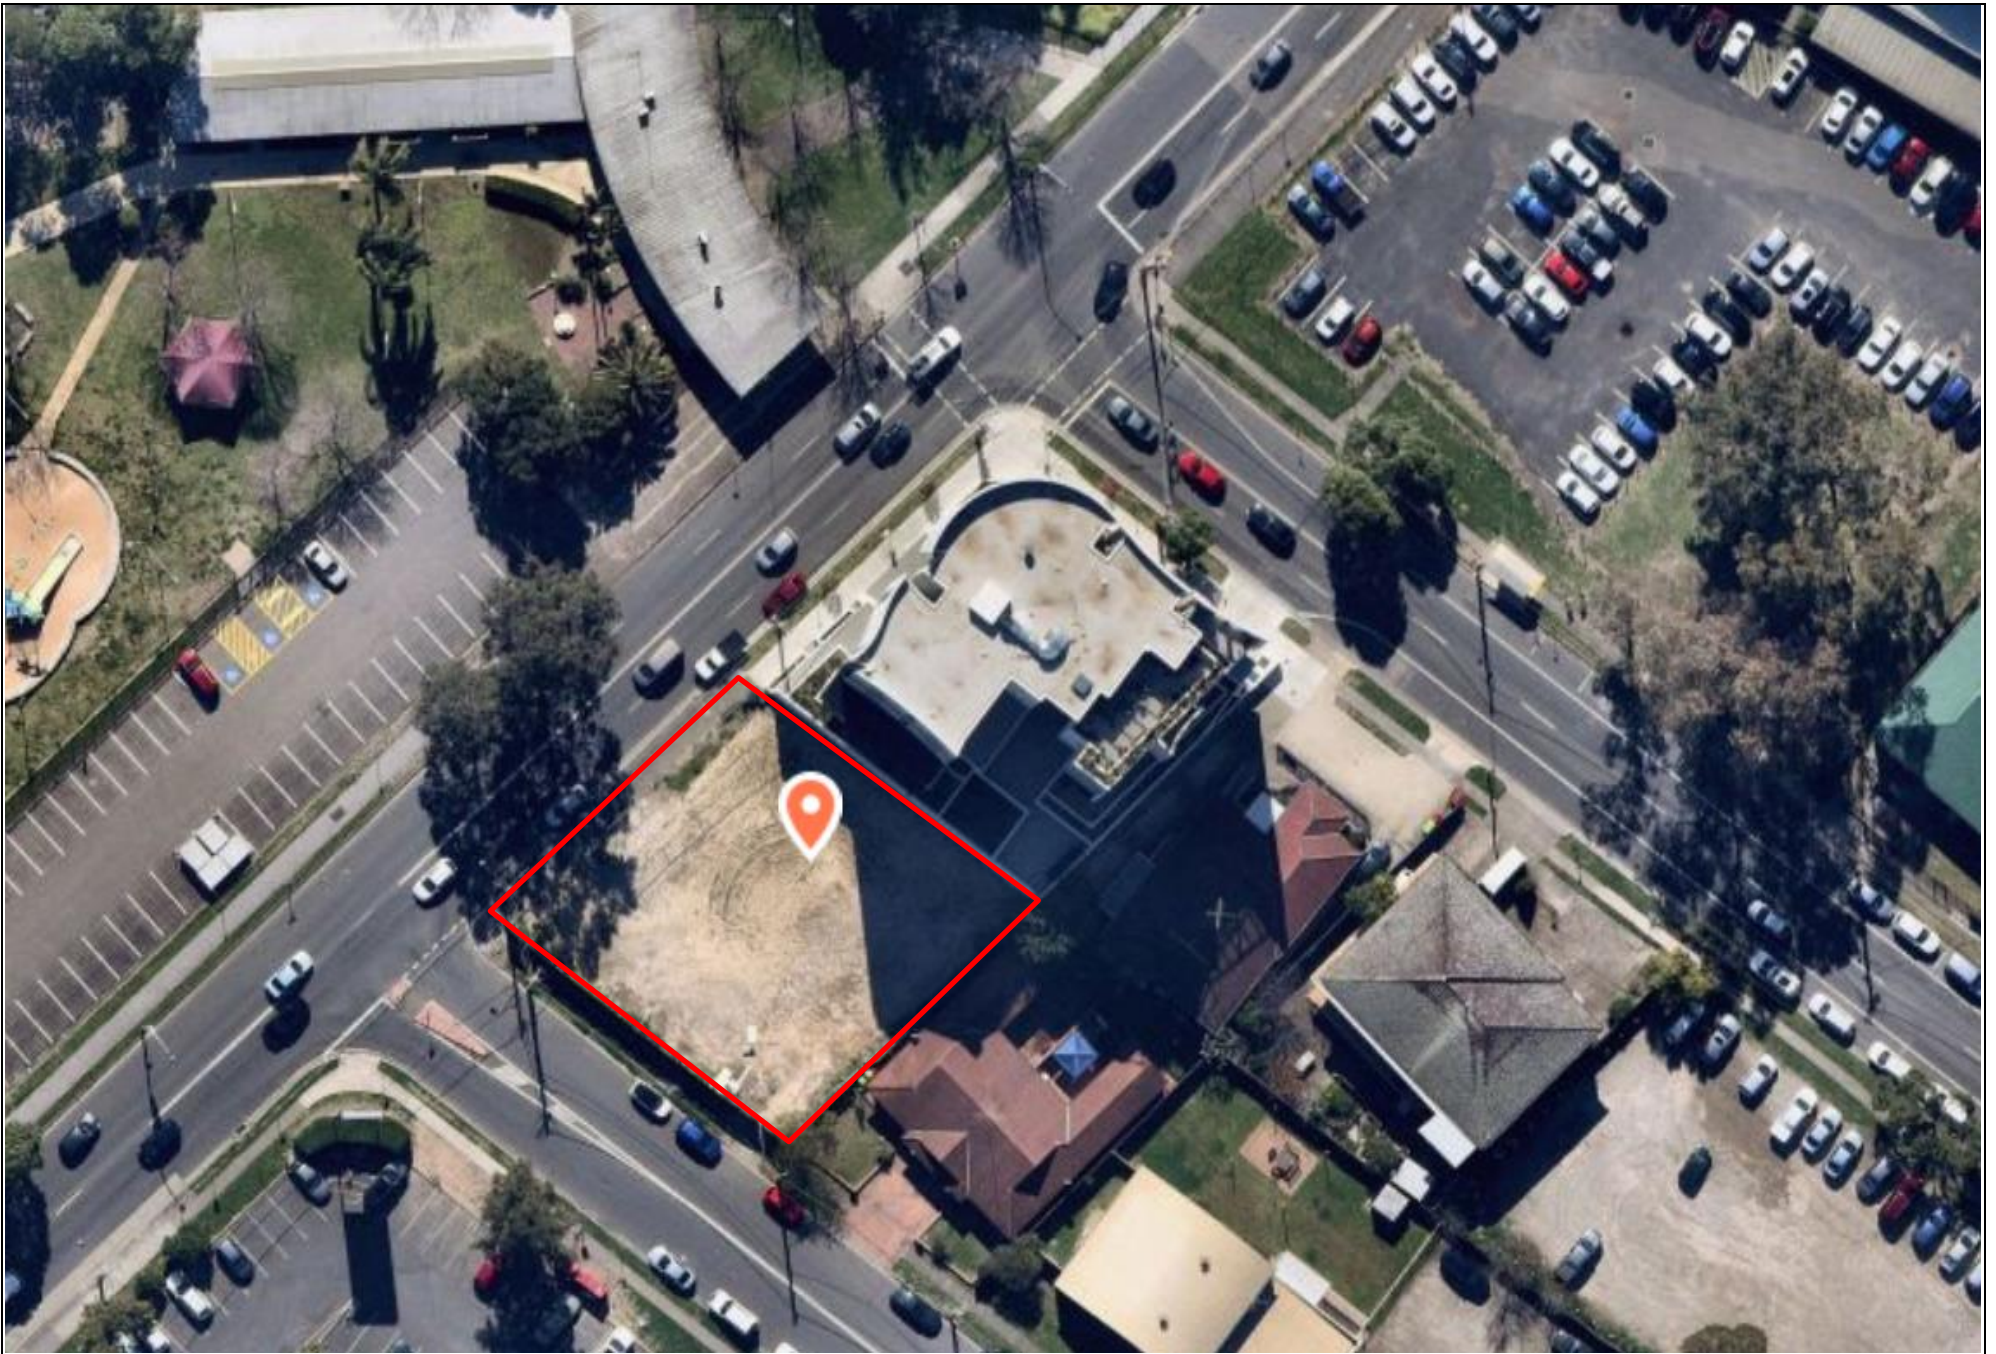
Current Site		Architecture Design Studio (NSW) Pty Ltd 118-120 Station Street Penrith, NSW, 2750		Job No	AG-533_1
			Drawn By	NS	Drawing No	AG-533-1DWG
			Approved By	NS	Ref No	
					Scale	Not to scale

Current – The site is vacant, it is understood that structures occupying the site were demolished in 2018.
