Lot 8, 175 Cranebrook Road, Cranebrook

Contaminated Land Assessment

Client : Peter & Charlene Adcock
Prepared by : Australian Wetlands Consulting Pty Ltd
Project # : 3-16778_3a
Date : November 2016

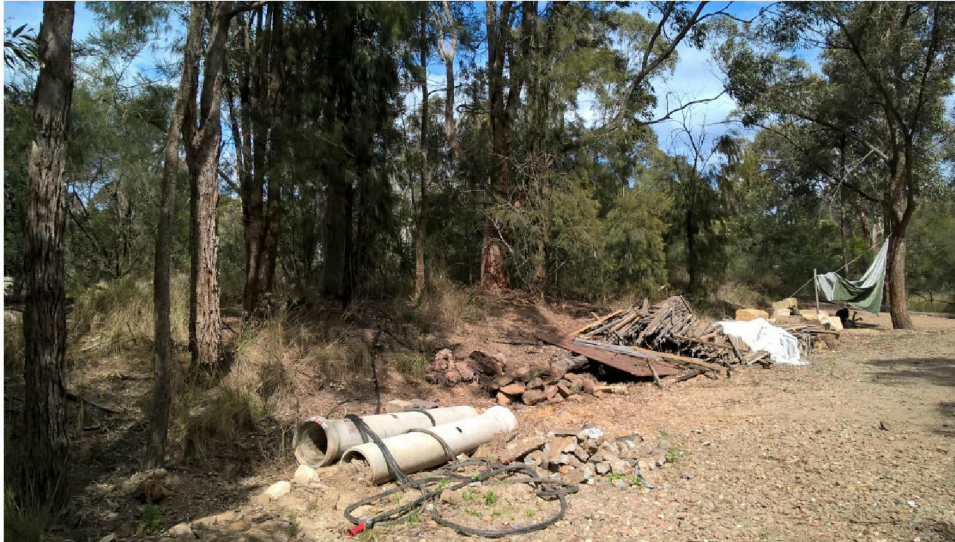
Additionally, as an extension to the nursery, a landscaping business was administered from the site. There were areas where equipment and machinery were stored, though not in the location of the proposed dwellings. The location of the proposed dwellings has been used as a stockpile area for imported soils, mulches and other landscape related supplies; green waste was stockpiled and intermittently burned in that location (refer Photo 2-1). The area has accumulated a layer of approximately 0.5m depth of fill material (refer Photo 2-2).

Photo 2-1: Landscape material holding area and stockpile areas

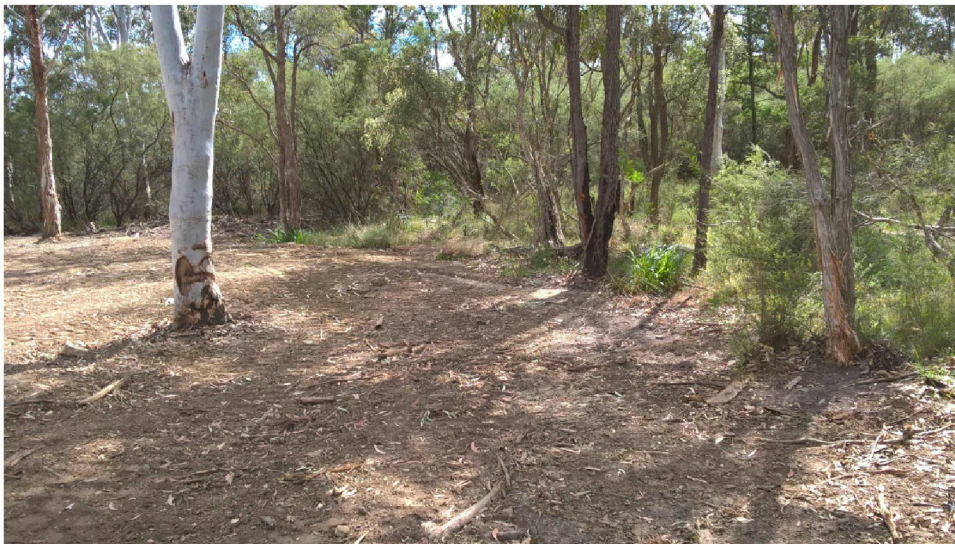
Photo 2-2: Landscape material stockpile area (disused) note fill material

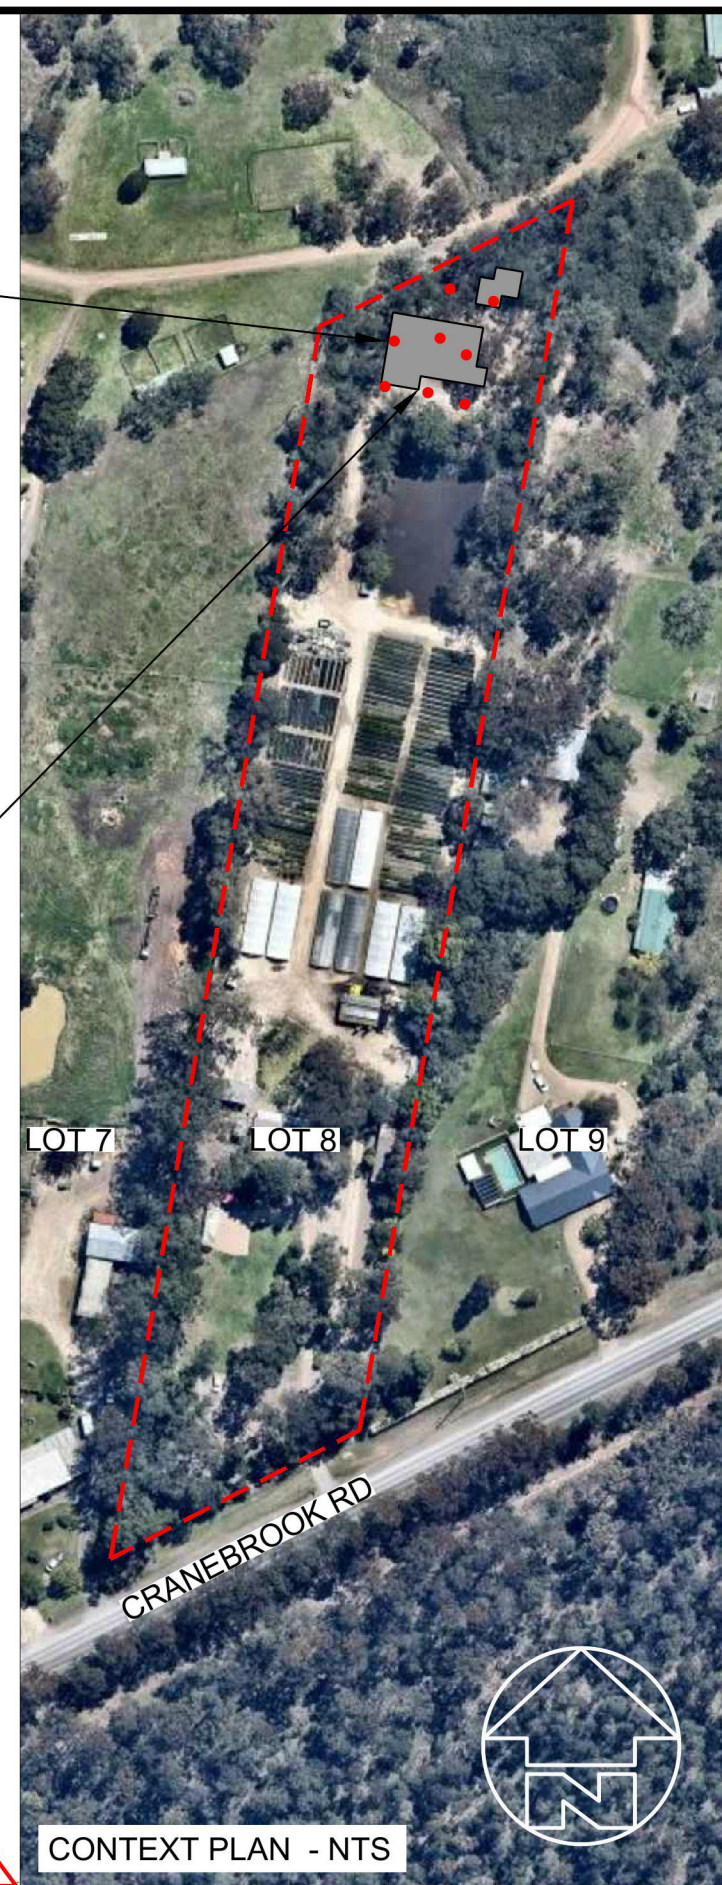
Soil Sample Locations

Samples were generally in a grid pattern through the area of the proposed dwelling. Table 3-1 provides detail and comment on the locations of the samples and the plan in Appendix A shows the sample locations in landscape context.

Soils taken from the fill material (A1, 2, 3, & 4 and B1 & 2) were a mix of clays and aggregate while the two samples collected from the existing site soil (B3 & 4) was sandy loam topsoil.
