Project: Proposed Childcare Centre

Site Location: 97 – 99 Victoria Street, Werrington NSW 2747

Reference: 13004-GR-1-1

Geotechnical Investigation Report

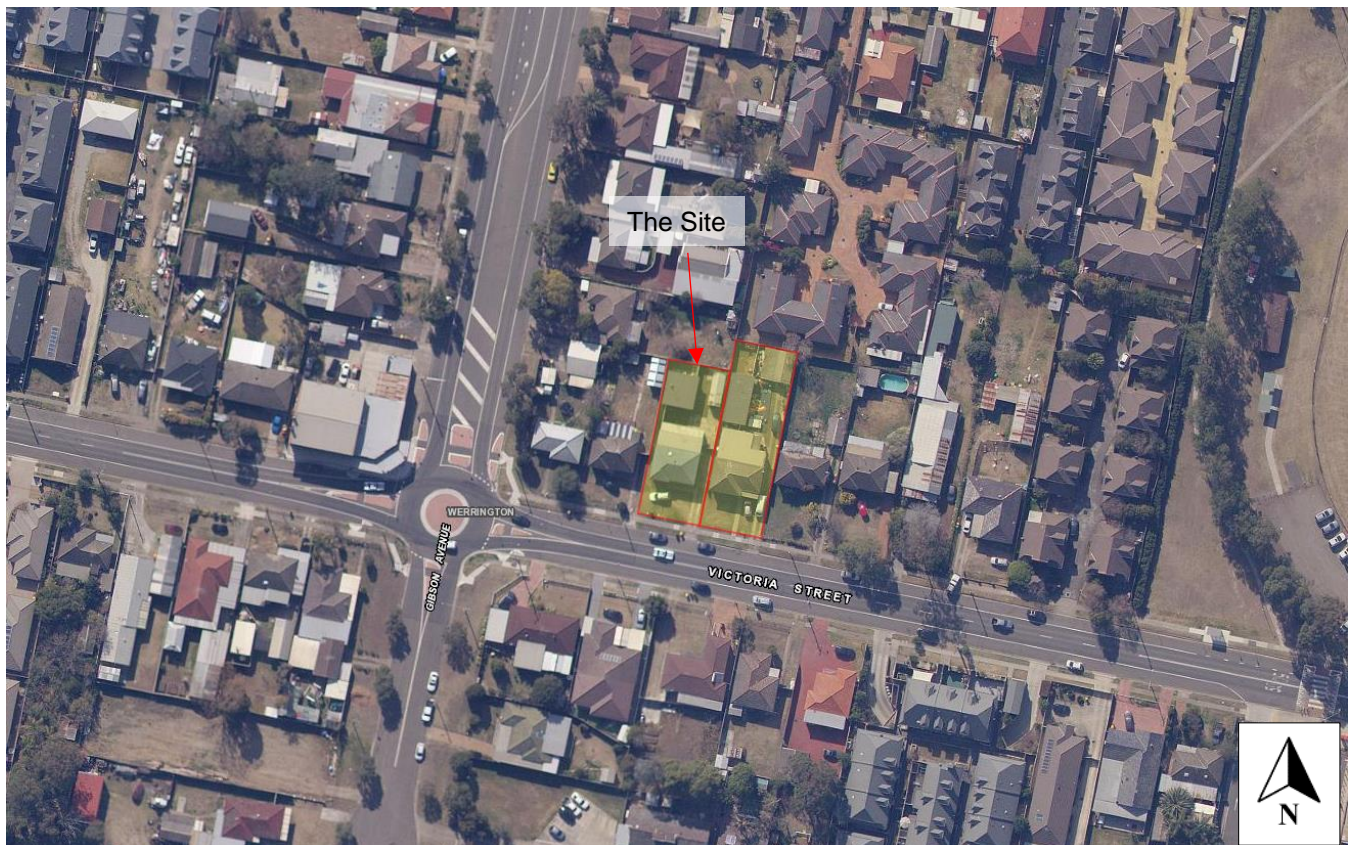
Figure 1 - The Site Location

The site comprises of two adjacent residential lots within the suburb of Werrington in the City of Penrith local council encompassing an irregular rectangular-shaped block of land with an approximate total area of 1277m². The site is bounded by other residential houses and by Victoria Street to the south as shown in Figure 1.

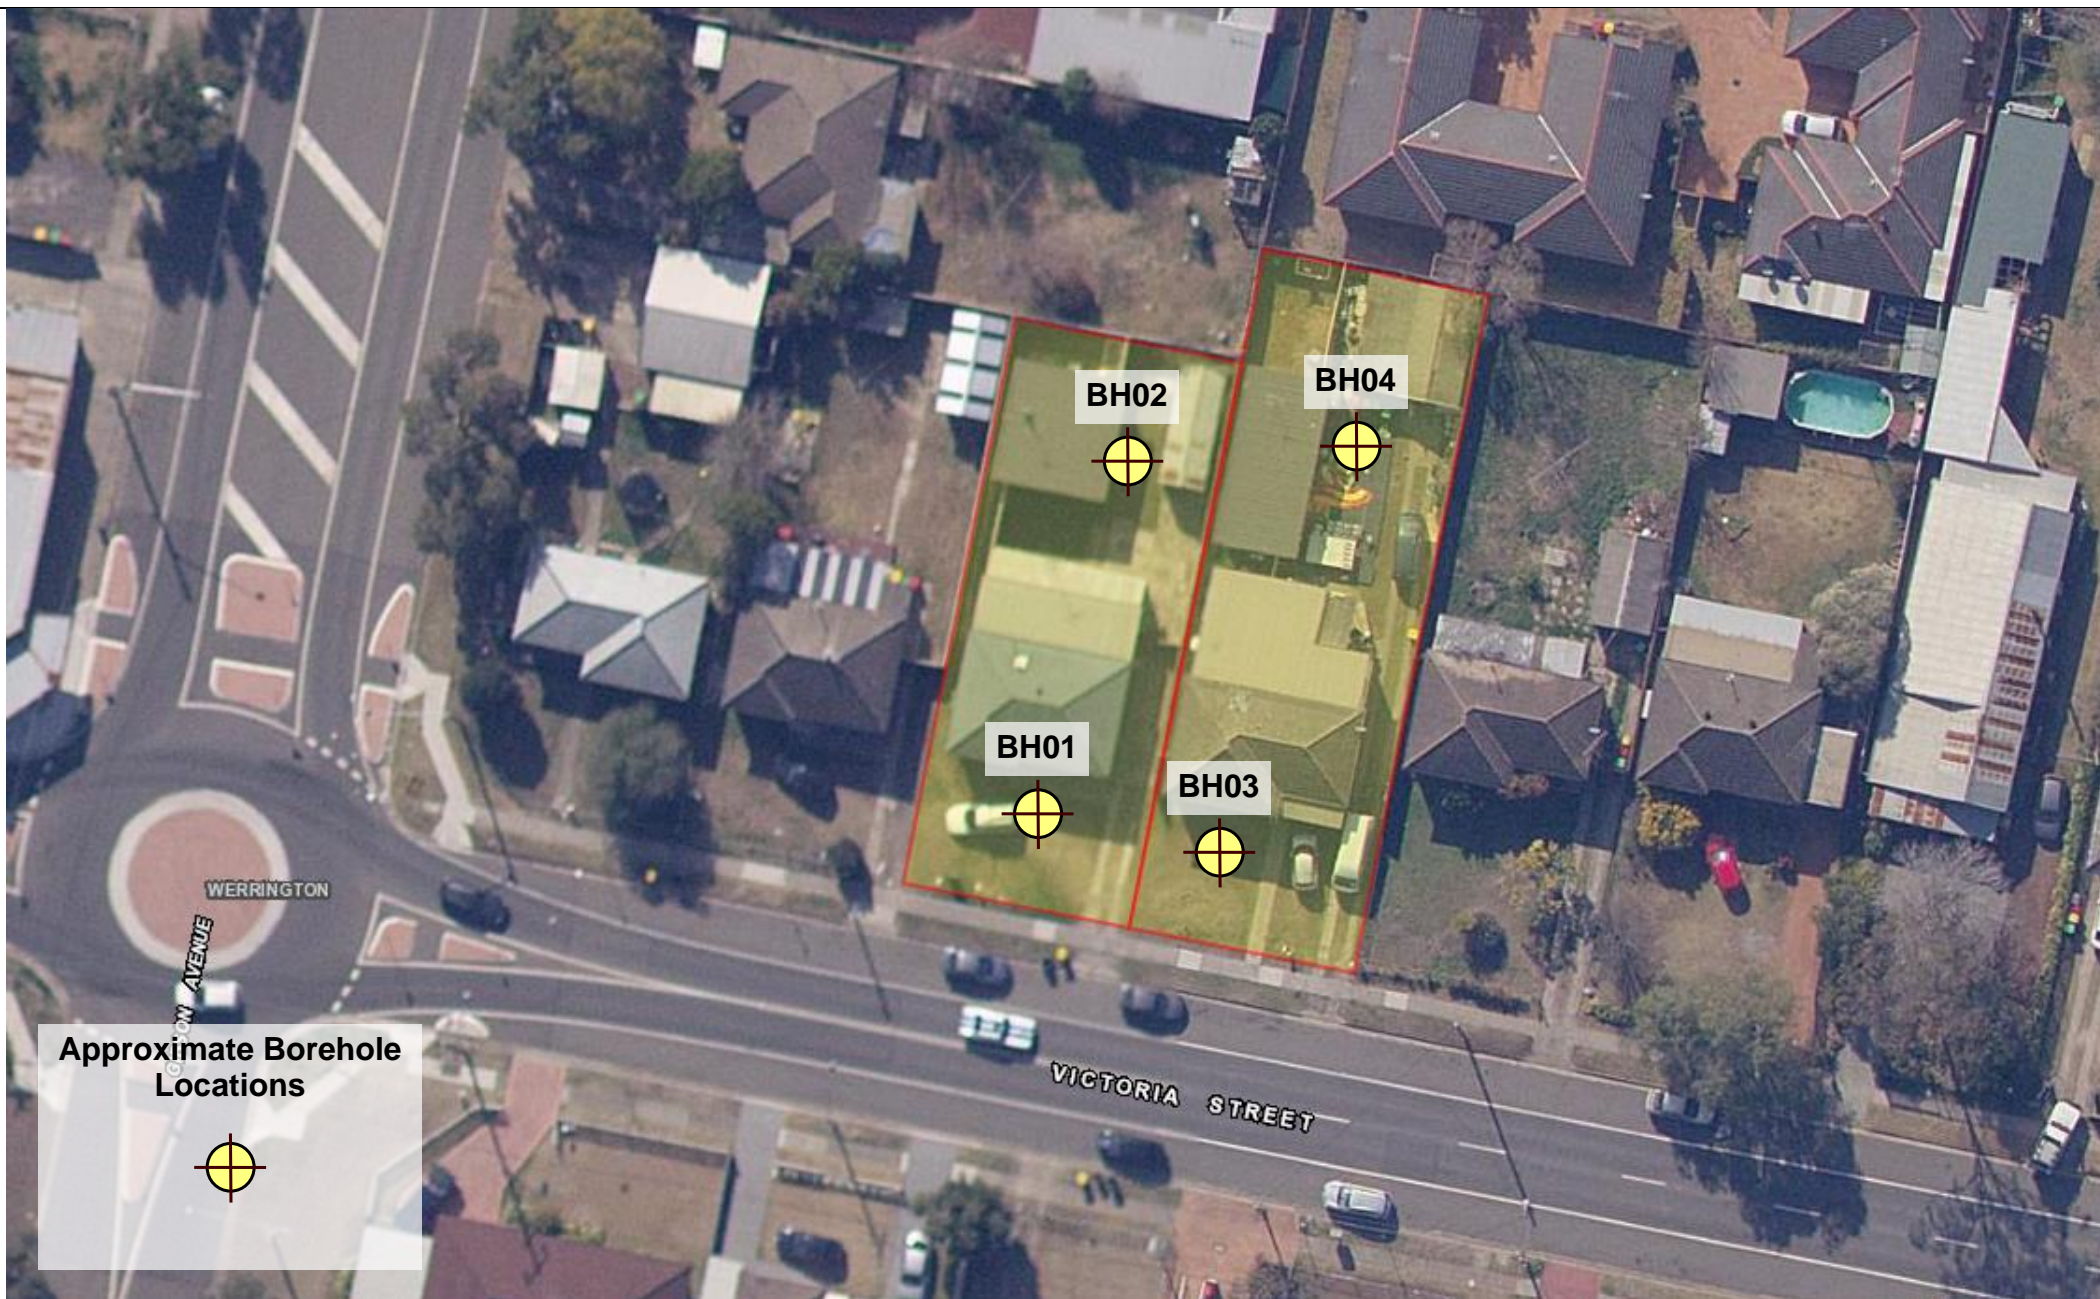
Borehole Location Plan

After the site walkover and inspection, the proposed borehole positions located in front yard and back yard were checked against Dial Before You Dig (DBYD) plans for services and utilities. Two boreholes were drilled on each property, one in the front of the property and one in the rear of the property. A total of 4 boreholes were drilled to a maximum depth of 6.0m below ground level (BGL) using a using a ute-mounted rig with Tungsten Carbide (TC) bit.
