## SITE AUDIT REPORT AND SITE AUDIT STATEMENTS

# Caddens Release Area, Kingswood, NSW, 2747

**Report Number:** 097623019 007 R Rev0

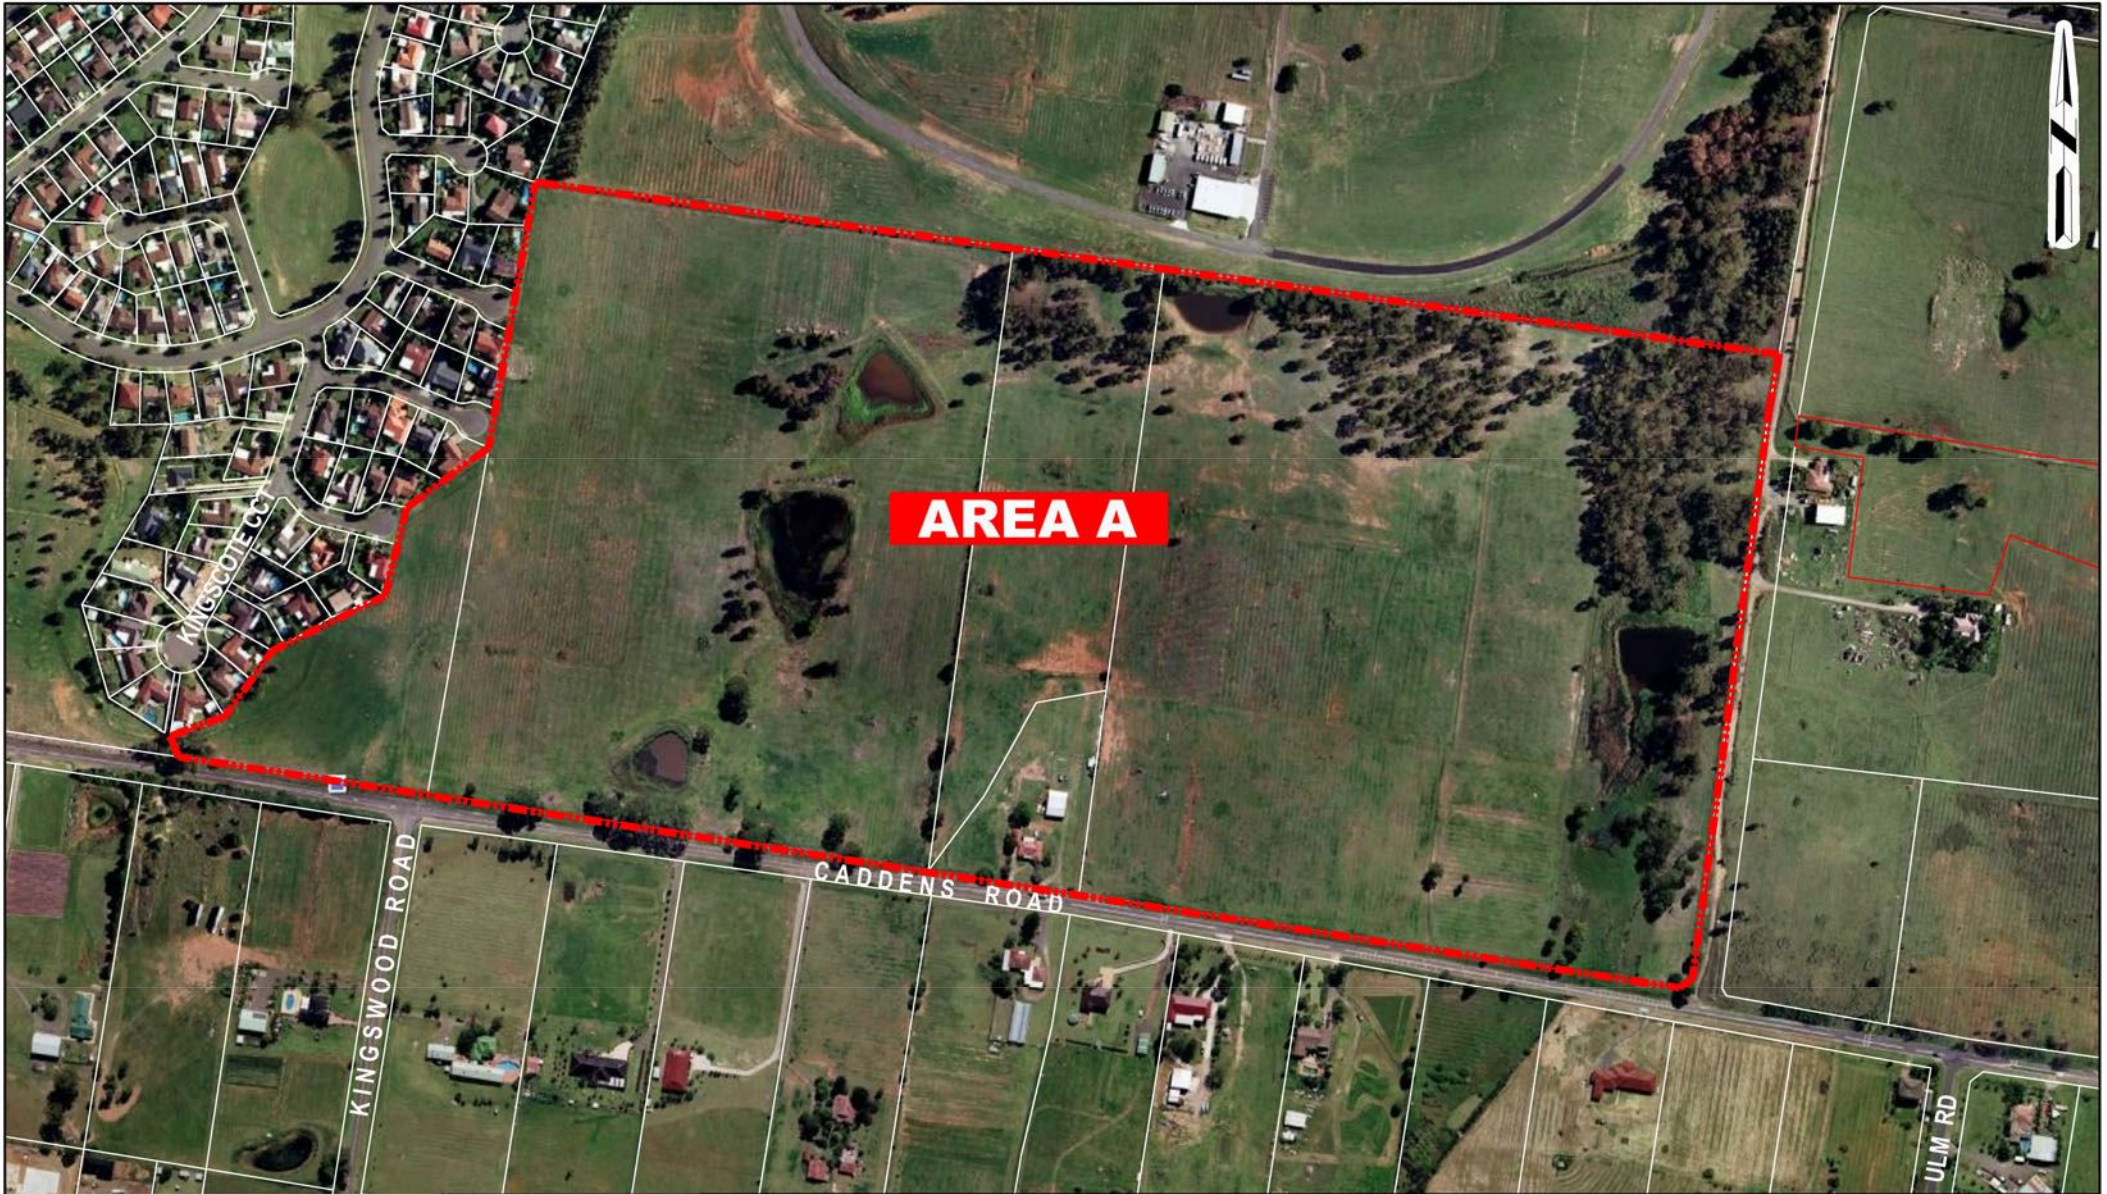
**AREA A**

CLIENT LANDCOM		PROJECT SITE AUDIT REPORT : CADDENS RELEASE AREA, KINGSWOOD, NSW	
DRAWN HC	DATE 14.08.2009	TITLE <b>AREA A</b> <b>(SITE AUDIT STATEMENT RJP022)</b>	
CHECKED MU	DATE 14.08.2009	PROJECT No 097623019	DOC No 007
SCALE 1:5000	A4	DOC TYPE R	FIGURE No F0002
		REV No 0	FIGURE 2a

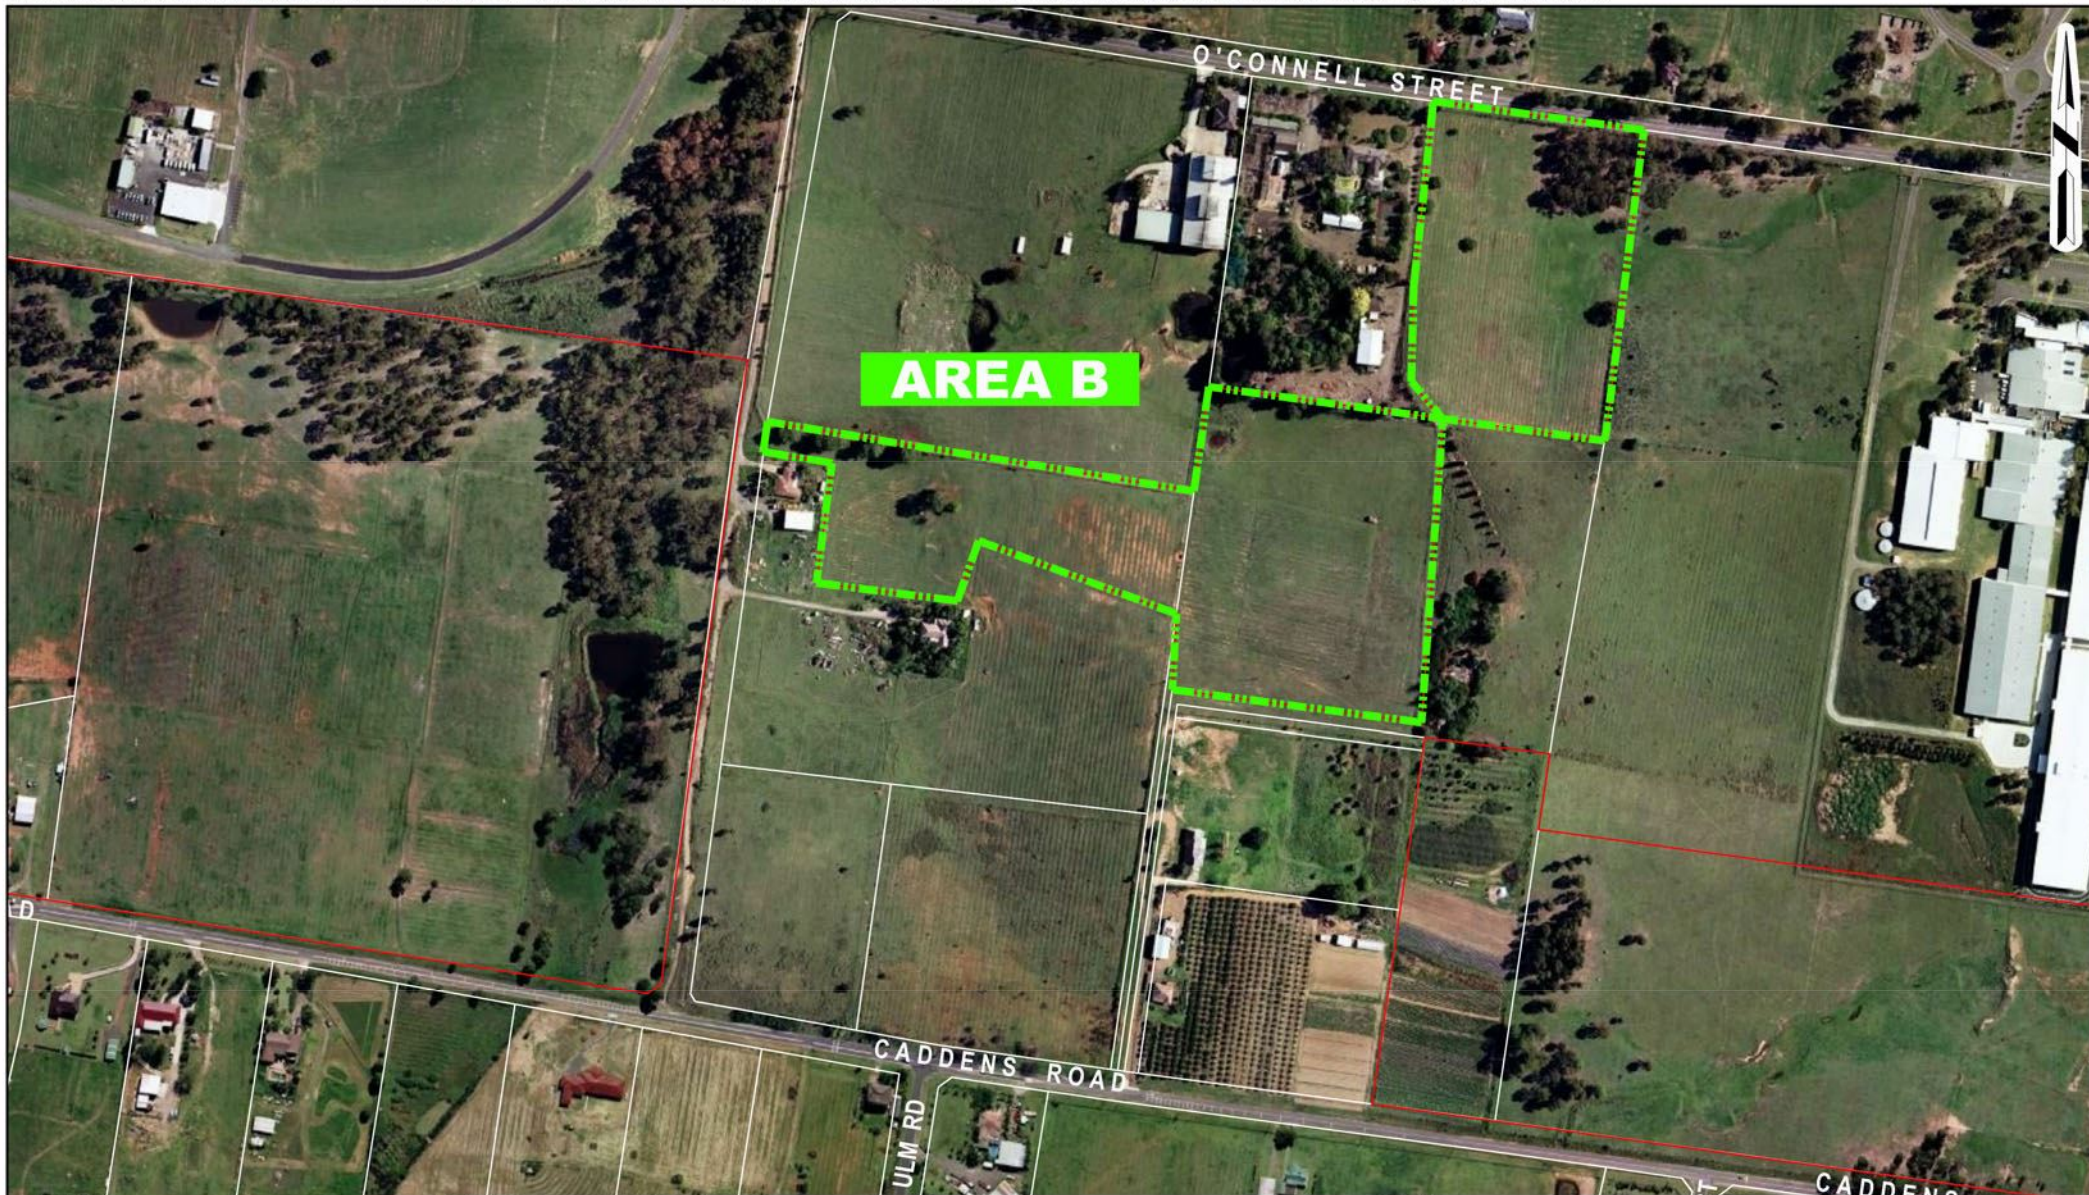
<b>LEGEND</b> BOUNDARY OF AREA B	 © 2008 Source: Google Earth Pro 2008 IMAGE DATED: 20 01 2007 SUPPLIED BY AND SOURCED UNDER LICENCE FROM GOOGLE EARTH PRO ON 14 08 2009 IMAGE GEOREFERENCED BY GOLDBER AND INTENDED FOR INDICATIVE PURPOSES ONLY	CLIENT LANDCOM		PROJECT SITE AUDIT REPORT : CADDENS RELEASE AREA, KINGSWOOD, NSW							
		DRAWN HC	DATE 14.08.2009	TITLE AREA B (SITE AUDIT STATEMENT RJP023)							
ADAPTED FROM DIGITAL CADASTRE DATABASE, NSW DEPARTMENT OF LANDS, 2004, ZONE 56 MGA COORDINATES		 www.golder.com GOLDBER ASSOCIATES PTY LTD		CHECKED MU	DATE 14.08.2009	PROJECT No 097623019	DOC No 007	DOC TYPE R	FIGURE No F0002	REV No 0	FIGURE 2b
1:5,000 		SCALE 1:5000		A4

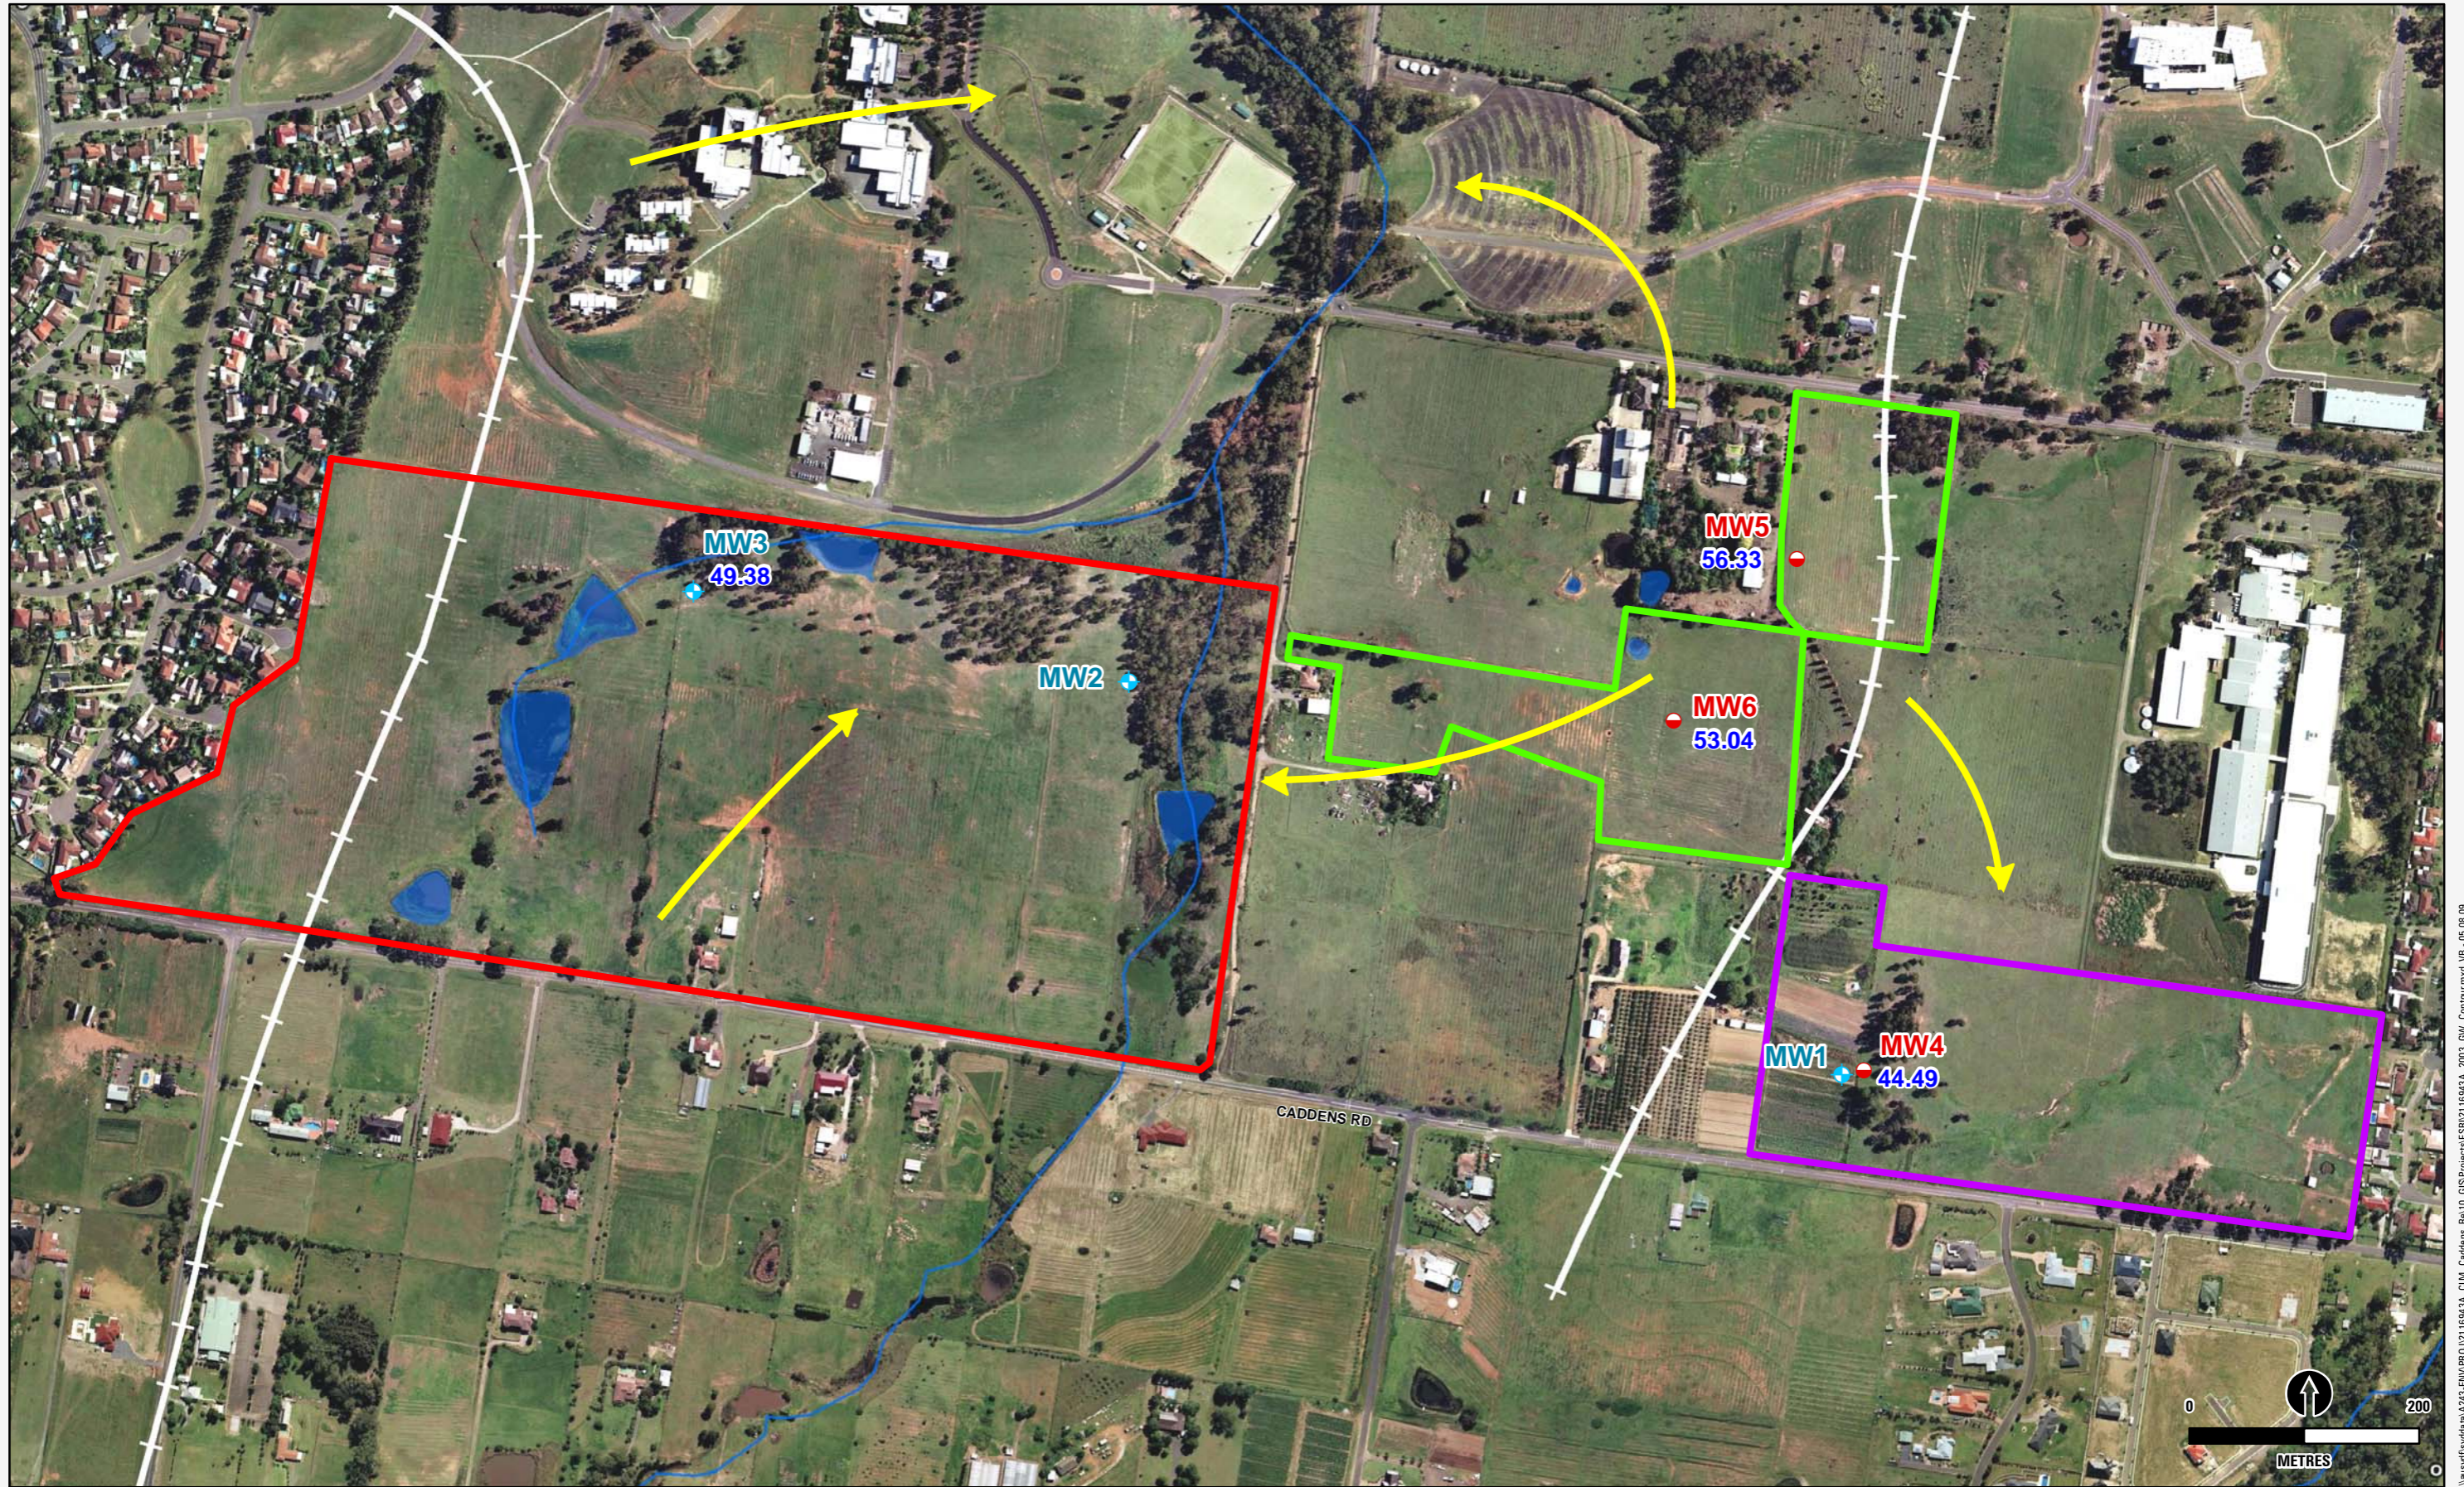
**Figure 12** Groundwater Flow

- Catchment divide
- Inferred groundwater flow direction
- 49.3 Groundwater elevation (mAHD)

#### 4.4 Query 30 relating to Section 8.4 Groundwater conditions
