PENRITH CITY COUNCIL

MAJOR ASSESSMENT REPORT

Application number:	DA18/0038
Proposed development:	Land Remediation Works
Property address:	3 North Street, PENRITH NSW 2750 4 North Street, PENRITH NSW 2750 5 North Street, PENRITH NSW 2750 6 North Street, PENRITH NSW 2750 7 North Street, PENRITH NSW 2750 8 North Street, PENRITH NSW 2750 9 North Street, PENRITH NSW 2750 10 North Street, PENRITH NSW 2750 12 North Street, PENRITH NSW 2750 13 North Street, PENRITH NSW 2750 14 North Street, PENRITH NSW 2750 15 North Street, PENRITH NSW 2750
Property description:	Lot 2 DP 112677 Lot 1 DP 711683 Lot B DP 164794 Lot A DP 164794 Lot 1 DP 986707 Lot 1 DP 198625 Lot 1 DP 794510 Lot B DP 160112 Lot A DP 160112 Lot 92 DP 1133279 Lot 1 DP 115384 Lot 1 DP 794511
Date received:	15 January 2018
Assessing officer	Donna Clarke
Zoning:	Zone B4 Mixed Use - LEP 2010 SP2 Infrastructure - Classified Road - LEP 2010
Class of building:	N/A
Recommendations:	Approve

LIMITED SUBSURFACE ASBESTOS INVESTIGATION

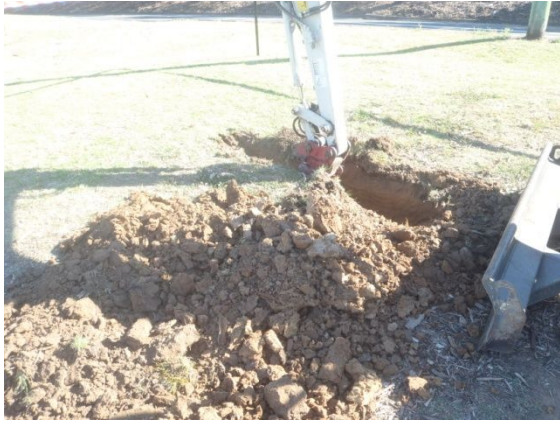
Photograph 1
Test Pit 1

No visually identifiable asbestos containing materials were noted on the edges, at the base or within the excavated material of Test Pit 1.

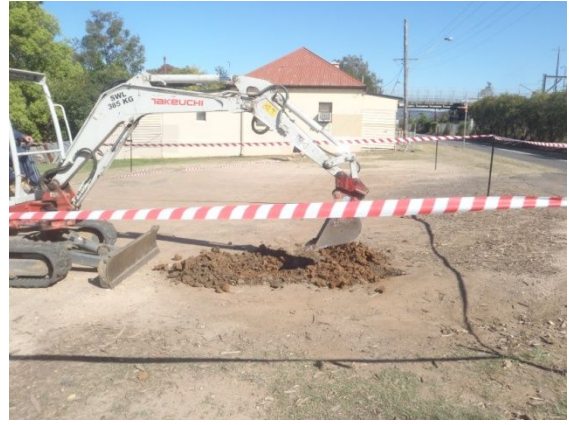
Photograph 4
Test Pit 4

Minor occurrences of asbestos containing materials were noted on the ground surface to the east of the Test Pit to a distance of between 10 -15 metres.

No signs of visually identifiable asbestos containing materials were noted on the edges or at the base of Test Pit 4.

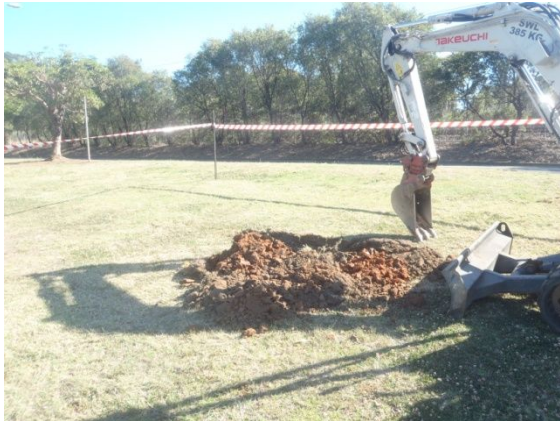
Photograph 2
Test Pit 2

Minor occurrences of asbestos containing materials were noted on the ground surface to the west and south-west of Test Pit 2 at a distance of 15 metres.

No signs of visually identifiable asbestos containing materials were noted on the edges, at the base or within the excavated material of Test Pit 2.

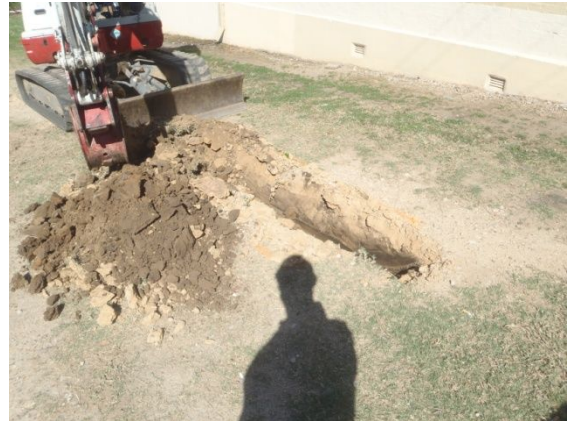
Photograph 5
Test Pit 5

No visually identifiable asbestos containing materials were noted on the edges, at the base or within the excavated material of Test Pit 5.

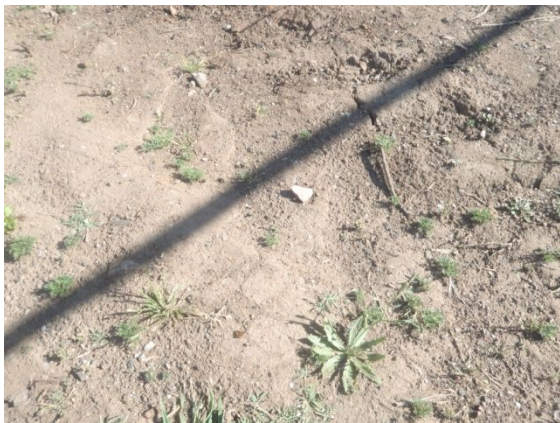
Test Pit 3: The Horizon A layer is 0.2 metres deep and dark brown in colour, containing fragments of broken glass. The Horizon B layer is +0.2 metres deep and consists of red clay.

Minor occurrences of asbestos containing materials were noted on the ground surface surrounding the Test Pit to a distance of between 0-10 metres.

No signs of visually identifiable asbestos containing materials were noted on the edges, at the base or within the excavated material of Test Pit 3.

Photograph 3
Asbestos Cement debris adjacent to Test Pit 3

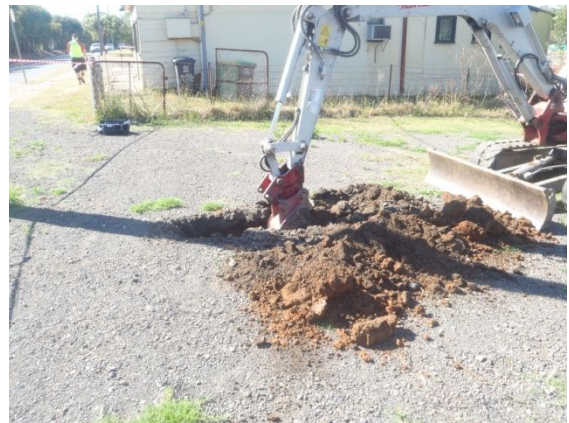
Photograph 6
Test Pit 6

No visually identifiable asbestos containing materials were noted on the edges, at the base or within the excavated material of Test Pit 6.

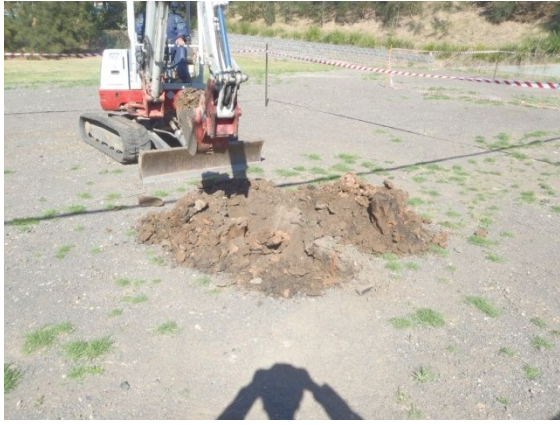
Photograph 7
Test Pit 7

No visually identifiable asbestos containing materials were noted on the edges, at the base or within the excavated material of Test Pit 7.

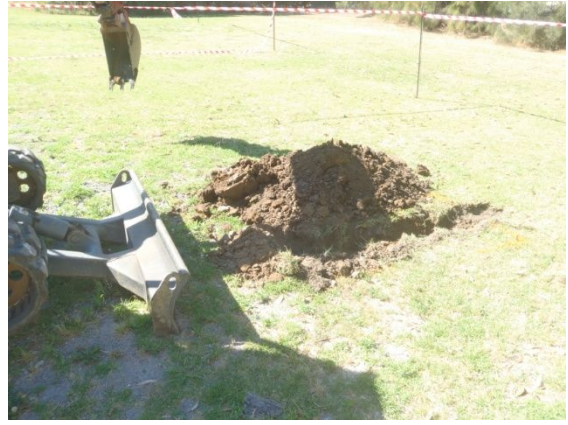
Photograph 10
Test Pit 9

No visually identifiable asbestos containing materials were noted on the edges, at the base or within the excavated material of Test Pit 9.

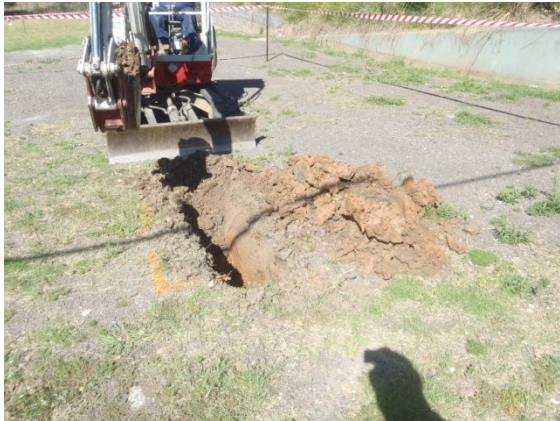
Photograph 8
Test Pit 8

No visually identifiable asbestos containing materials were noted on the edges, at the base or within the excavated material of Test Pit 8.

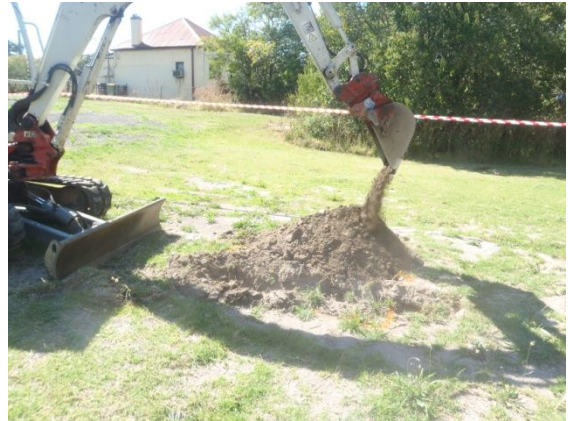
Photograph 11
Test Pit 10

Fragments of asbestos containing materials were noted within the excavated material from the Horizon B soil layer of Test Pit 10.

All areas identified of having a high potential for building/demolition waste to be encountered are to be classified as asbestos contaminated soil and is to be managed under an Asbestos Management Plan.

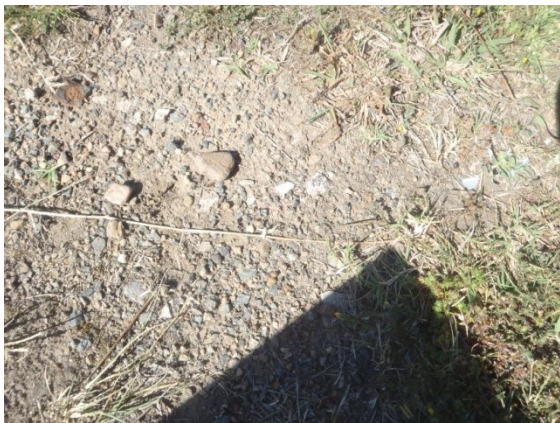
Photograph 9
Asbestos Cement debris adjacent to Test Pit 8

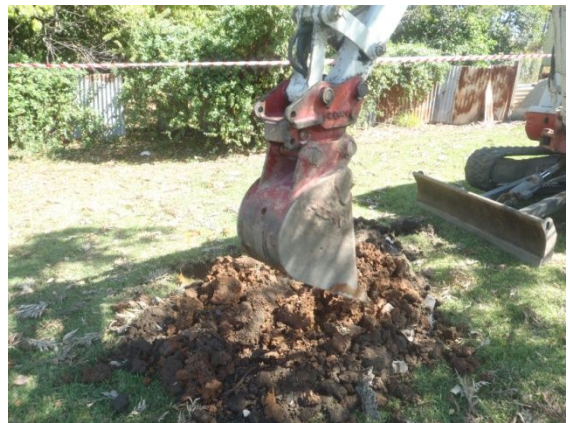
Photograph 12
Test Pit 11

No visually identifiable asbestos containing materials were noted on the edges, at the base or within the excavated material of Test Pit 11.

Minor fragments of asbestos containing debris were noted on the ground surface at the base of the tree to the east of the test pit.

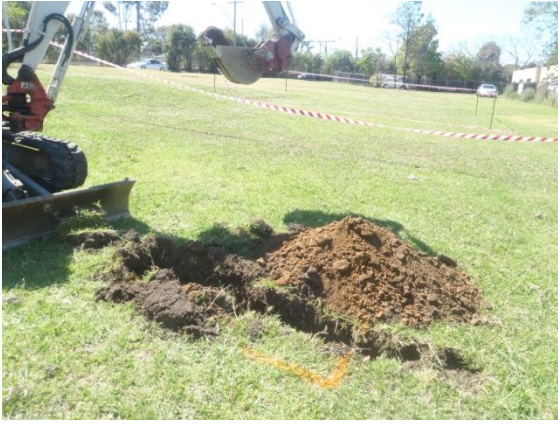
Photograph 13
Test Pit 12

No visually identifiable asbestos containing materials were noted on the edges, at the base or within the excavated material of Test Pit 12.

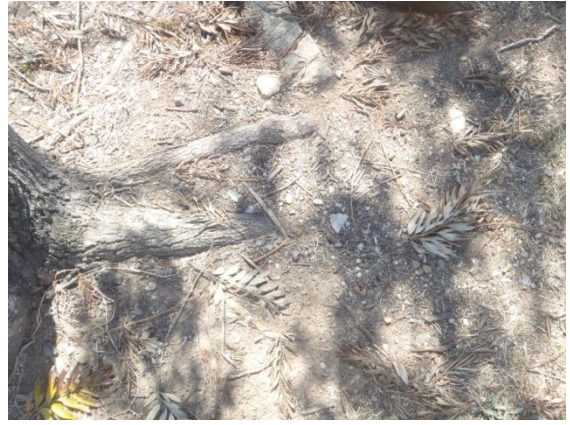
Minor fragments of asbestos containing cement debris were noted on the ground surface at the base of the tree to the east of the test pit.

Photograph 16
Asbestos Cement debris adjacent to Test Pit 15

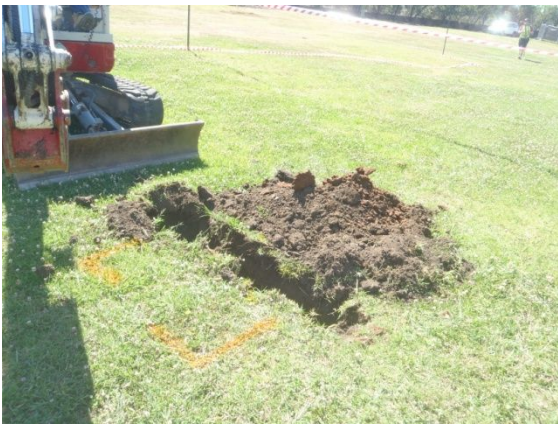
Photograph 14
Test Pit 13

No visually identifiable asbestos containing materials were noted on the edges, at the base or within the excavated material of Test Pit 13.

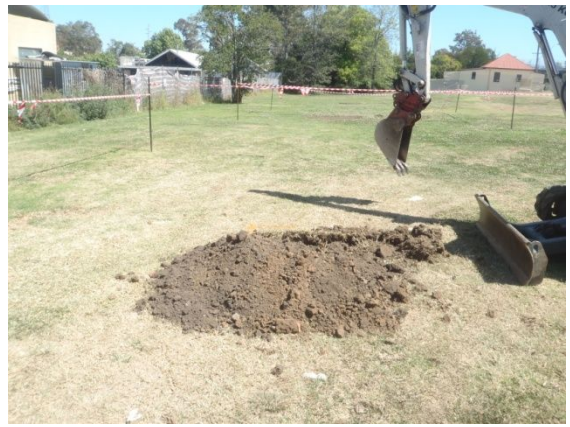
Photograph 17
Test Pit 15

No visually identifiable asbestos containing materials were noted on the edges, at the base or within the excavated material of Test Pit 15.

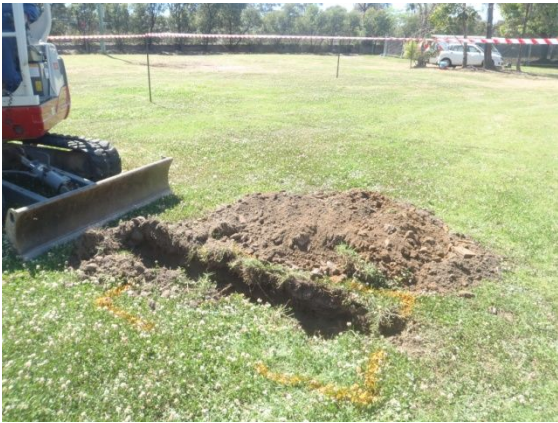
Photograph 15
Test Pit 14

No visually identifiable asbestos containing materials were noted on the edges, at the base or within the excavated material of Test Pit 14.

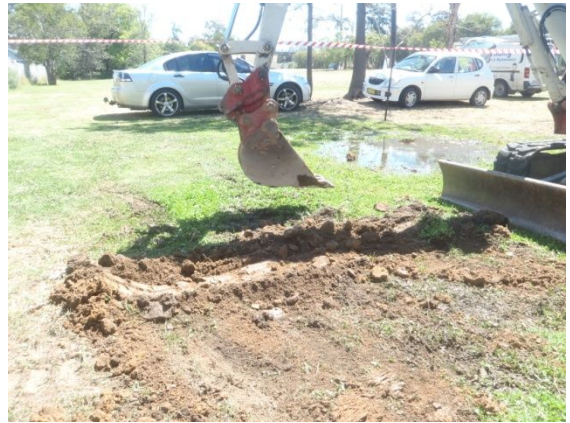
Photograph 18
Test Pit 16

No visually identifiable asbestos containing materials were noted on the edges, at the base or within the excavated material of Test Pit 16.

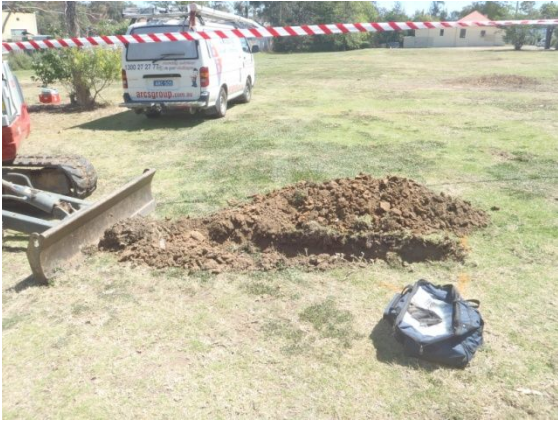
Photograph 19
Test Pit 17

No visually identifiable asbestos containing materials were noted on the edges, at the base or within the excavated material of Test Pit 17.

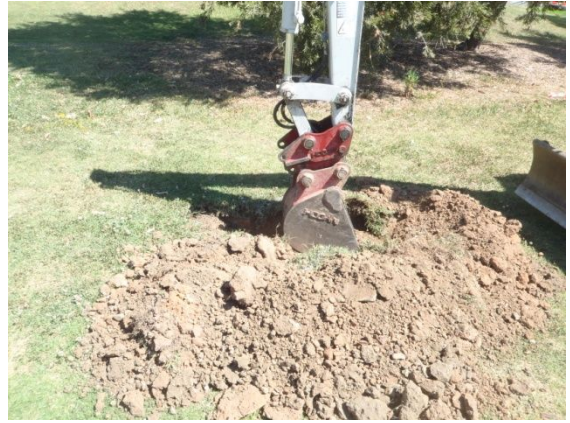
Photograph 22
Test Pit 20

Fragments of asbestos containing materials were noted within the excavated material from the Horizon A soil layer of Test Pit 20.

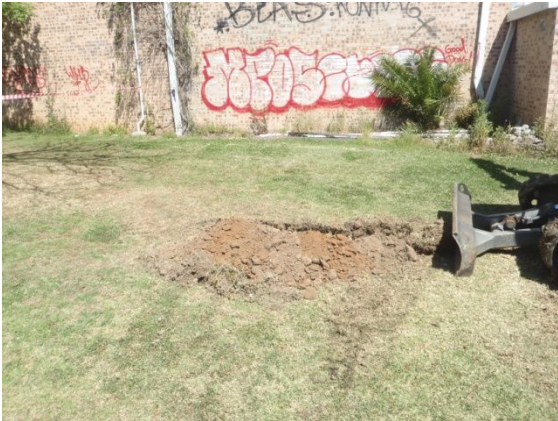
Photograph 20
Test Pit 18

Fragments of asbestos containing materials were noted within the excavated material from the Horizon A soil layer of Test Pit 18.

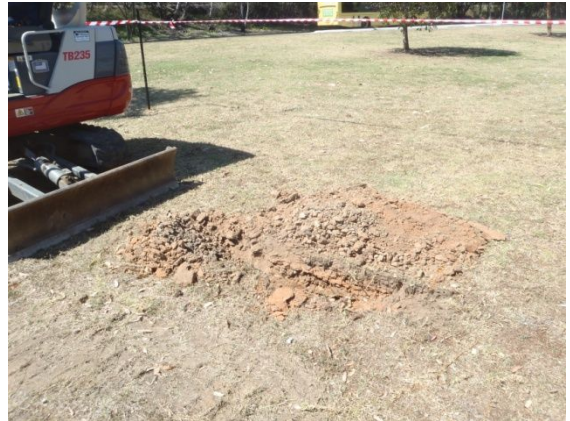
Photograph 23
Test Pit 22

No visually identifiable asbestos containing materials were noted on the edges, at the base or within the excavated material of Test Pit 22.

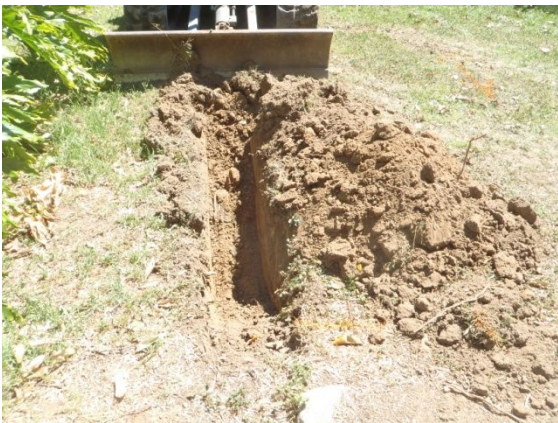
Photograph 21
Test Pit 19

Fragments of asbestos containing materials were noted within the excavated material from the Horizon A soil layer of Test Pit 19.

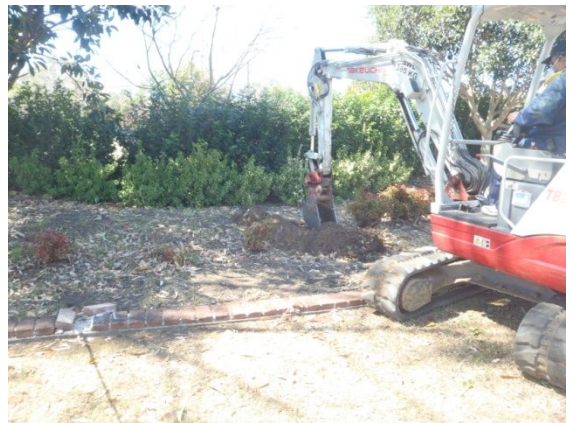
Photograph 24
Test Pit 23

It is the opinion of the consultant that the subsurface soil east of and including Test Pits 22, 23 and 28 is free of building demolition waste and asbestos containing materials. All other soil locations on the site will have a high potential for building/demolition waste to be present and to contain asbestos.

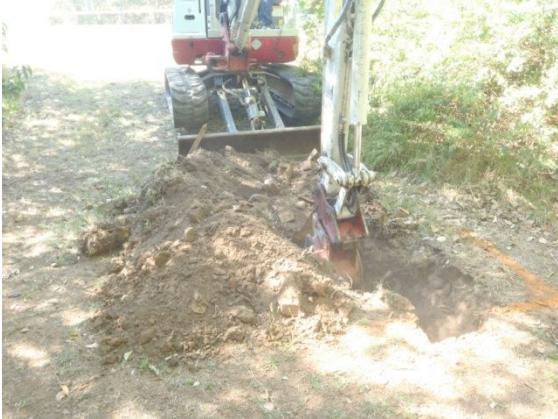
Photograph 32
Test Pit 31

Fragments of asbestos containing materials were noted within the excavated material from within Horizon A soil layer of Test Pit 31.

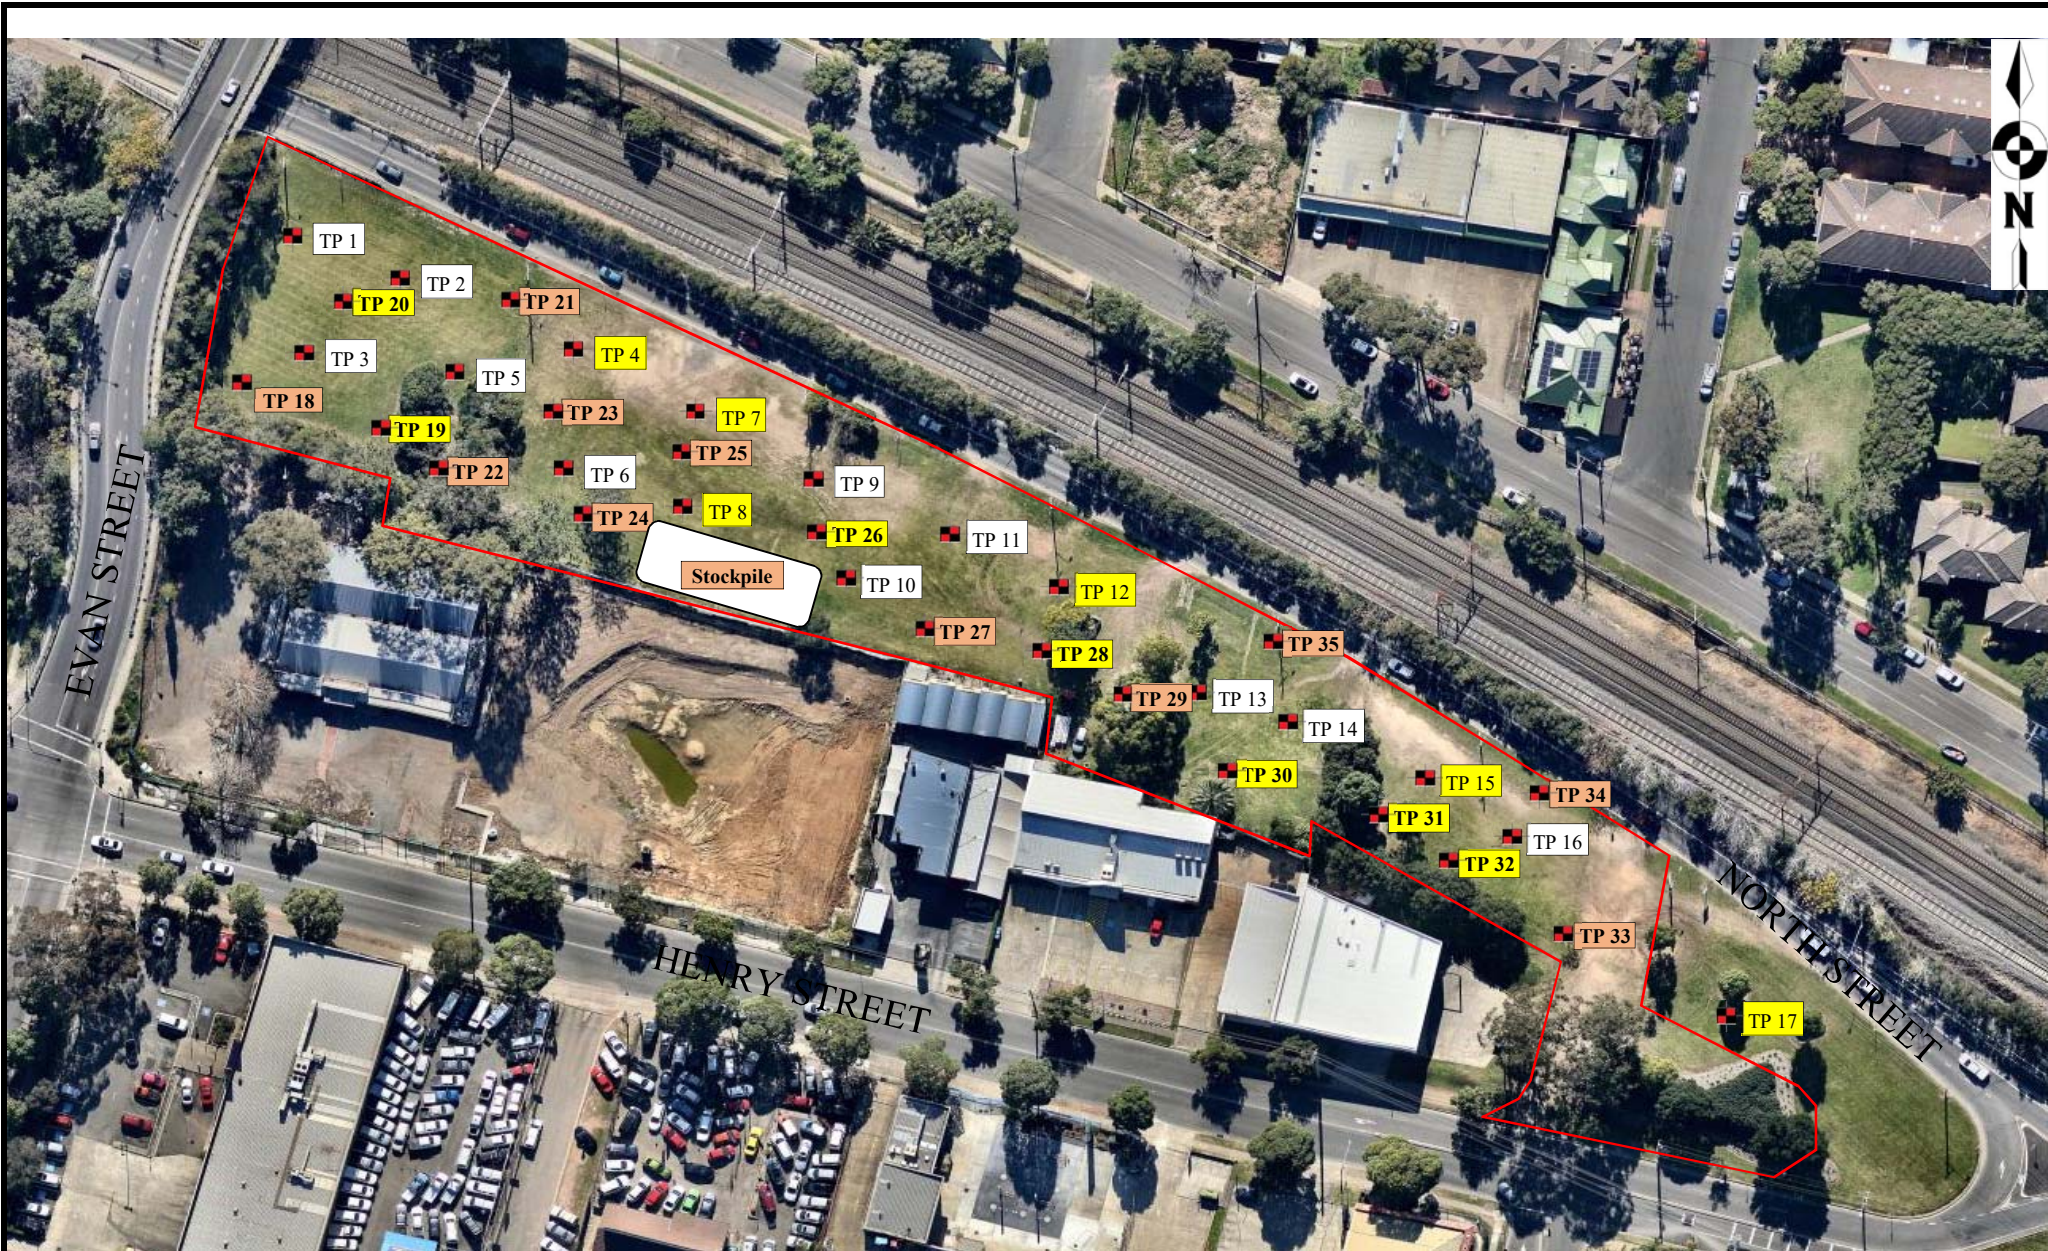
On the basis that about 40% of the test pits (ie 13 out of 35 test pits) were found to have asbestos, a rough estimate of about 1500 to 2000m³ of topsoil/fill may be impacted by asbestos. We note that final volume of asbestos impacted soil could only be determined during remediation works when all topsoil/fill is excavated and the site is fully exposed.

Legend
 TP 1 Test Pits with asbestos impacted topsoil/fill

- Excavation of all topsoil/fill from the site to expose the underlying natural clean clay noting that the insitu topsoil/fill is generally considered not suitable for reuse without treatment or improvement from a geotechnical perspective. Prior to excavation, the grass and vegetation should be stripped from the surface and the exposed area should be noted for concentration of asbestos.
