# Remediation Action Plan for the Proposed Nepean Gardens Cemetery, Wallacia, NSW

**Prepared for Catholic Cemeteries Board**

Report No: P1706171JR08V01

27 November 2020

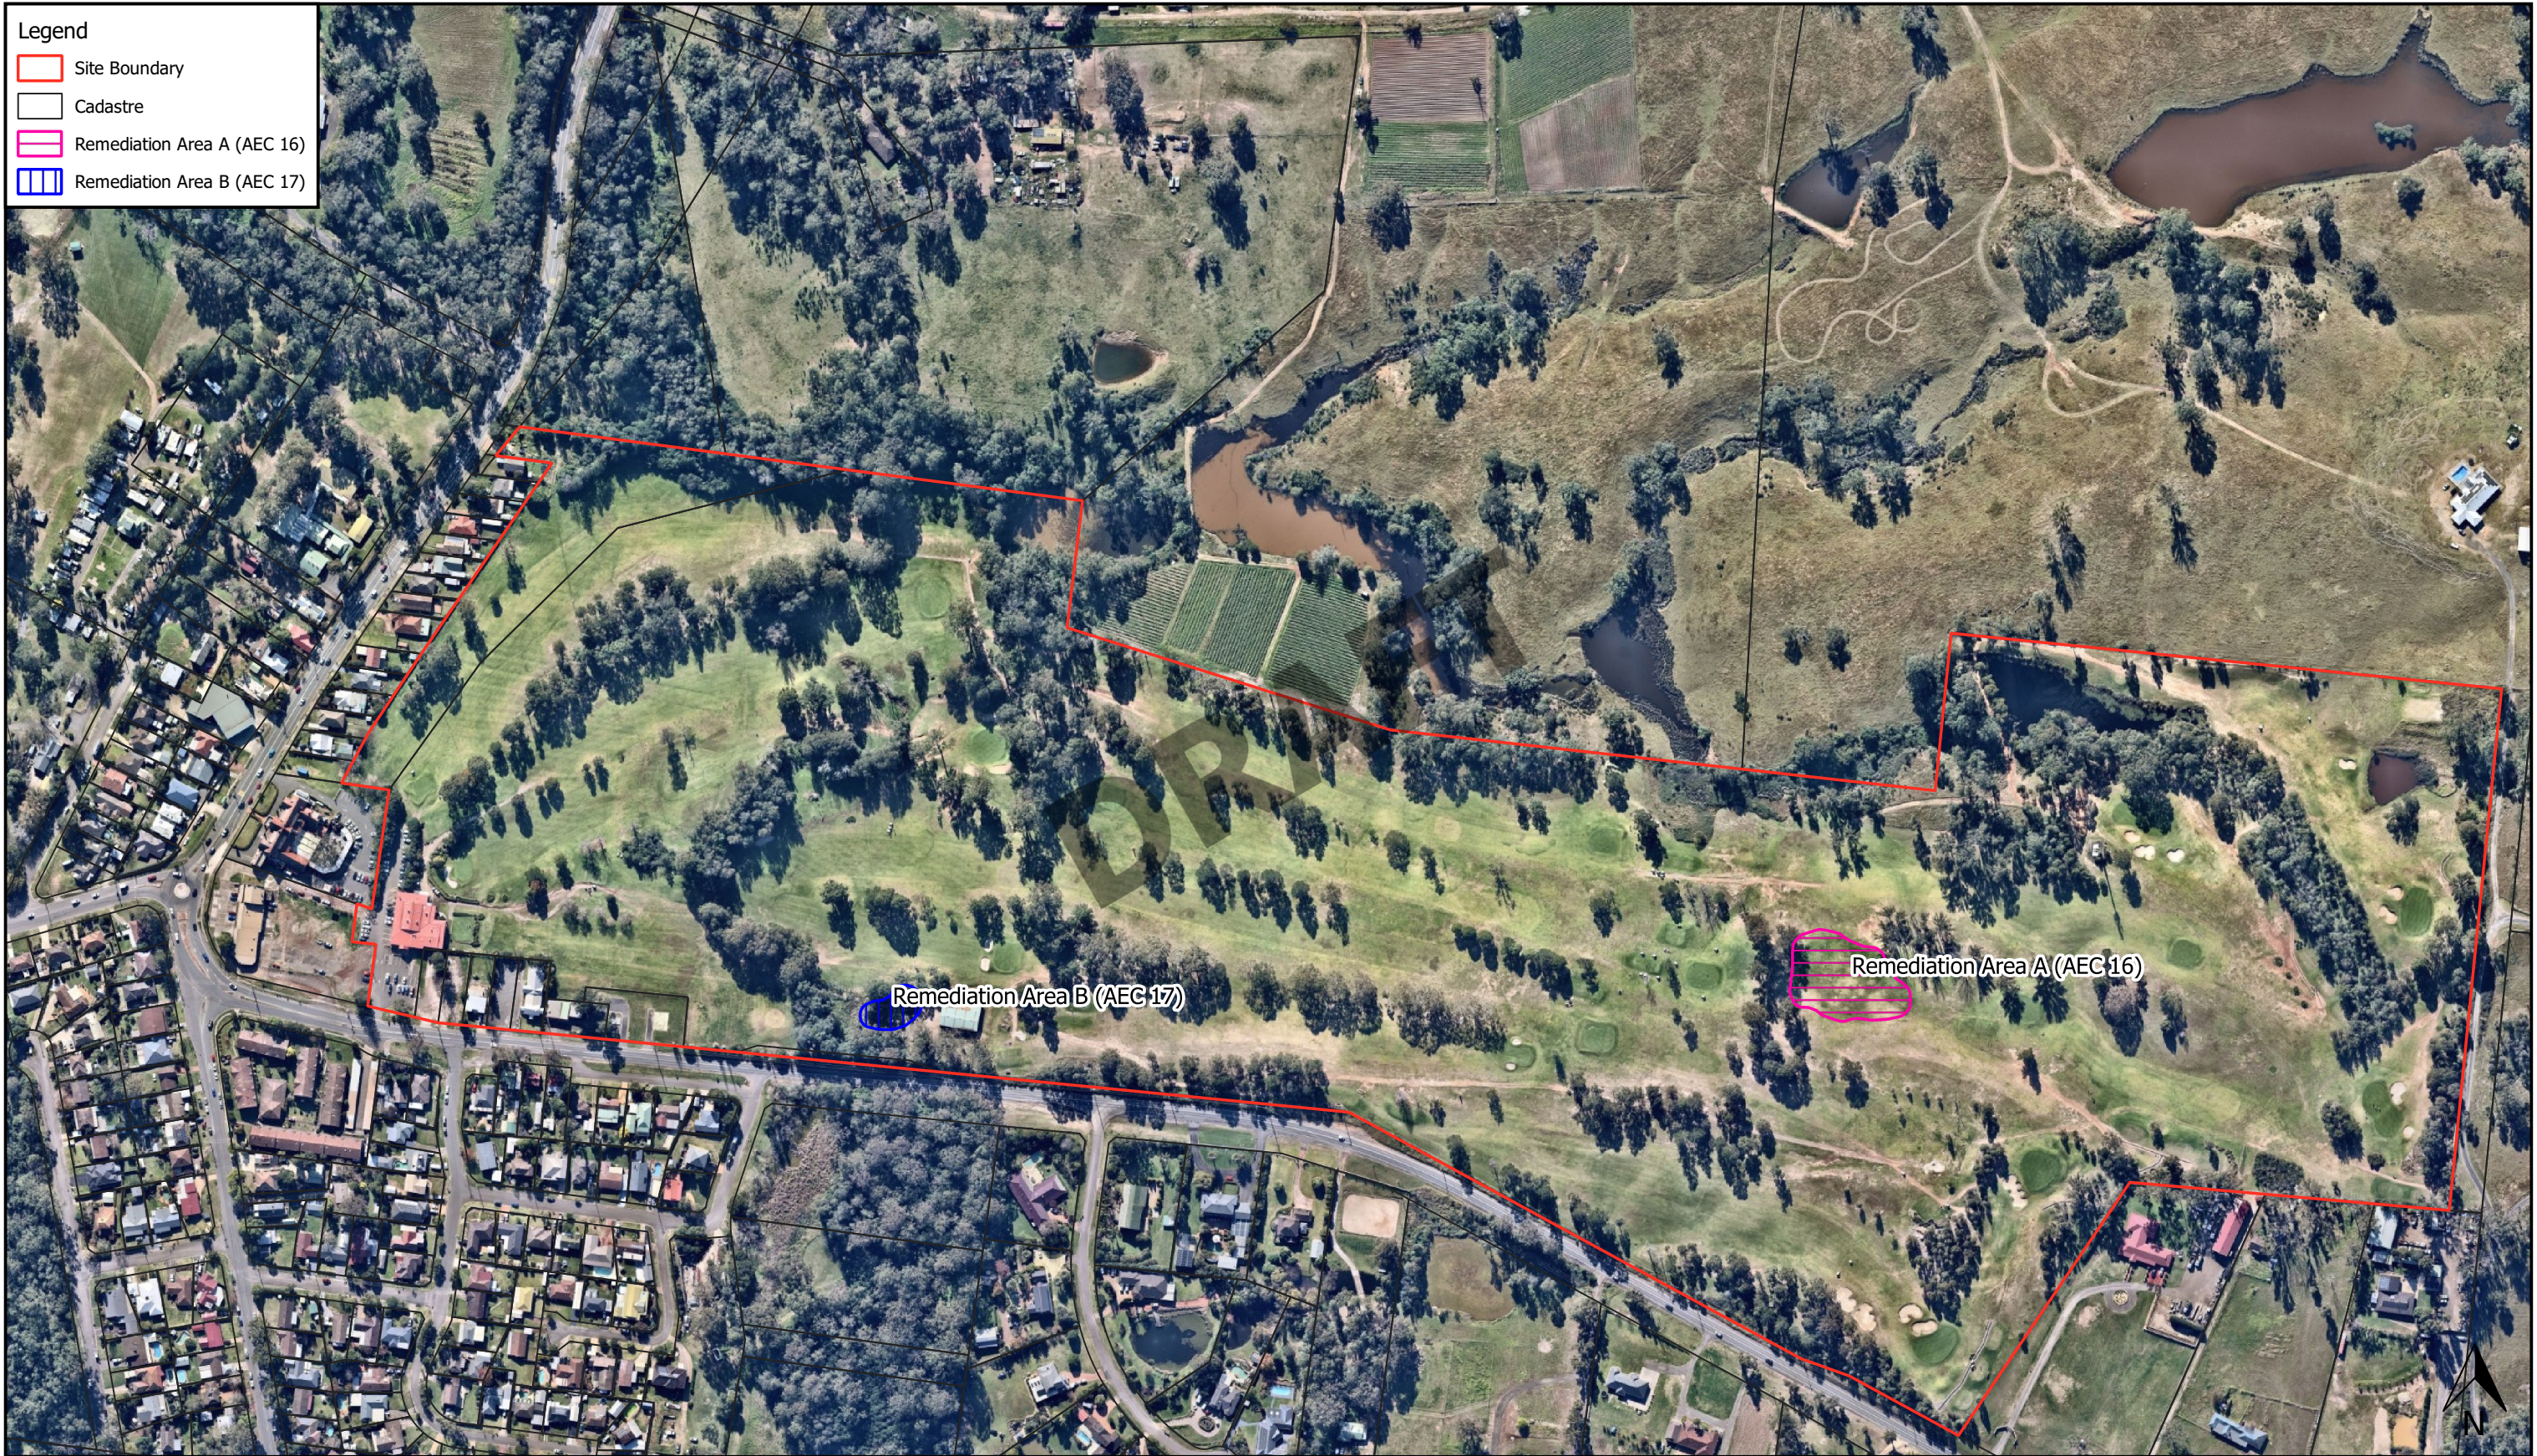
<b>Map 02</b>	Map
Wallacia Golf Course	Site
Proposed Cemetery	Project
Remedial Action Plan	Sub-Project
CMCT	Client
12/11/2020	Date

- Site Boundary
- Cadastre
- Remediation Area A (AEC 16)
- Remediation Area B (AEC 17)

Based on the DSI (MA, 2020) findings, site contamination is limited to fill material containing bonded asbestos fragments within AEC 16 and AEC 17 as follows:

- Remediation Area A (AEC 16) – Fill material was observed in several test pit locations in AEC 16, with depths ranging between 0.0 mbgl and > 1.8 mbgl. The area of AEC has been estimated as approximately 3,200 m<sup>2</sup>. The MA (2020) DSI indicated that fill material within AEC 16 contains bonded ACM fragments. Based on an approximate average depth of fill (1.0 m), the volume of ACM impacted fill requiring remediation is approximately 3,200 m<sup>3</sup>.
- Remediation Area B (AEC 17) – A stockpile of approximately 100 m<sup>3</sup> of soil fill material was located in AEC 17. The MA (2020) DSI indicated that fill material within this stockpile contains bonded ACM fragments.

The location of remediation areas (AEC 16 and AEC 17) is provided in Attachment A.

- Excavate fill in the remediation area until underlying natural residual silty clays are exposed. Residual silty clays are expected at depths ranging from 0.0 mbgl to > 1.8 mbgl. It is anticipated that the fill material in this area will need to be excavated to an average depth of 1.0 mbgl and over an area of approximately 3,200 m<sup>2</sup>.
- The estimated lateral extent of the remediation area is shown on the site plan in Attachment A.

Excavate fill in the remediation area stockpile until underlying natural residual clays are exposed. The lateral extent of the remediation area stockpile is shown on the site plan in Attachment A.

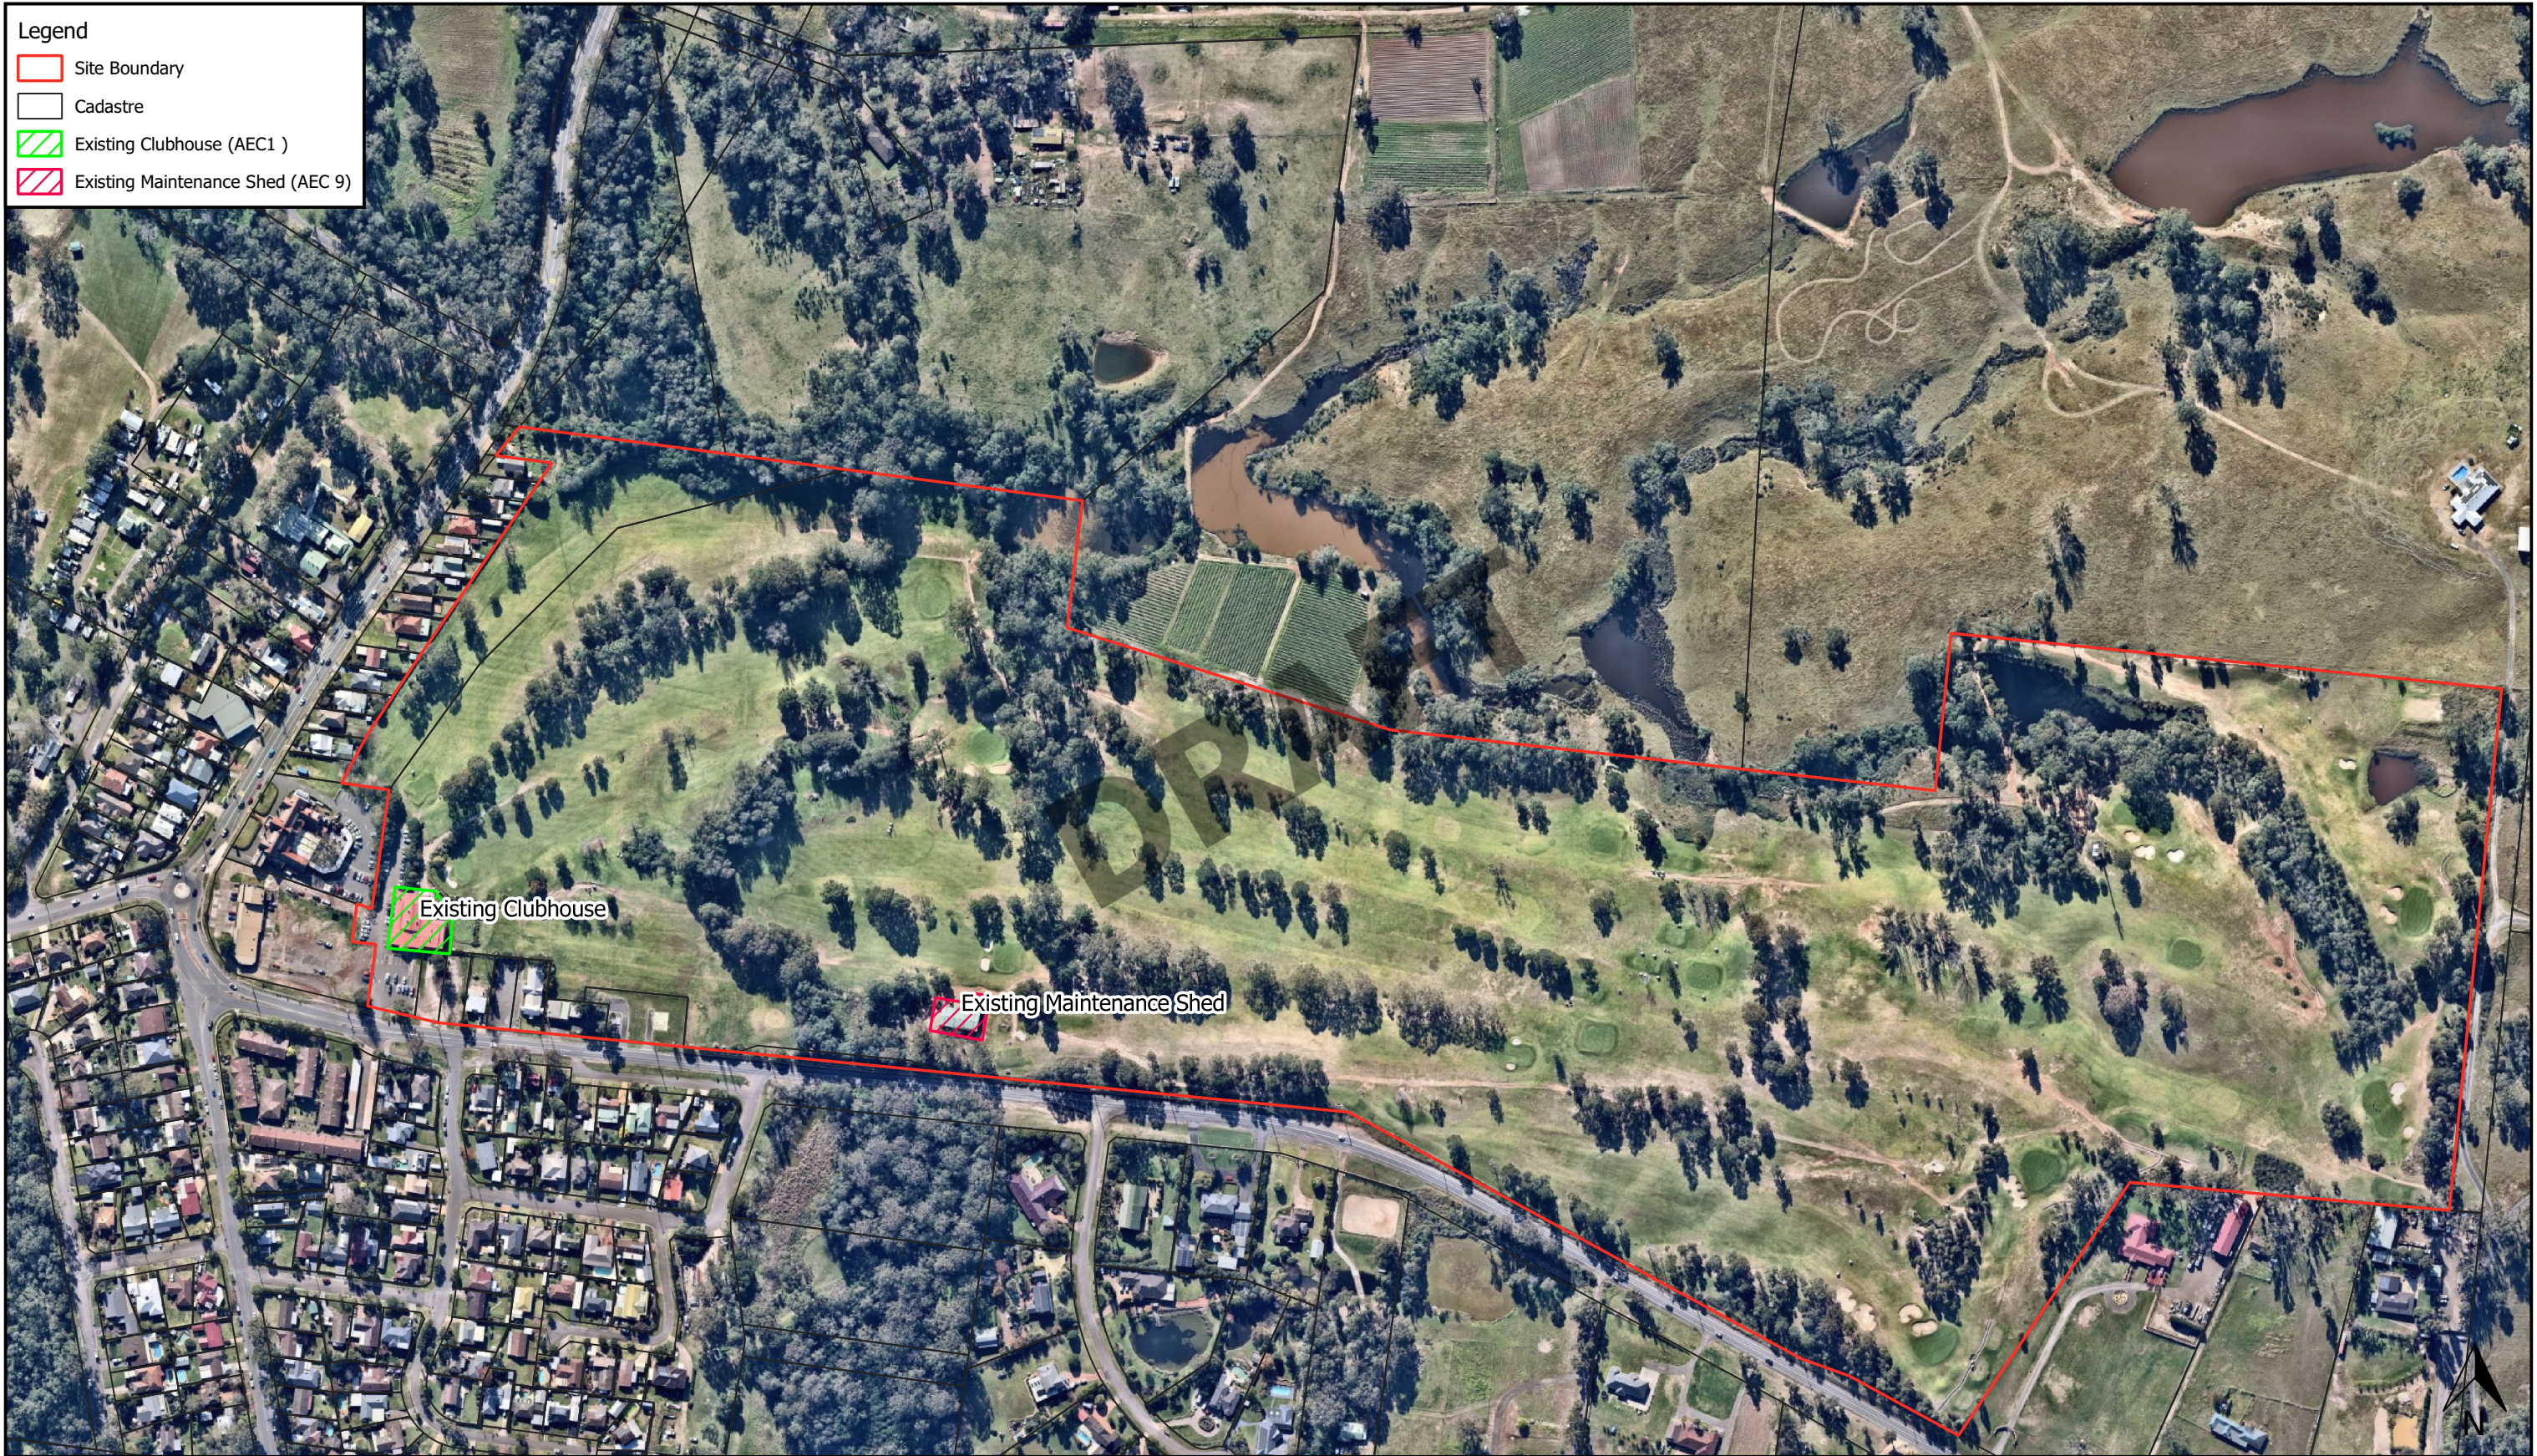
- Site Boundary
- Cadastre
- Existing Clubhouse (AEC1 )
- Existing Maintenance Shed (AEC 9)

1. AEC 1: Footprint of existing clubhouse.
2. AEC 9: Footprint of existing maintenance shed.

The footprints beneath these structures could not be accessed during the DSI field investigations and will require assessment post demolition, if such structures are to be removed. If the structures are to remain, then no further assessment is necessary.

Data gap locations are shown in the site plan in Attachment A.
