# Geotechnical Investigation

32-36 Hope Street, Penrith NSW

Prepared for: Designcorp Architects Pty Ltd

DSC-06-13286/ GT11  
v1 final  
15<sup>th</sup> December 2017

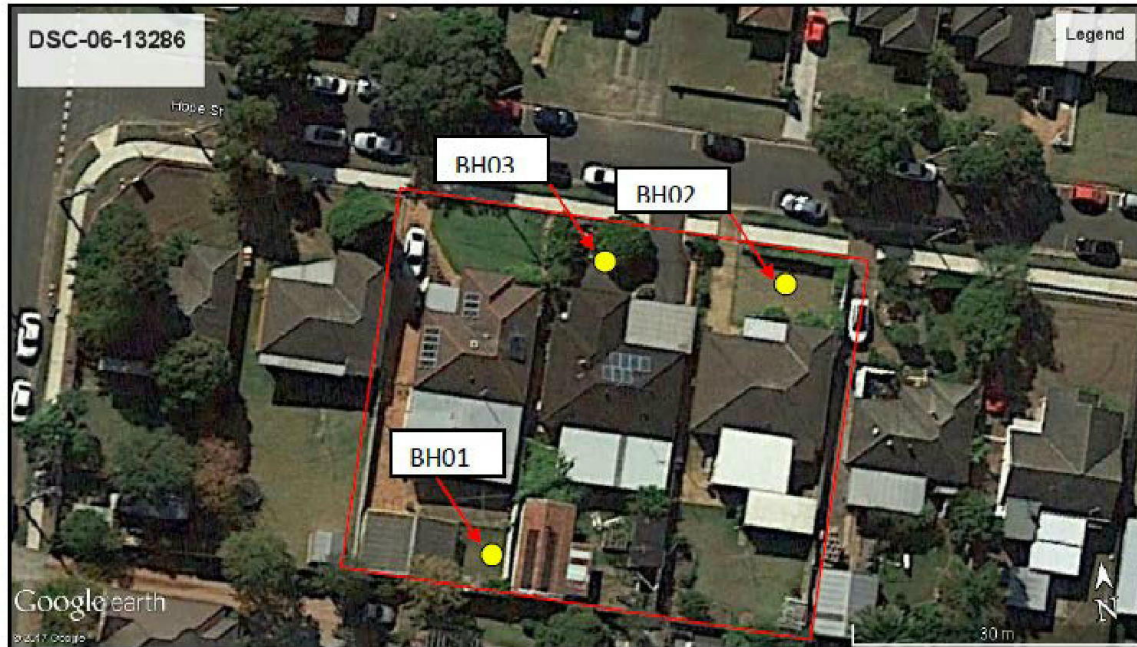
**Figure 1** Site plan with the approximate borehole location, taken from Google Earth on 15.12.2017

The fieldworks were undertaken on the 4<sup>th</sup> to 11<sup>th</sup> of December 2017. The field investigation comprised the drilling of three (3) boreholes (BH1 to BH3) to a depth of 9.7 m to 14.0 m bgl. SPTs were undertaken in the borehole within soils to assess the subsurface soil consistency and density, and estimate soil strength parameters. Rock coring and core sample retrieval were undertaken for rock classification, determination of RQD and laboratory testing. The borehole was logged on-site by an experienced geotechnical engineer in accordance with AS 1726 – 2017, *Geotechnical Site Investigations*. The approximate location of the borehole is shown on the Site Plan (Refer to *Appendix I – Site Plan*).

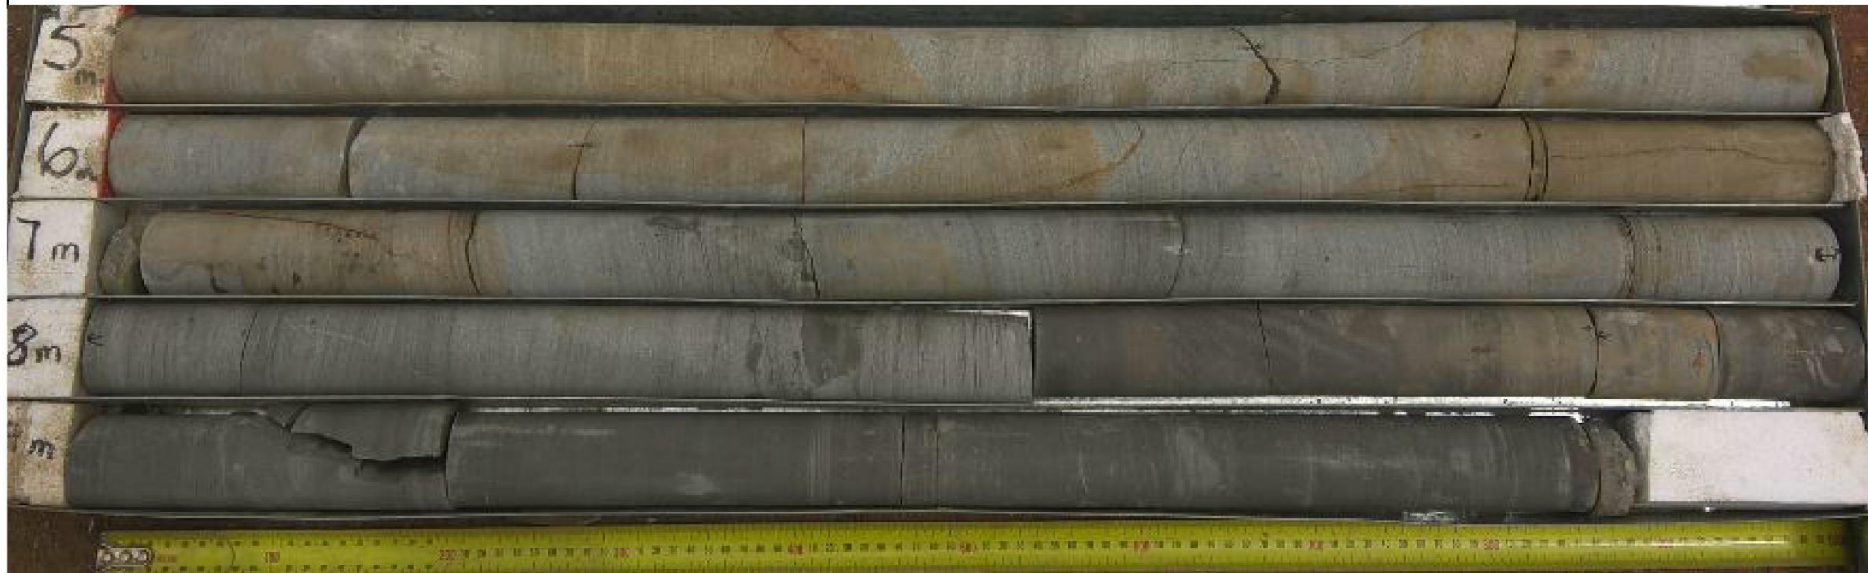
Core Photo : BH1

Depth : 5.0 m – 10.0 m

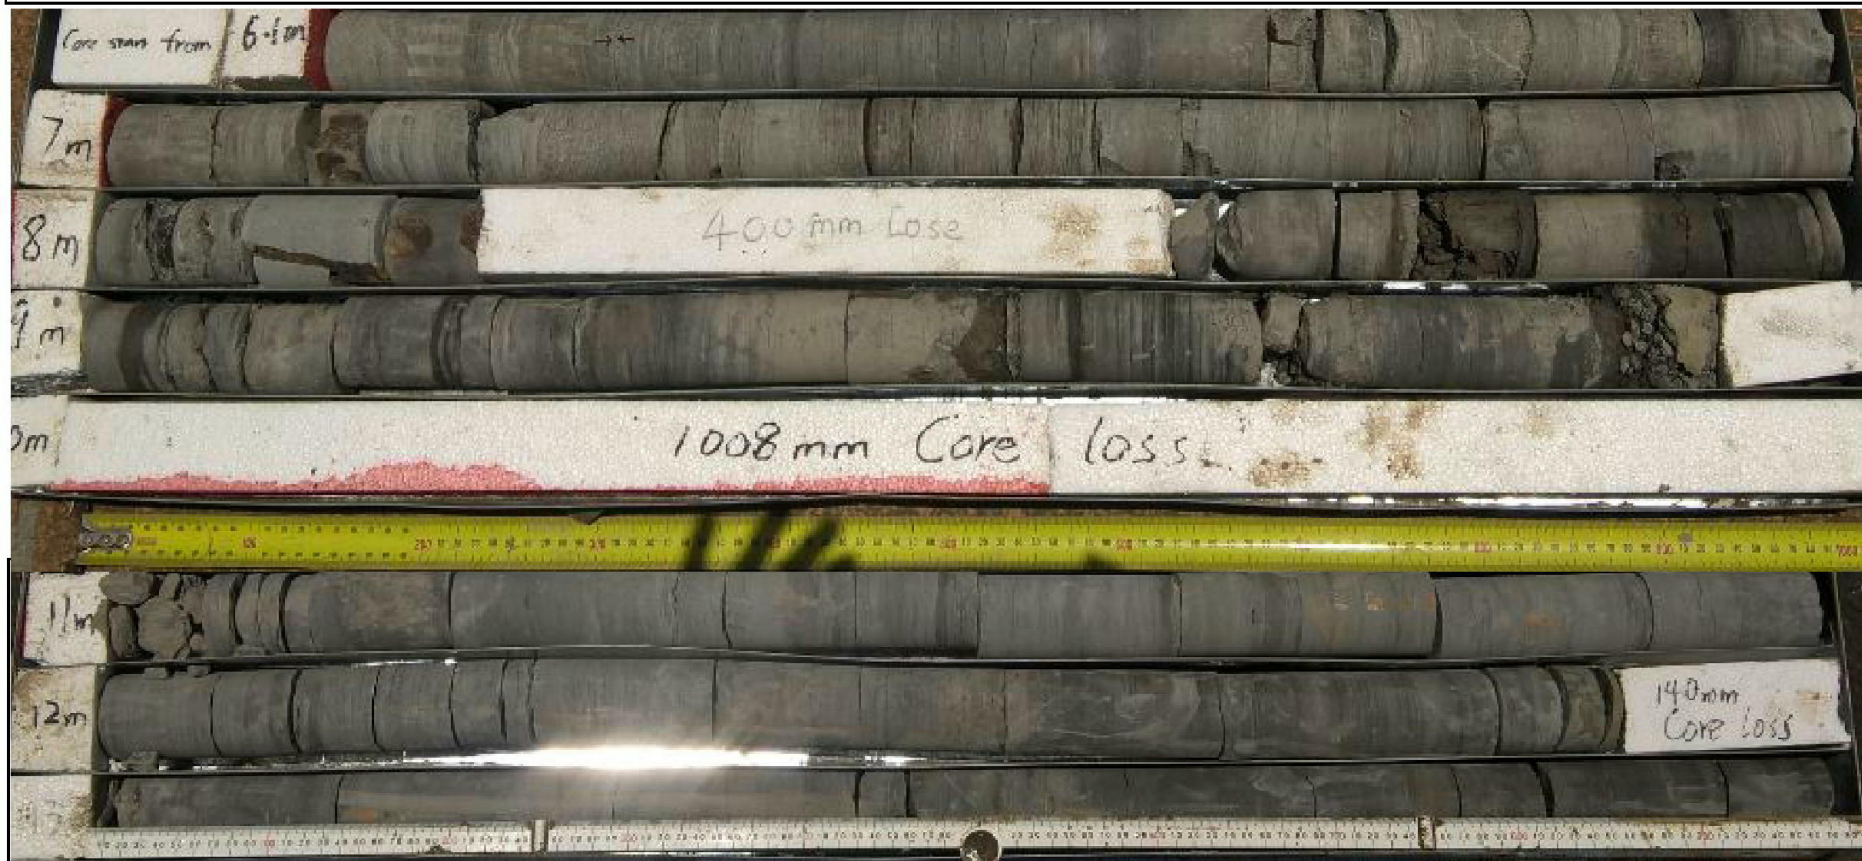
Core Photo : BH2

Depth : 6.1 m – 14.0 m

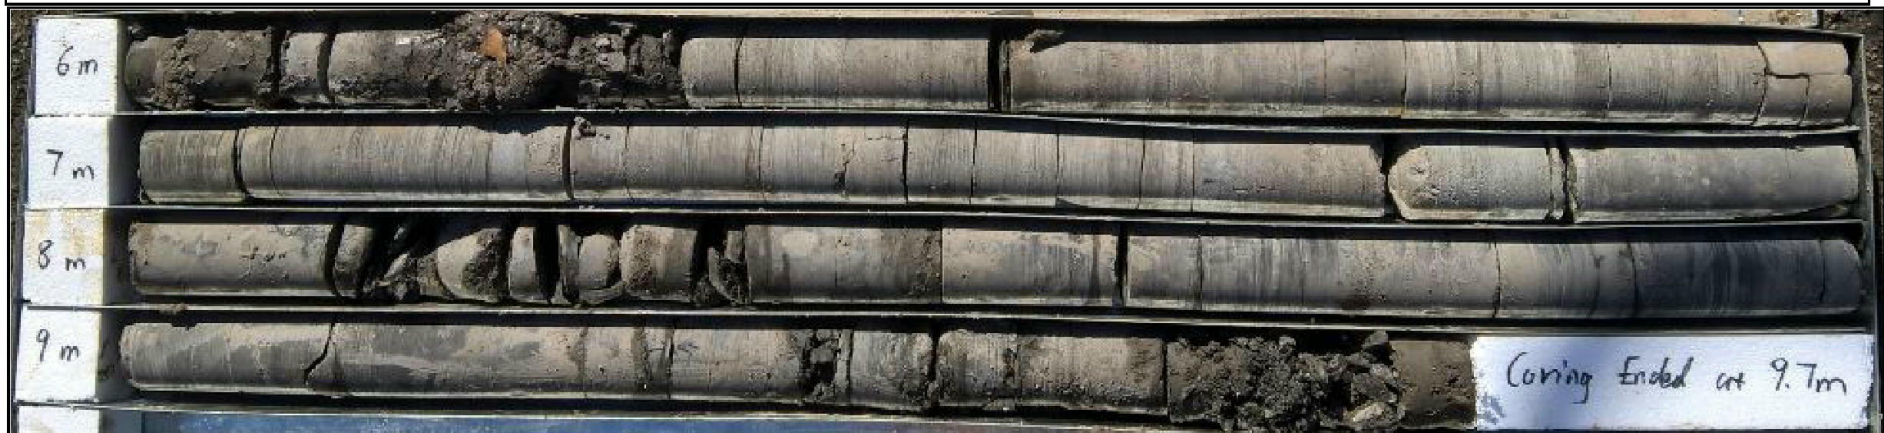
Core Photo : BH3

Depth : 6.0 m – 9.7 m
