Groundwater Monitoring Event Report

Caltex Werrington (28569), Cnr Dunheved Rd and Henry Lawson,
Werrington NSW

16 May 2011

60153489-200

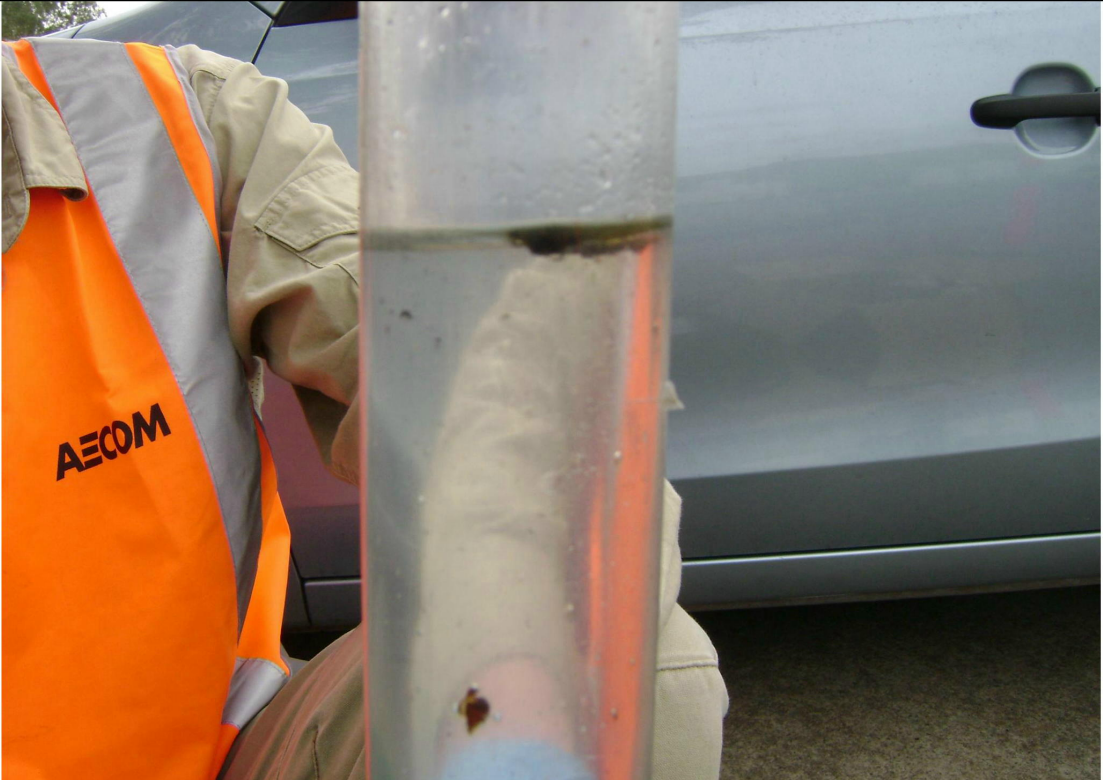
Site Name: Caltex Werrington (Caltex ID 28569)		Site Location: Corner Dunheved Rd and Henry Lawson Drive, Werrington NSW	Project No: 60153489-200
Plate No. 1	Date: 16/02/11

Direction Photo Taken: Not applicable			
Description: Approximately 0.002m of greenish PSH was observed in the bailer collected from MW03. The PSH was not detected by the interface probe.

- The SWLs were between 2.200 metres below top of casing (m btoc) and 3.930 m btoc;
- The groundwater elevation was between 37.420 m AHD and 39.060 m AHD; and
- PSH (0.002 m) was observed in MW03 but was not detected by the interface probe.

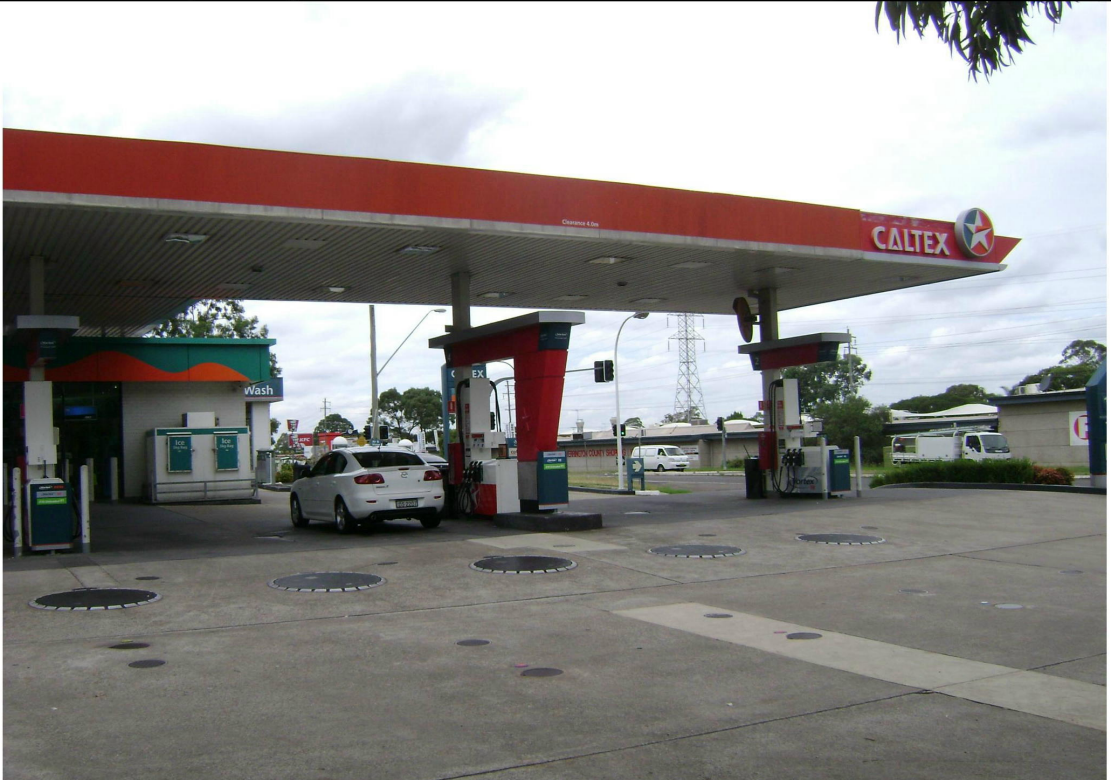
Site Name: Caltex Werrington (Caltex ID 28569)		Site Location: Corner Dunheved Rd and Henry Lawson Drive, Werrington NSW	Project No: 60153489-200
Plate No. 3	Date: 16/02/11

Direction Photo Taken: Southeast			
Description: Photograph (towards Dunheved Road) showing the southern fuel dispensers and UST access points in the forecourt.

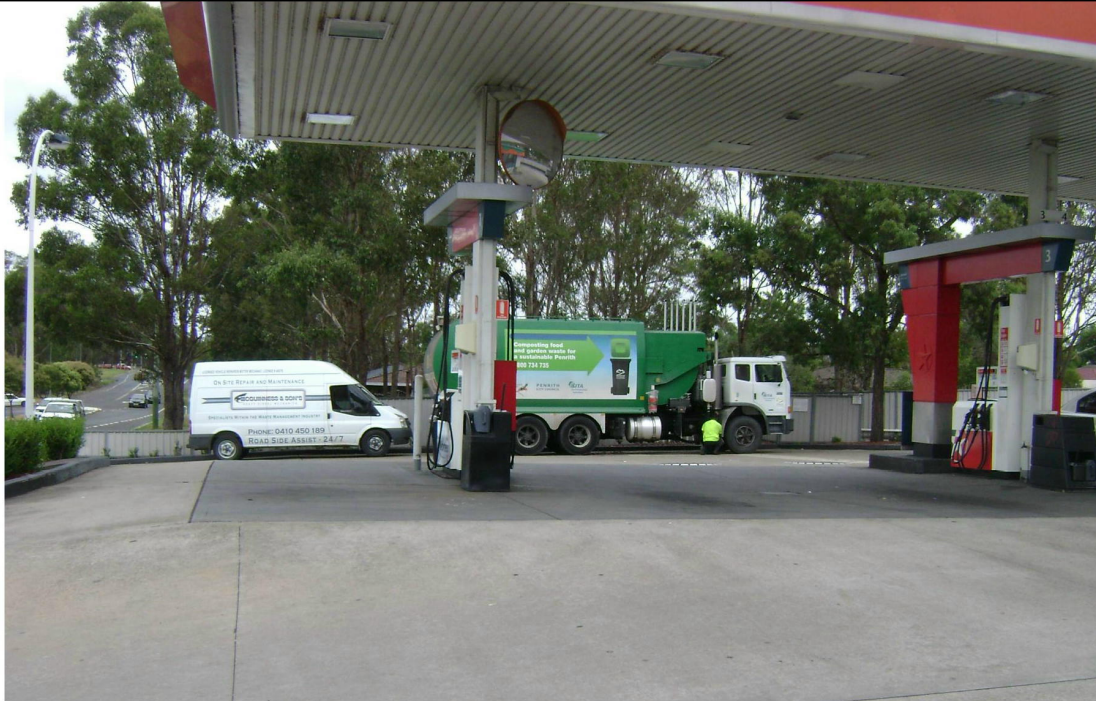
Site Name: Caltex Werrington (Caltex ID 28569)		Site Location: Corner Dunheved Rd and Henry Lawson Drive, Werrington NSW	Project No: 60153489-200
Plate No. 5	Date: 16/02/11

Direction Photo Taken: West			
Description: Photograph showing the southwest corner of the site adjacent to Dunheved Road.

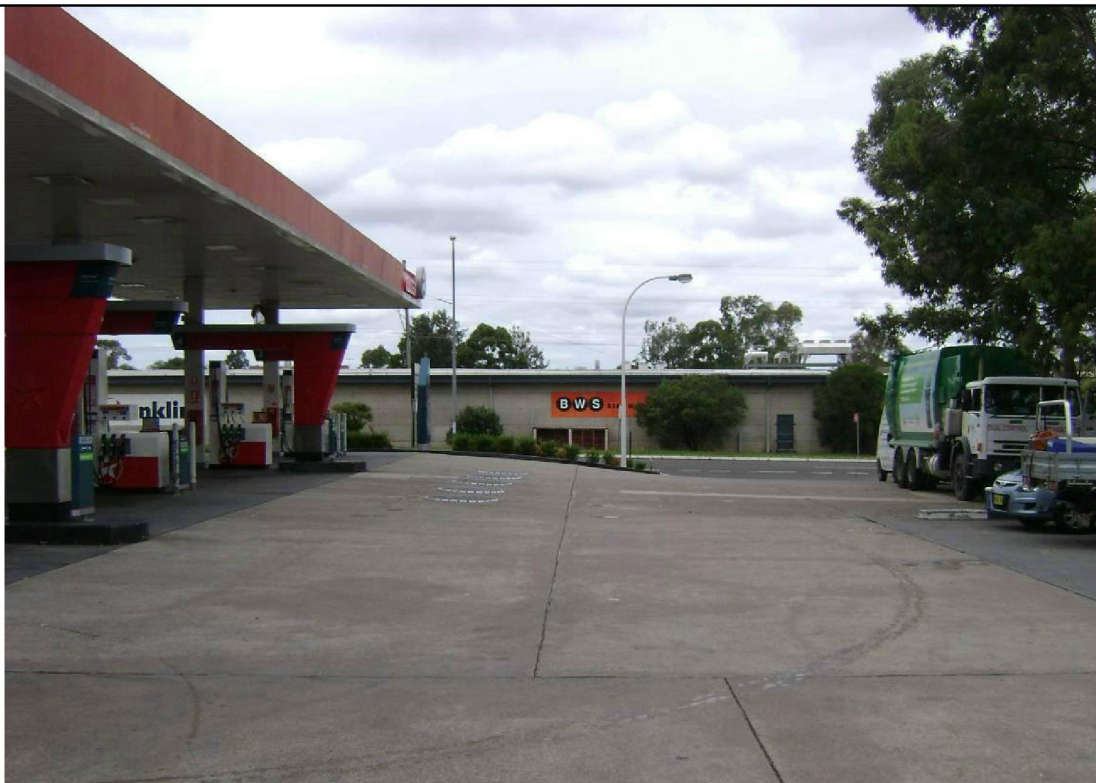
Plate No. 6	Date: 16/02/11

Direction Photo Taken: South		
Description: Photograph showing the western forecourt area of the site, looking towards Dunheved Road.
