# PHASE 1 (PRELIMINARY) ENVIRONMENTAL SITE ASSESSMENT

**307-321 Cranebrook Rd, Cranebrook NSW**

OUR REFERENCE: REP-164514

ISSUE DATE: 16<sup>th</sup> December 2014

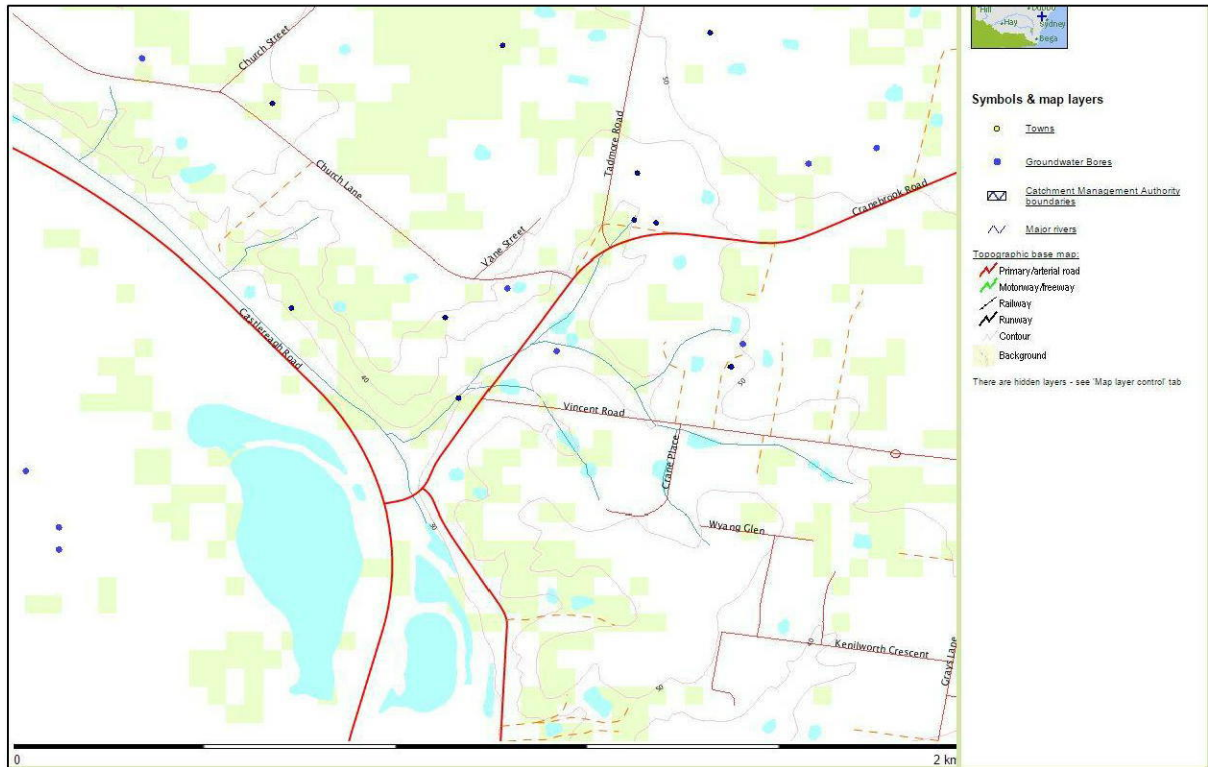
Figure 5: Groundwater bore locations (accessed via NRAtlas.nsw.gov.au on the 11/12/14)

A review of the NRAtlas resource revealed nine (9) bores within a 2km radius of the site however public data regarding these bores is not available. Below is a diagram showing the location of the bores.

Groundwater levels fluctuate according to rainfall events, and the standing water levels of nearby creeks rivers. Based on the low lying nearby lakes which have been excavated and altered the groundwater flow over many years, as well as general topography, the groundwater flow is expected to go to the south.
