Flood Study for 1 Station Lane Penrith

Reference: R.S20386.001.01.1StationLnPenrith_FS.docx
Date: August 2018
Confidential

<p>BMT WBM Pty Ltd Suite G2, 13-15 Smail Street Ultimo, Sydney, NSW, 2007 Australia PO Box 1181, Broadway NSW 2007</p> <p>Tel: +61 2 8960 7755 Fax: +61 2 8960 7745</p> <p>ABN 54 010 830 421</p> <p>www.bmt.org</p>	Document:	R.S20386.001.00.1StationLnPenrith_FS
	Title:	Flood Study for 1 Station Lane Penrith
	Project Manager:	Joshua Eggleton
	Author:	Sam Drysdale
	Client:	Station Lane Pty Ltd ATF The Station Lane Trust
	Client Contact:	Antoine Saouma
	Client Reference:	
Synopsis: Flood study for 1 Station Lane, Penrith

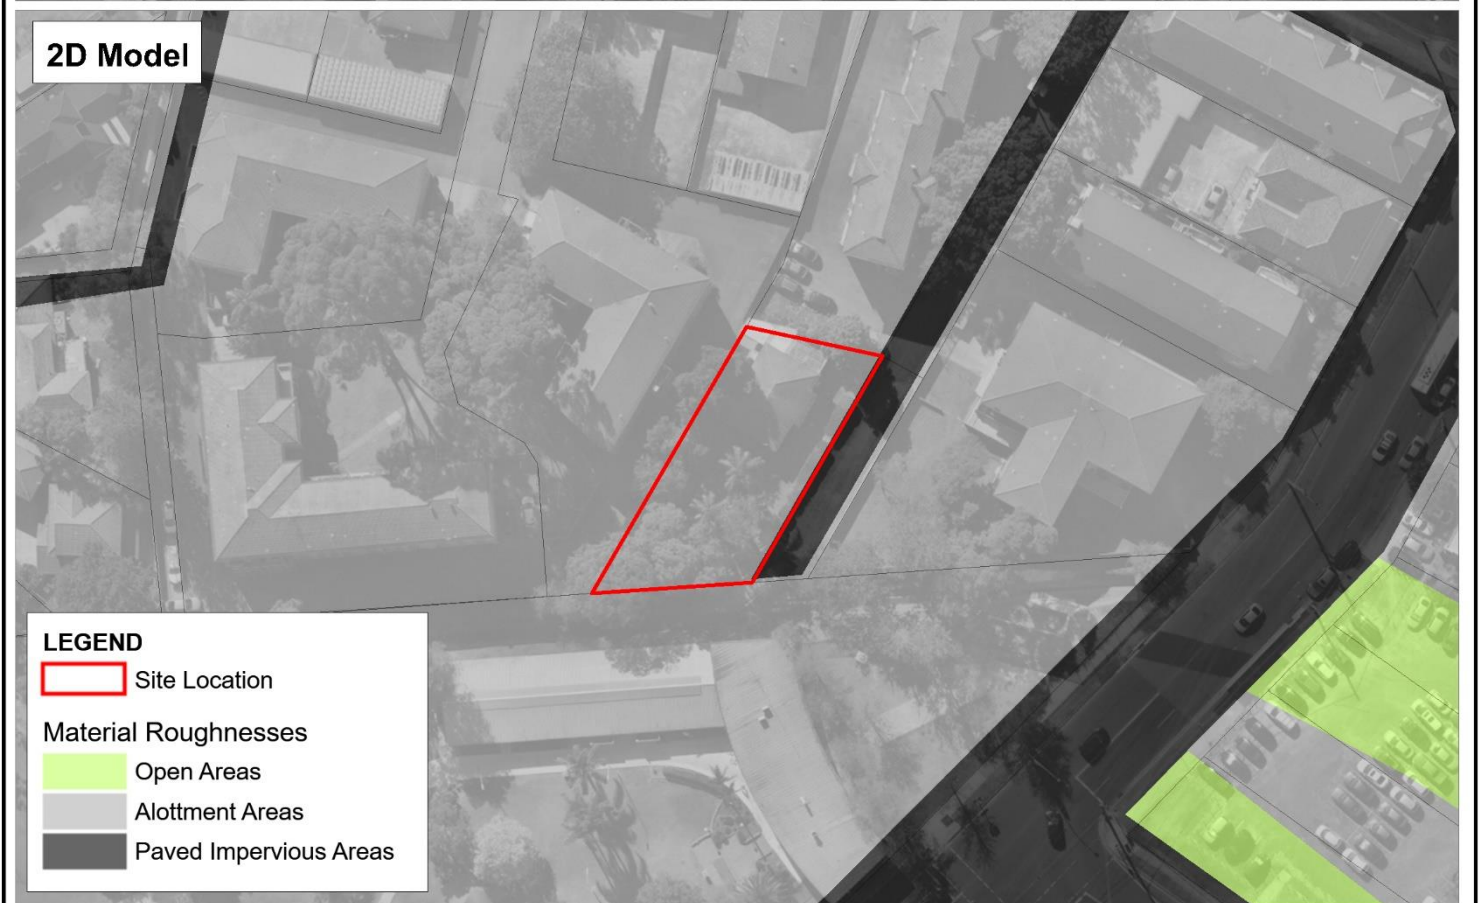
Figure:
2-1

The TUFLOW hydraulic model schematisation local to the site is presented in Figure 2-1. The site backs onto the open channel with 1D/2D model connections parallel to the site boundary. Model roughness layers do not provide significant detail local to the site. Allotments local to the site had a hydraulic roughness of 0.100, whilst the Station Lane has a roughness of 0.015. Within the channel two roughness's were employed, 0.020 for the centre of the concrete channel and 0.035 for vegetated areas at the top of channel.

Title:
**Penrith Overland Flood Study TUFLOW Schematisation
 1D and 2D Models**

A fine grid (1m cell size) was utilised for the TUFLOW model. Open channels and pit and pipe networks within the study area are represented as 1D elements embedded within the 2D model domain, while overland flow through the catchment is modelled in the 2D domain.

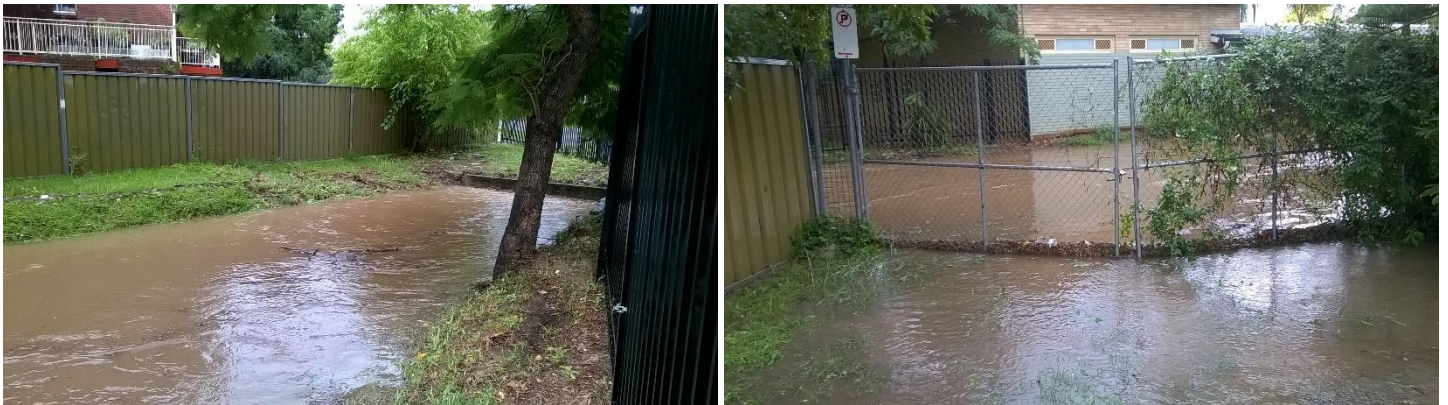
Council has previously indicated that the open concrete channel to the south of the site overtopped during the January 2016. The debris deposited on the upstream side of the wire fence shown in Figure 3-4 supports this, with water flowing from the channel into Station Lane.

Figure 3-4 Flow within the adjacent channel (Left) Upstream of the channel with flow entering from a culvert under Station St (Right) Flow from the channel into Station Lane

Blockage was also considered at the upstream culvert passing under Station Street, this is the same culvert seen to be submerged within Figure 3-4. Blockage of this structure did not significantly alter the peak flood level in the open channel adjacent to the site.

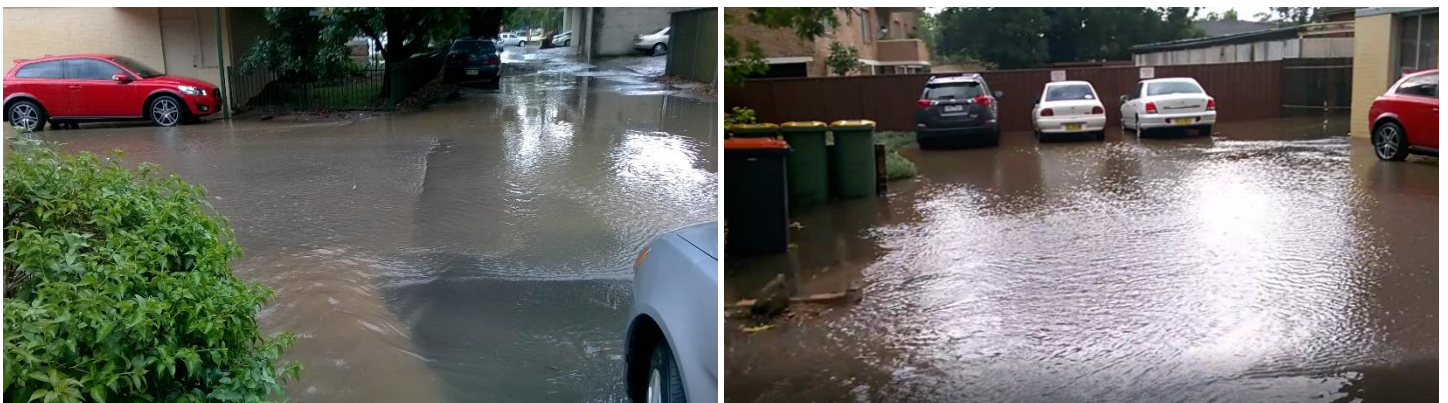
In addition to the mainstream flows spilling from the open channel adjacent to the site, overland flows originating from Union Road approach the site from the north down Station Lane. This overland converges at Station Lane and inundates the rear/southern portion of the adjacent 20 Union Road site, with some floodwaters then inundating the proposed development site, as shown in Figure 3-2. This is supported by the video recording provided by Council.

Figure 3-5 Flow from Station Lane to the back of 20 Union Road (Left) Station Lane looking toward Union Road (Right) Back of 20 Union Road Residence

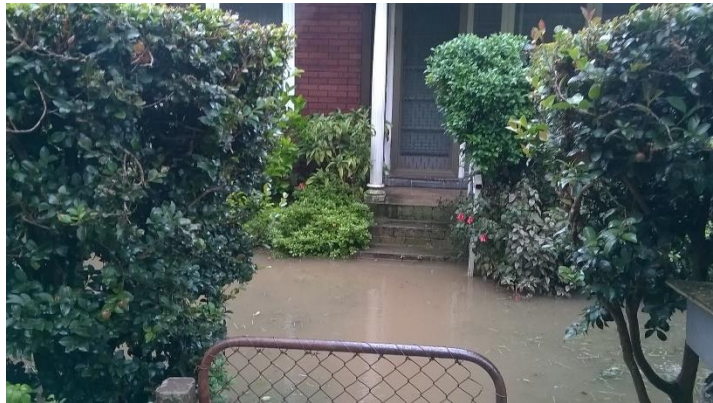
As previously noted, flood depths less than 15cm are removed from Council's flood mapping. In observation of the photographic and video evidence, the inundation in the vicinity of the development site appears to be shallow in depth, hence even if such flooding behavior was simulated in Council's model, it would be filtered out due to shallow depths. Figure 3-3 depicts the inundation at 1 Station Lane, these depths appear to be relatively shallow < 20cm.

Figure 3-6 Inundation experienced at 1 Station Lane
