Maryland Development Company

Phase 1 Preliminary Site Assessment  
Eastern Connector Road

Jordan Springs East, NSW

54581/113744 (Rev 2)

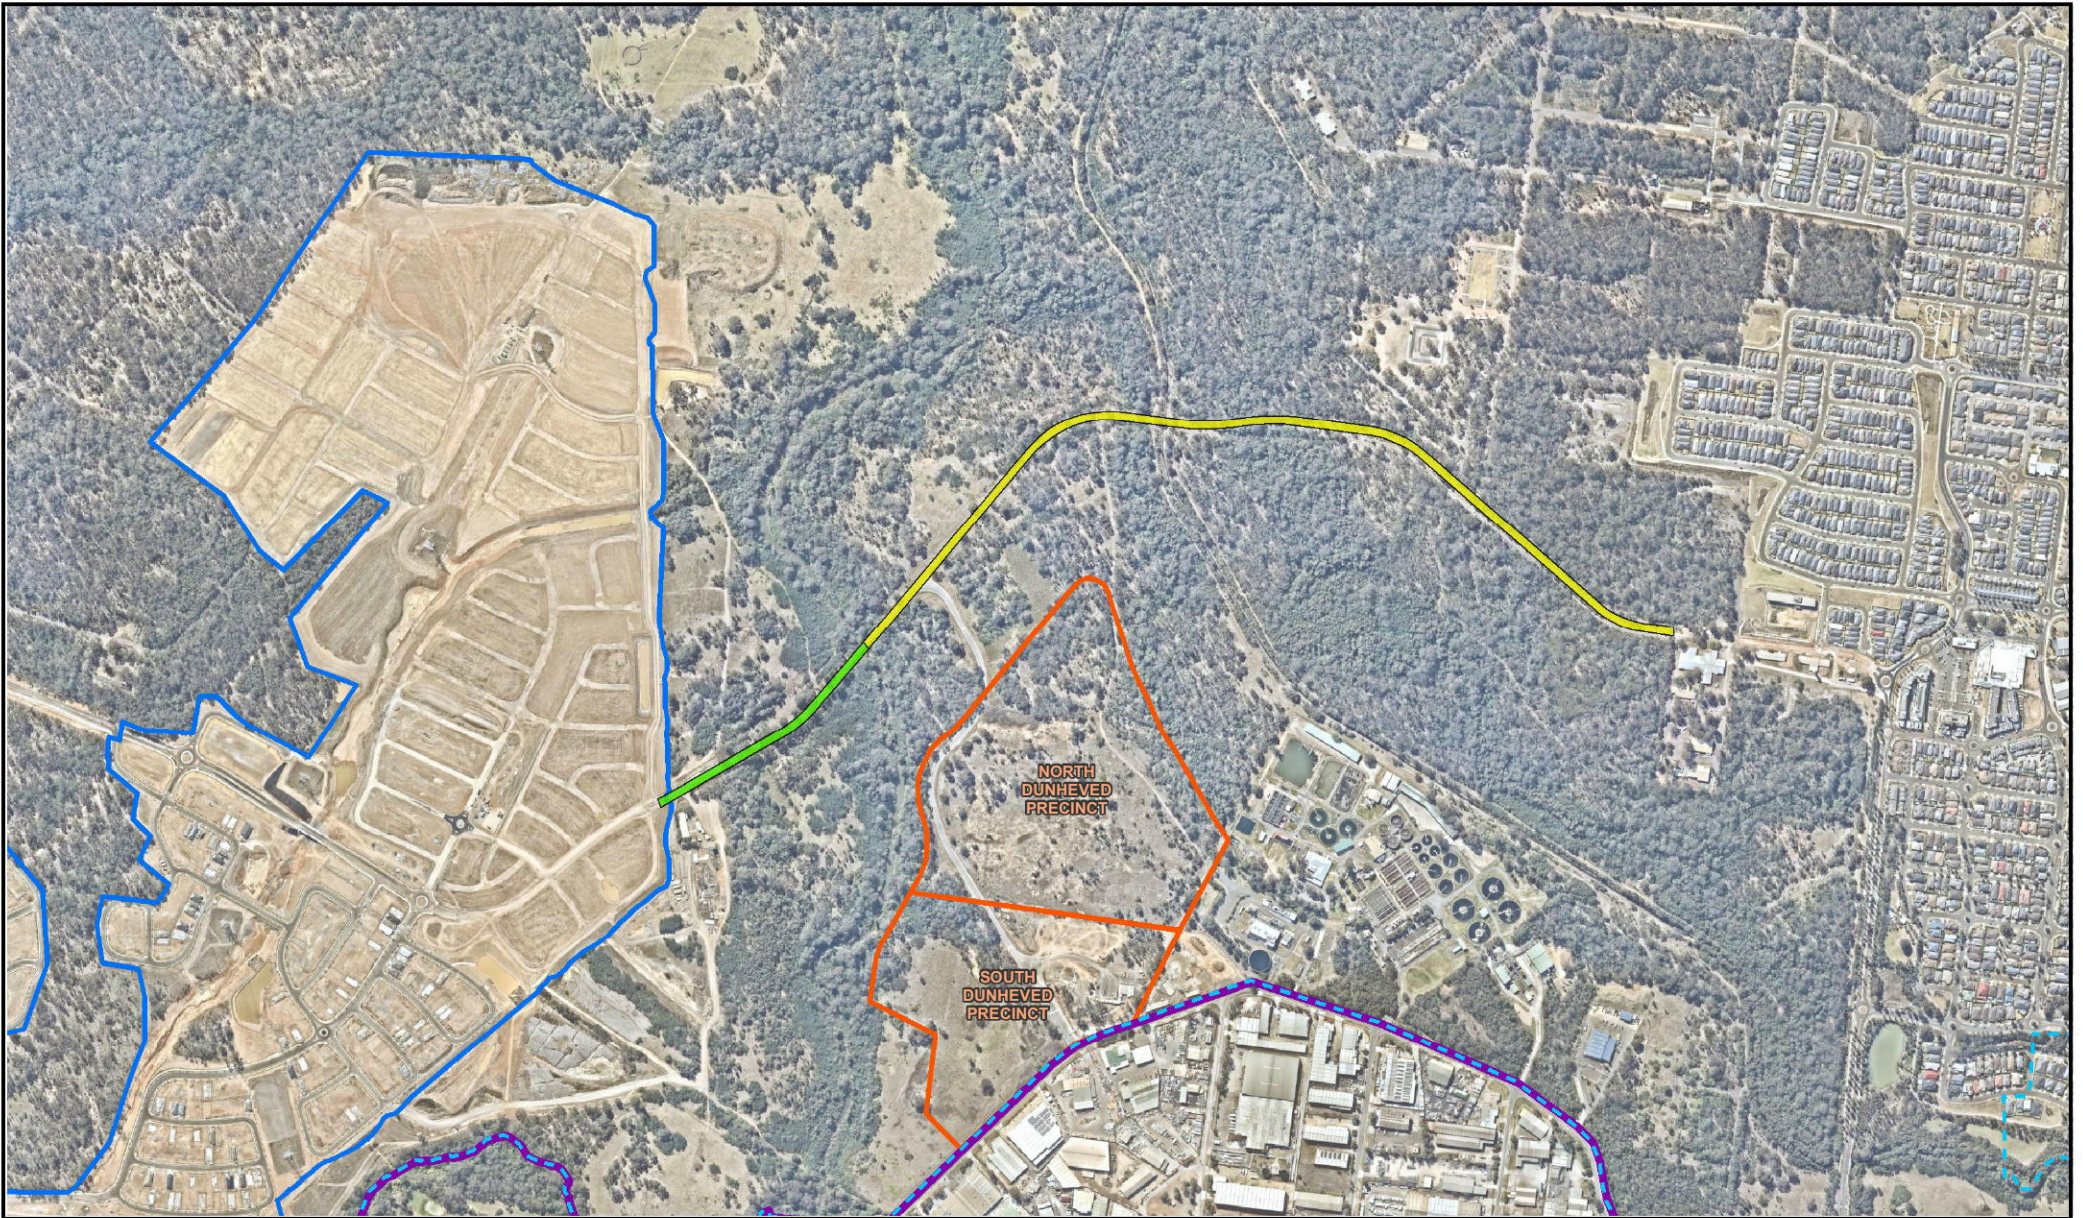
Figure 1: Site Location

The location of the site is shown in **Figure 1**, the site layout and surrounding areas are shown in **Figure 2**. Details of the site are summarised in **Table 2.1** below.

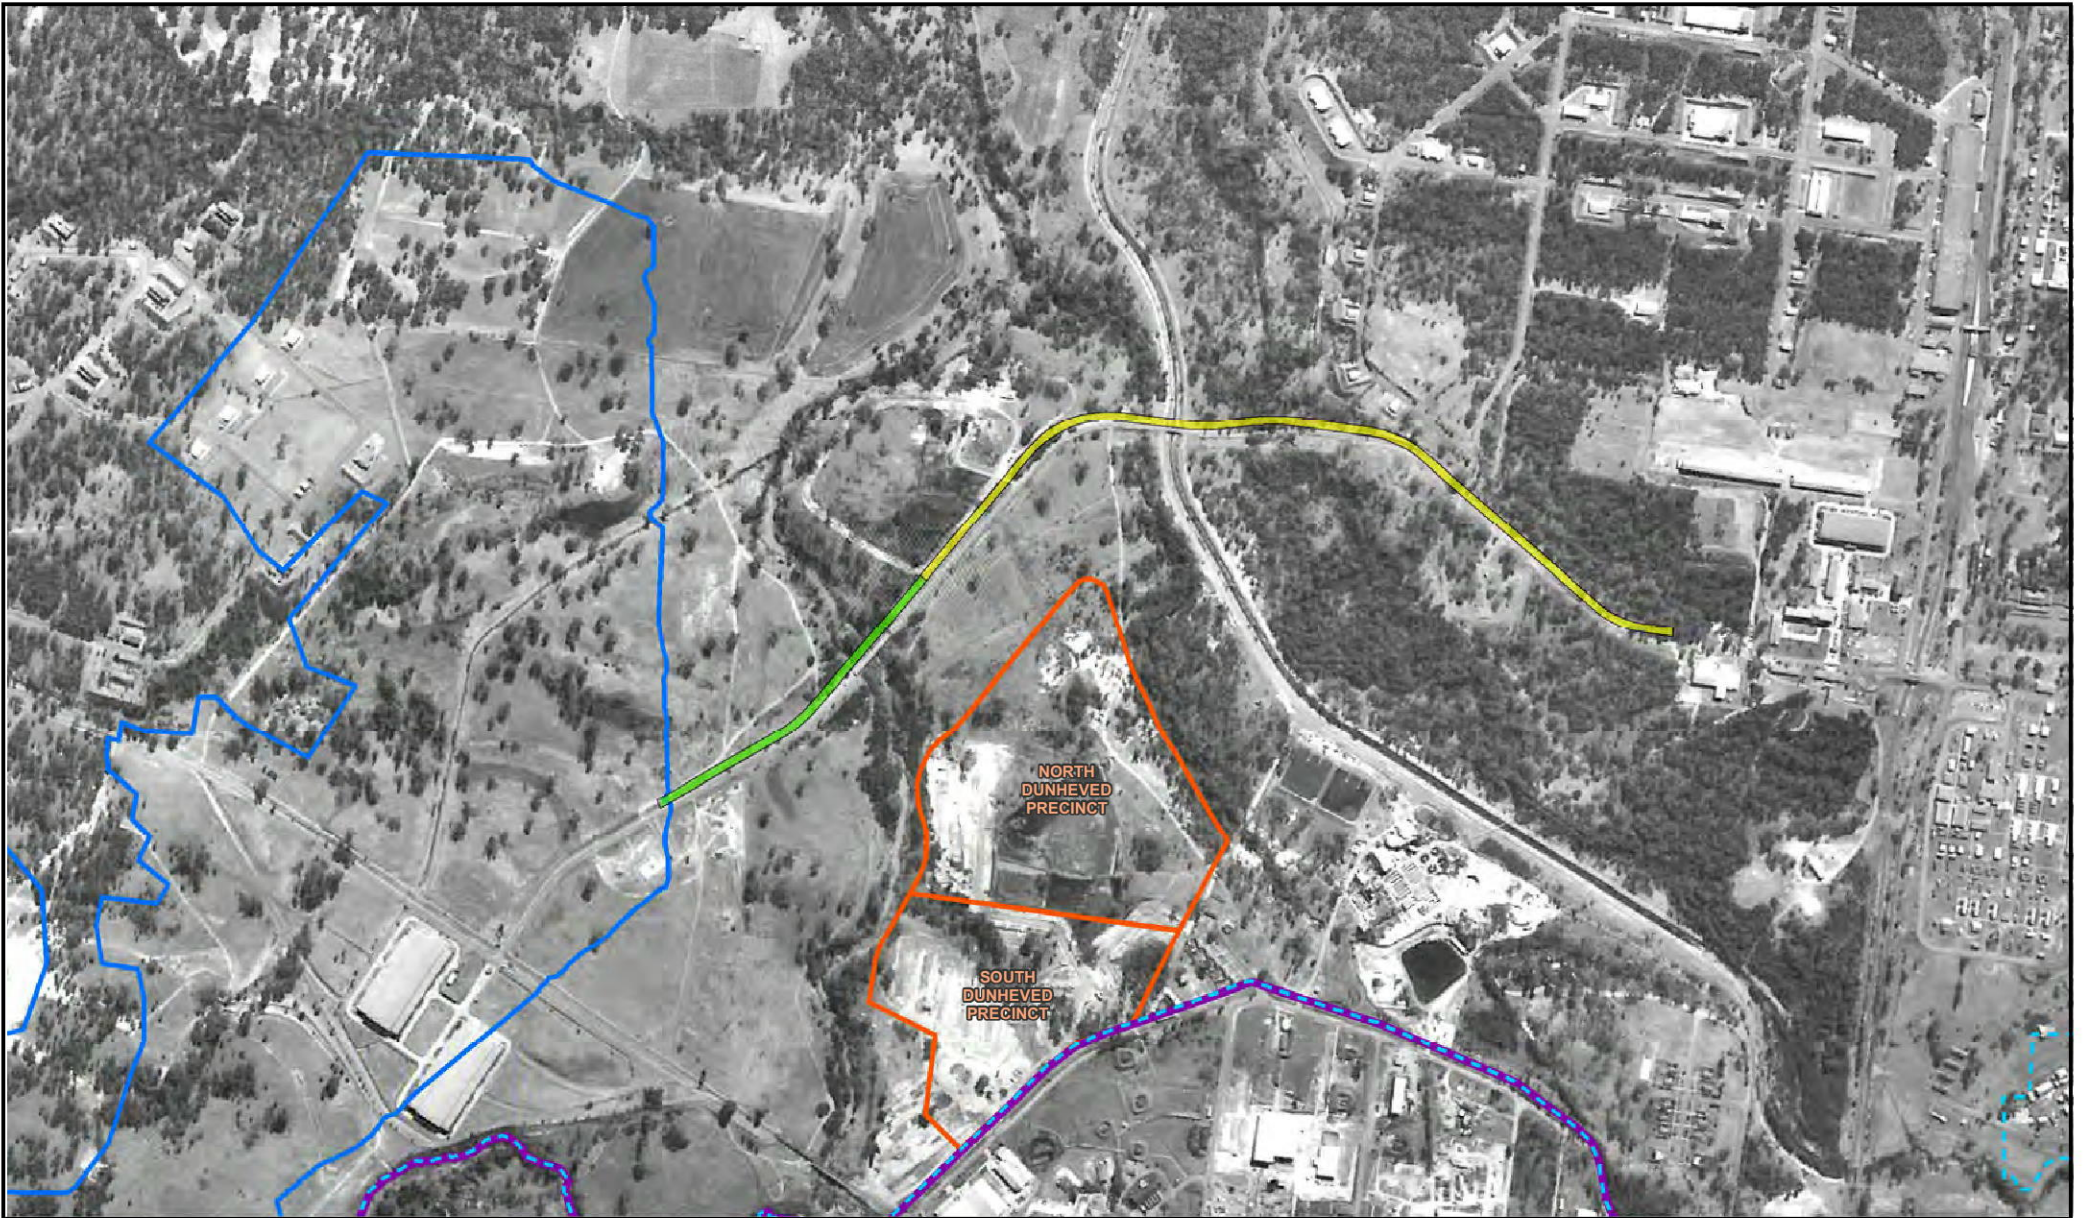
Reference: Spatial Services NSW, 1975

- **1975** – the site appeared similar to the description provided for the previous image. It is noted that the entire site could be observed in this image and the road was observed to extent the entire length of the site. Surrounding areas to the site included ADI associated buildings and activities. Disturbance to ground was noted north of the mid portion of the site and also to the south, within the proposed Dunheved precinct. Increase in vegetation to surrounding areas was observed.

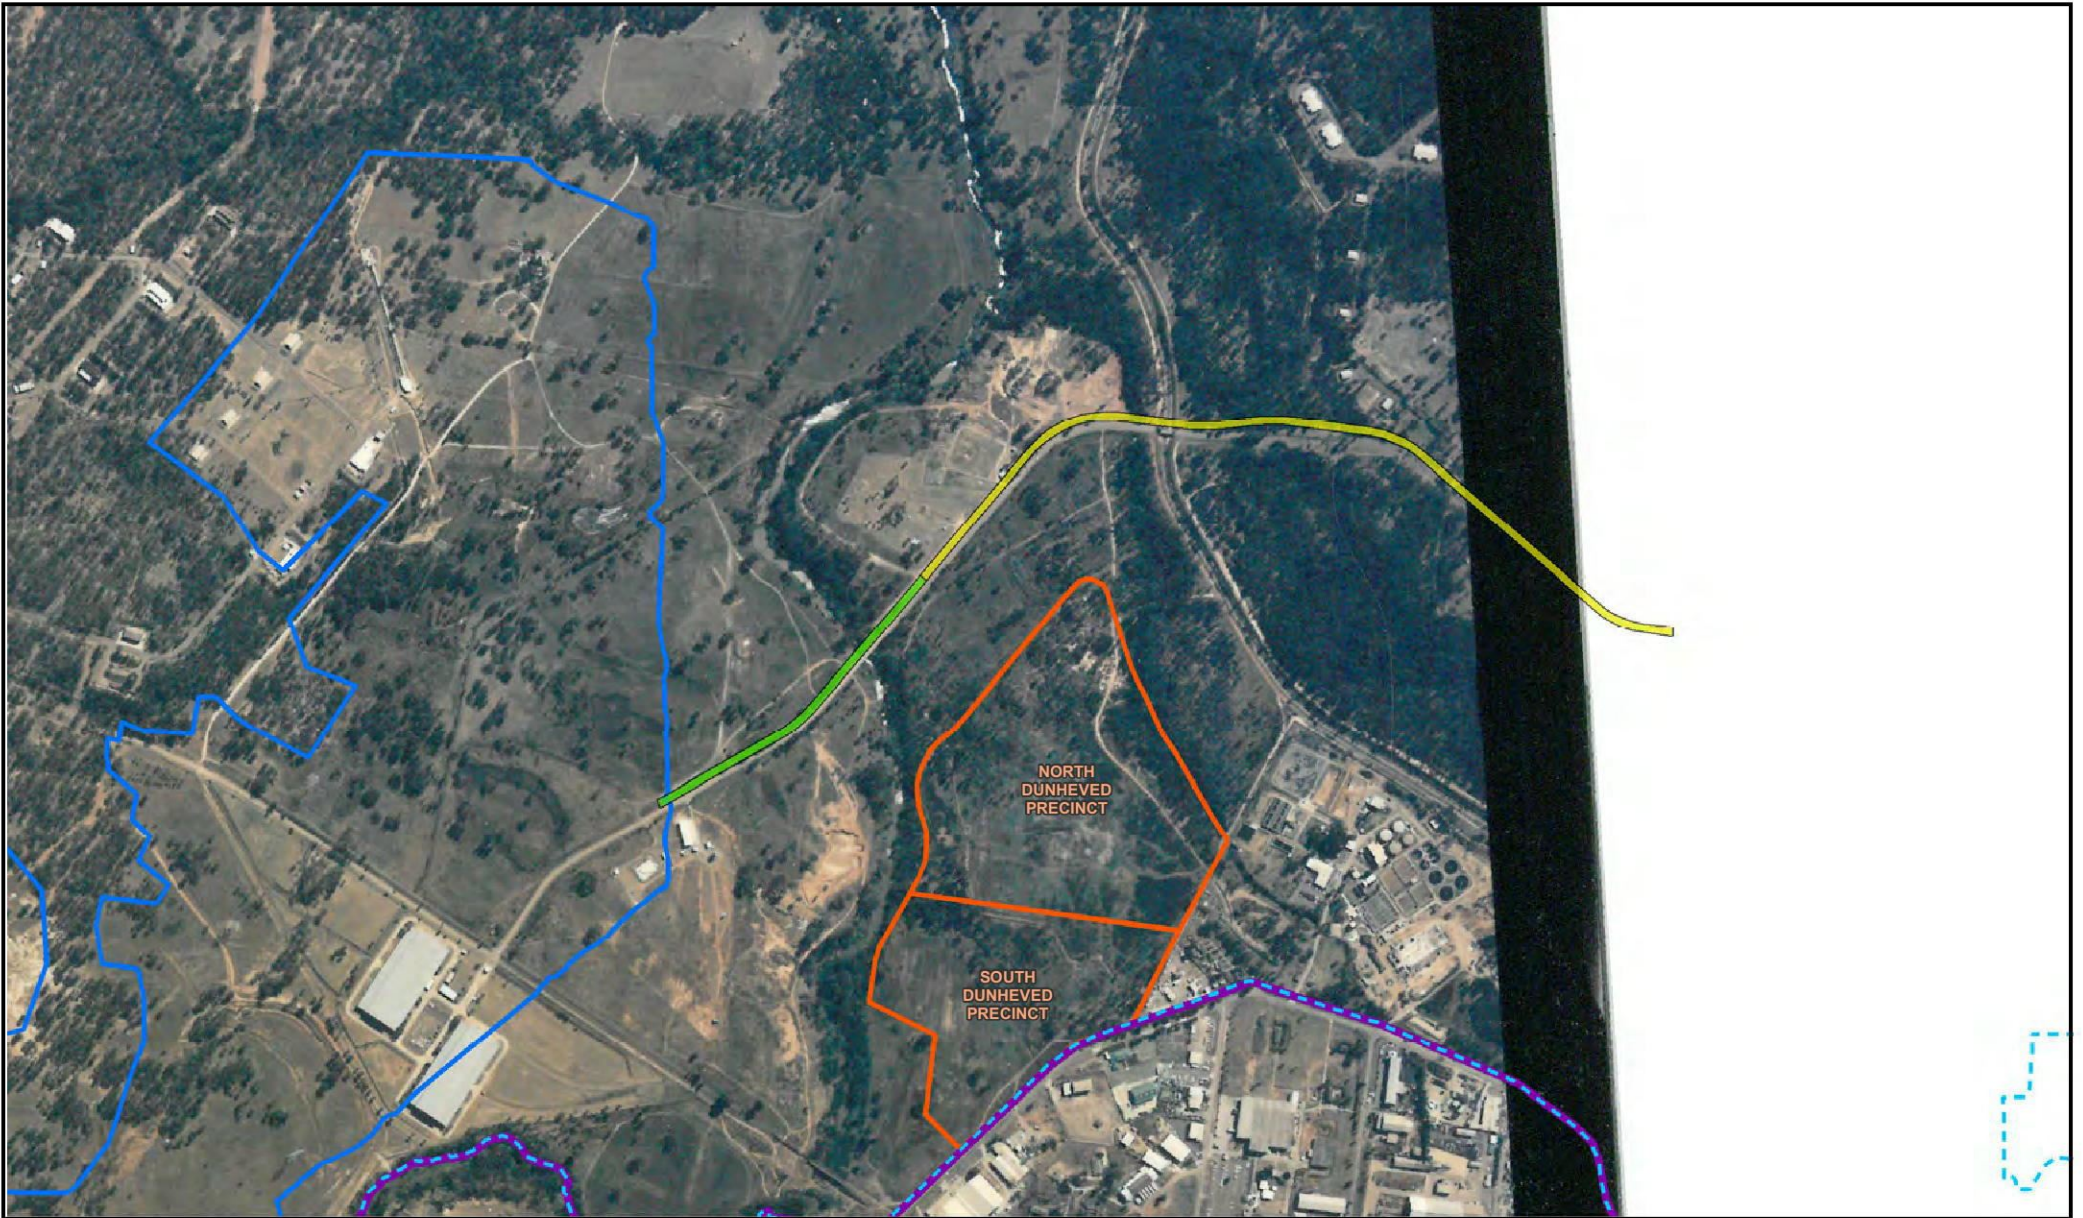
Reference: Spatial Services NSW, 1991

- **1991** – the site and surrounding areas appeared similar to the previous image.
- **2002** – the site appeared similar to the previous image. Changes to the surrounding areas including stockpiling of soils north -west of the site and excavation to the north and south of the site were observed.
